## Baseline Assessment – Stream Attributes

**Reach S-H153 (Pipeline ROW)**

**Lewis County, West Virginia**

Site PROFILE AND CROSS-SECTIONS  
BASELINE SURVEY  
CROSSING S-H153 - UNNAMED TRIBUTARY  
BENS RUN (MP 59.41)  
LEWIS COUNTY, WV

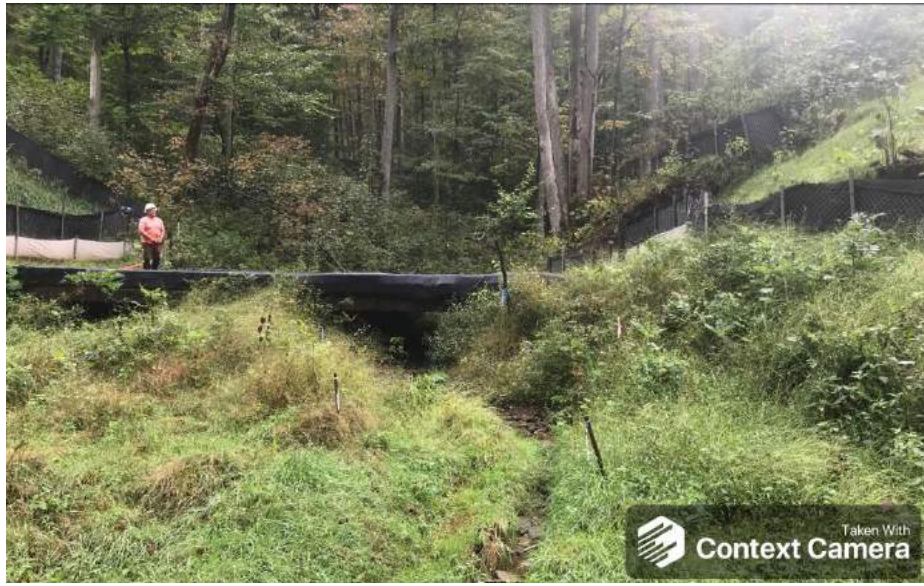
Photo Type: DS, US View

Location, Orientation, Photographer Initials: Downstream Edge of ROW, Upstream View, RH/VM

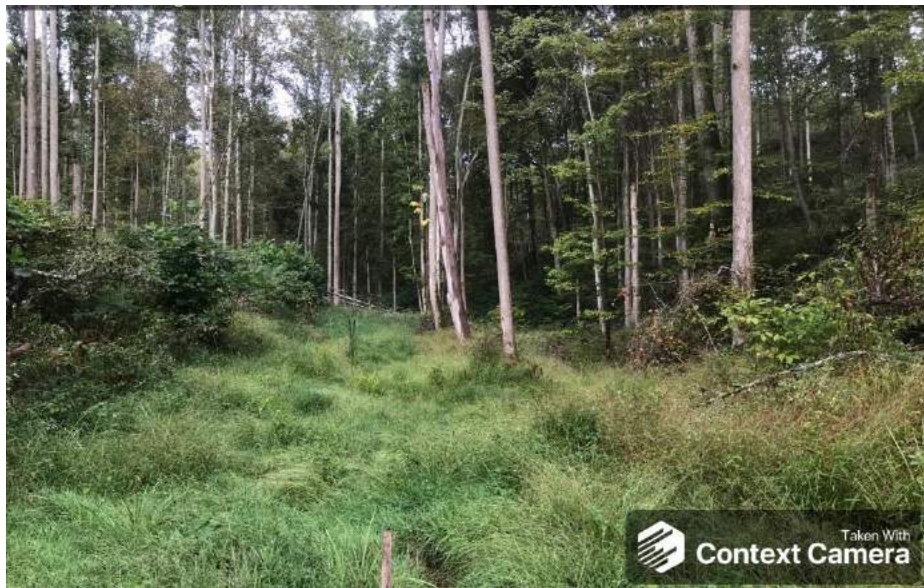
Photo Type: DS, DS View

Location, Orientation, Photographer Initials: Downstream Edge of ROW, Downstream View, RH/VM

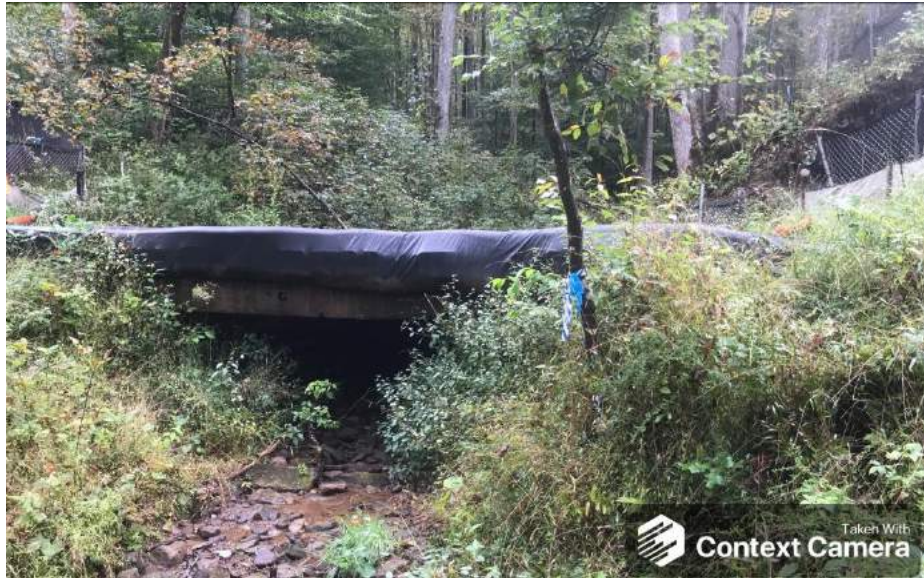
Photo Type: US View at Center  
Location, Orientation, Photographer Initials: Center ROW, Upstream View, RH/VM  
Lat: 38.922846 Long: -80.579227

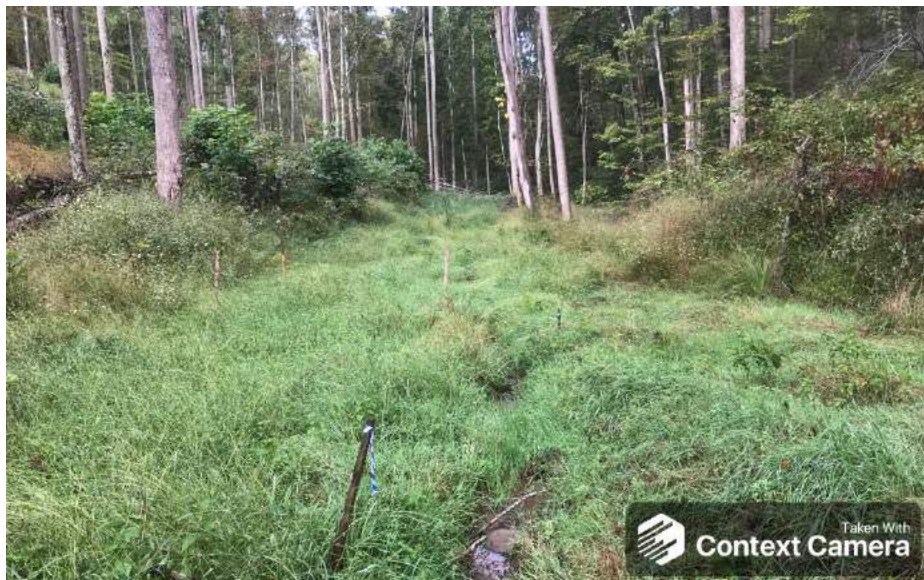
Photo Type: DS View at Center  
Location, Orientation, Photographer Initials: ROW Center, Downstream View, RH/VM  
Lat: 38.922846 Long: -80.579227

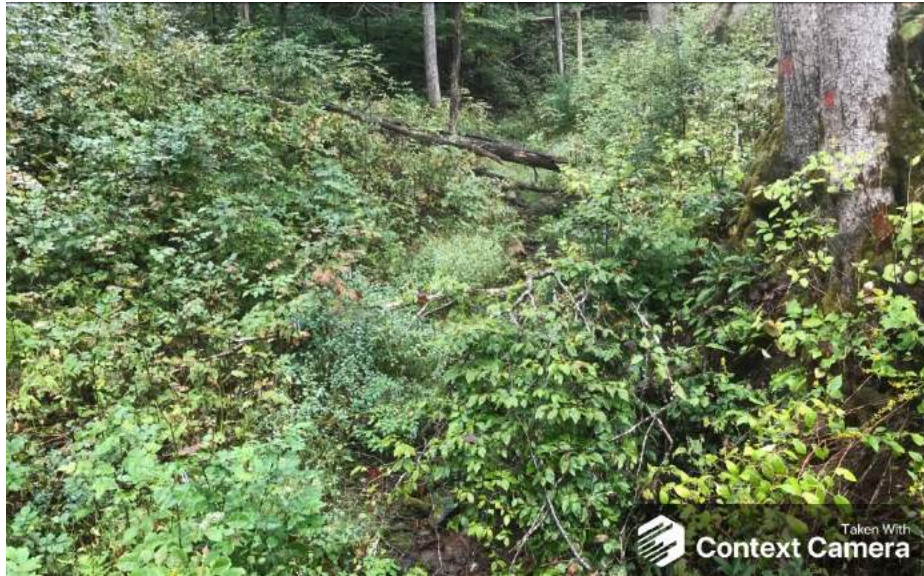
Photo Type: US, US View

Location, Orientation, Photographer Initials: Upstream Edge of ROW, Upstream View, RH/VM

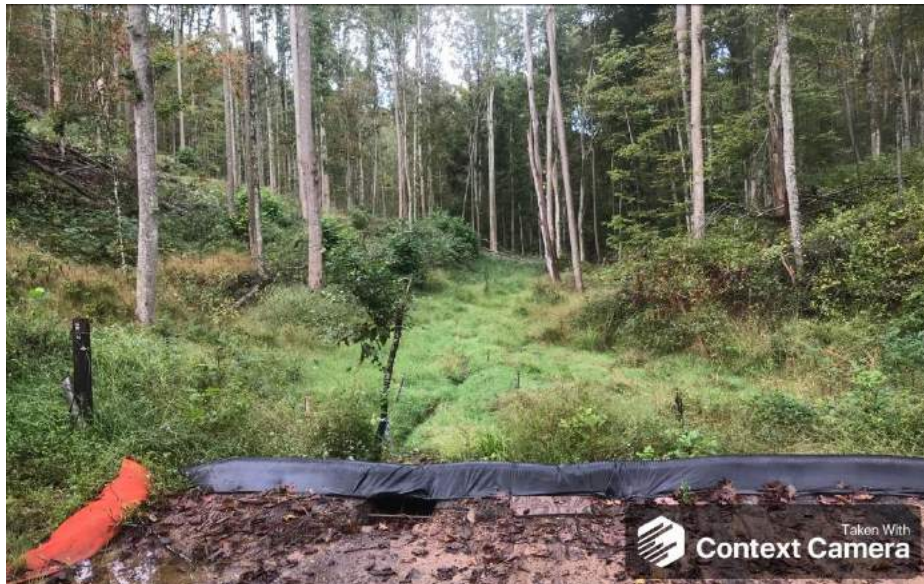
Photo Type: US, DS View

Location, Orientation, Photographer Initials: Upstream Edge of ROW, Downstream View, RH/VM

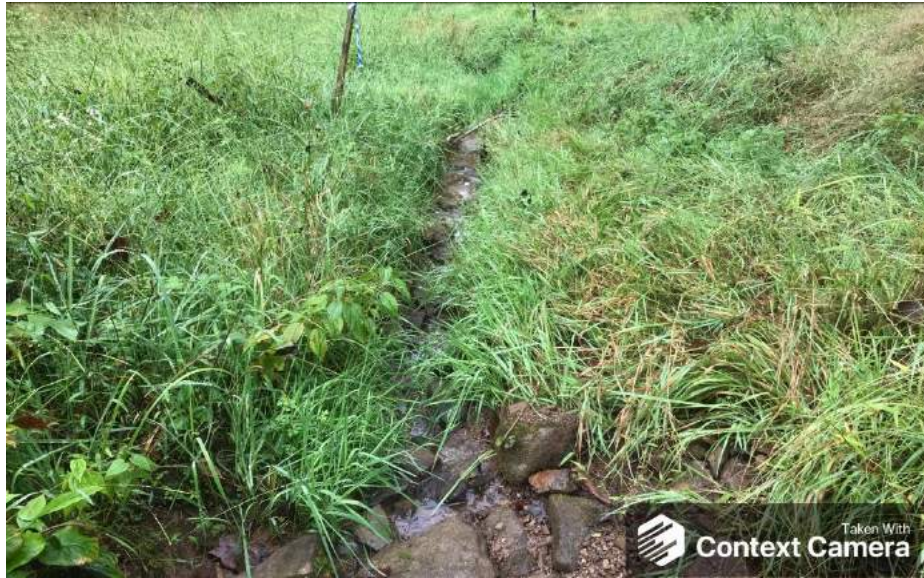
Photo Type: Riffle, DS View  
Location, Orientation, Photographer Initials: Upstream of Riffle, Downstream View, RH/VM  
Lat: 38.922846 Long: -80.579227

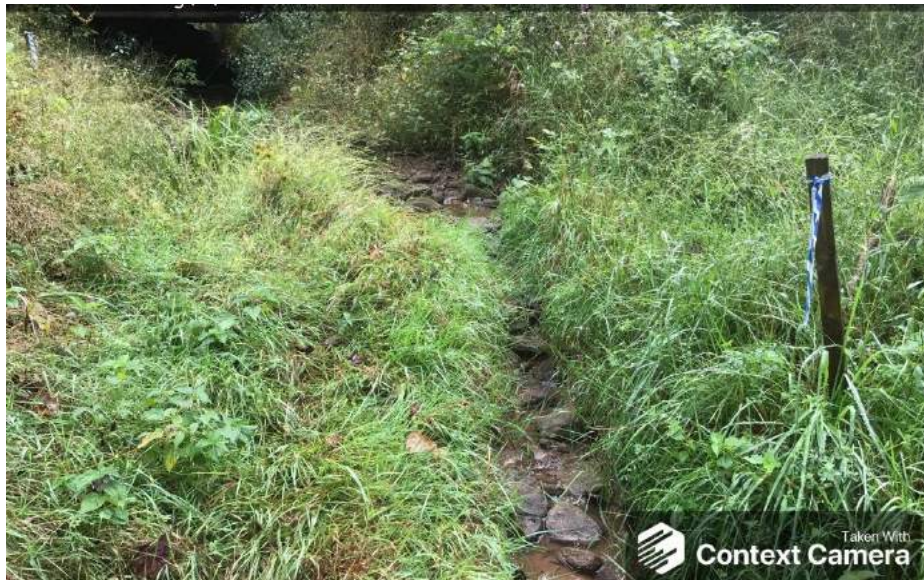
Photo Type: Riffle, US View  
Location, Orientation, Photographer Initials: Downstream of Riffle, Upstream View, RH/VM  
Lat: 38.922846 Long: -80.579227

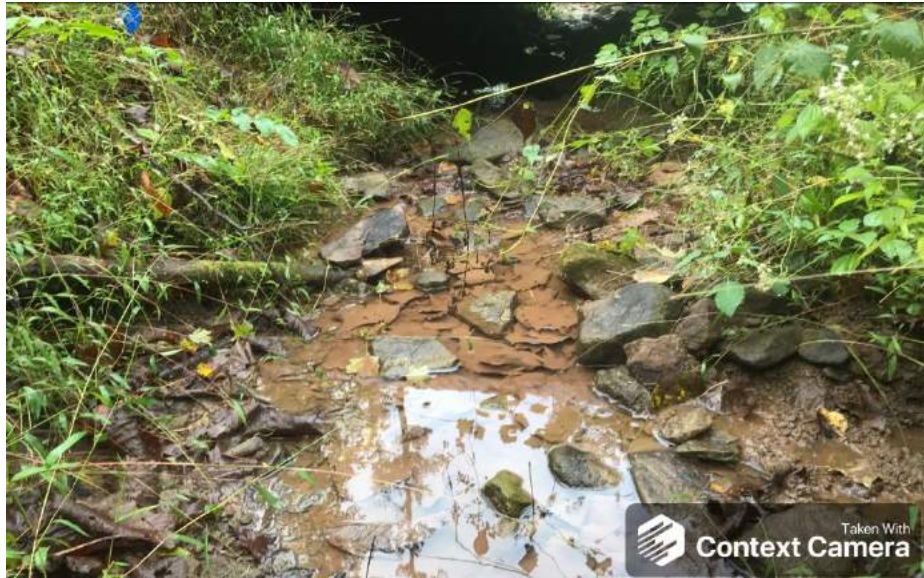
Photo Type: Pool, DS View

Location, Orientation, Photographer Initials: Upstream of Pool, Downstream View, RH/VM

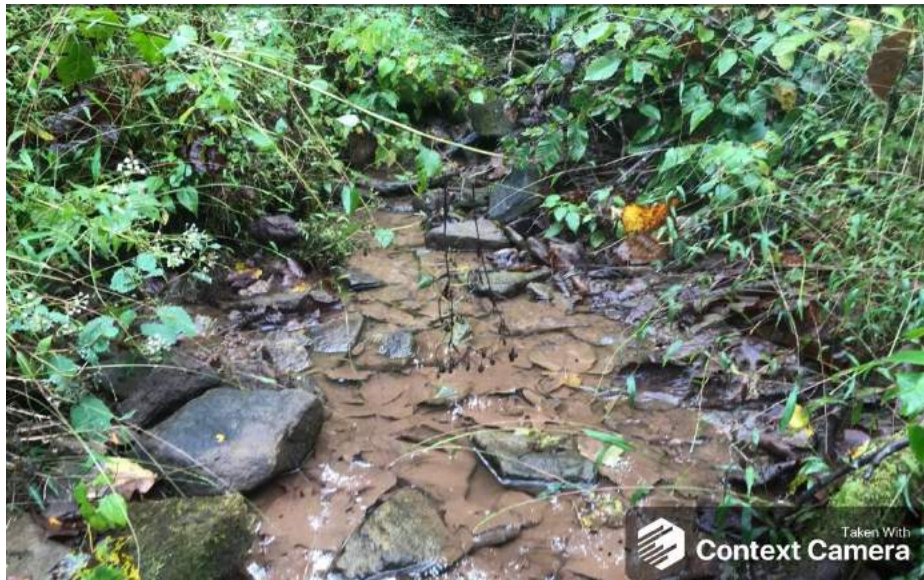
Photo Type: Pool, US View

Location, Orientation, Photographer Initials: Downstream of Pool, Upstream View, RH/VM

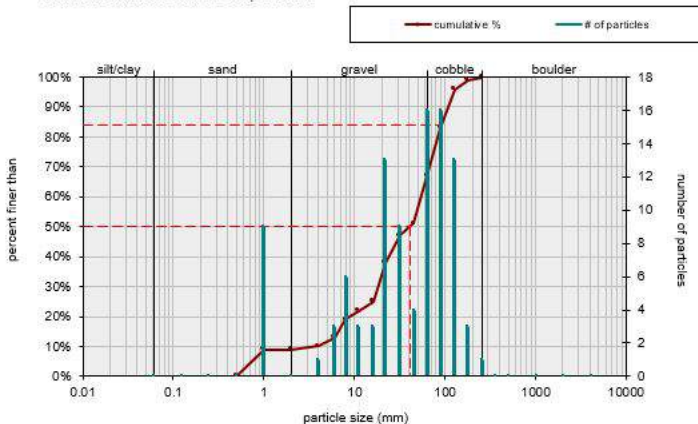
# Bankfull Channel Pebble Count, S-H153

Size (mm)	
D16	6.9
D35	20
D50	41
D65	61
D84	92
D95	120

Size Distribution	
mean	25.2
dispersion	4.1
skewness	-0.20

Type	
silt/clay	0%
sand	9%
gravel	58%
cobble	33%
boulder	0%

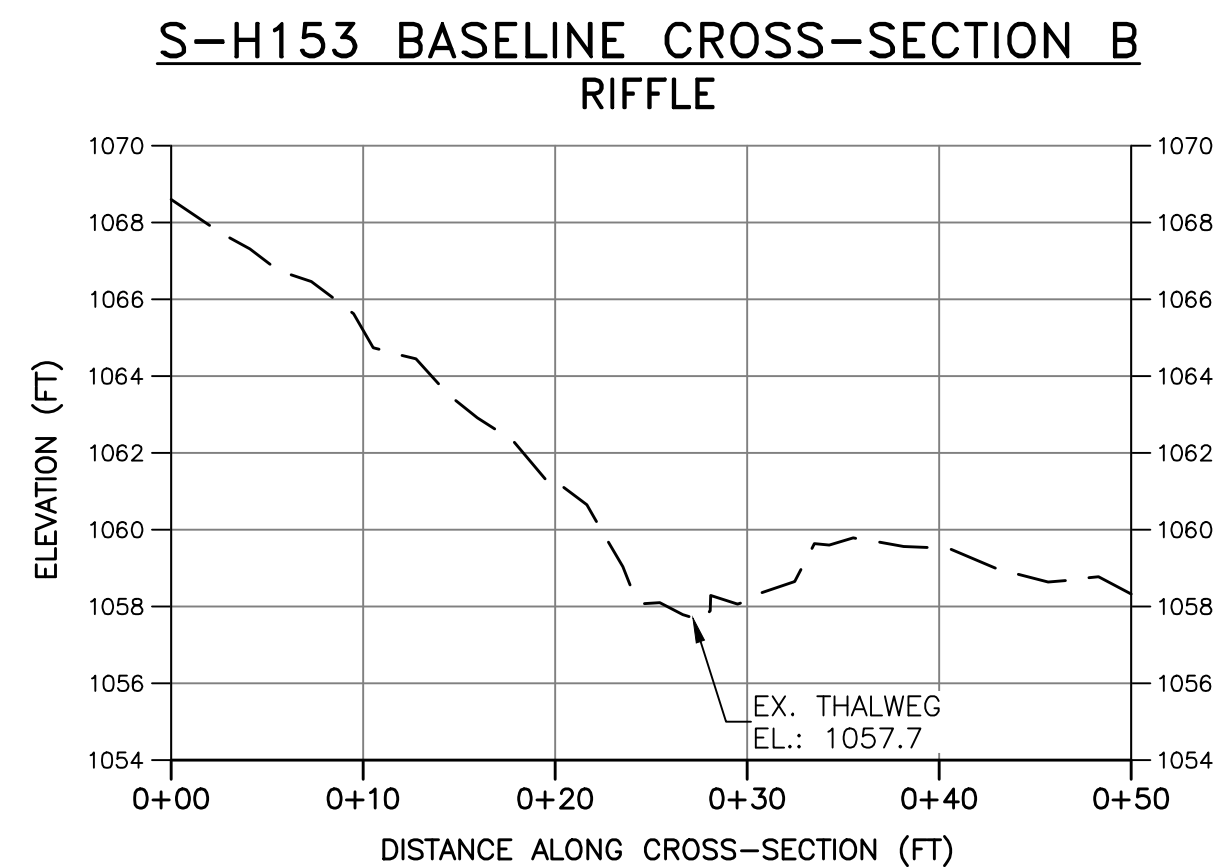
4. ALL SECTION VIEWS SHOWN LEFT TO RIGHT FACING DOWNSTREAM.
5. POST-CROSSING SURVEY INFORMATION SHOWN IN RED. DATA PENDING.
6. POST-CROSSING SURVEY POINTS FOR CROSS SECTIONS AND THALWEG ARE PROJECTED ONTO PRE-CROSSING SECTION AND PROFILE VIEWS FOR COMPARISON.
