Baseline Assessment – Stream Attributes

Reach S-H99 (Pipeline ROW) Perennial Spread D Nicholas County, West Virginia

Title PROFILE AND CROSS-SECTIONS
BASELINE SURVEY
CROSSING S-H99 - UNNAMED TRIB.
BEAVER CREEK (MP 115.82)
NICHOLAS COUNTY, WV

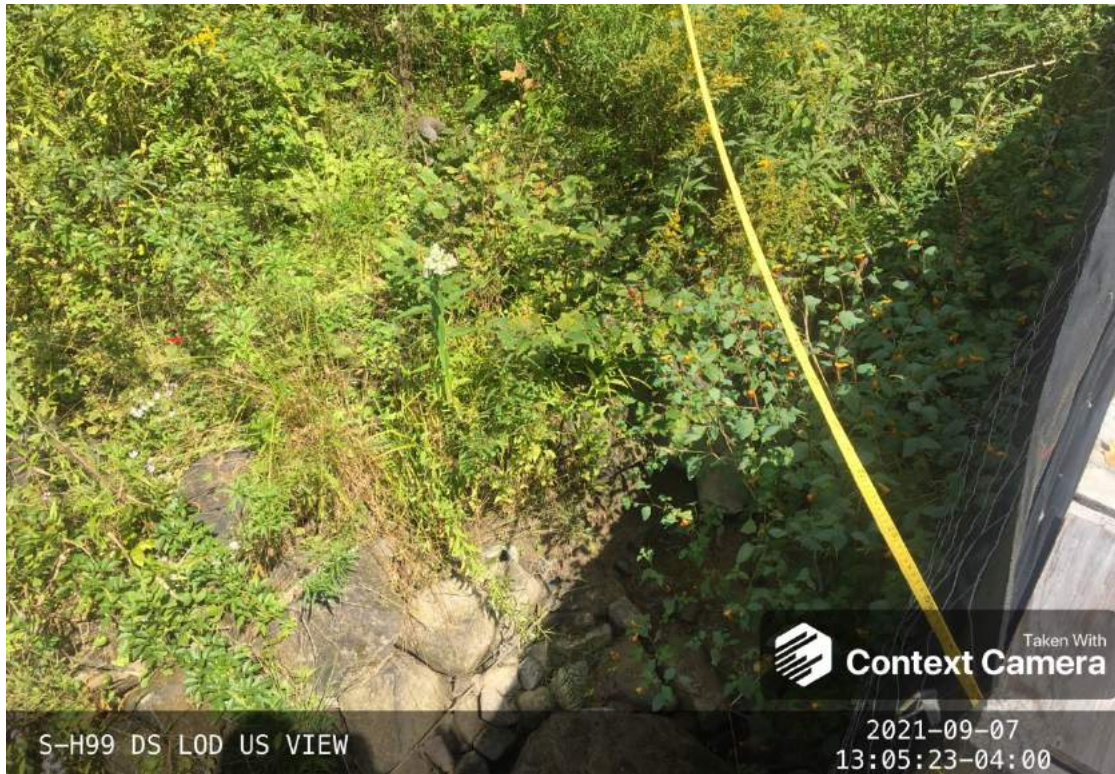
Photo Type: DS, US View

Location, Orientation, Photographer Initials: Downstream Edge of ROW, Upstream View, VM, SK, HK
Lat: 38.312952 Long: -80.673145

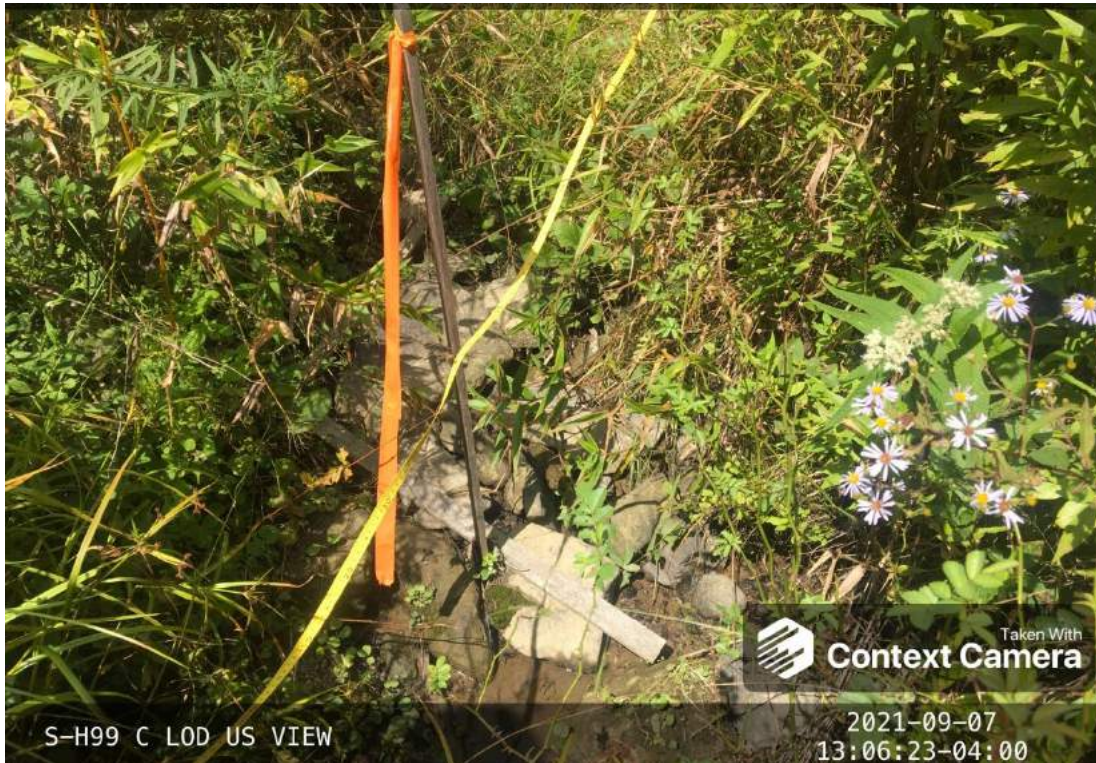
Photo Type: US View at Center
Location, Orientation, Photographer Initials: Center ROW, Upstream View, VM, SK, HK
Lat: 38.312952 Long: -80.673145

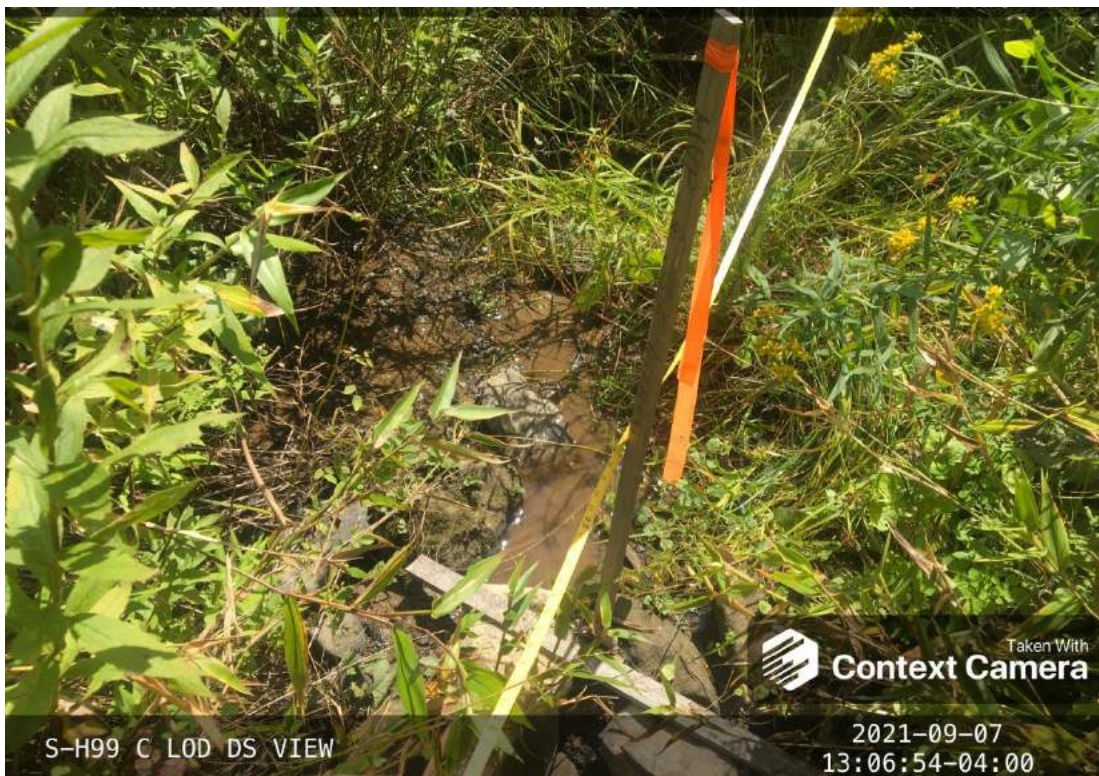
Photo Type: DS View at Center
Location, Orientation, Photographer Initials: ROW Center, Downstream View, VM, SK, HK
Lat: 38.312952 Long: -80.673145

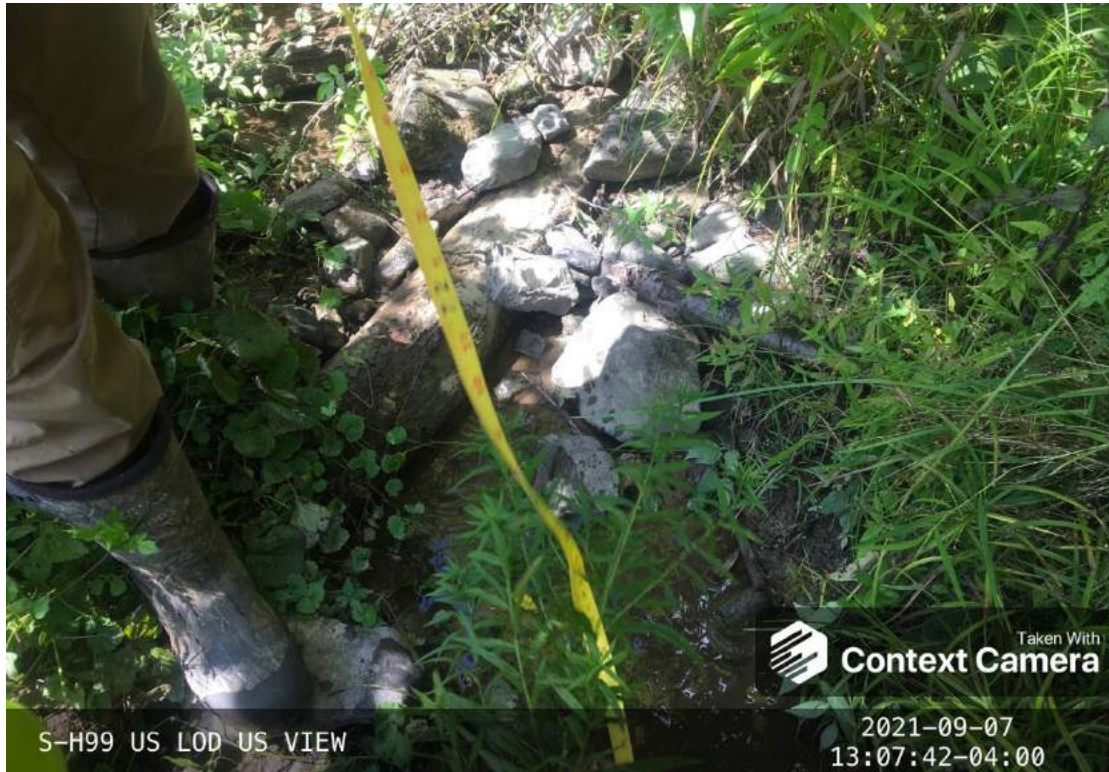
Photo Type: US, US View
Location, Orientation, Photographer Initials: Upstream Edge of ROW, Upstream View, VM, SK, HK
Lat: 38.312952 Long: -80.673145

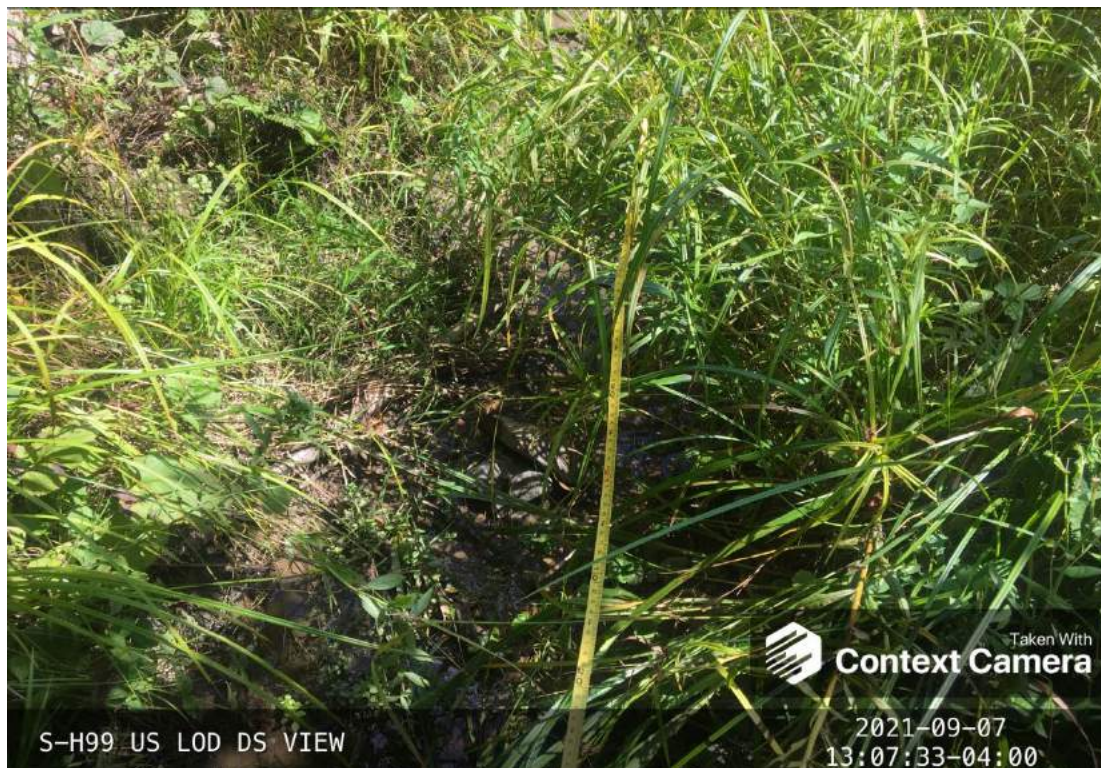
Photo Type: US, DS View
Location, Orientation, Photographer Initials: Upstream Edge of ROW, Downstream View, VM, SK, HK
Lat: 38.312952 Long: -80.673145

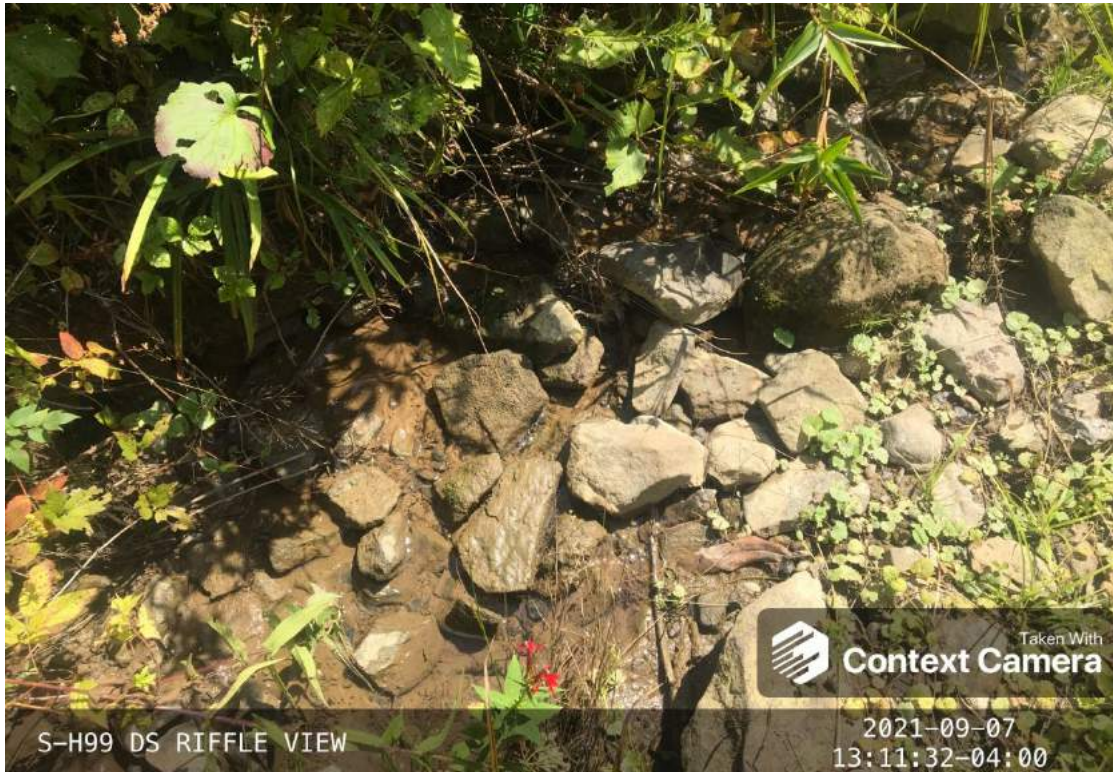
Photo Type: Riffle, DS View
Location, Orientation, Photographer Initials: Upstream of Riffle, Downstream View, VM, SK, HK
Lat: 38.312952 Long: -80.673145

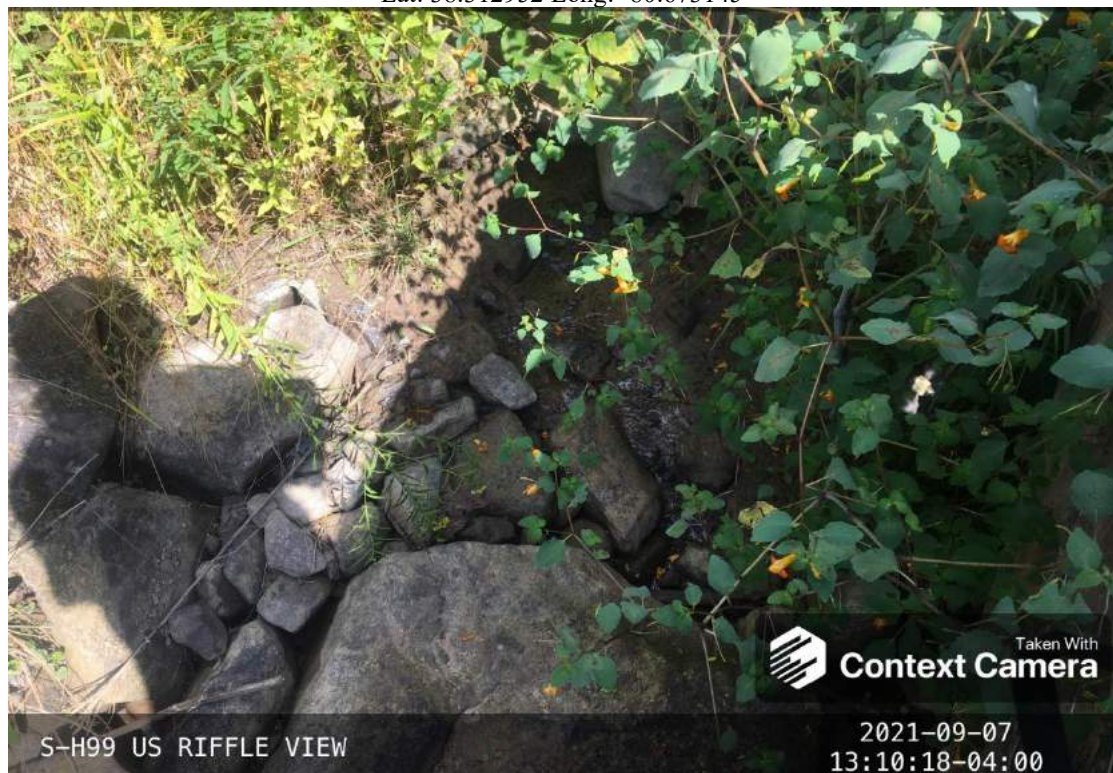
Photo Type: Riffle, US View
Location, Orientation, Photographer Initials: Downstream of Riffle, Upstream View, VM, SK, HK
Lat: 38.312952 Long: -80.673145

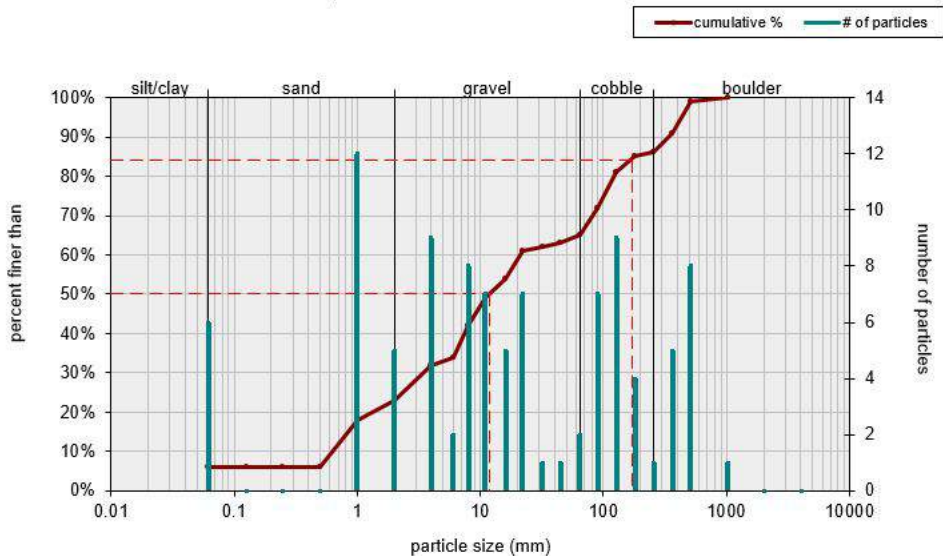
Bankfull Channel Pebble Count, S-H99

Size (mm)	
D16	0.89
D35	6.2
D50	12
D65	64
D84	170
D95	430

Size Distribution	
mean	12.3
dispersion	13.8
skewness	0.01

Type	
silt/clay	6%
sand	17%
gravel	42%
cobble	21%
boulder	14%

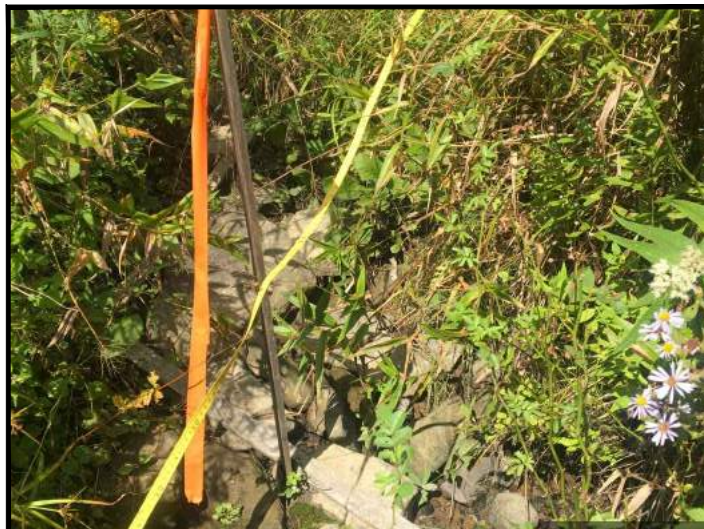
PHOTO TAKEN LOOKING UPSTREAM FROM
DOWNSTREAM IMPACT LIMITS
