Baseline Assessment – Stream Attributes

Reach S-I22 (Pipeline ROW) Intermittent Spread E Greenbrier County, West Virginia

Title
PROFILE AND CROSS-SECTIONS
BASELINE SURVEY
CROSSING S-122 - UNNAMED TRIB. TO
BOGGS CREEK (MP 149.93)
GREENBRIER COUNTY, WV

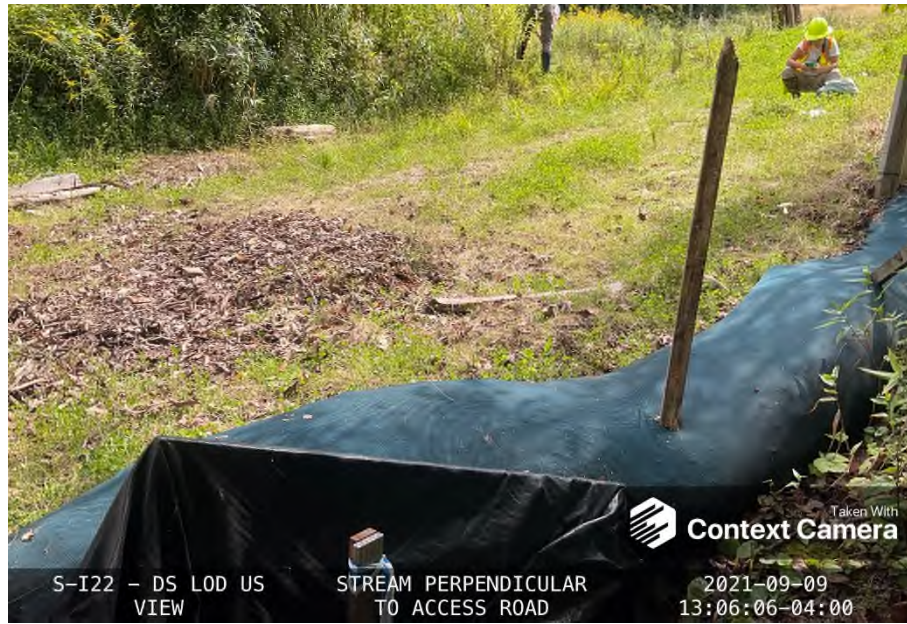
Photo Type: DS, US VIEW

Location, Orientation, Photographer Initials: Downstream Edge of ROW, Upstream View, CNJ

Lat: 37.918041 Long: -80.736833

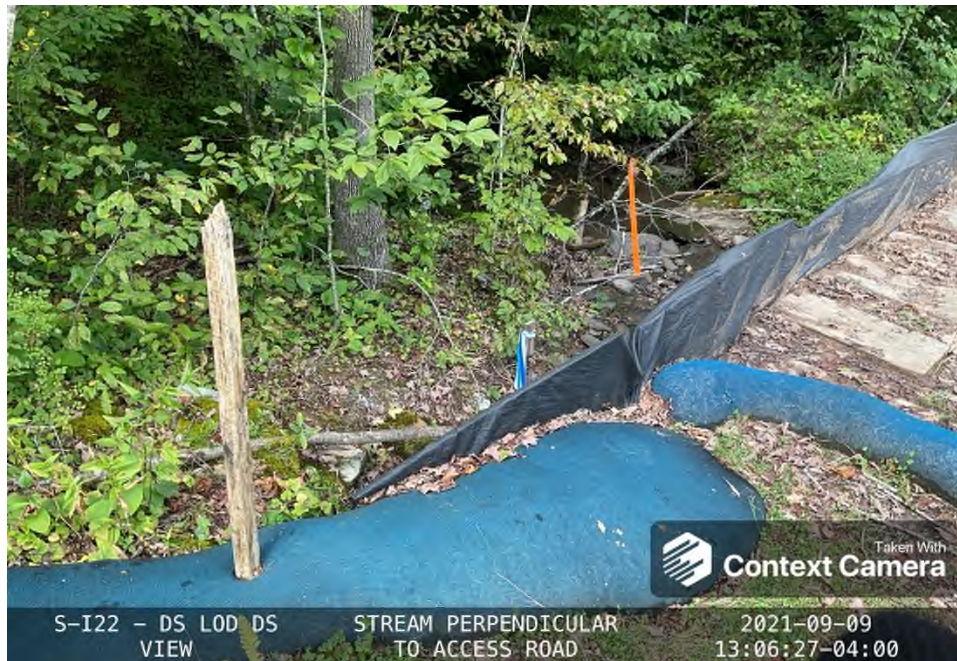
Photo Type: DS, DS VIEW

Location, Orientation, Photographer Initials: Downstream Edge of ROW, Downstream View, CNJ

Lat: 37.918041 Long: -80.736833

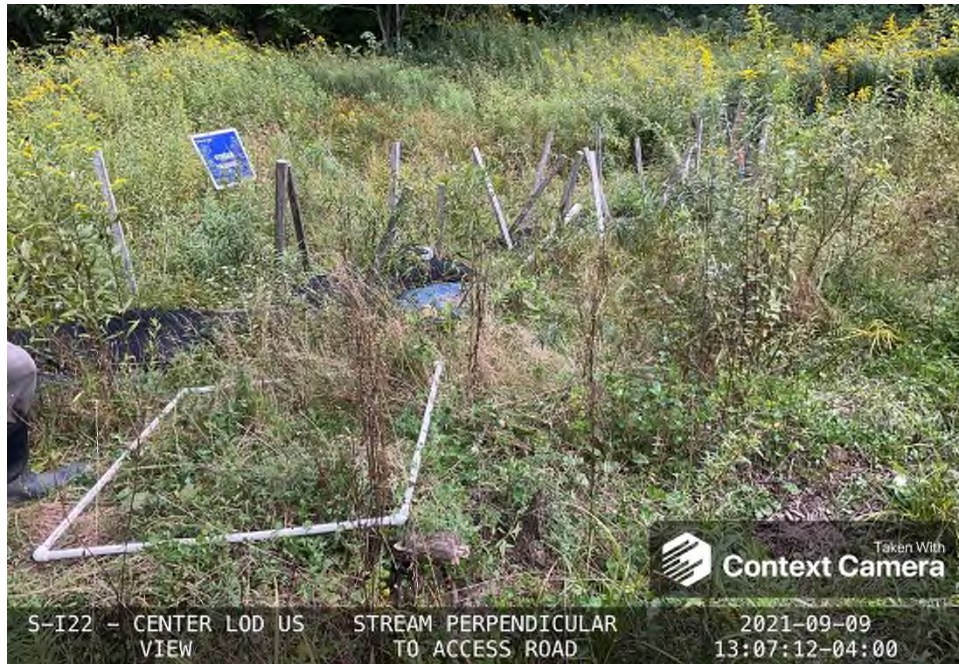
Photo Type: US View at Center
Location, Orientation, Photographer Initials: Center ROW, Upstream View, CNJ
Lat: 37.918041 Long: -80.736833

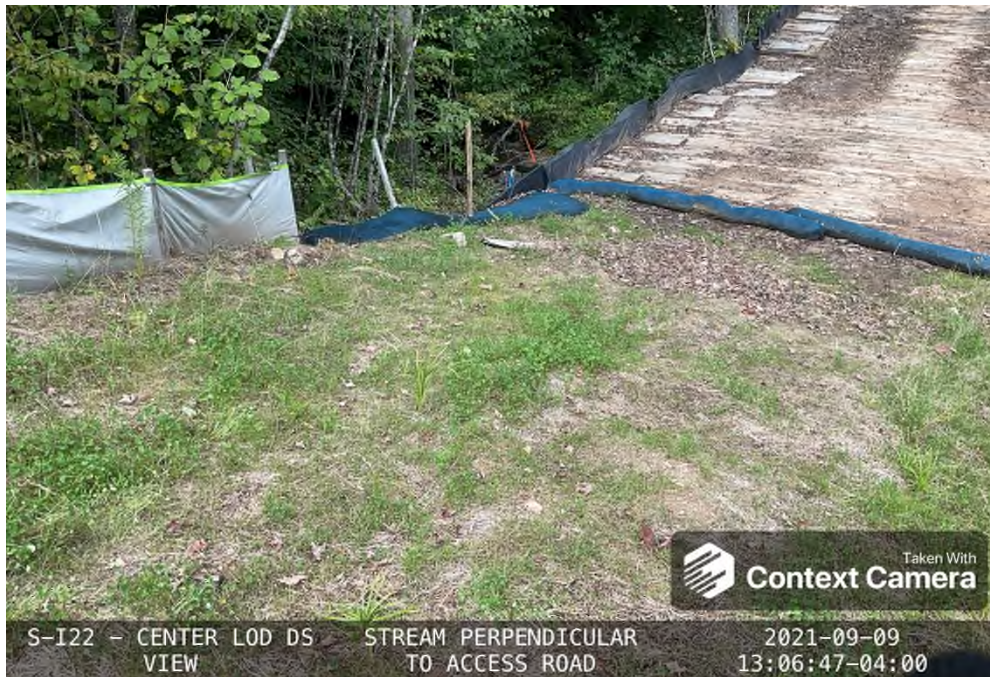
Photo Type: DS View at Center
Location, Orientation, Photographer Initials: ROW Center. Downstream View, CNJ
Lat: 37.918041 Long: -80.736833

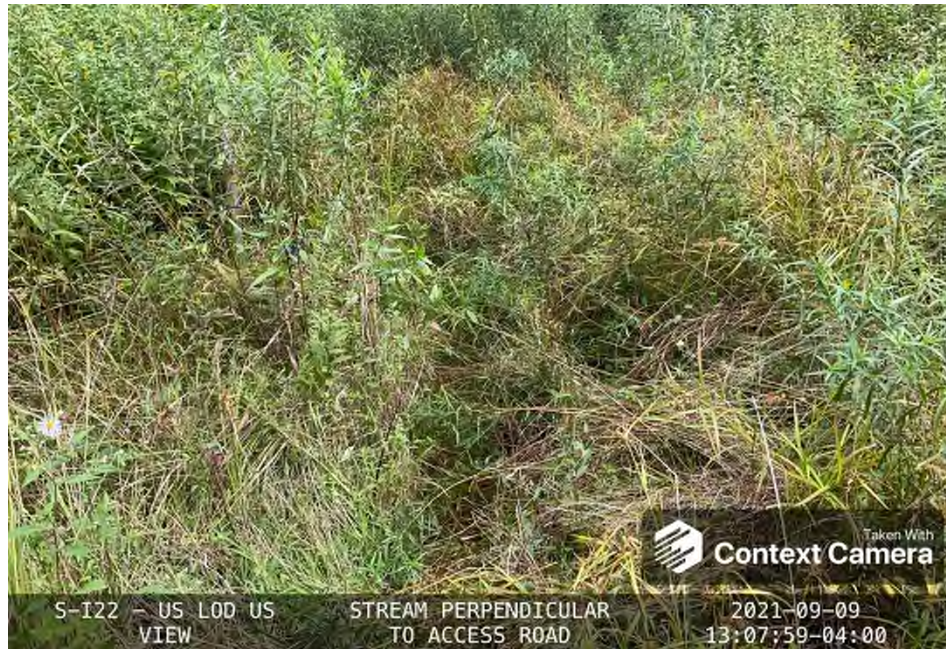
Photo Type: US, US View

Location, Orientation, Photographer Initials: Upstream Edge of ROW, Upstream View, CNJ
 Lat: 37.918041 Long: -80.736833

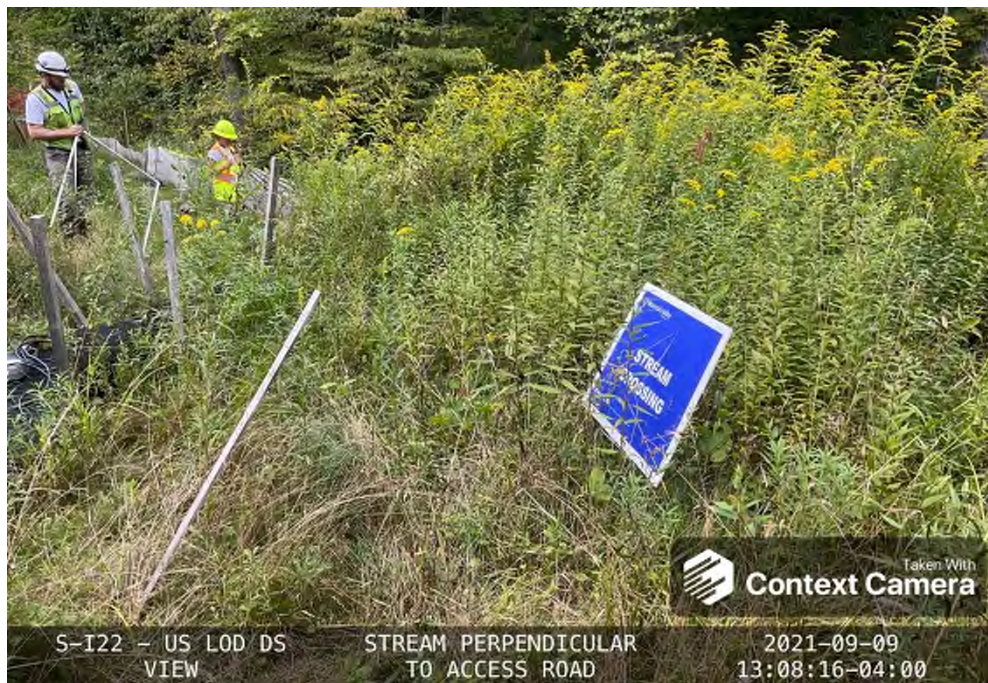
Photo Type: US, DS View

Location, Orientation, Photographer Initials: Upstream Edge of ROW, Downstream View, CNJ
 Lat: 37.918041 Long: -80.736833

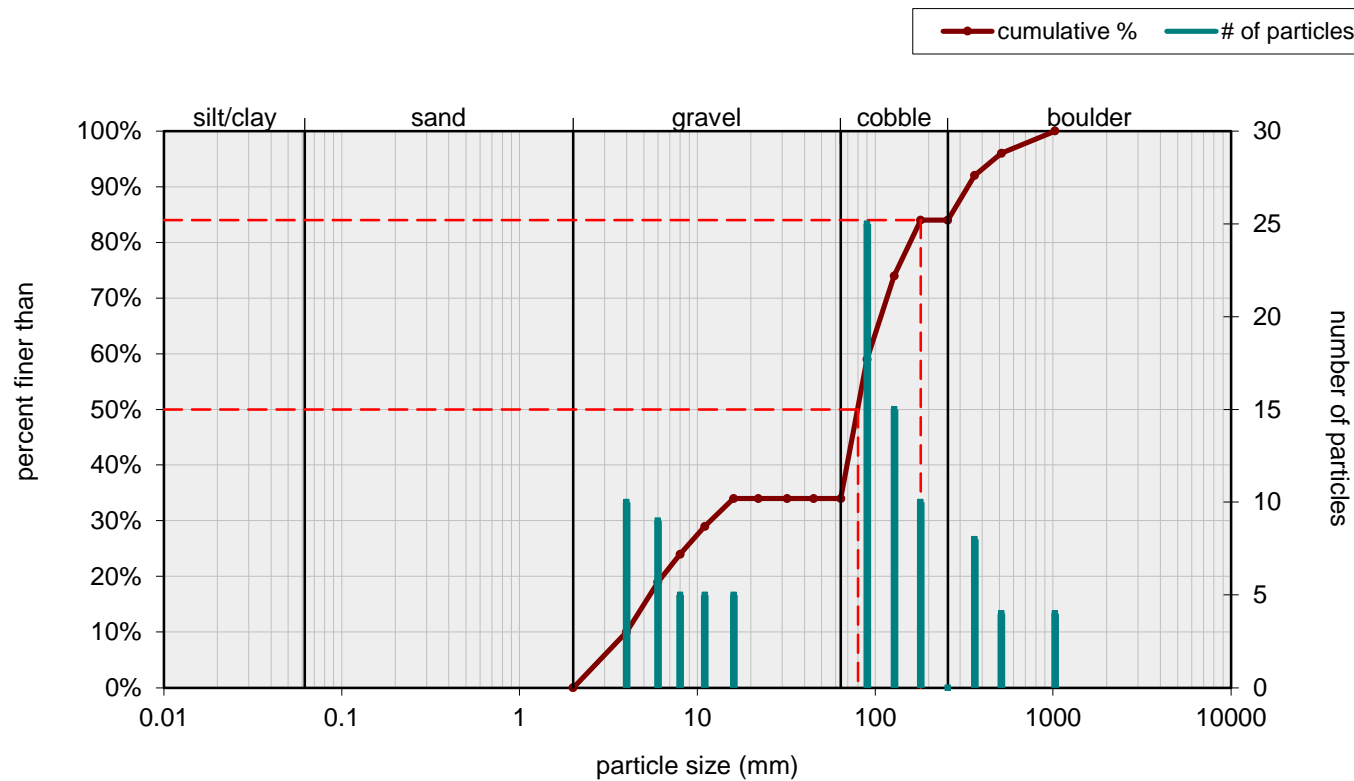
Bankfull Channel Pebble Count, S-I22; UNT to Boggs Creek

Size (mm)		Size Distribution		Type	
D16	5.2	mean	30.6	silt/clay	0%
D35	65	dispersion	8.8	sand	0%
D50	80	skewness	-0.34	gravel	34%
D65	100			cobble	50%
D84	180			boulder	16%
D95	470

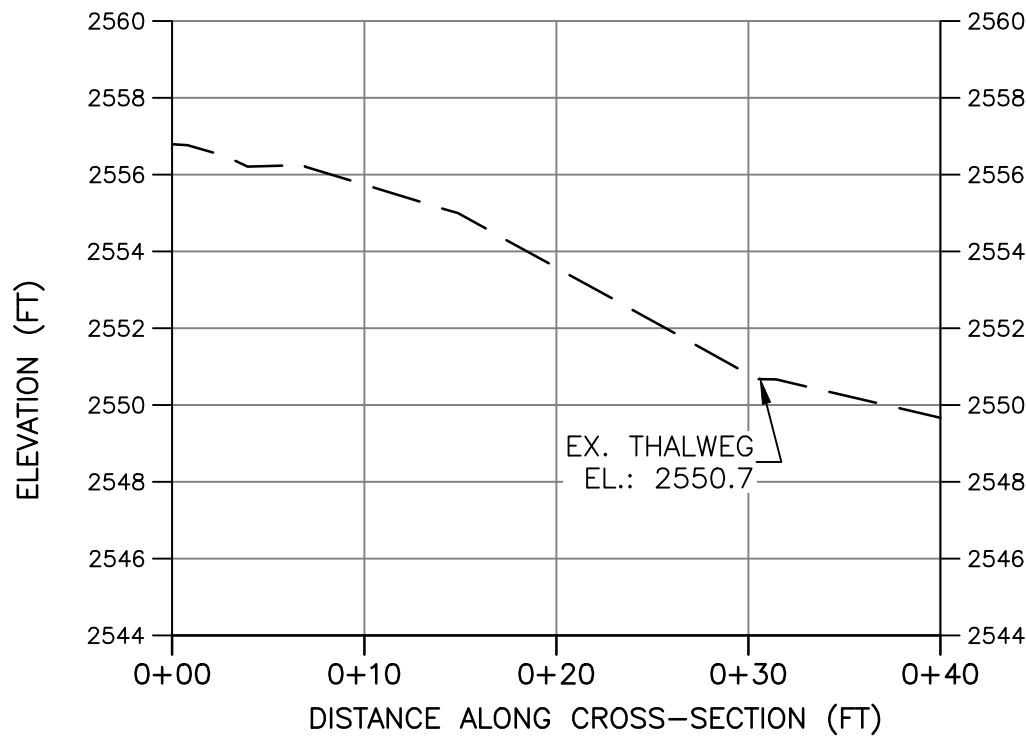
S-122 BASELINE CROSS-SECTION A PIPELINE

SCALE: H: 1"=10'
V: 1"=5'

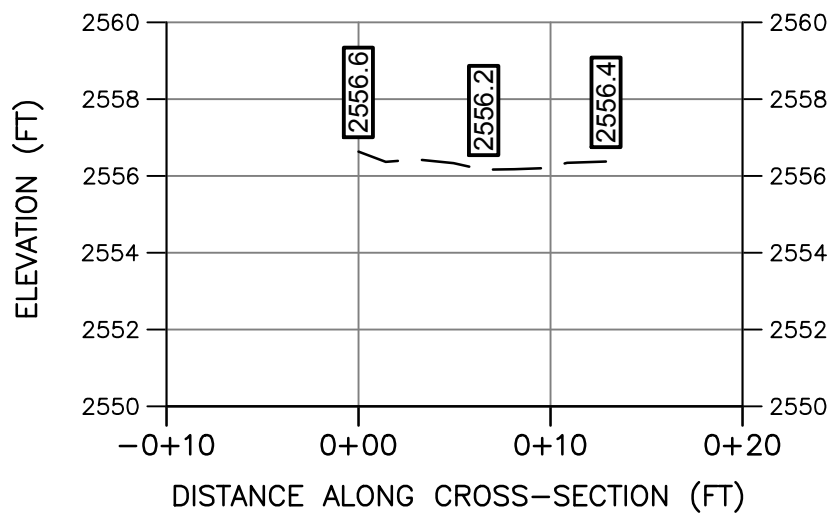
S-122 BASELINE THALWEG PROFILE

- EXISTING STREAM PROFILE
- - - INVERT ALONG THALWEG

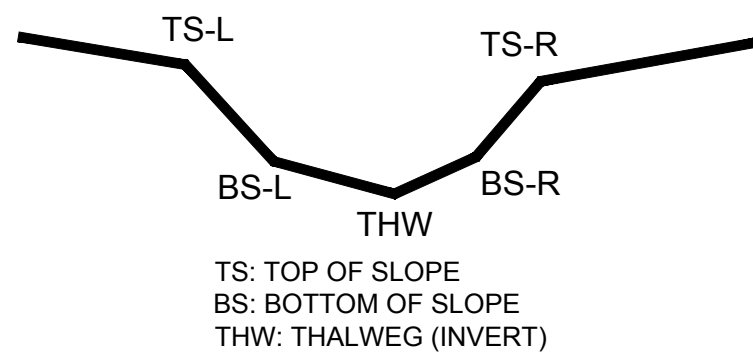
TYPICAL 5-POINT CROSS-SECTION (FACING DOWNSTREAM)

SCALE: H: 1"=10'
V: 1"=5'

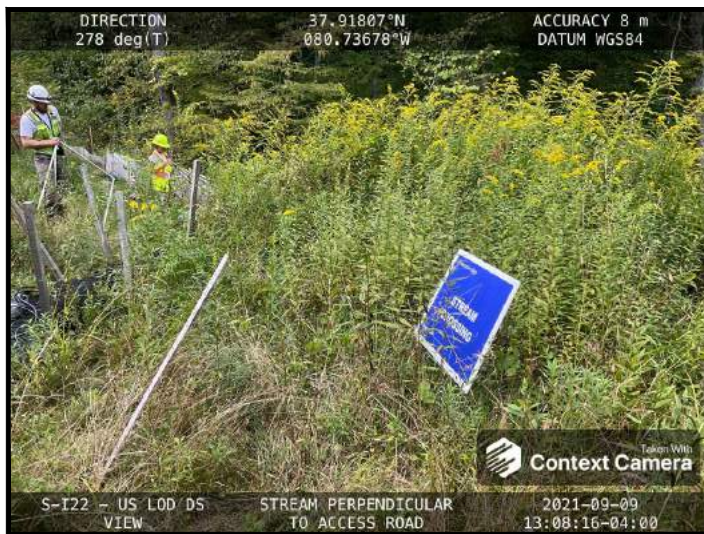
PHOTO TAKEN LOOKING DOWNSTREAM FROM UPSTREAM IMPACT LIMITS

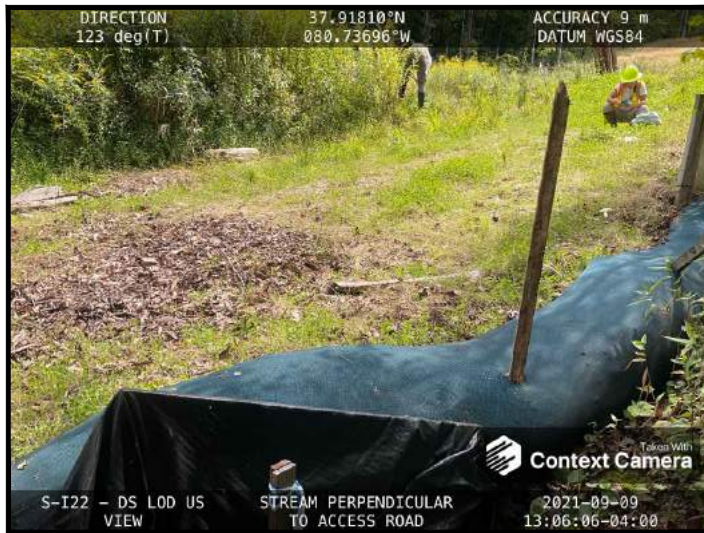
PHOTO TAKEN LOOKING UPSTREAM FROM DOWNSTREAM IMPACT LIMITS
