Baseline Assessment – Stream Attributes

Reach S-I60 (Timber Mat Crossing) Intermittent Spread C Braxton County, West Virginia

Spread C Stream S-I60 (Timber Mat Crossing) Braxton County

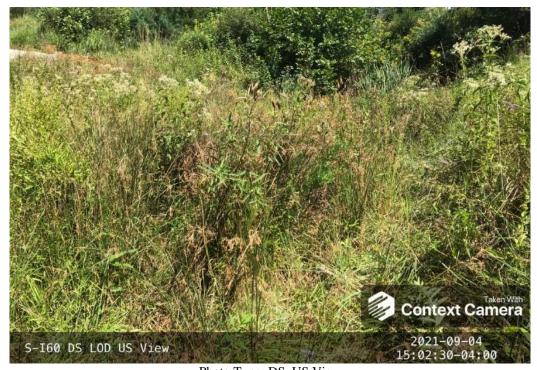
Photo Type: DS, US View Location, Orientation, Photographer Initials: Downstream Edge of ROW, Upstream View, DH, HK Lat: 38.781068 Long: -80.524577

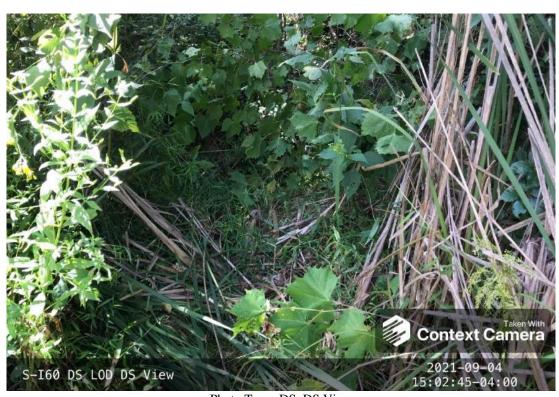
Photo Type: DS, DS View Location, Orientation, Photographer Initials: Downstream Edge of ROW, Downstream View, DH, HK Lat: 38.781068 Long: -80.524577

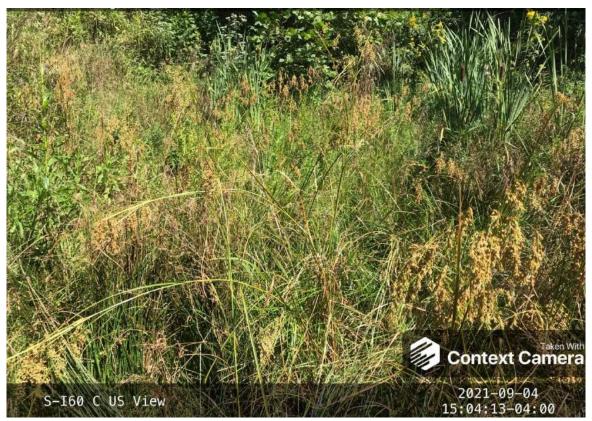
Photo Type: US View at Center Location, Orientation, Photographer Initials: Center ROW, Upstream View, DH, HK Lat: 38.781068 Long: -80.524577

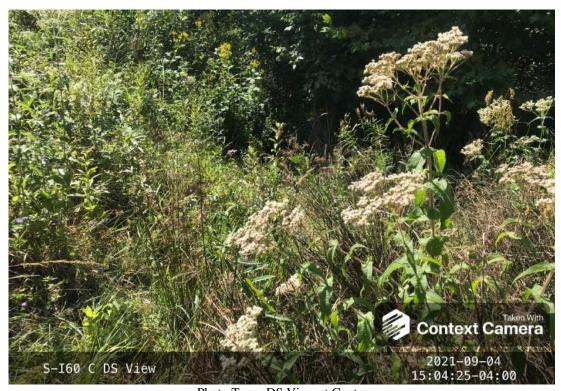
Photo Type: DS View at Center Location, Orientation, Photographer Initials: ROW Center, Downstream View, DH, HK Lat: 38.781068 Long: -80.524577

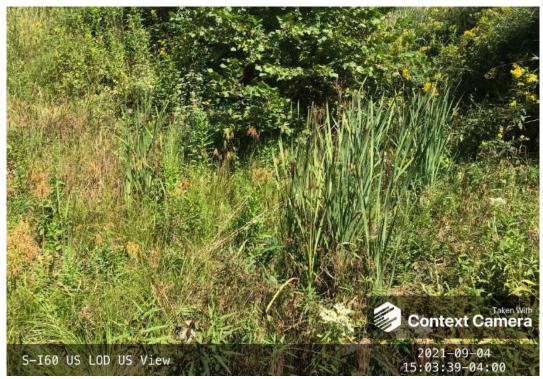
Photo Type: US, US View Location, Orientation, Photographer Initials: Upstream Edge of ROW, Upstream View, DH, HK Lat: 38.781068 Long: -80.524577

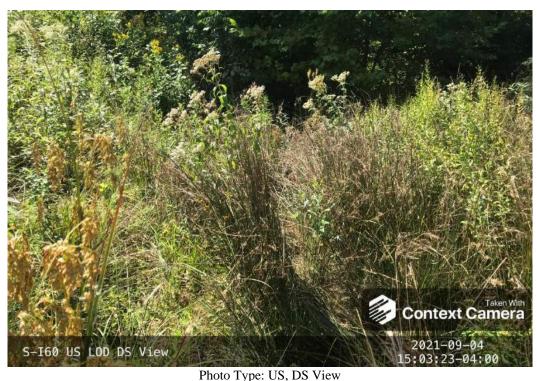
Location, Orientation, Photographer Initials: Upstream Edge of ROW, Downstream View, DH, HK
Lat: 38.781068 Long: -80.524577

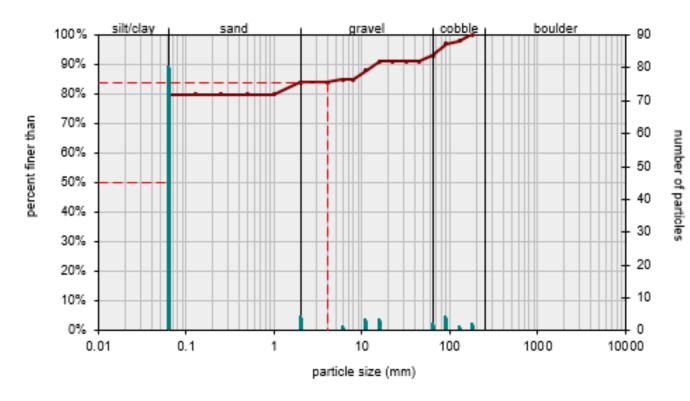
Size (r	nm)	1
□16	0.062	
□35	0.062	
□50	0.062	
□65	0.062	
□84	4	
□95	76

Size Dist	ribution
mean	0.5
dispersion	32.8
skewness	0.67

Type	
silt/clay	80%	
sand	4%	
gravel	9%	
cobble	7%	
boulder	0%

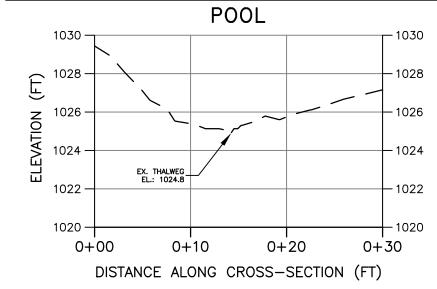
S-160 BASELINE CROSS-SECTION A

AS-BUILT TABLE: S-160 CROSS SECTION A							
	PR	AS-E	UILT				
PT. LOC.	NORTHING	EASTING	ELEV	VERT. DIFF.	HORZ. DIFF.		
TS-L	14083264.1800 ^r	1775884.3560	1026.163'				
BS-L	14083264.9600	1775884.24801	1025.530'				
THW	14083271.1300	1775884.4800	1025.005'				
BS-R	14083271.6700	1775884.4240	1025.136'	·			
TS-R	14083274.3900	1775884.54601	1025.842'

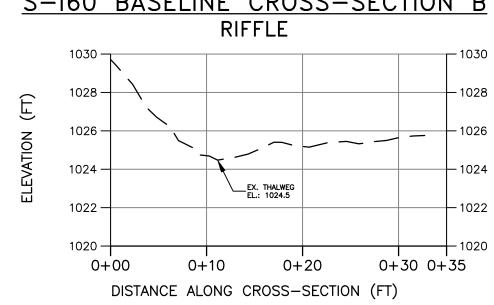
S-160 BASELINE CROSS-SECTION B

CROSS SECTION
H: 1"=10'
V: 1"=5'

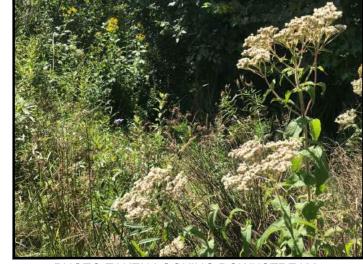
PHOTO TAKEN LOOKING DOWNSTREAM FROM UPSTREAM IMPACT LIMITS

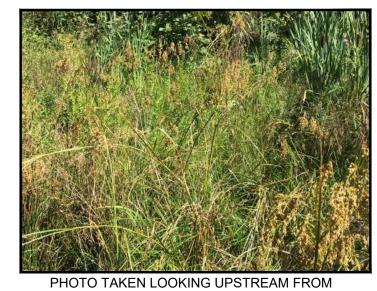
DOWNSTREAM IMPACT LIMITS
