Baseline Assessment – Stream Attributes

Reach S-IJ57 (Pipeline ROW) Perennial Spread D Nicholas County, West Virginia

Spread D Stream S-IJ57 (Pipeline ROW) Nicholas County

Title PROFILE AND CROSS-SECTIONS
BASELINE SURVEY
CROSSING S-IJ57 - UNNAMED TRIBUTARY
BARN RUN (MP 111.60)
NICHOLAS COUNTY, WV

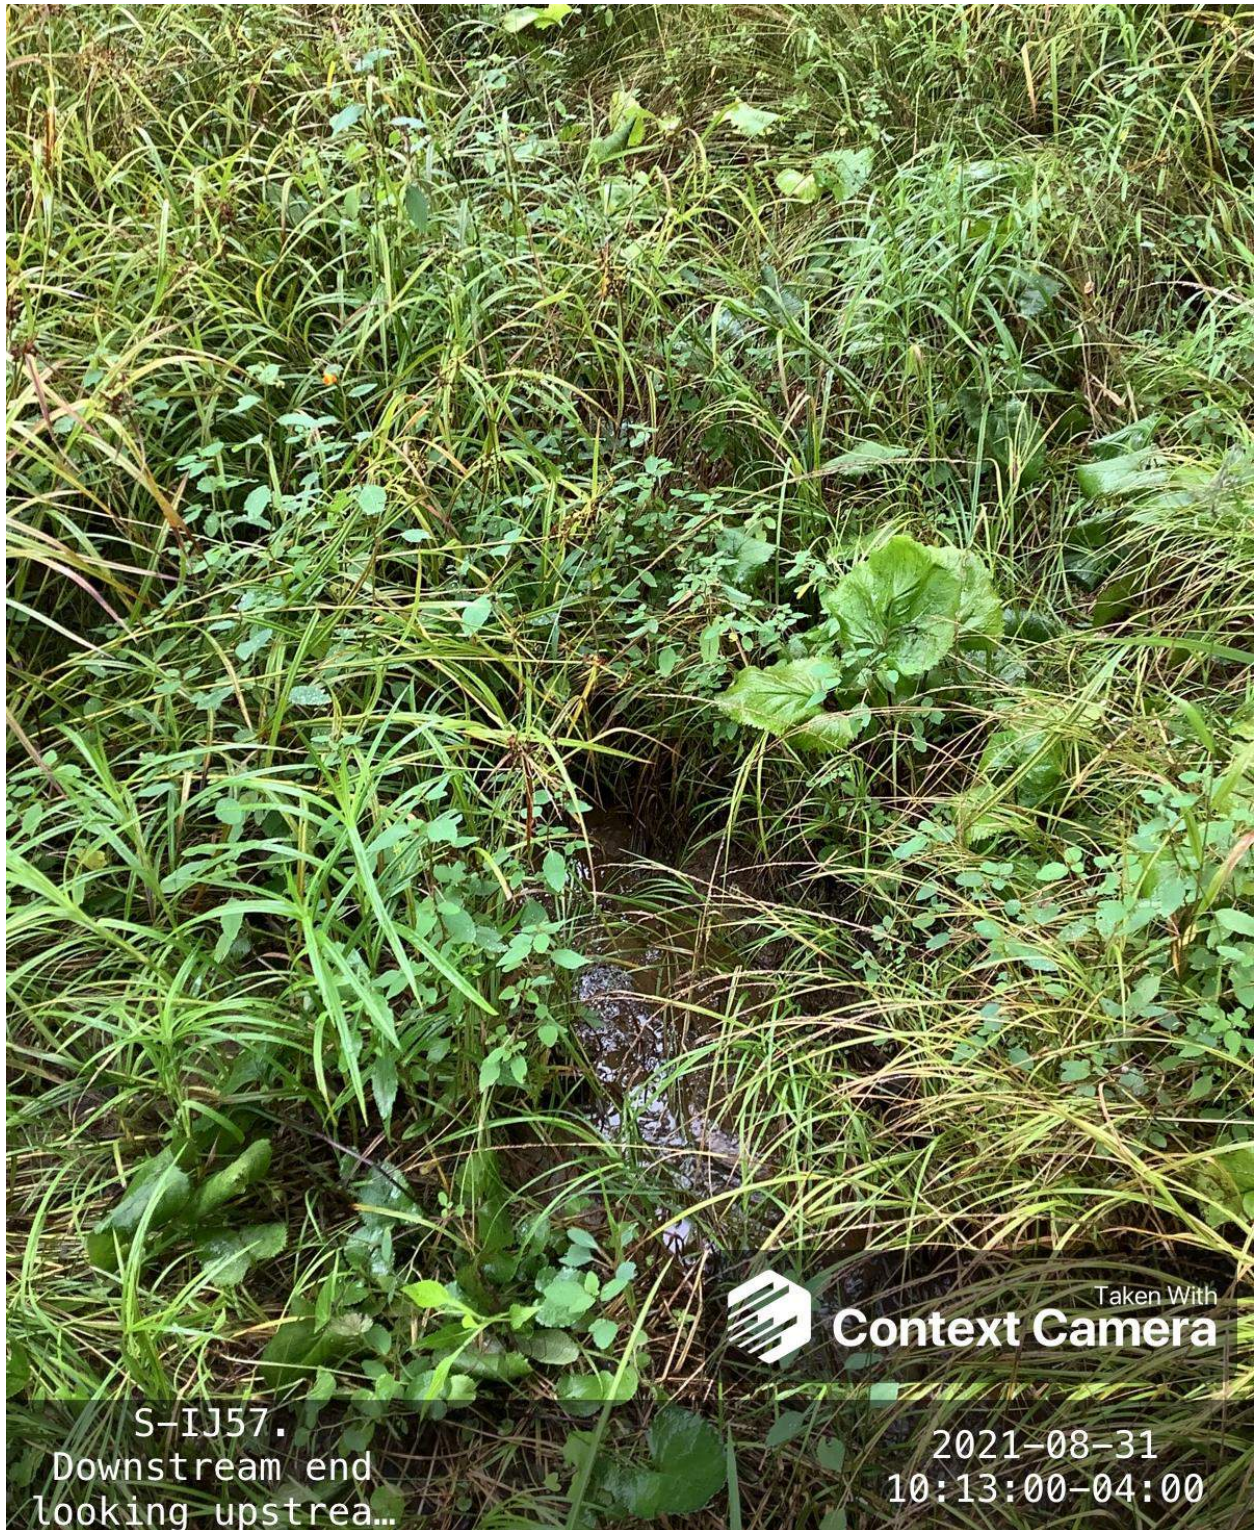
S-IJ57.
Downstream end
looking upstream...

Photo Type: DS, US View
Location, Orientation, Photographer Initials: Downstream Edge of ROW, Upstream View, JR/KP
Lat: 38.352362 Long: -80.636401

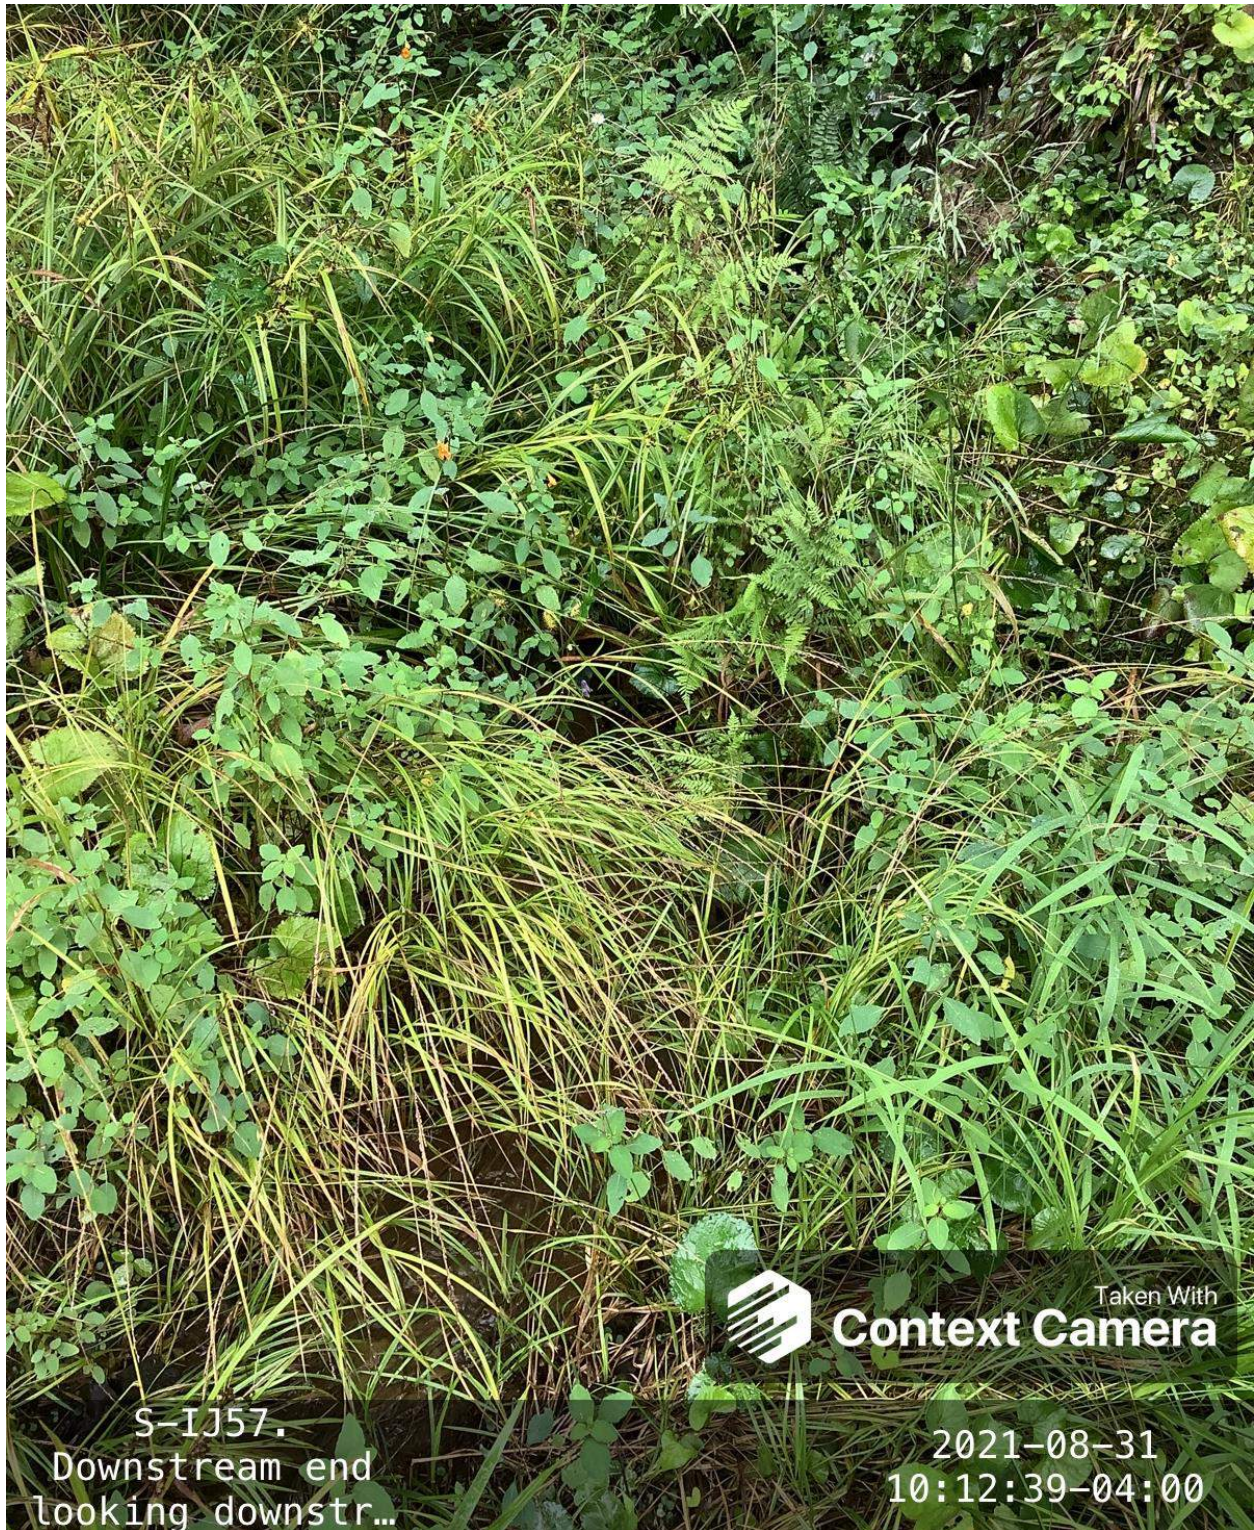
Photo Type: DS, DS View
Location, Orientation, Photographer Initials: Downstream Edge of ROW, Downstream View, JR/KP
Lat: 38.352362 Long: -80.636401

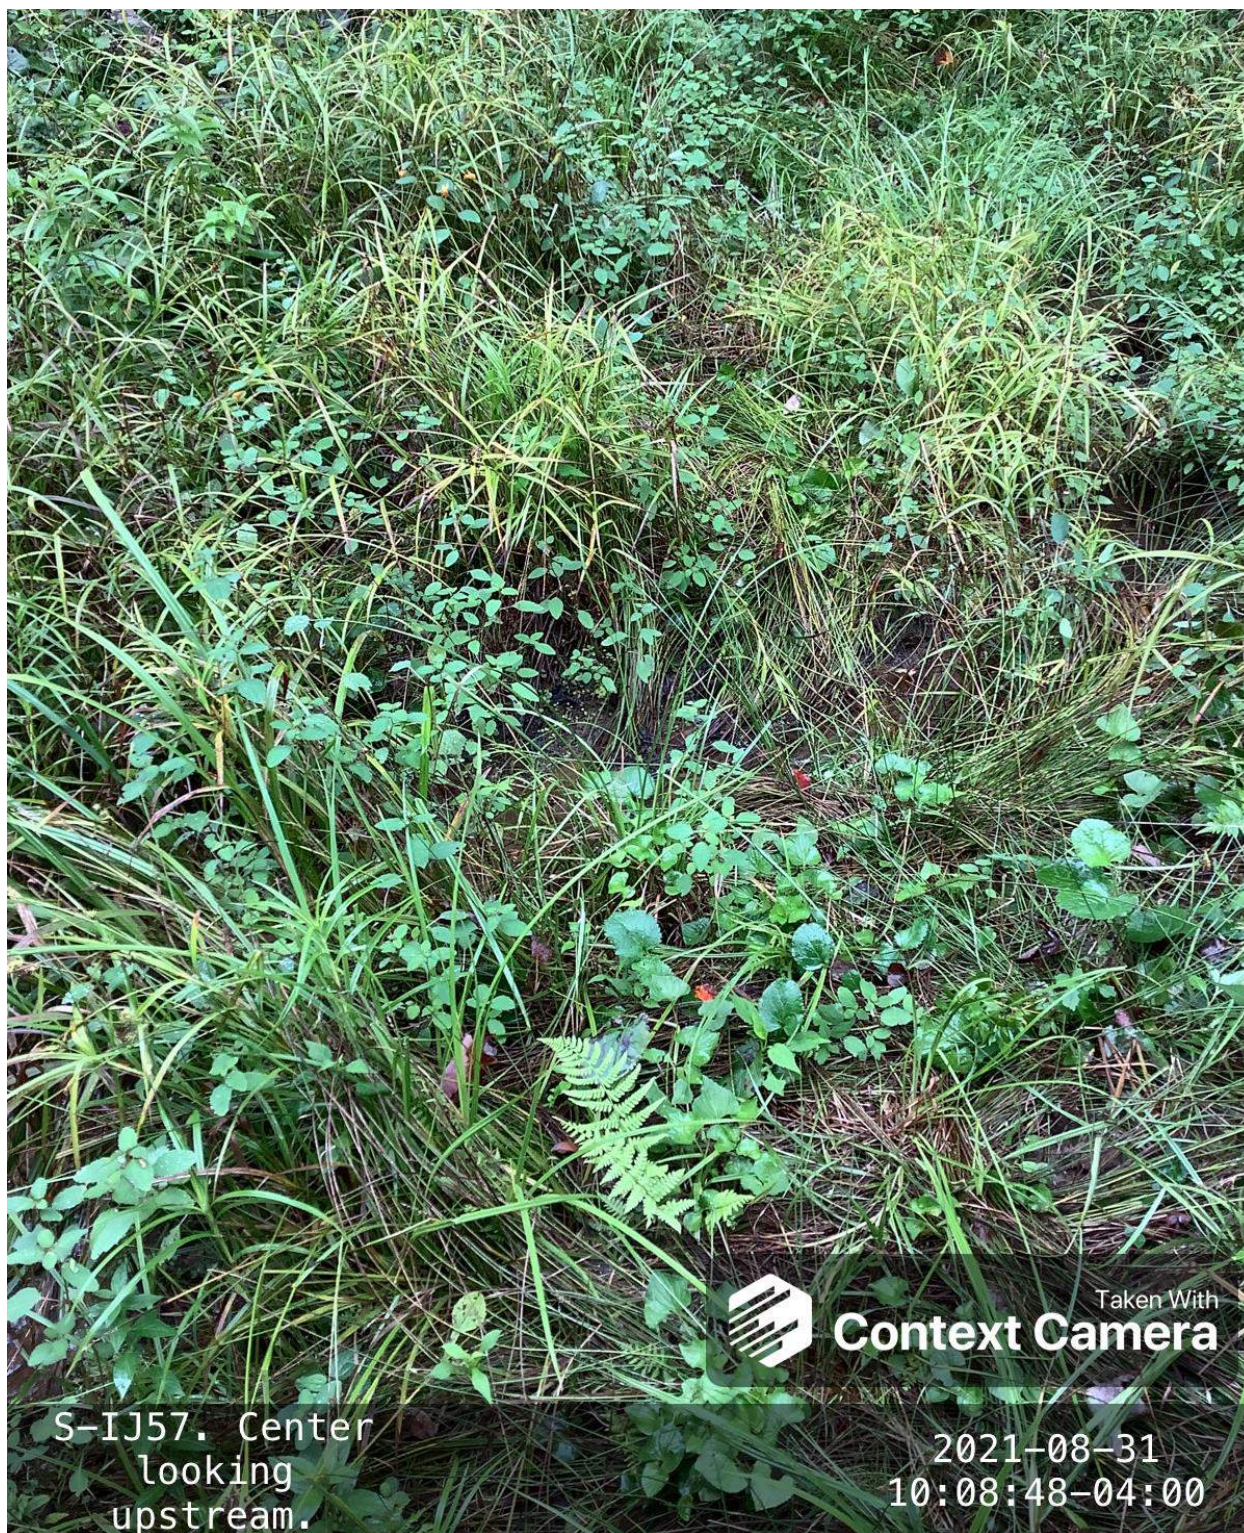
S-IJ57. Center
looking
upstream.

Photo Type: US View at Center
Location, Orientation, Photographer Initials: Center ROW, Upstream View, JR/KP
Lat: 38.352362 Long: -80.636401

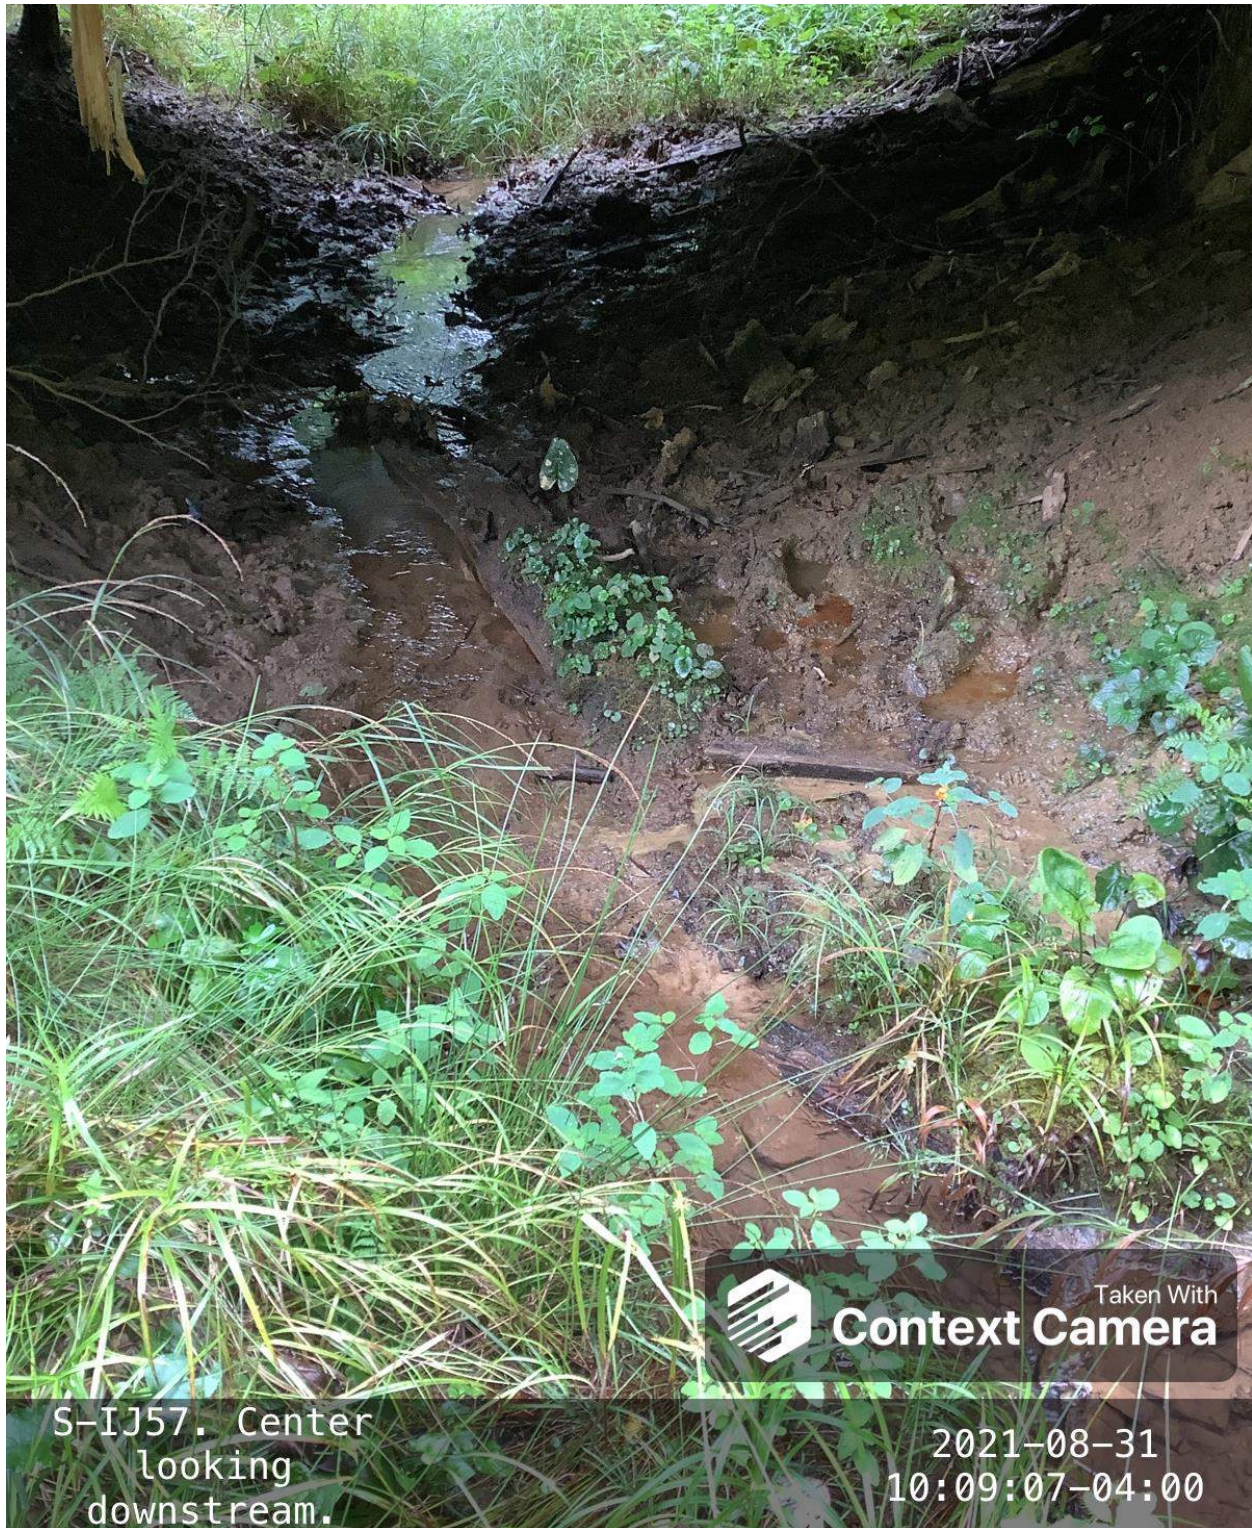
S-IJ57. Center
looking
downstream.

Photo Type: DS View at Center
Location, Orientation, Photographer Initials: Center ROW, Downstream View, JR/KP
Lat: 38.352362 Long: -80.636401

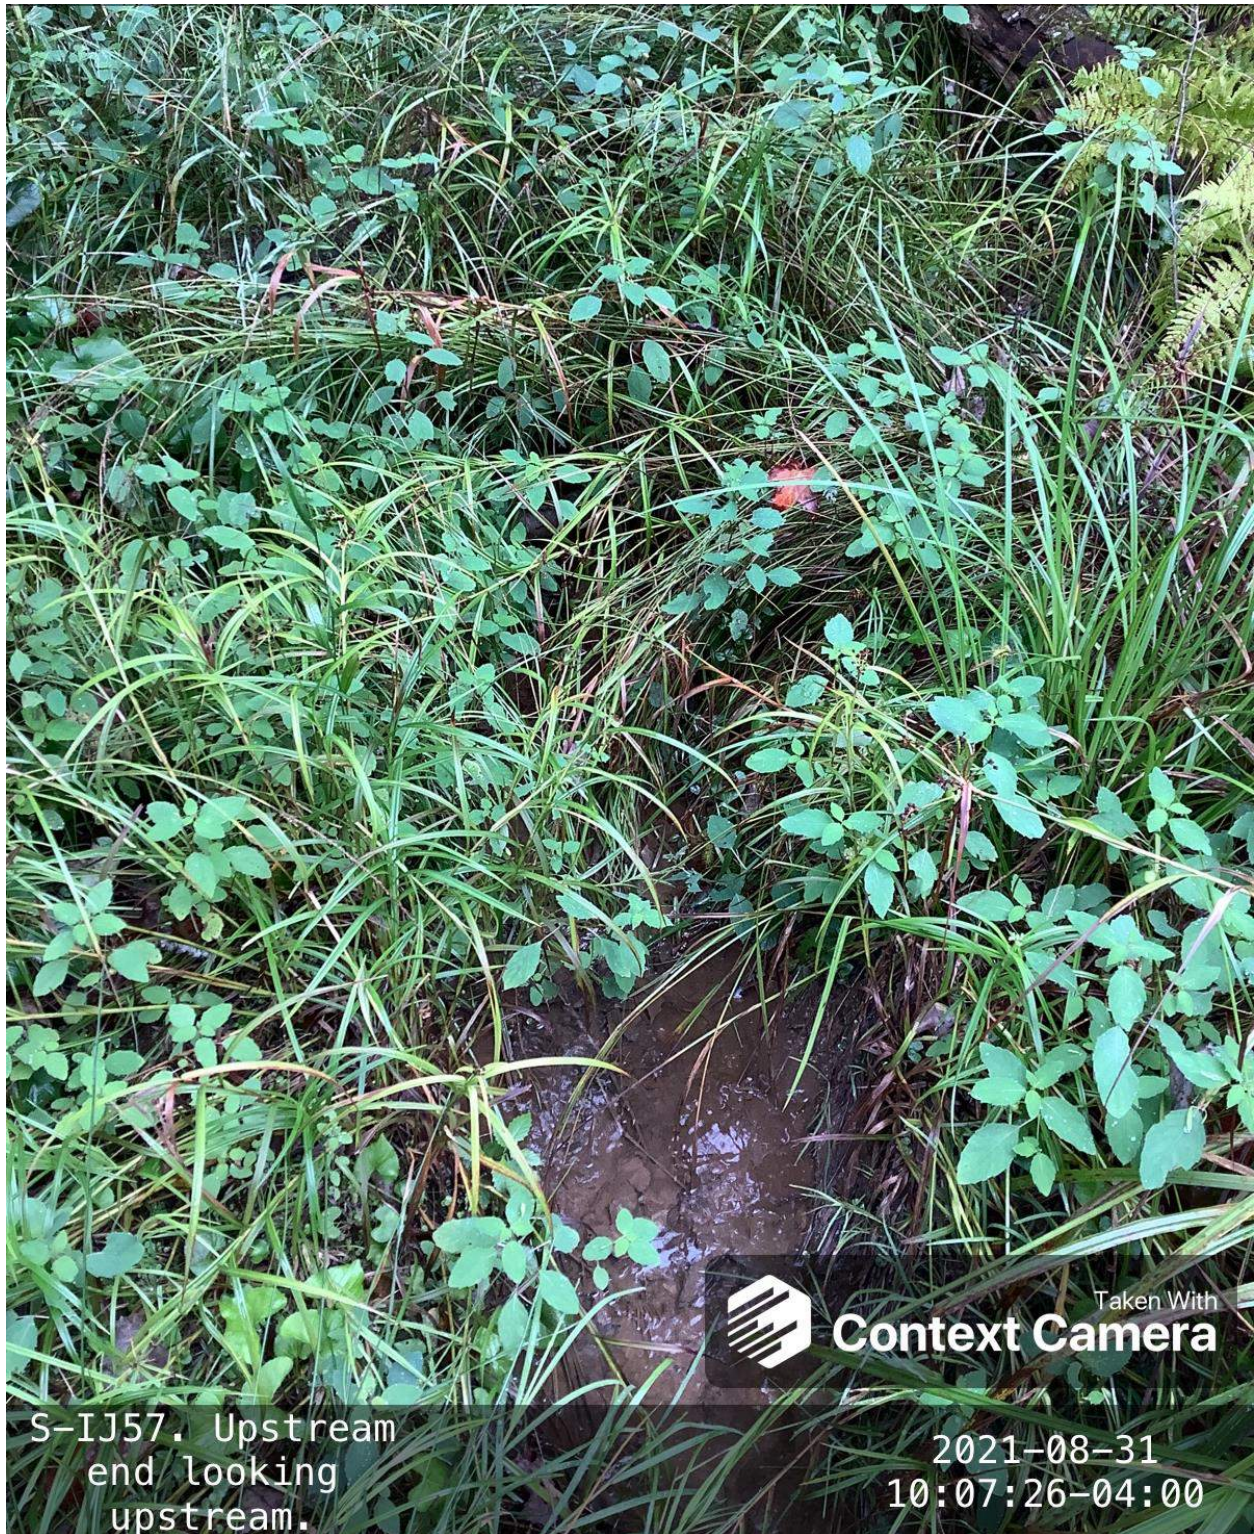
Photo Type: US, US View
Location, Orientation, Photographer Initials: Upstream Edge of ROW, Upstream View, JR/KP
Lat: 38.352362 Long: -80.636401

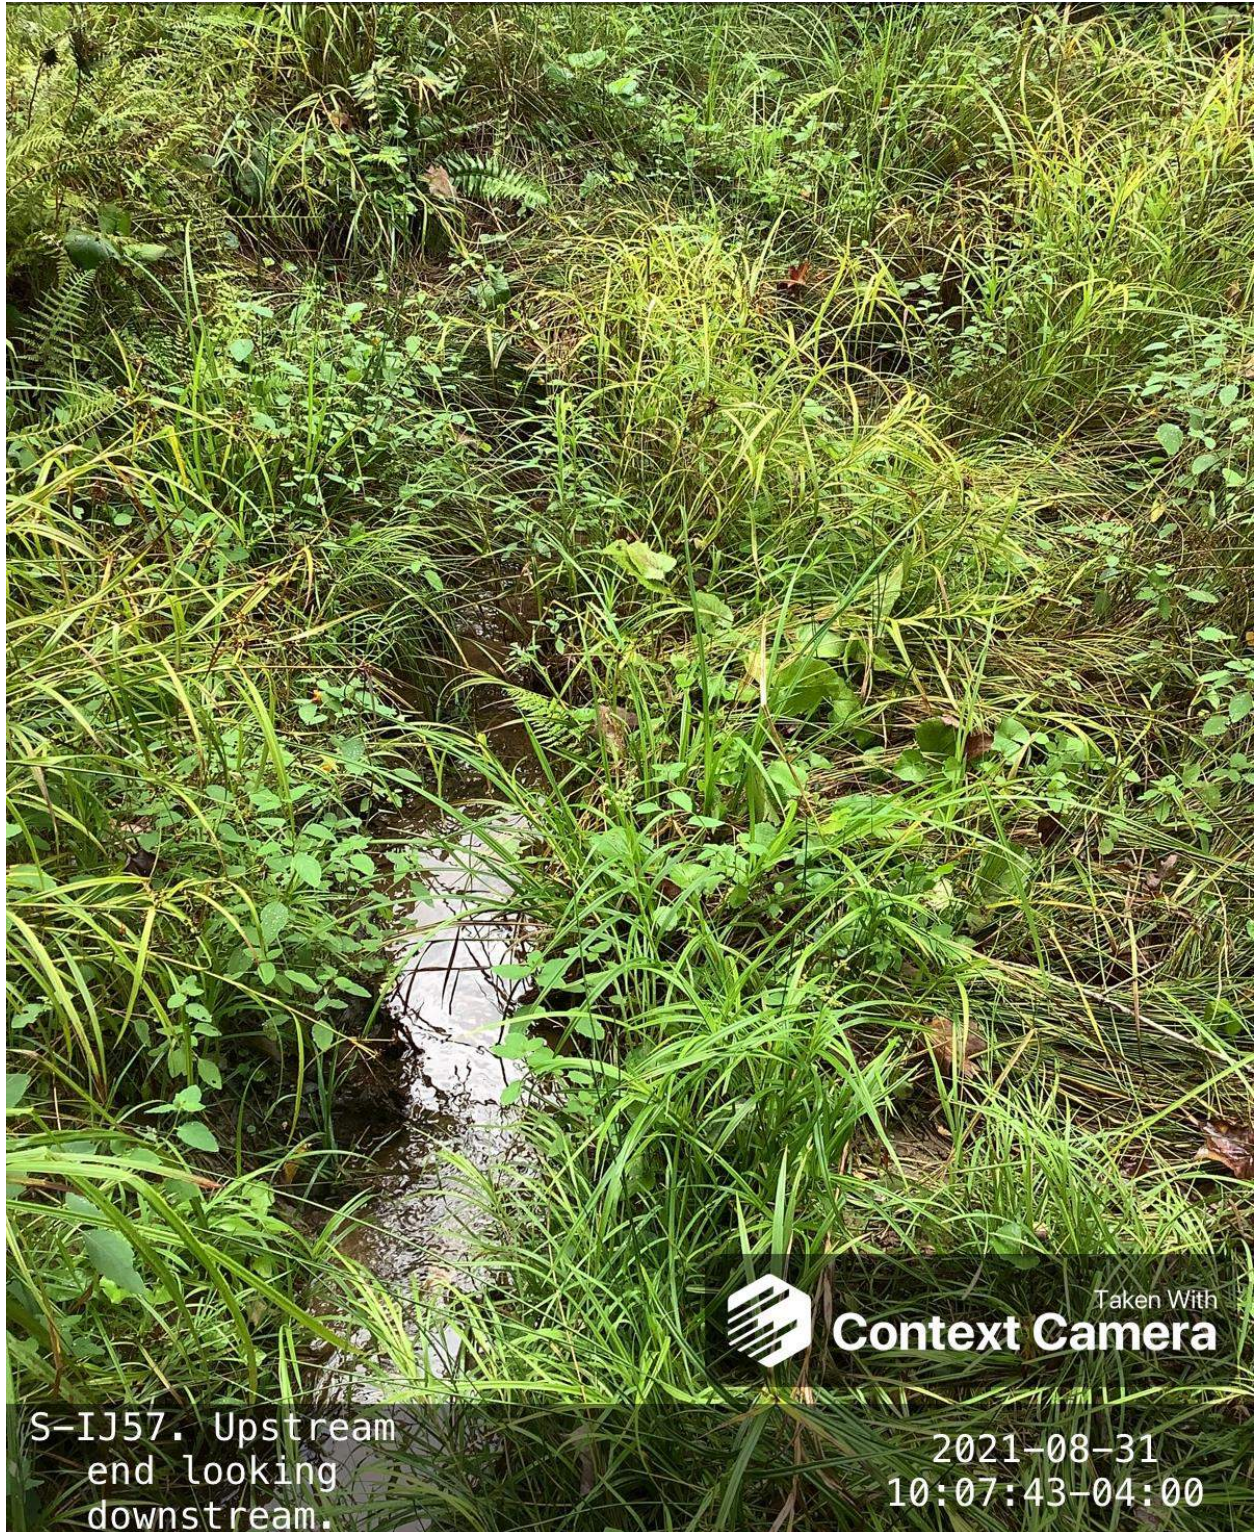
S-IJ57. Upstream
end looking
downstream.

Photo Type: US, DS View
Location, Orientation, Photographer Initials: Upstream Edge of ROW, Downstream View, JR/KP
Lat: 38.352362 Long: -80.636401
