Baseline Assessment – Stream Attributes

Reach S-IJ59 (Timber Mat Crossing) Ephemeral Spread D Nicholas County, West Virginia

Title PROFILE AND CROSS-SECTIONS
BASELINE SURVEY
CROSSING S-IJ59 - UNNAMED TRIB.
BARN RUN (MP 112.09)
NICHOLAS COUNTY, WV

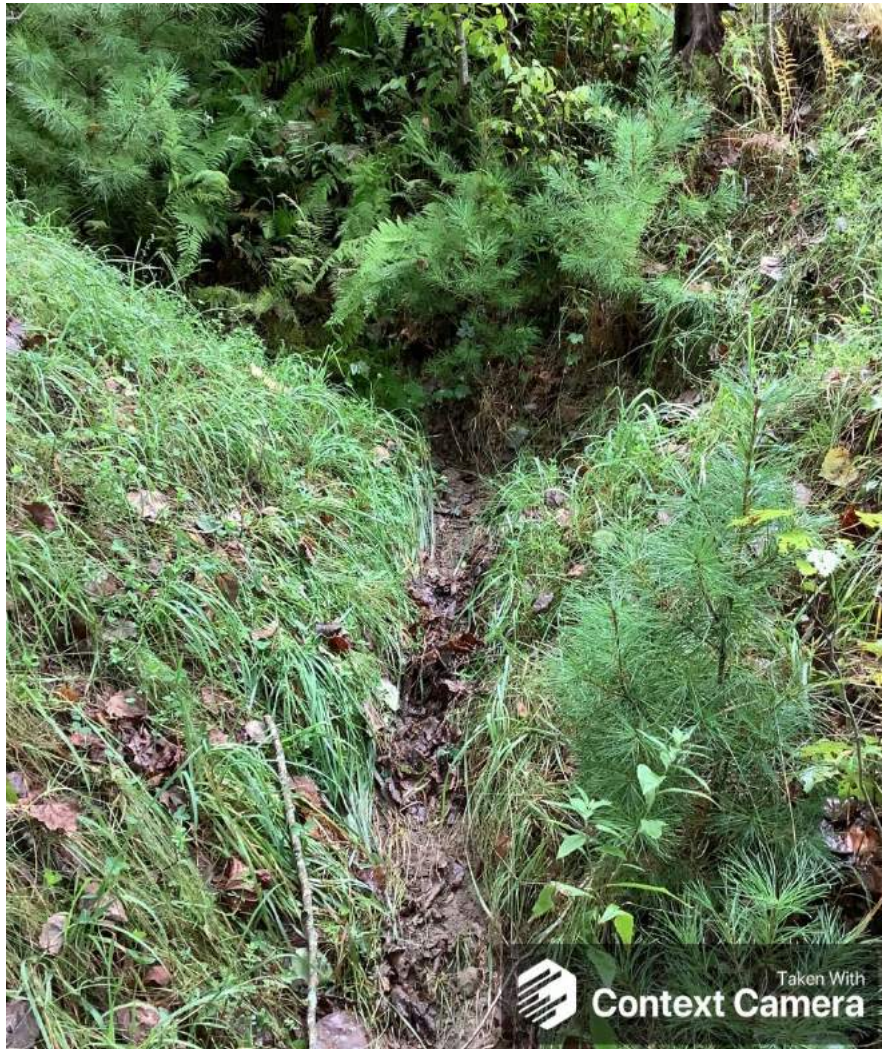
Spread D Stream S-IJ59 (Timber Mat Crossing) Nicholas County

Photo Type: DS, US View

Location, Orientation, Photographer Initials: Downstream Edge of ROW, Upstream View, JR/KP

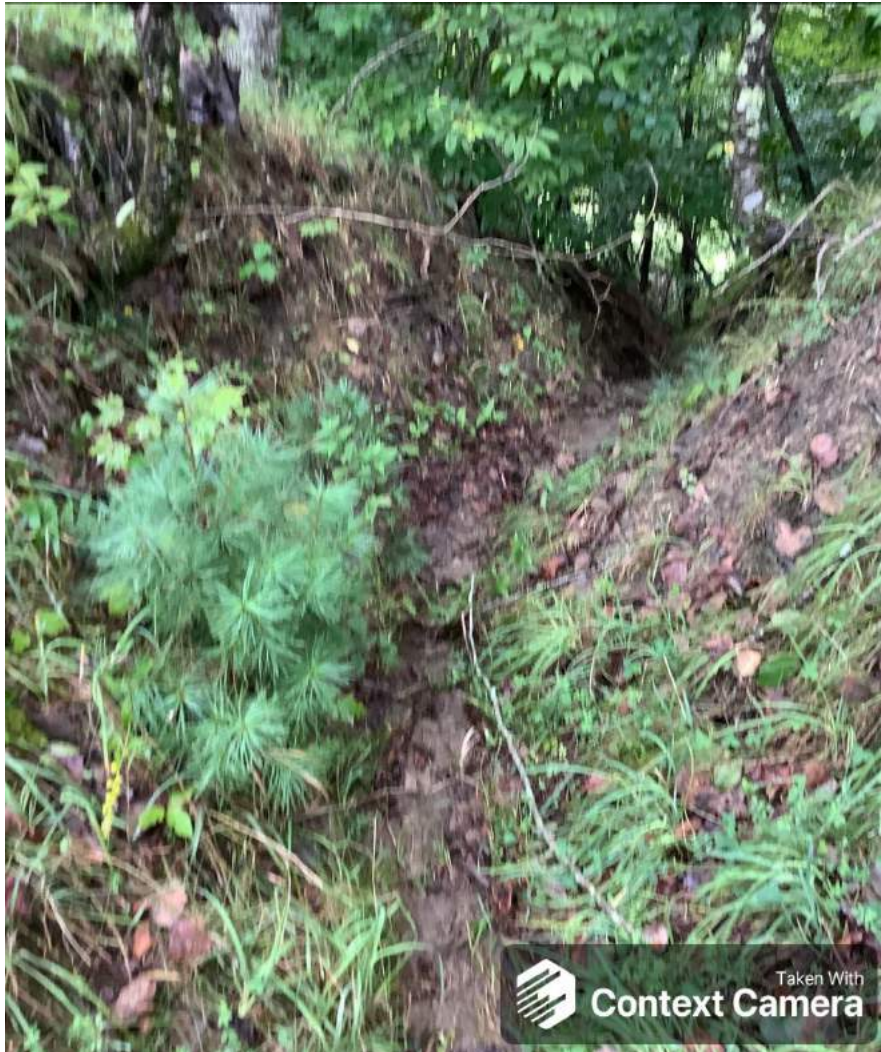
Spread D Stream S-IJ59 (Timber Mat Crossing) Nicholas County

Photo Type: DS, DS View

Location, Orientation, Photographer Initials: Downstream Edge of ROW, Downstream View, JR/KP
Lat: 38.348372 Long: -80.641152

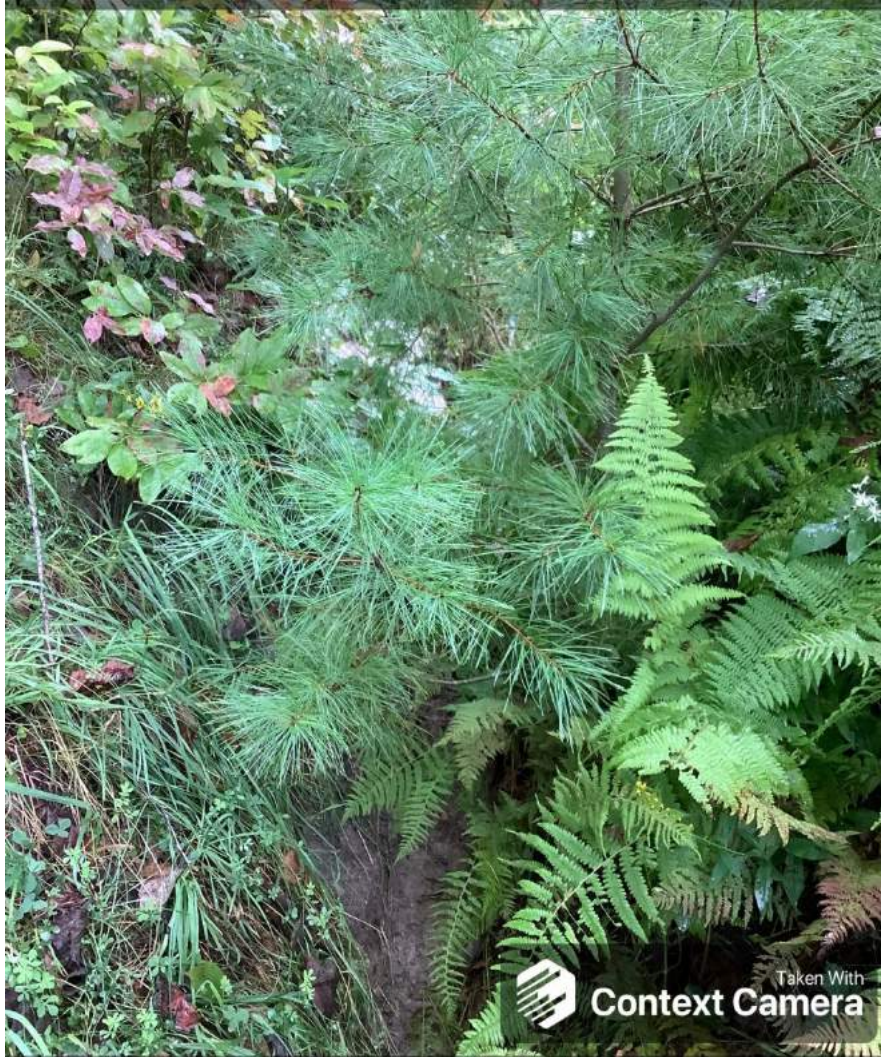
Spread D Stream S-IJ59 (Timber Mat Crossing) Nicholas County

Photo Type: US View at Center
Location, Orientation, Photographer Initials: Center ROW, Upstream View, JR/KP
Lat: 38.348372 Long: -80.641152

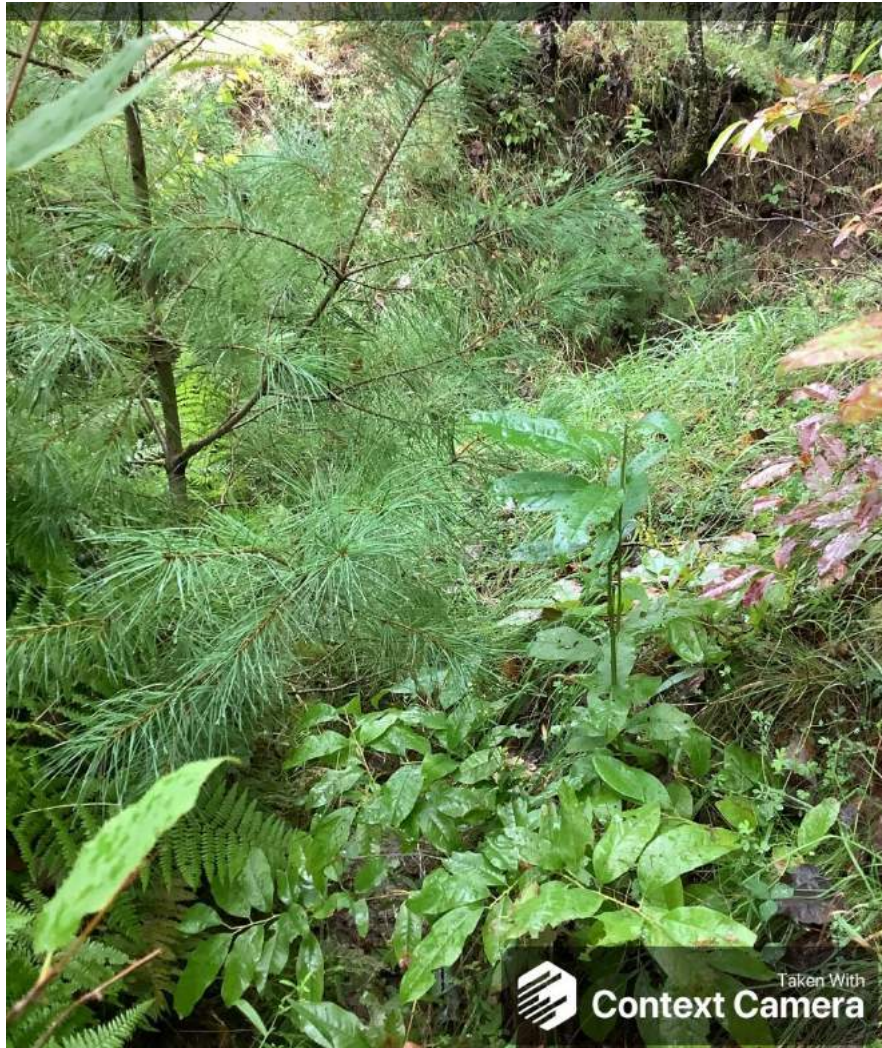
Spread D Stream S-IJ59 (Timber Mat Crossing) Nicholas County

Photo Type: DS View at Center
Location, Orientation, Photographer Initials: ROW Center, Downstream View, JR/KP
Lat: 38.348372 Long: -80.641152

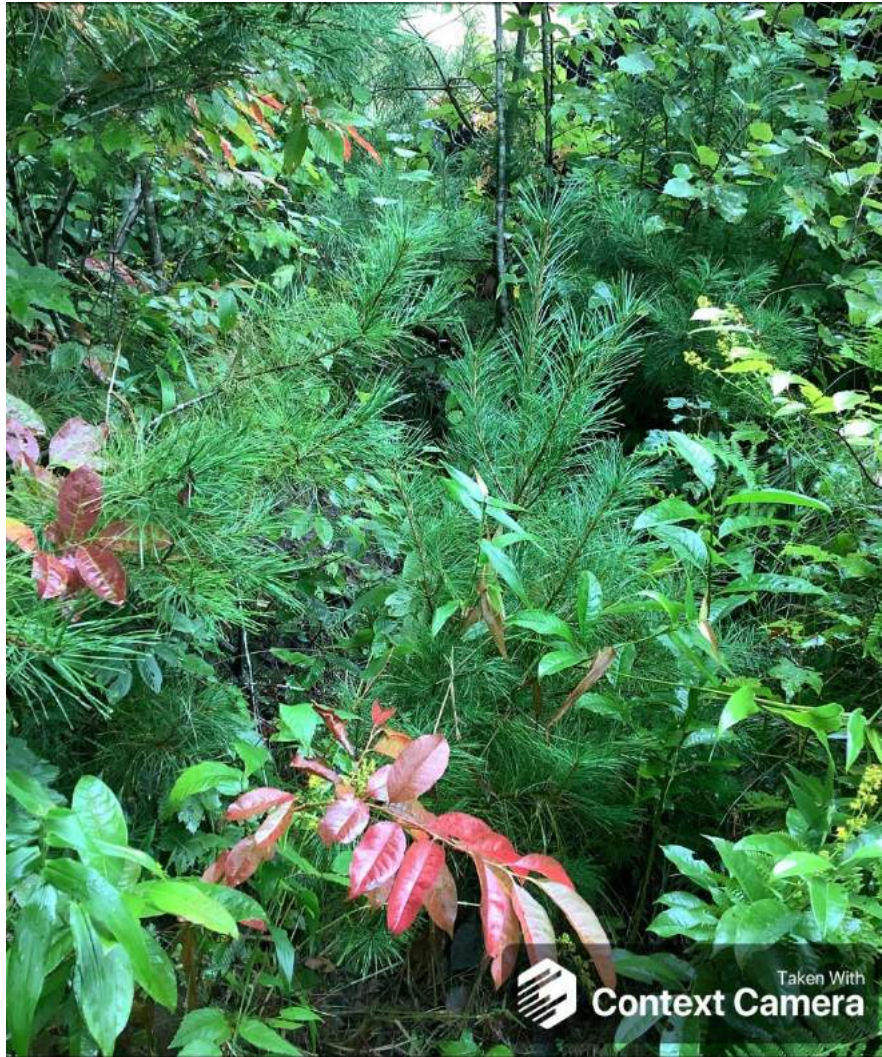
Spread D Stream S-IJ59 (Timber Mat Crossing) Nicholas County

Photo Type: US, US View

Location, Orientation, Photographer Initials: Upstream Edge of ROW, Upstream View, JR/KP
Lat: 38.348372 Long: -80.641152

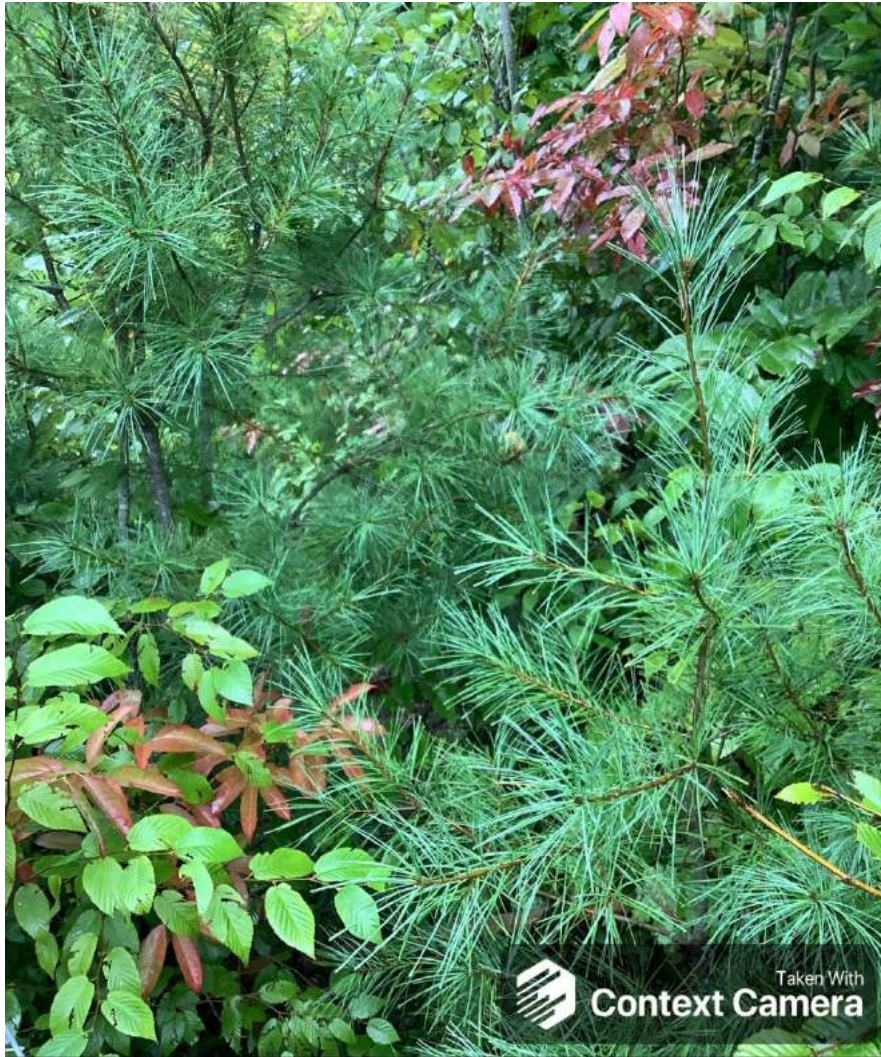
Spread D Stream S-IJ59 (Timber Mat Crossing) Nicholas County

Photo Type: US, DS View

Location, Orientation, Photographer Initials: Upstream Edge of ROW, Downstream View, JR/KP
Lat: 38.348372 Long: -80.641152
