Baseline Assessment – Stream Attributes

Reach S-IJ62 (Pipeline ROW) Intermittent Spread D Nicholas County, West Virginia

PROFILE AND CROSS-SECTIONS

CROSSING S-IJ62 - UNNAMED TRIB. TO

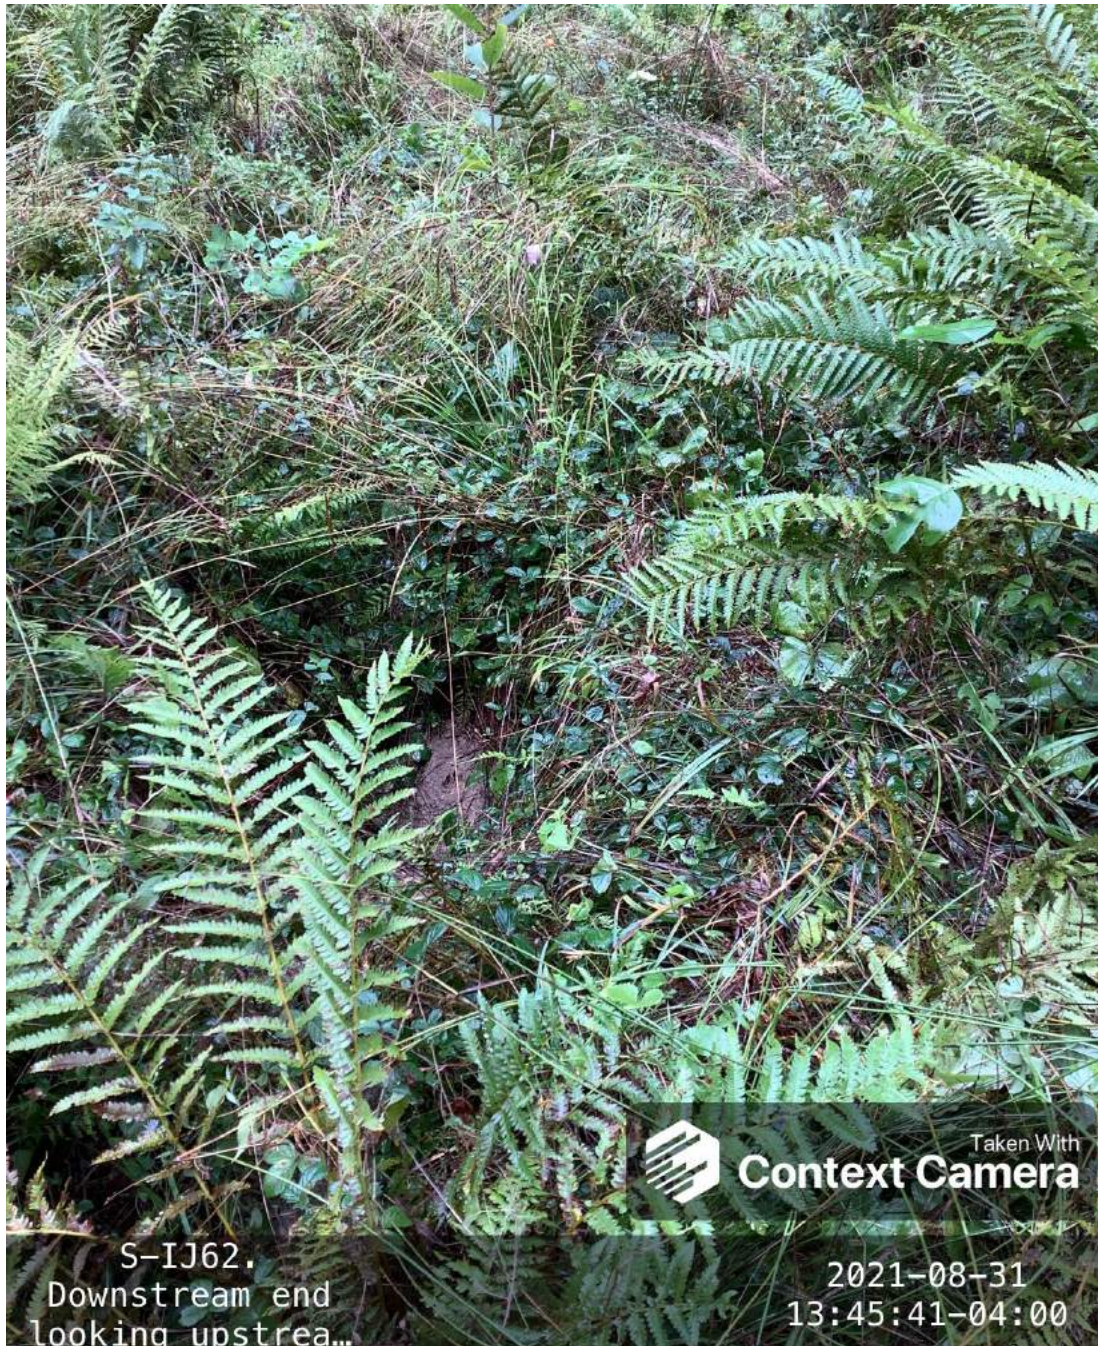
Photo Type: DS, US View
Location, Orientation, Photographer Initials: Downstream Edge of ROW, Upstream View, JR KP
Lat: 38.343547 Long: -80.647035

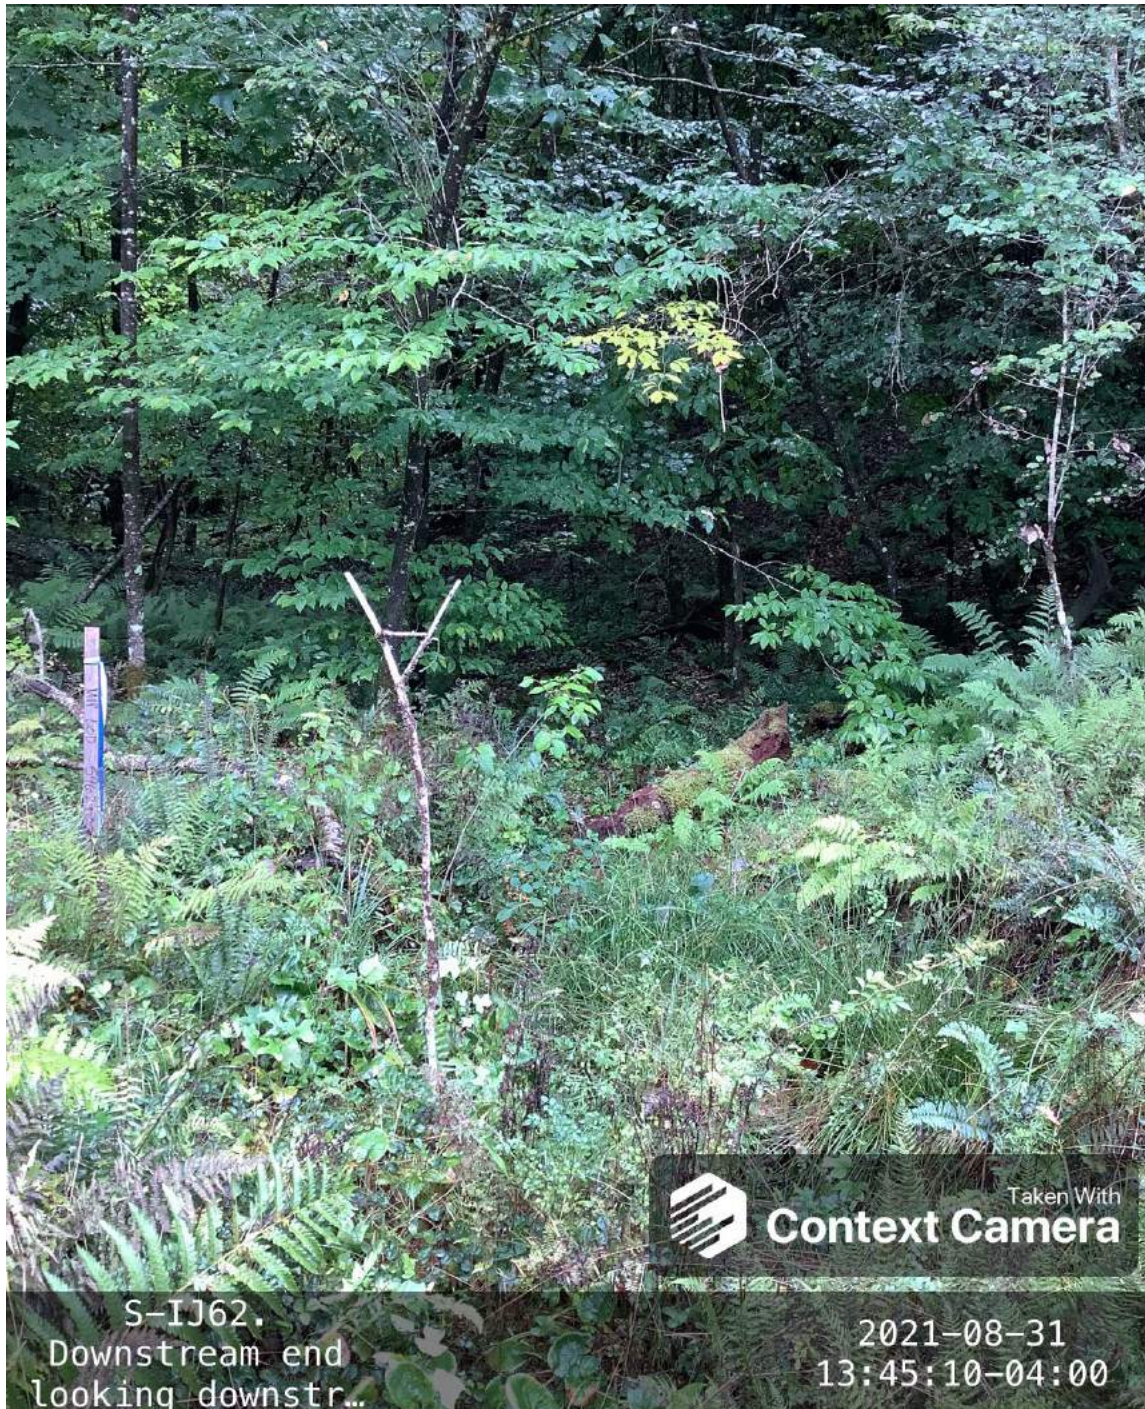
Photo Type: DS, DS View

Location, Orientation, Photographer Initials: Downstream Edge of ROW, Downstream View, JR KP
Lat: 38.343547 Long: -80.647035

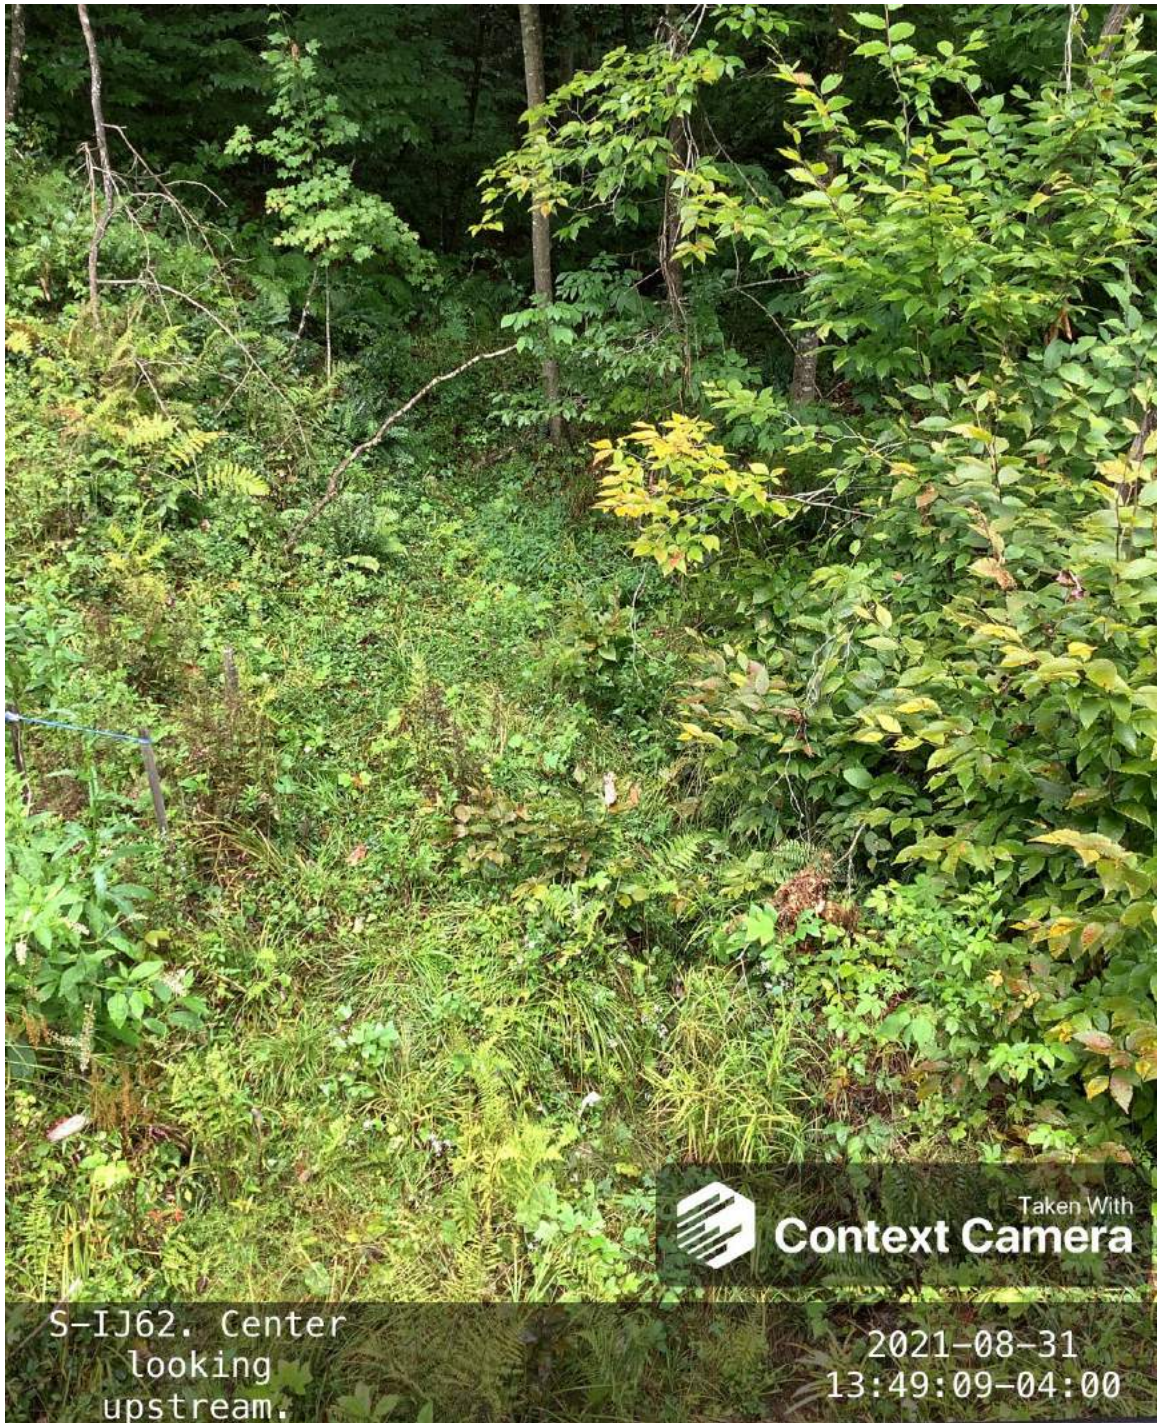
S-IJ62. Center
looking
upstream.

Photo Type: US View at Center
Location, Orientation, Photographer Initials: Center ROW, Upstream View, JR KP
Lat: 38.343547 Long: -80.647035

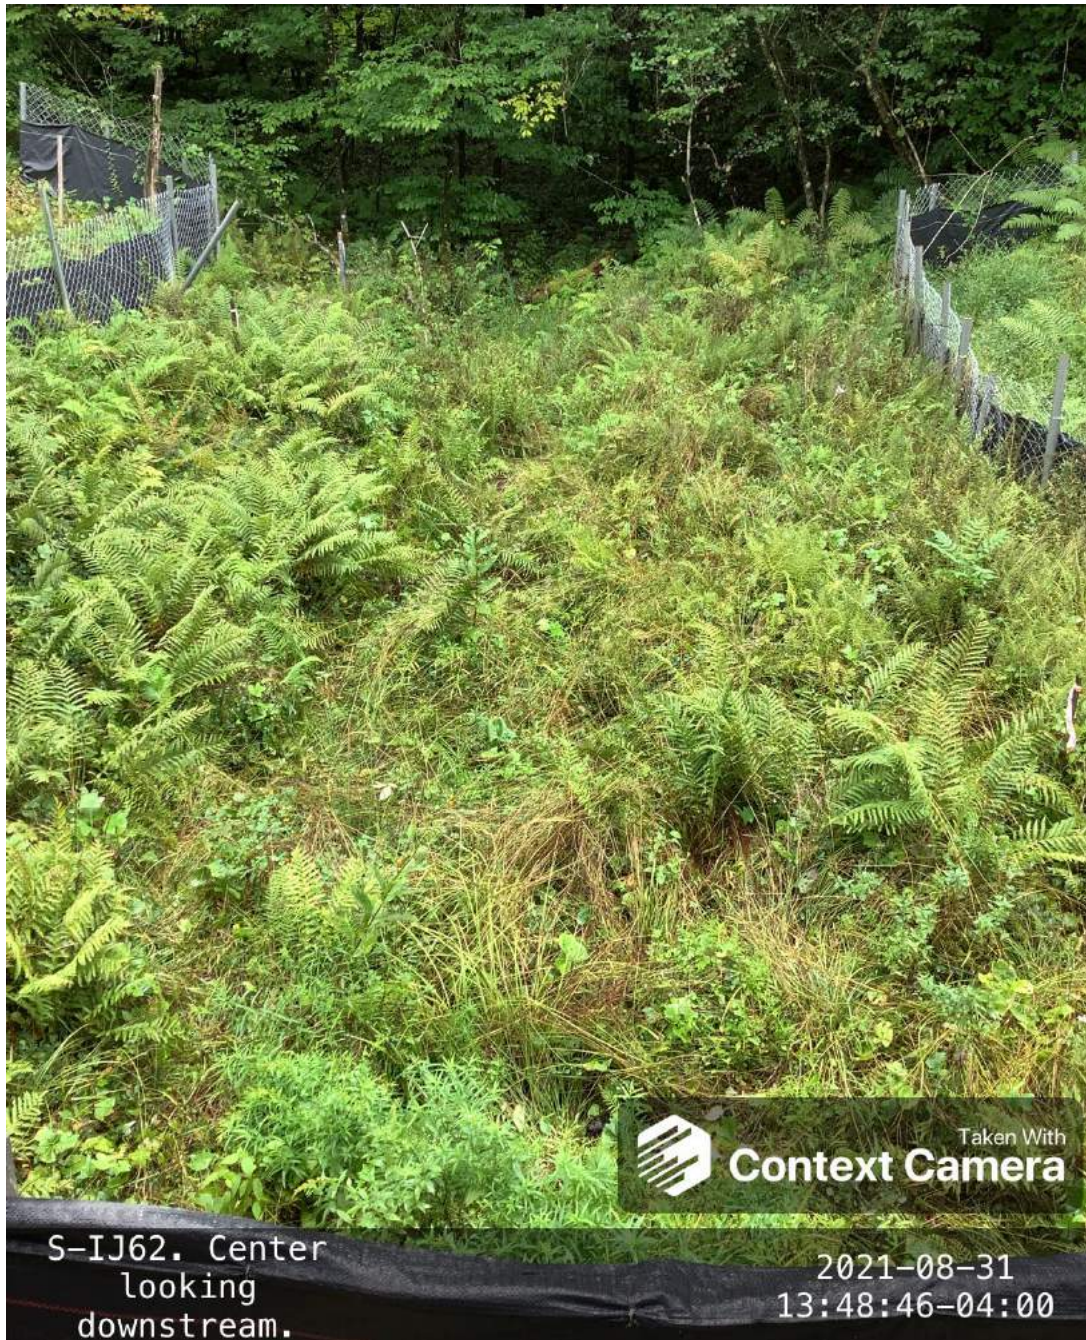
S-IJ62. Center
looking
downstream.

Photo Type: DS View at Center
Location, Orientation, Photographer Initials: ROW Center, Downstream View, JR KP
Lat: 38.343547 Long: -80.647035

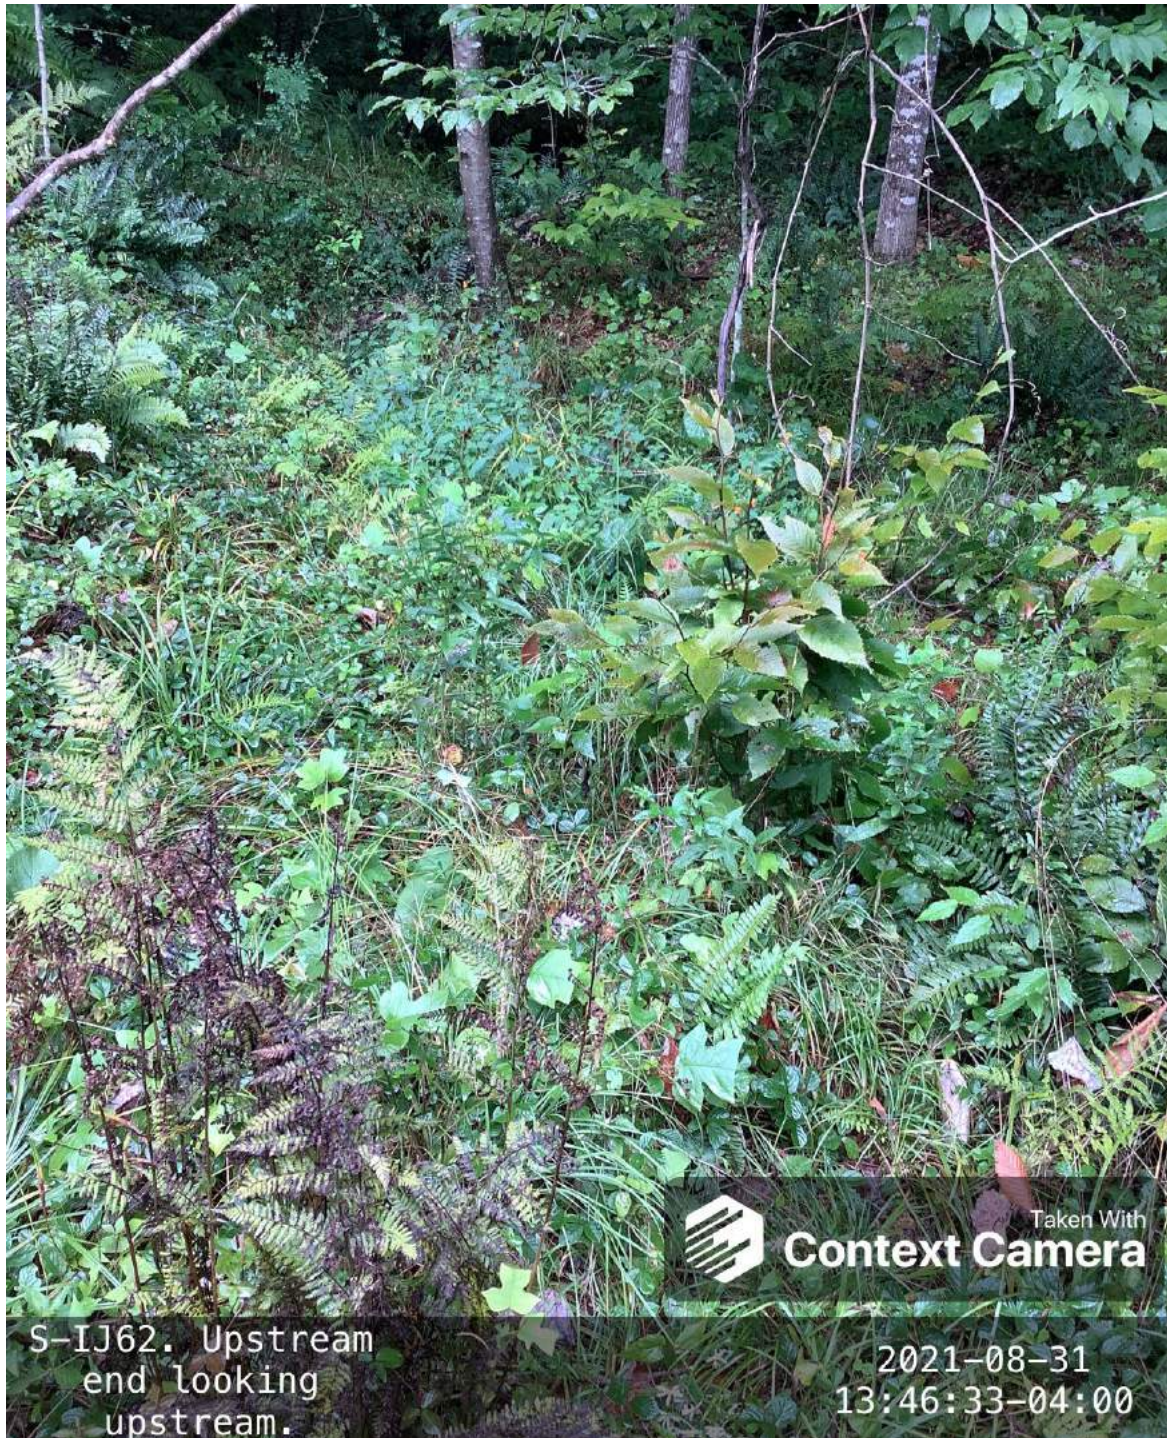
Photo Type: US, US View
Location, Orientation, Photographer Initials: Upstream Edge of ROW, Upstream View, JR KP
Lat: 38.343547 Long: -80.647035

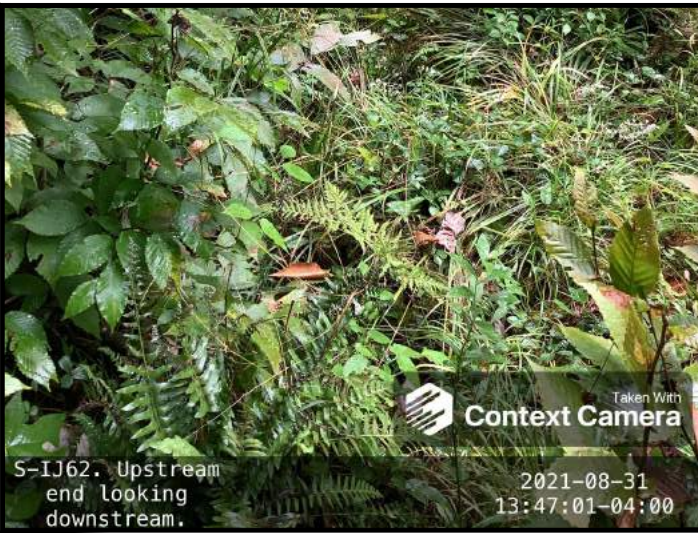
PHOTO TAKEN LOOKING DOWNSTREAM FROM UPSTREAM IMPACT LIMITS

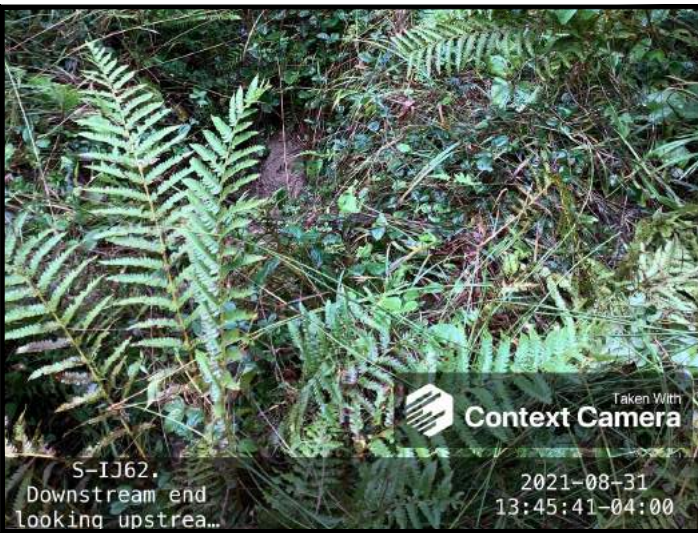
PHOTO TAKEN LOOKING UPSTREAM FROM DOWNSTREAM IMPACT LIMITS
