Baseline Assessment – Stream Attributes

Reach S-J28 (Pipeline ROW) Intermittent Spread D Nicholas County, West Virginia

Title	Client
PROFILE AND CROSS-SECTIONS BASELINE SURVEY CROSSING S-128 - UNNAMED TRIB. TO LITTLE LAUREL CREEK (MP 119.74) NICHOLAS COUNTY, WV	MO 222

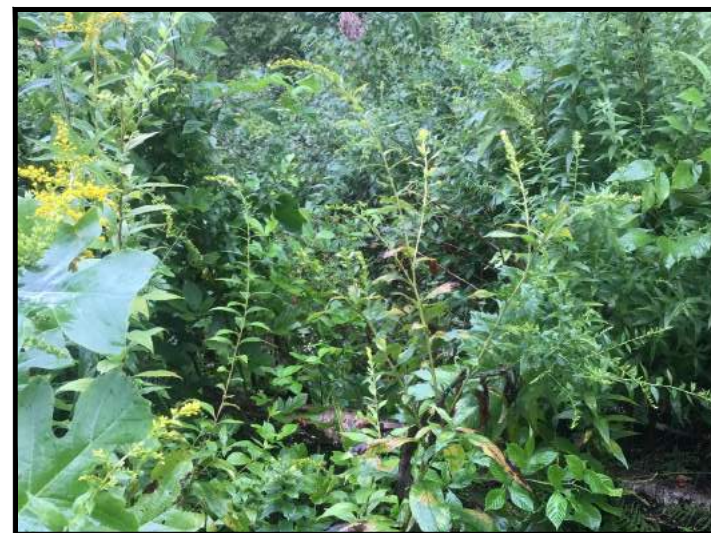
PHOTO TAKEN LOOKING DOWNSTREAM
FROM UPSTREAM IMPACT LIMITS

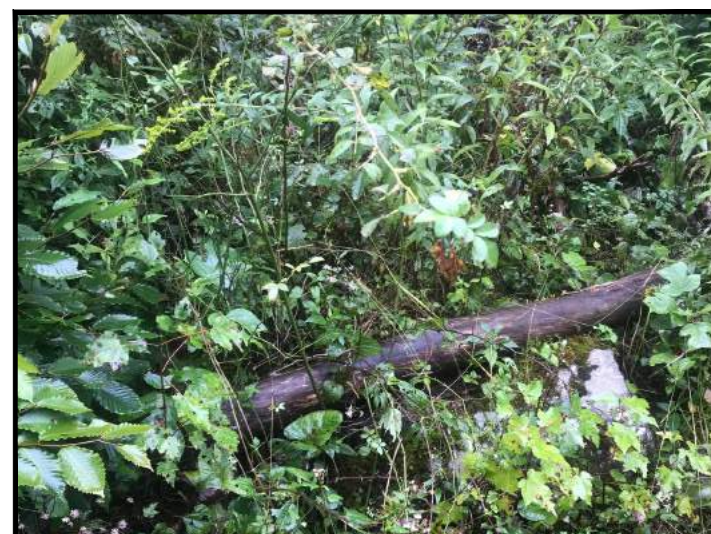
PHOTO TAKEN LOOKING UPSTREAM FROM
DOWNSTREAM IMPACT LIMITS

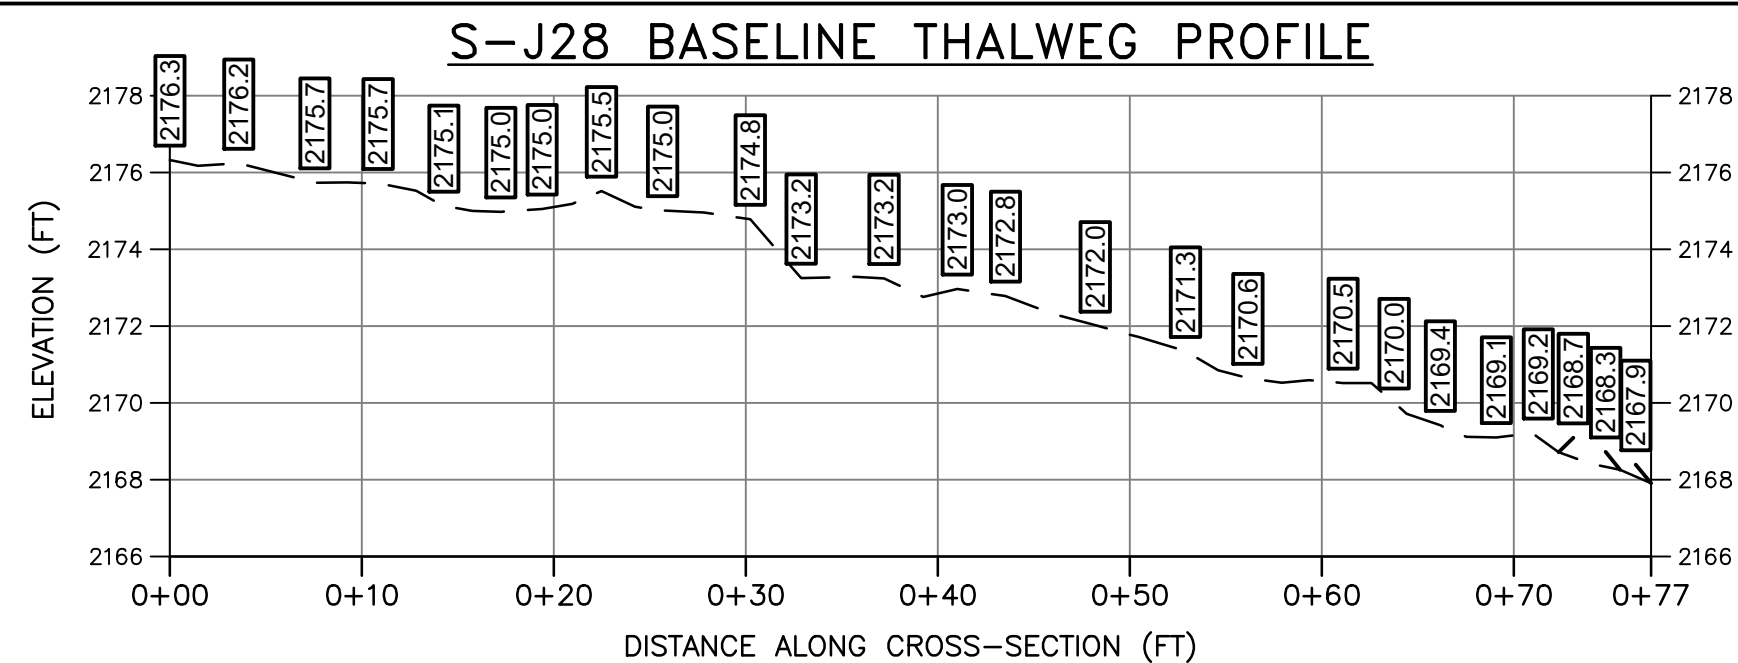
EXISTING STREAM PROFILE
INVERT ALONG THALWEG

PROFILE
SCALE: H: 1"=10'
V: 1"=5'
