## Baseline Assessment – Stream Attributes

### Reach S-J32 (Timber Mat Crossing) Perennial Spread D Nicholas County, West Virginia

## Spread D Stream S-J32 (Timber Mat Crossing) Nicholas County

Client	<p>PROFILE AND CROSS-SECTIONS BASELINE SURVEY CROSSING S-J32 – BIG BEAVER CREEK (MP 114.36) NICHOLAS COUNTY, WV</p>
M/C	222

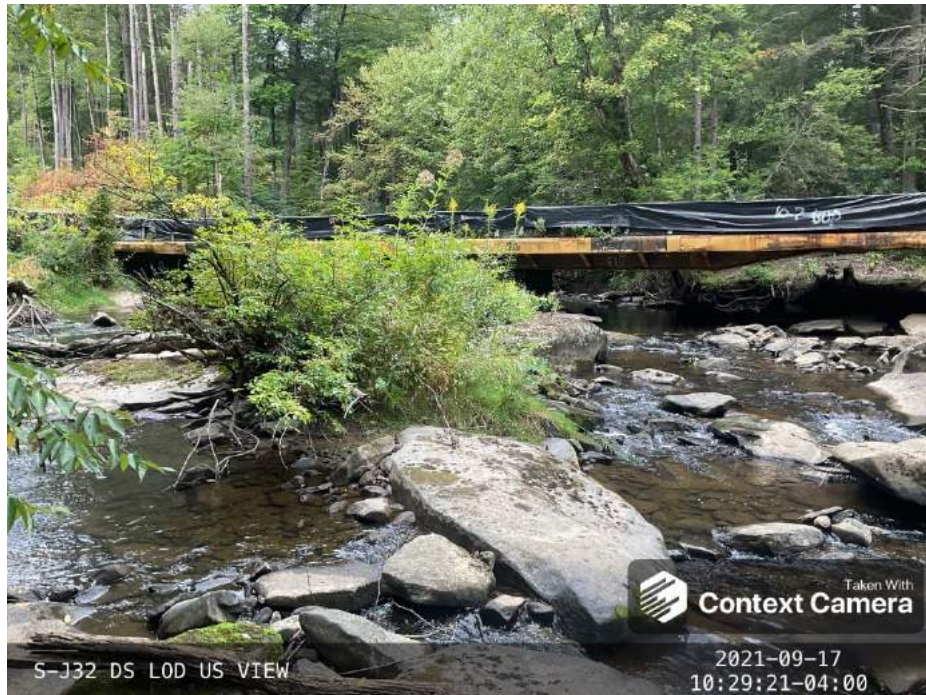
Photo Type: DS, US View

Location, Orientation, Photographer Initials: Downstream Edge of ROW, Upstream View, KY/ZS  
Lat: 38.331763 Long: -80.670342

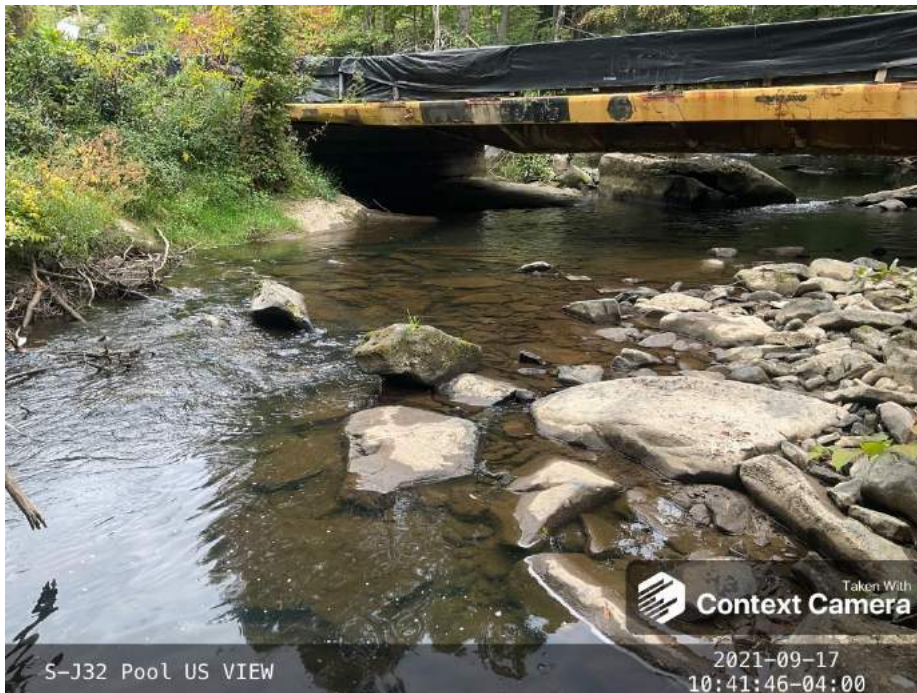
Photo Type: Pool, US View  
Location, Orientation, Photographer Initials: Downstream of Pool, Upstream View, KY/ZS  
Lat: 38.331763 Long: -80.670342

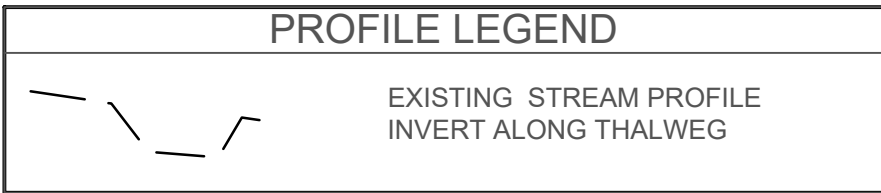
AS-BUILT TABLE: S-J32 CROSS SECTION A					
PRE-CROSSING				AS-BUILT	
PT. LOC.	NORTHING	EASTING	ELEV	VERT. DIFF.	HORZ. DIFF.
TS-L	13919520.8000	1734944.9610	2137.493'		
BS-L	-	-	-		
THW	13919533.7490	1734941.4440	2134.692'		
BS-R	13919549.6350	1734949.6520	2137.191'		
TS-R	1391957.1420	1734952.3500	2138.003'

NOTE: ALL SECTIONS VIEWS SHOWN LEFT TO RIGHT FACING DOWNSTREAM.

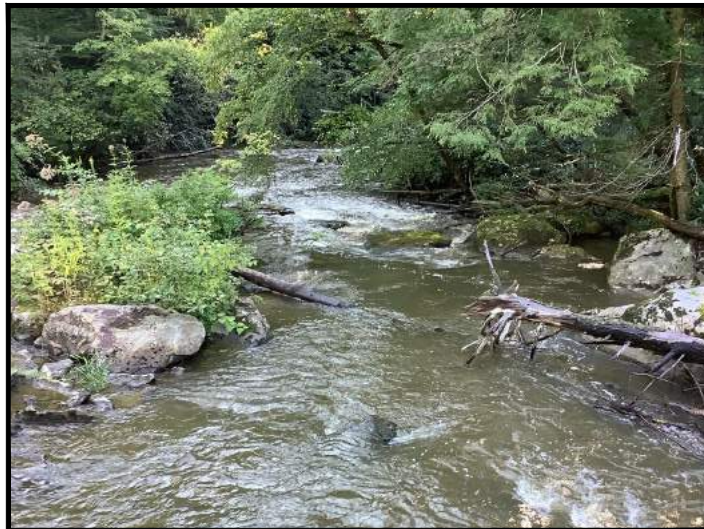
PHOTO TAKEN LOOKING DOWNSTREAM  
FROM UPSTREAM IMPACT LIMITS
