Baseline Assessment – Stream Attributes

Reach S-J56 TEMP AR (Temporary Access Road) Perennial Spread A Wetzel County, West Virginia

Spread A Stream S-J56 TEMP AR (Temporary Access Road) Wetzel County

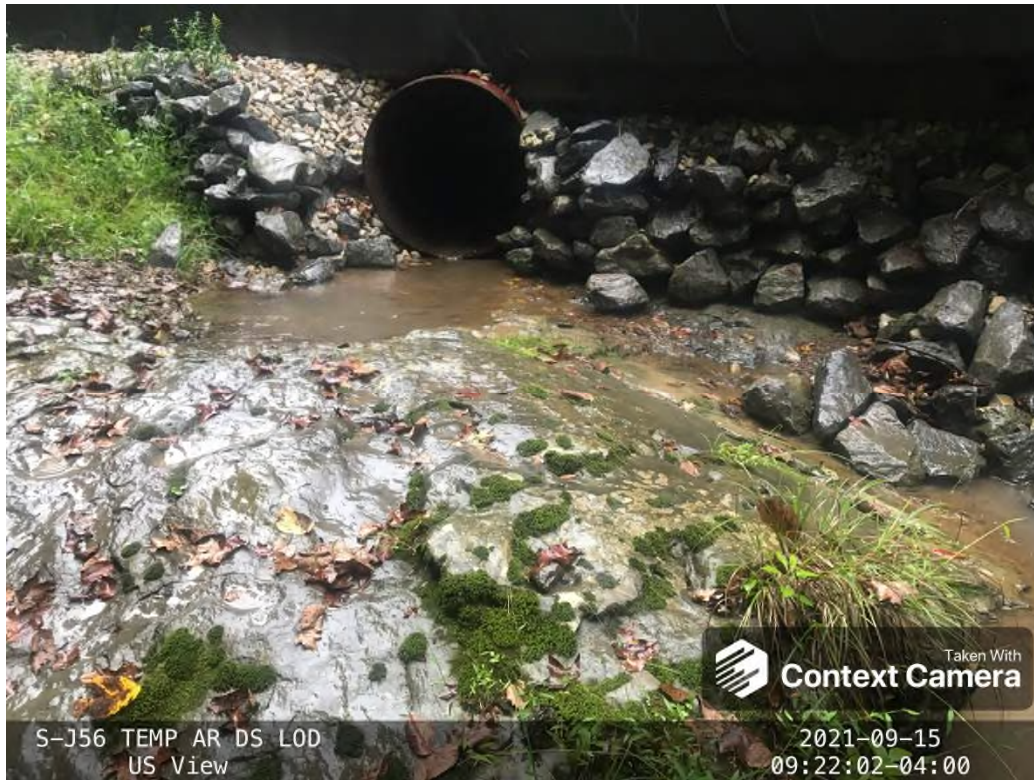
Photo Type: DS, US View

Location, Orientation, Photographer Initials: Downstream Edge of ROW, Upstream View, MG/SM
Lat: 39.464105 Long: -80.502318

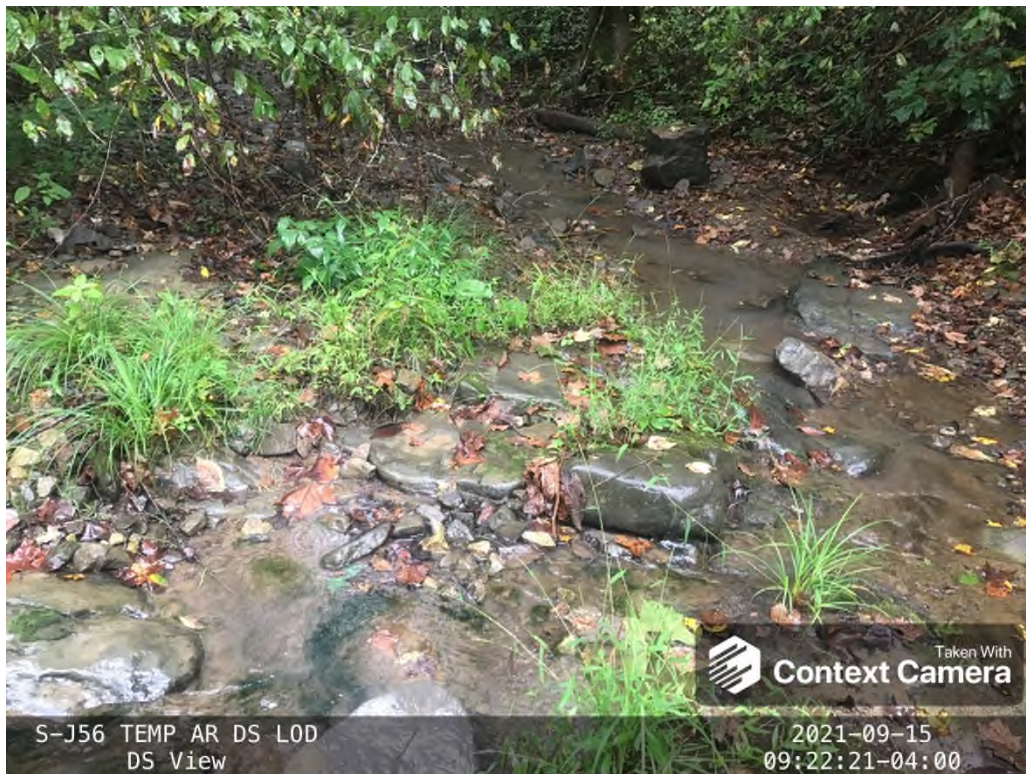
Photo Type: DS, DS View

Location, Orientation, Photographer Initials: Downstream Edge of ROW, Downstream View, MG/SM
Lat: 39.464105 Long: -80.502318

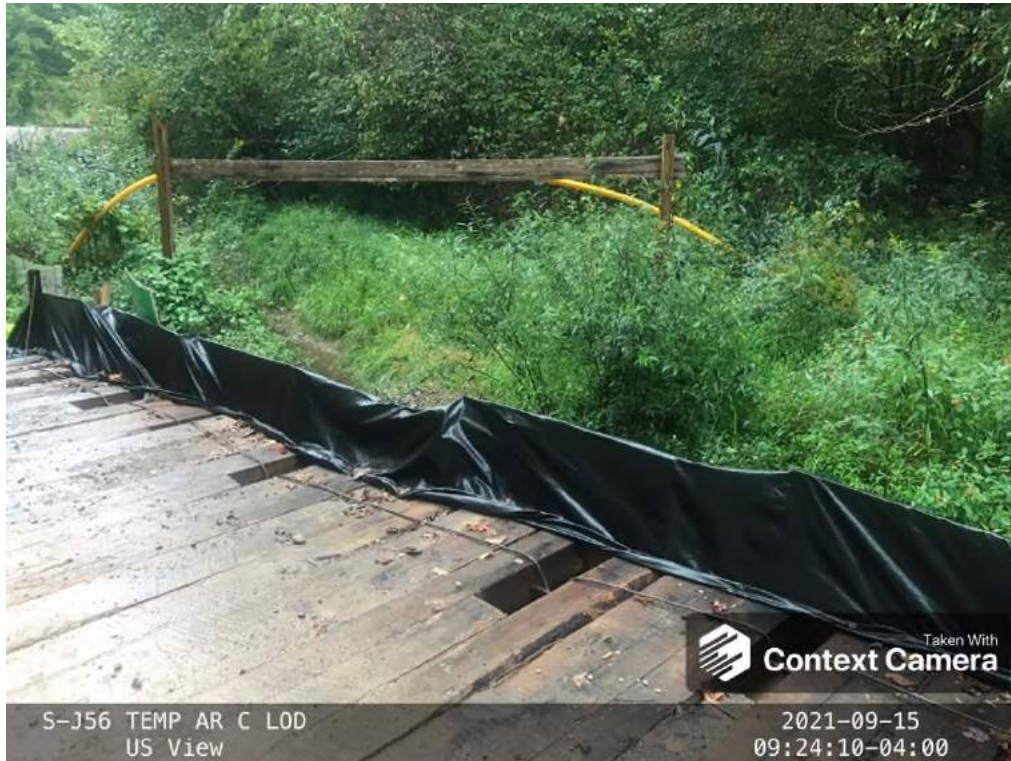
Photo Type: US View at Center
Location, Orientation, Photographer Initials: Center ROW, Upstream View, MG/SM
Lat: 39.464105 Long: -80.502318

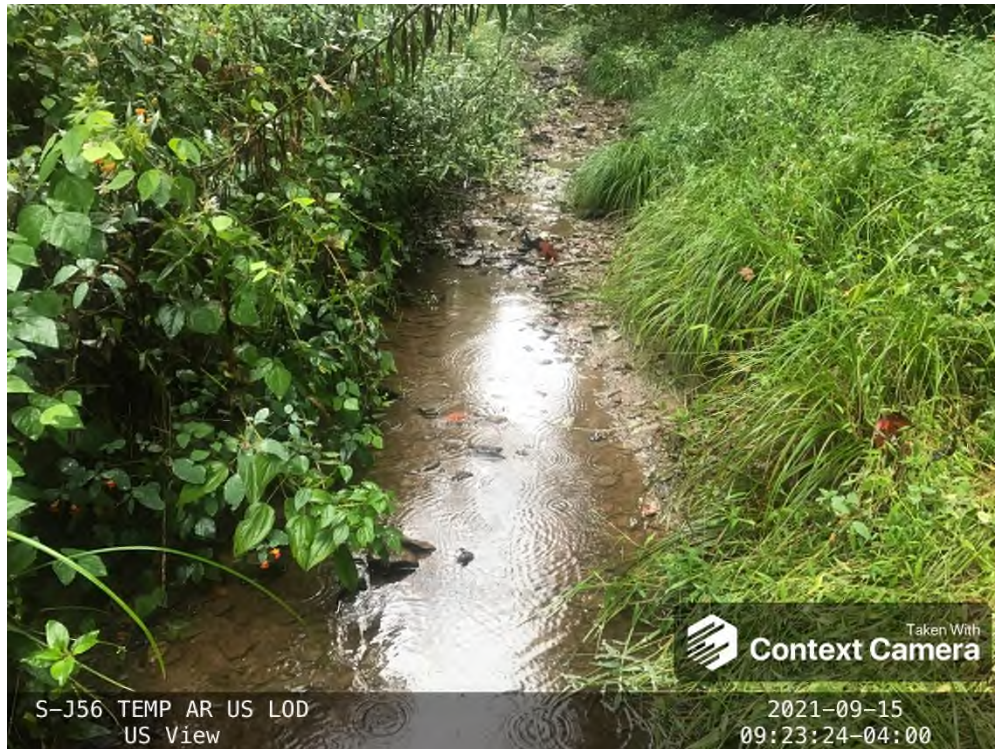
Photo Type: US, US View

Location, Orientation, Photographer Initials: Upstream Edge of ROW, Upstream View, MG/SM

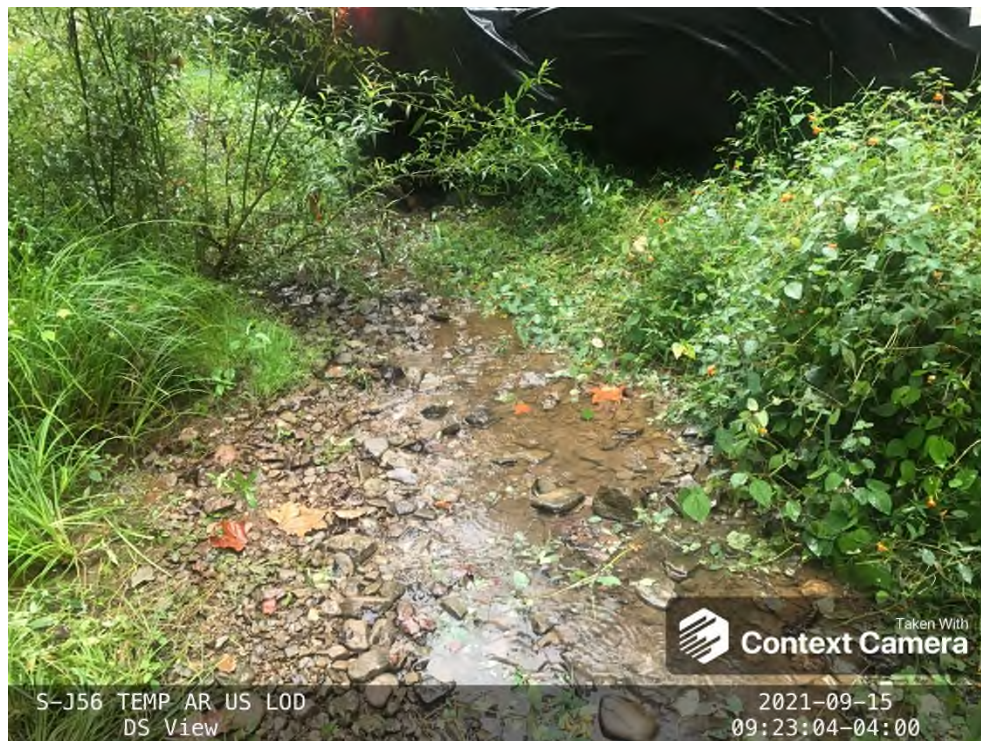
Photo Type: US, DS View

Location, Orientation, Photographer Initials: Upstream Edge of ROW, Downstream View, MG/SM

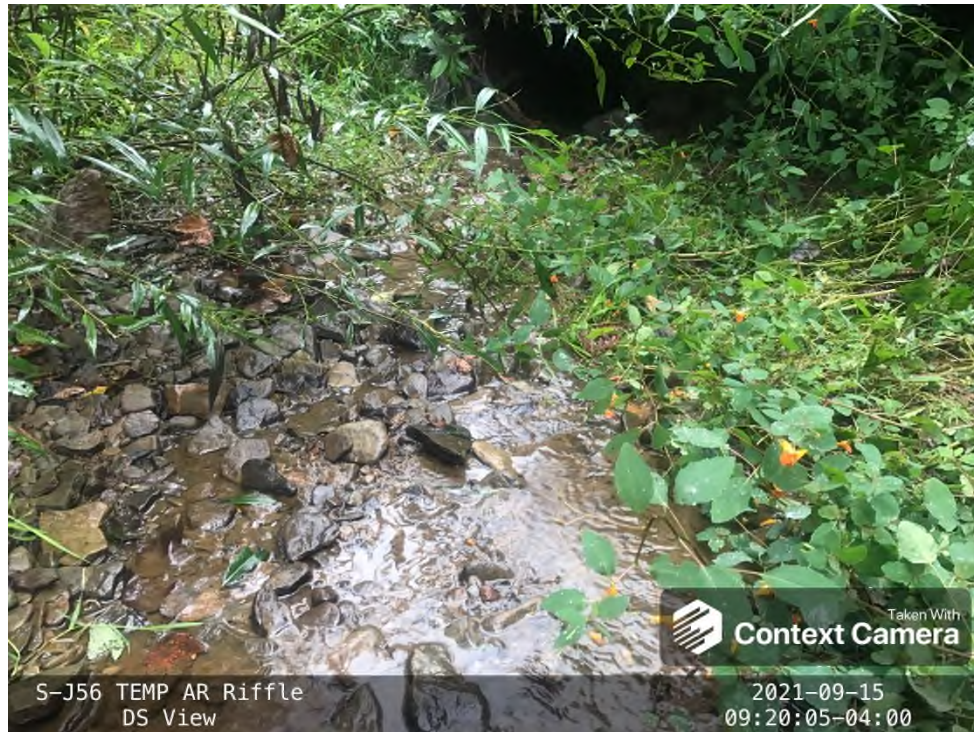
Photo Type: Riffle, DS View
Location, Orientation, Photographer Initials: Upstream of Riffle, Downstream View, MG/SM
Lat: 39.464105 Long: -80.502318

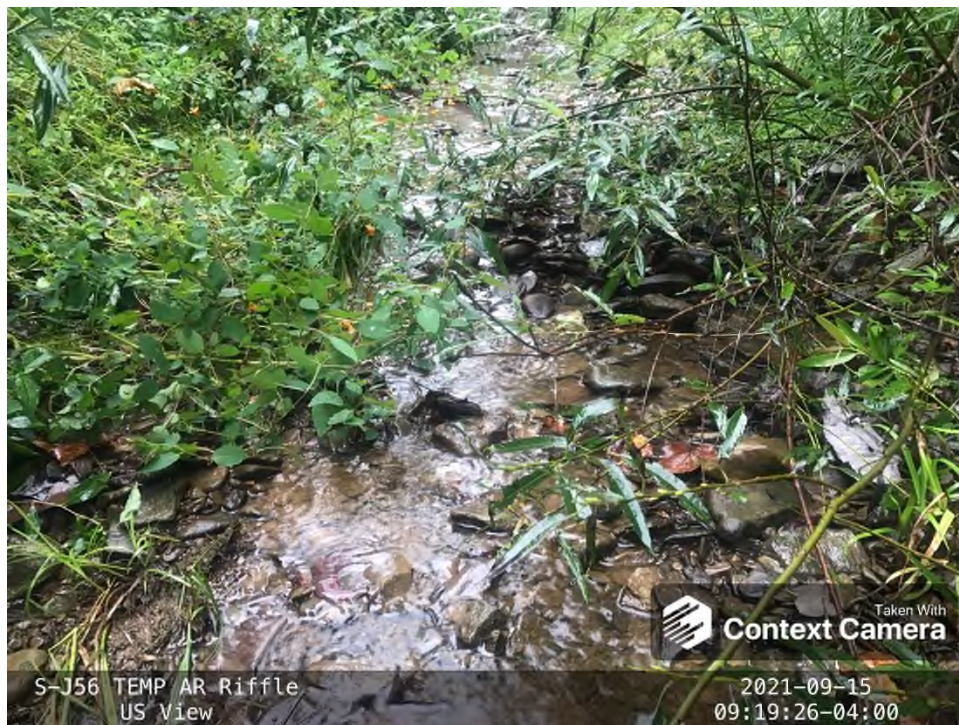
Photo Type: Riffle, US View
Location, Orientation, Photographer Initials: Downstream of Riffle, Upstream View, MG/SM
Lat: 39.464105 Long: -80.502318

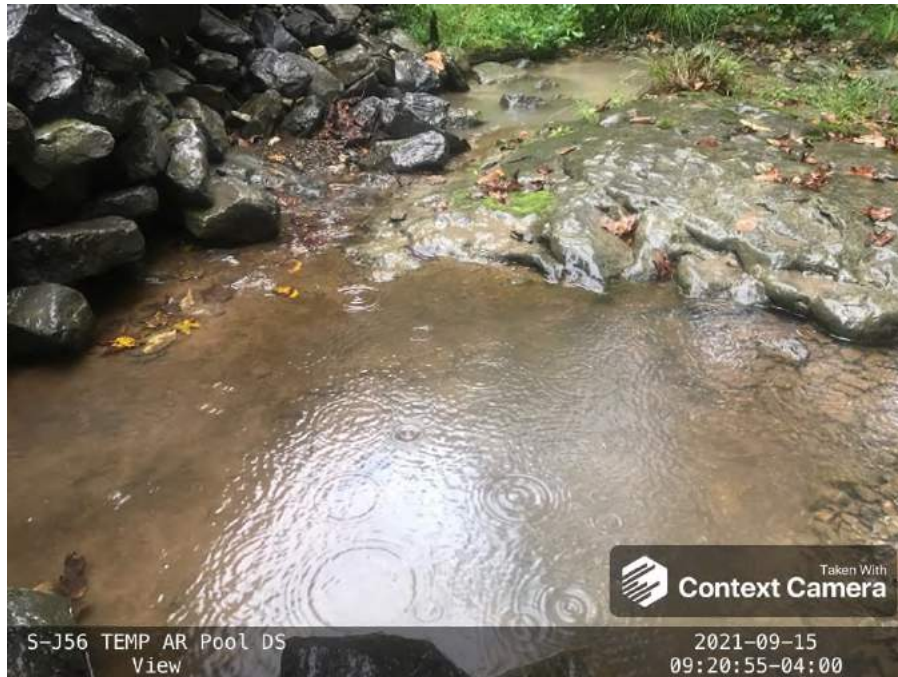
Photo Type: Pool, DS View

Location, Orientation, Photographer Initials: Upstream of Pool, Downstream View, MG/SM
Lat: 39.464105 Long: -80.502318

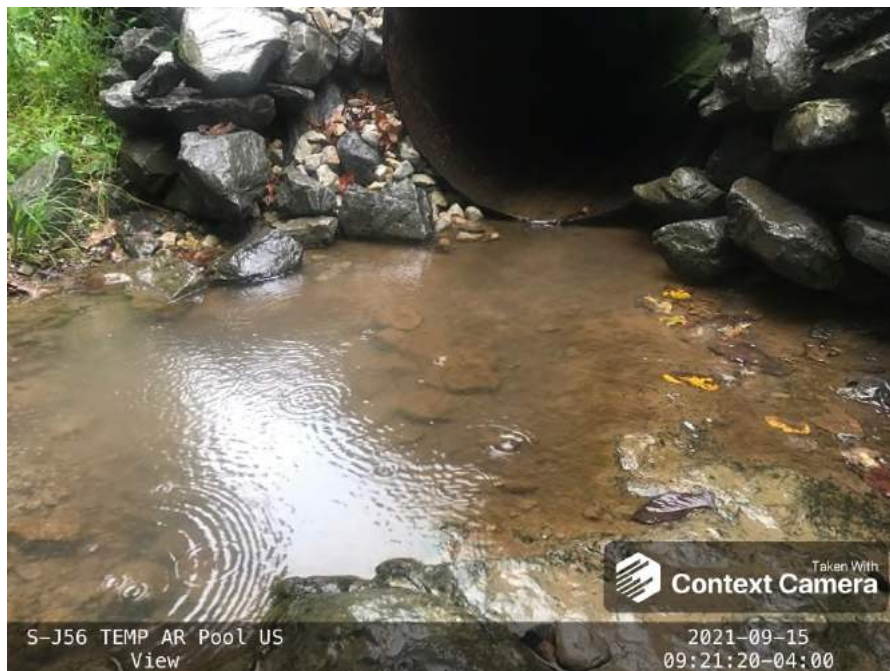
Photo Type: Pool, US View

Location, Orientation, Photographer Initials: Downstream of Pool, Upstream View, MG/SM
Lat: 39.464105 Long: -80.502318

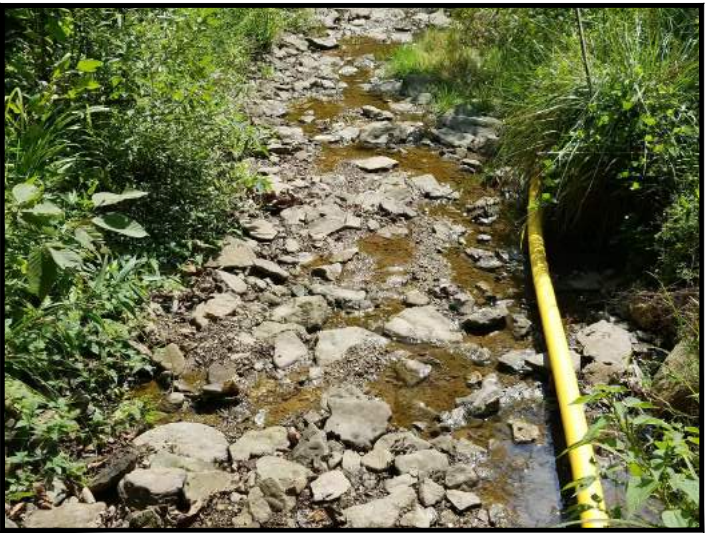
PHOTO TAKEN LOOKING DOWNSTREAM
FROM UPSTREAM IMPACT LIMITS

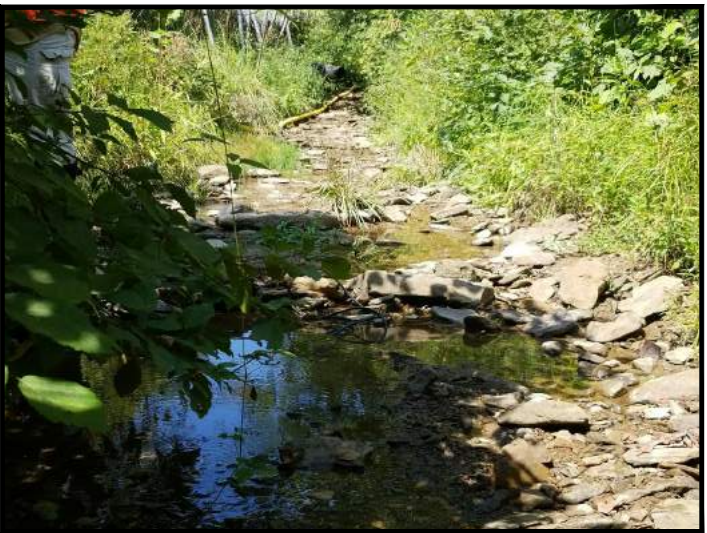
PHOTO TAKEN LOOKING UPSTREAM FROM
DOWNSTREAM IMPACT LIMITS
