Baseline Assessment – Stream Attributes

Reach S-K14 (Pipeline ROW) Ephemeral Spread F Summers County, West Virginia

Title PROFILE AND CROSS-SECTIONS
BASELINE SURVEY
CROSSING S-K14 - UNNAMED TRIB. TO
RIGHTHAND FORK HUNGARD CREEK (MP 169.5)
SUMMERS COUNTY, WV

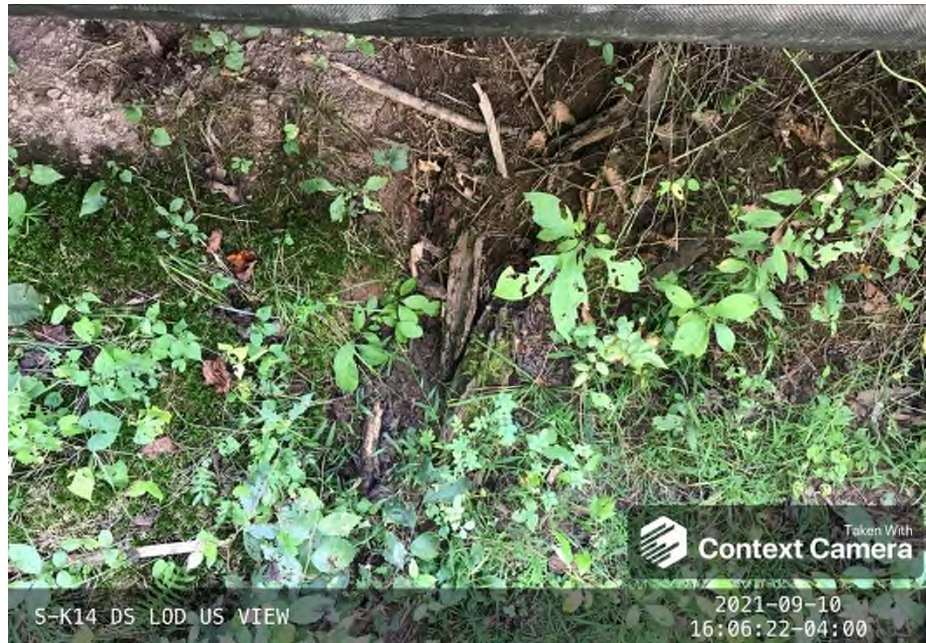
Photo Type: DS, US View

Location, Orientation, Photographer Initials: Downstream Edge of ROW, Upstream View, SM/MW

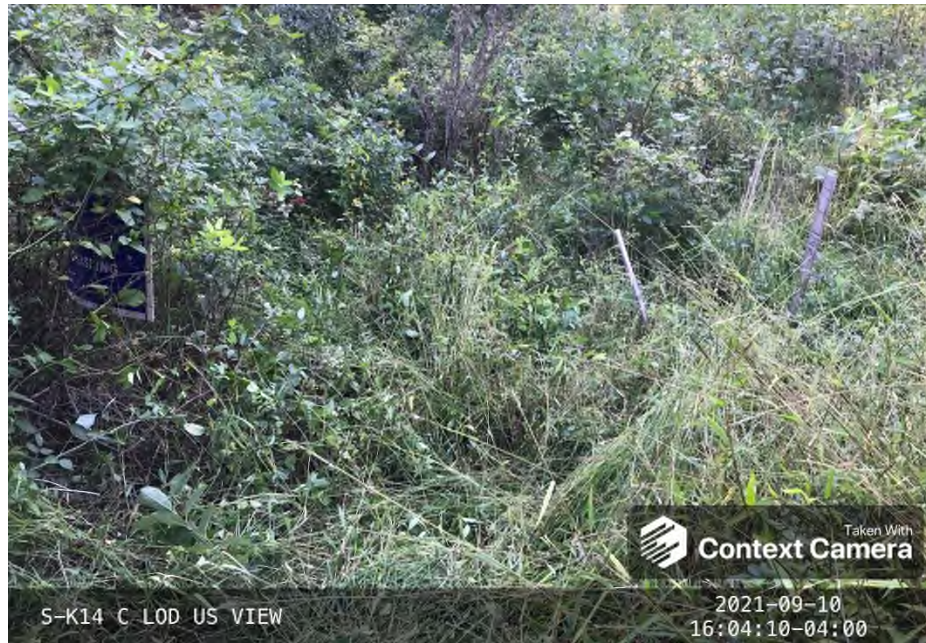
Photo Type: US View at Center
Location, Orientation, Photographer Initials: Center ROW, Upstream View, SM/MW
Lat: 37.696788 Long: -80.739242

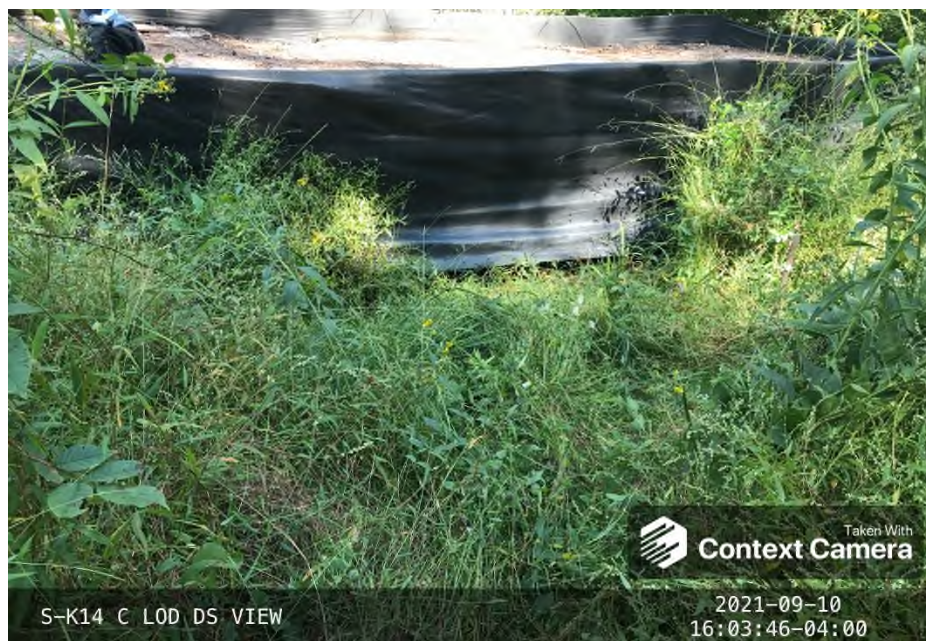
Photo Type: DS View at Center
Location, Orientation, Photographer Initials: ROW Center, Downstream View, SM/MW
Lat: 37.696788 Long: -80.739242

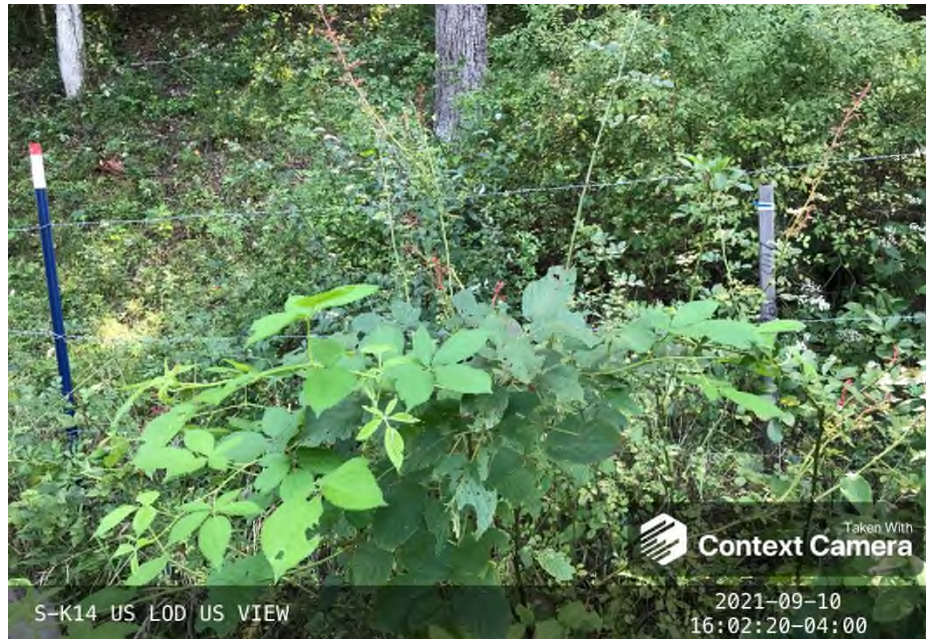
Photo Type: US, US View

Location, Orientation, Photographer Initials: Upstream Edge of ROW, Upstream View, SM/MW
Lat: 37.696788 Long: -80.739242

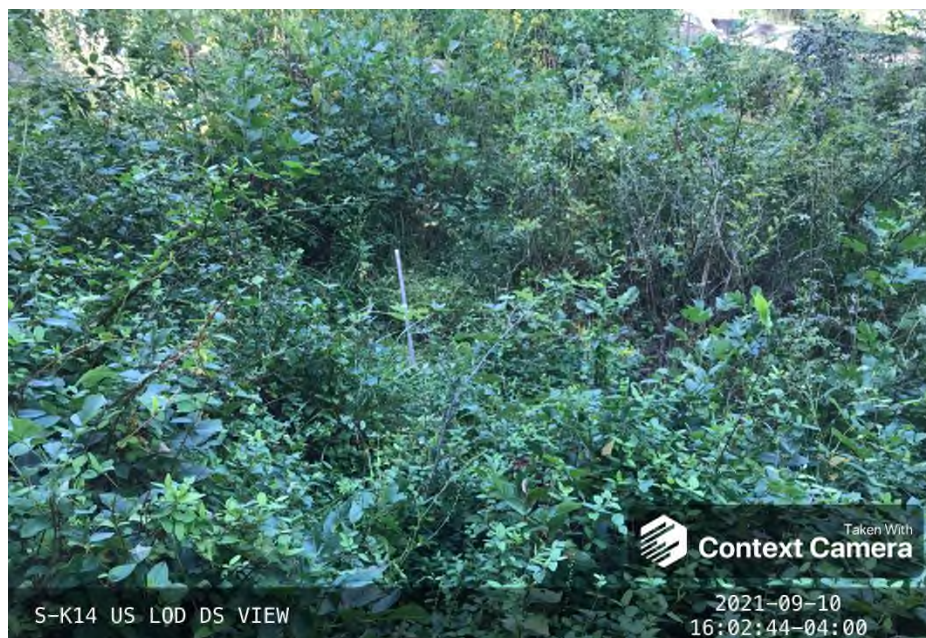
Photo Type: US, DS View

Location, Orientation, Photographer Initials: Upstream Edge of ROW, Downstream View, SM/MW
Lat: 37.696788 Long: -80.739242

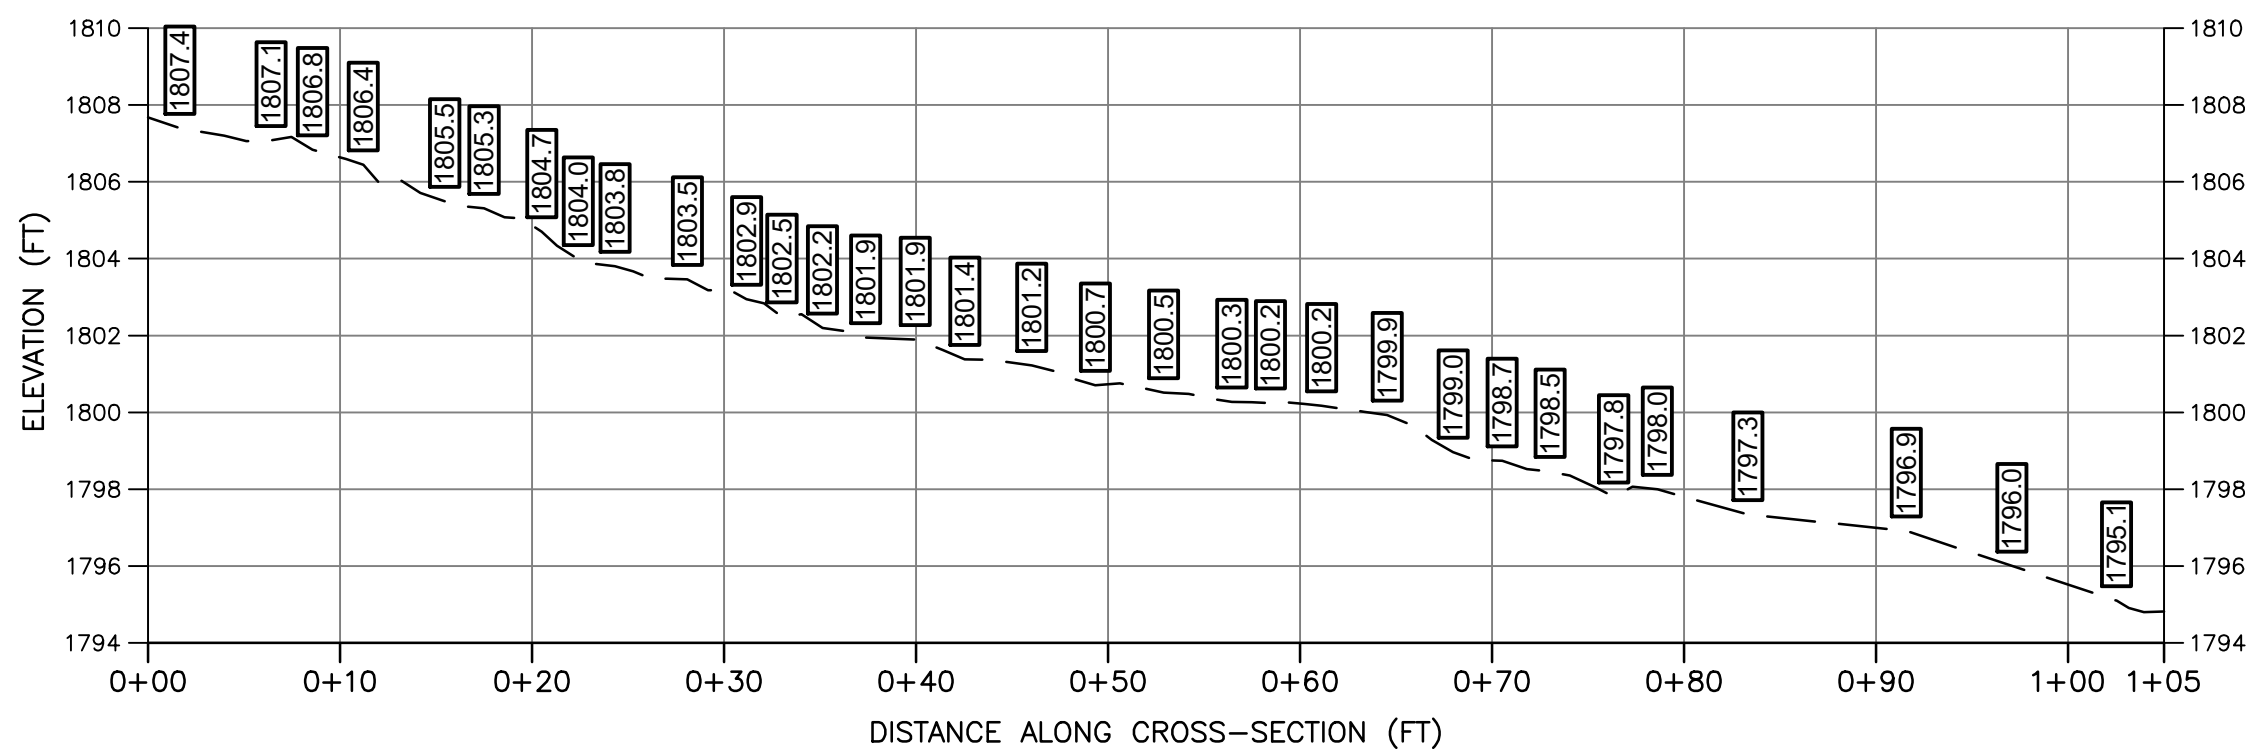
4. ALL SECTION VIEWS SHOWN LEFT TO RIGHT FACING DOWNSTREAM.
 5. POST-CROSSING SURVEY INFORMATION SHOWN IN RED. DATA PENDING.
 6. POST-CROSSING SURVEY POINTS FOR CROSS SECTIONS AND THALWEG ARE PROJECTED ONTO PRE-CROSSING SECTION AND PROFILE VIEWS FOR COMPARISON.

AS-BUILT TABLE: S-K14 CROSS SECTION A					
PRE-CROSSING				AS-BUILT	
PT. LOC.	NORTHING	EASTING	ELEV	VERT. DIFF.	HORZ. DIFF.
TS - L	13688309.2100	1715841.4650	1800.866'		
BS - L	13688304.9900	1715840.5680	1800.405'		
THW	13688300.7700	1715841.4710	1800.225'		
BS - R	13688300.8700	1715840.6120	1800.443'		
TS - R	13688298.1500	1715840.2070	1800.901'

NOTE: ALL SECTIONS VIEWS SHOWN LEFT TO RIGHT FACING DOWNSTREAM.

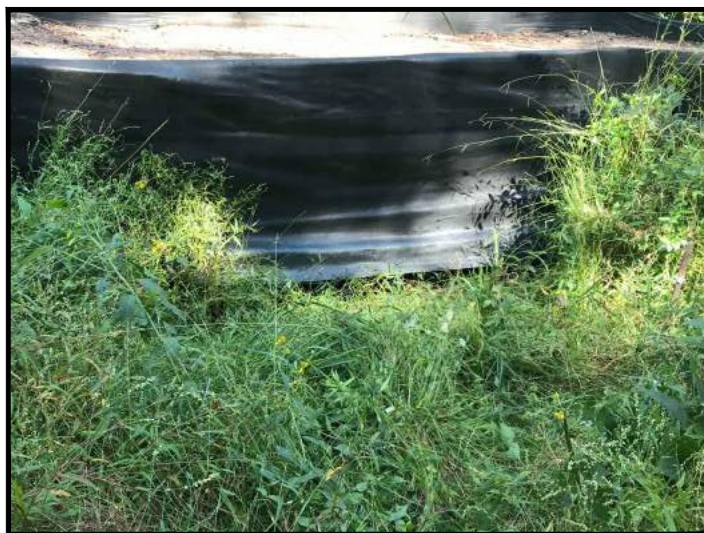
PHOTO TAKEN LOOKING DOWNSTREAM
FROM UPSTREAM IMPACT LIMITS

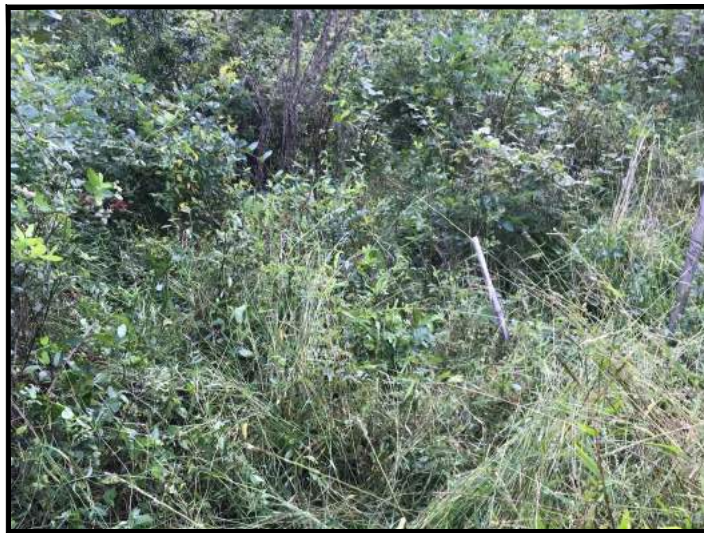
PHOTO TAKEN LOOKING UPSTREAM FROM
DOWNSTREAM IMPACT LIMITS
