Baseline Assessment – Stream Attributes

Reach S-K17 (Pipeline ROW)
Perennial
Spread F
Greenbrier County, West Virginia

Spread F Stream S-K17 (Pipeline ROW) Greenbrier County

PROFILE AND CROSS-SECTIONS
BASELINE SURVEY
CROSSING S-K17 - BUFFALO CREEK
(MP 154.88)
GREENBRIER COUNTY, WV

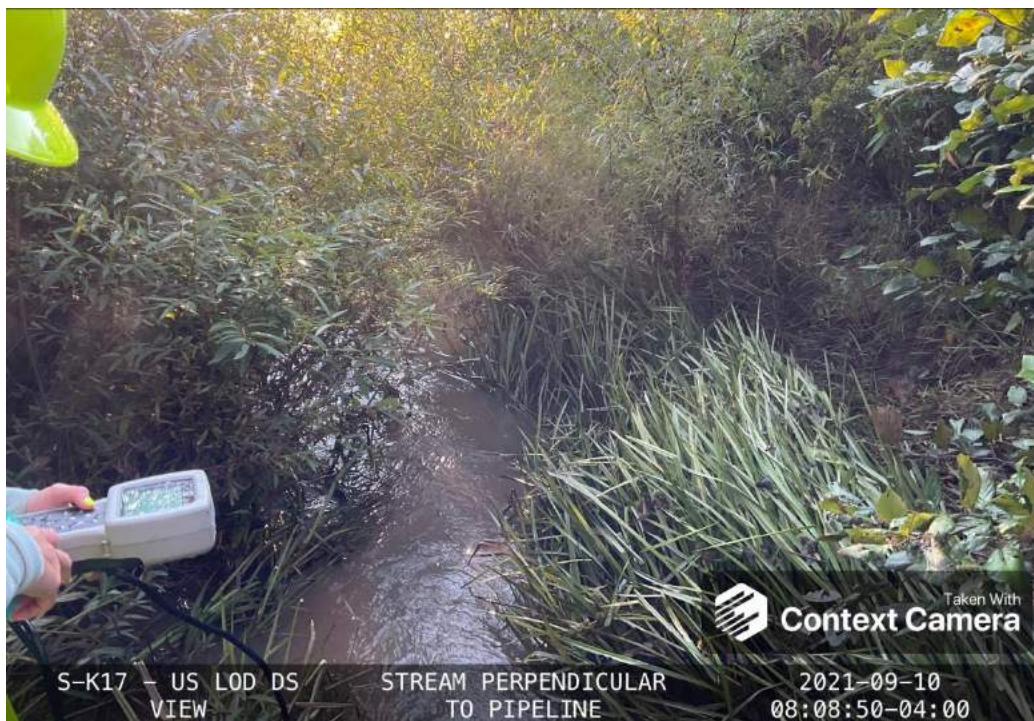
Photo Type: US, DS View
Location, Orientation, Photographer Initials: Upstream Edge of ROW, Downstream View, CNJ
Lat: 37.863065 Long: -80.757391

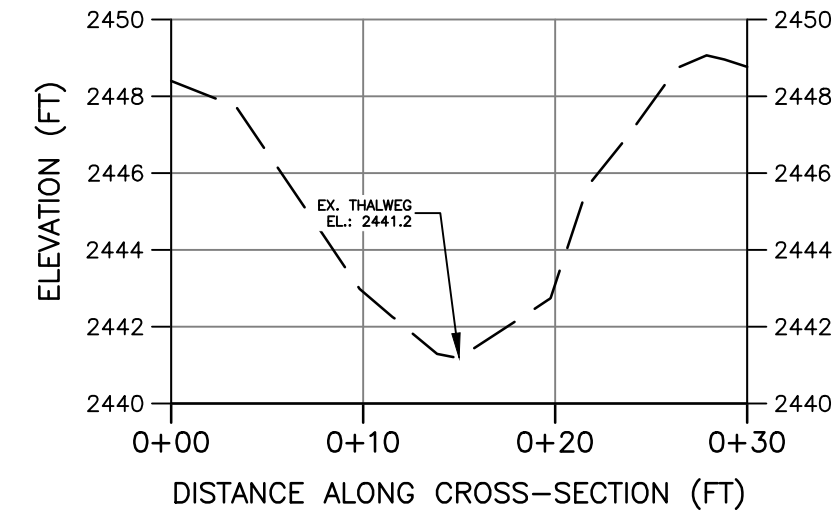
EXISTING STREAM PROFILE
INVERT ALONG THALWEG

Distance Along Cross-Section (FT)	Elevation (FT)
0+00	2443.5
0+05	2443.5
0+10	2442.3
0+15	2442.5
0+20	2442.3
0+25	2441.6
0+30	2441.7
0+35	2441.4
0+40	2441.2
0+45	2441.6
0+50	2441.1
0+55	2441.3
0+60	2441.7
0+65	2441.4
0+70	2441.3
0+70	2441.4
0+70	2441.2
0+70	2441.4

PROFILE
H: 1"=10'
V: 1"=5'

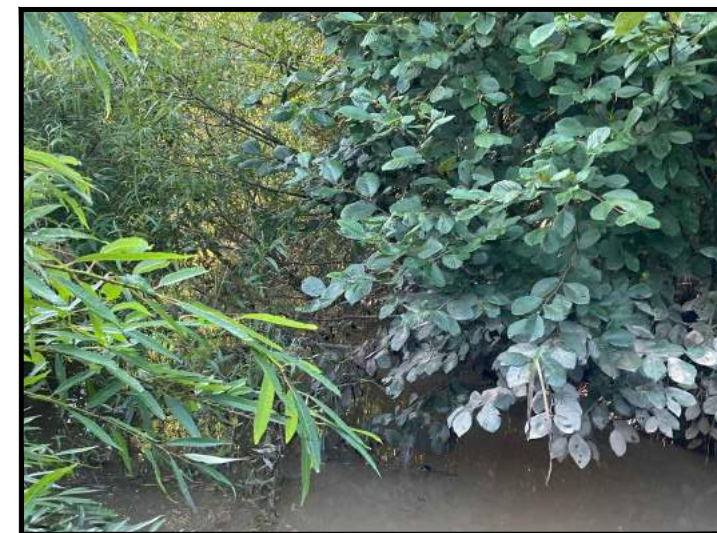
PHOTO TAKEN LOOKING DOWNSTREAM
FROM UPSTREAM IMPACT LIMITS

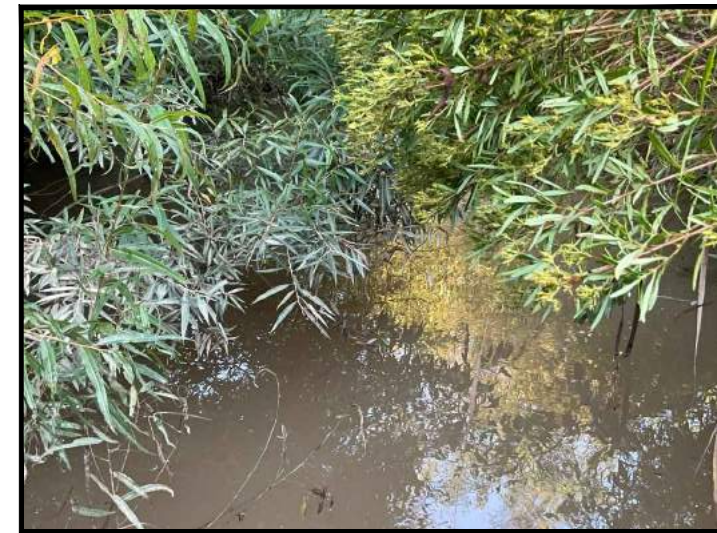
PHOTO TAKEN LOOKING UPSTREAM FROM
DOWNSTREAM IMPACT LIMITS
