Baseline Assessment – Stream Attributes

Reach S-K46 (Pipeline ROW)

Lewis County, West Virginia

Title
PROFILE AND CROSS-SECTIONS
BASELINE SURVEY
CROSSING S-K46 - UNNAMED TRIB. TO
LEFT FORK FREEMANS CREEK (MP 45.8)
LEWIS COUNTY, WV

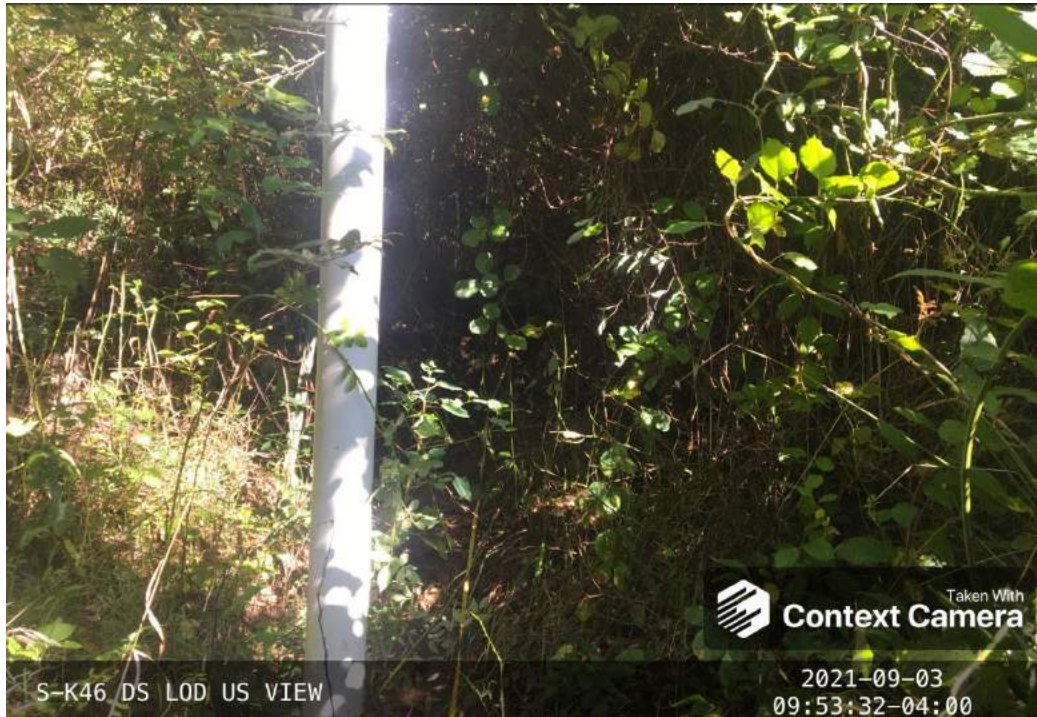
Photo Type: DS, US View

Location, Orientation, Photographer Initials: Downstream Edge of ROW, Upstream View, DP/VM/HK
Lat: 39.080252 Long: -80.58143

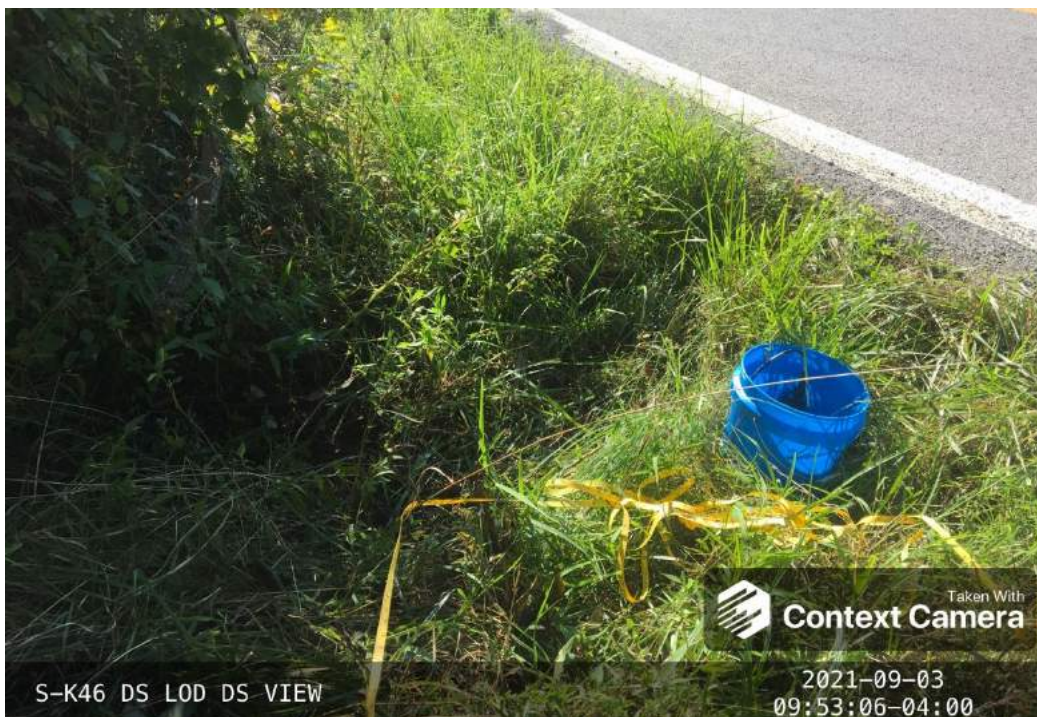
Photo Type: DS, DS View

Location, Orientation, Photographer Initials: Downstream Edge of ROW, Downstream View, DP/VM/HK
Lat: 39.080252 Long: -80.58143

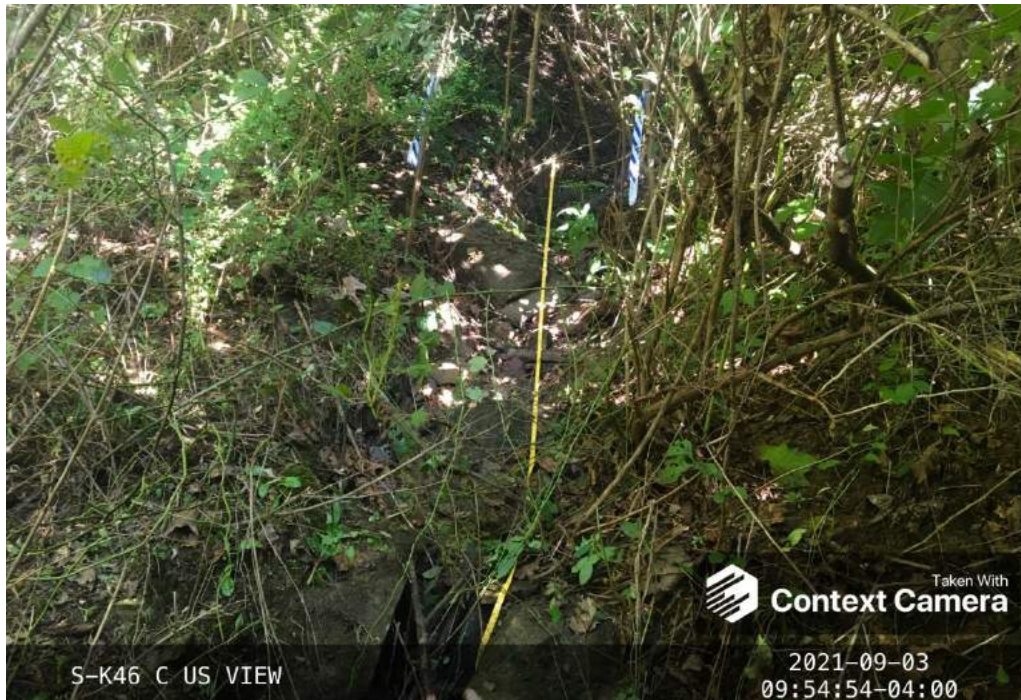
Photo Type: US View at Center
Location, Orientation, Photographer Initials: Center ROW, Upstream View, DP/VM/HK
Lat: 39.080252 Long: -80.58143

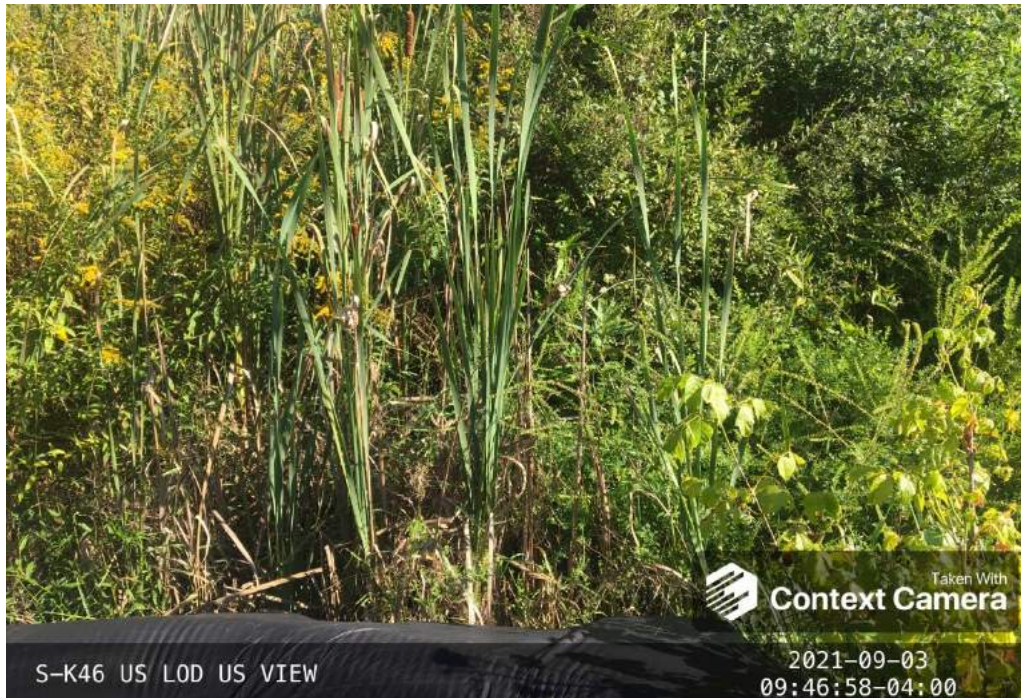
Photo Type: US, US View

Location, Orientation, Photographer Initials: Upstream Edge of ROW, Upstream View, DP/VM/HK
Lat: 39.080252 Long: -80.58143

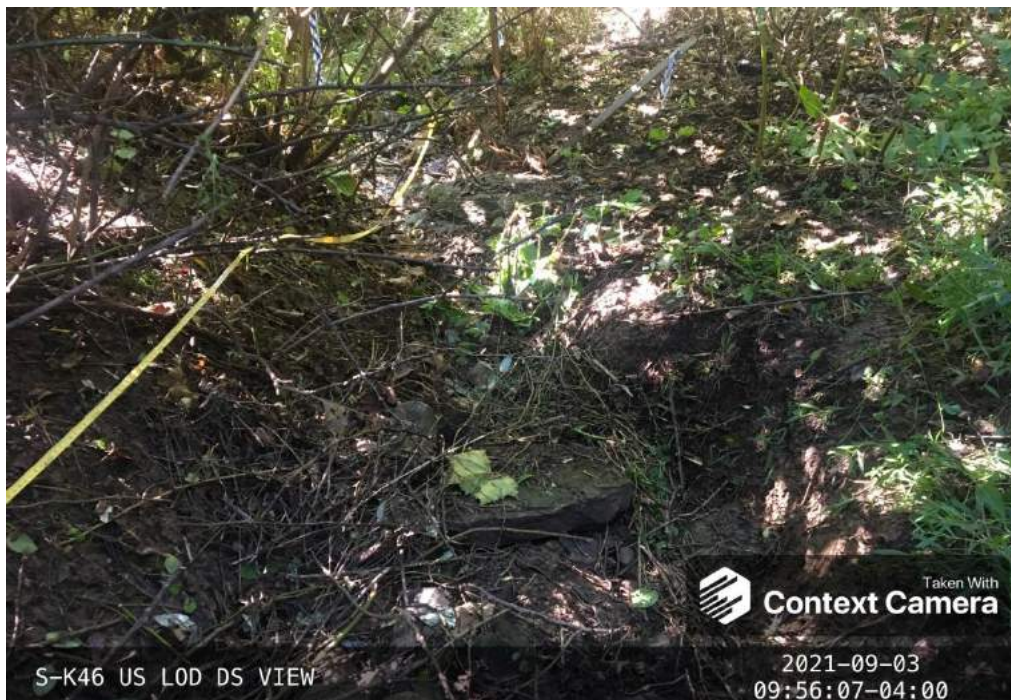
Photo Type: US, DS View

Location, Orientation, Photographer Initials: Upstream Edge of ROW, Downstream View, DP/VM/HK
Lat: 39.080252 Long: -80.58143

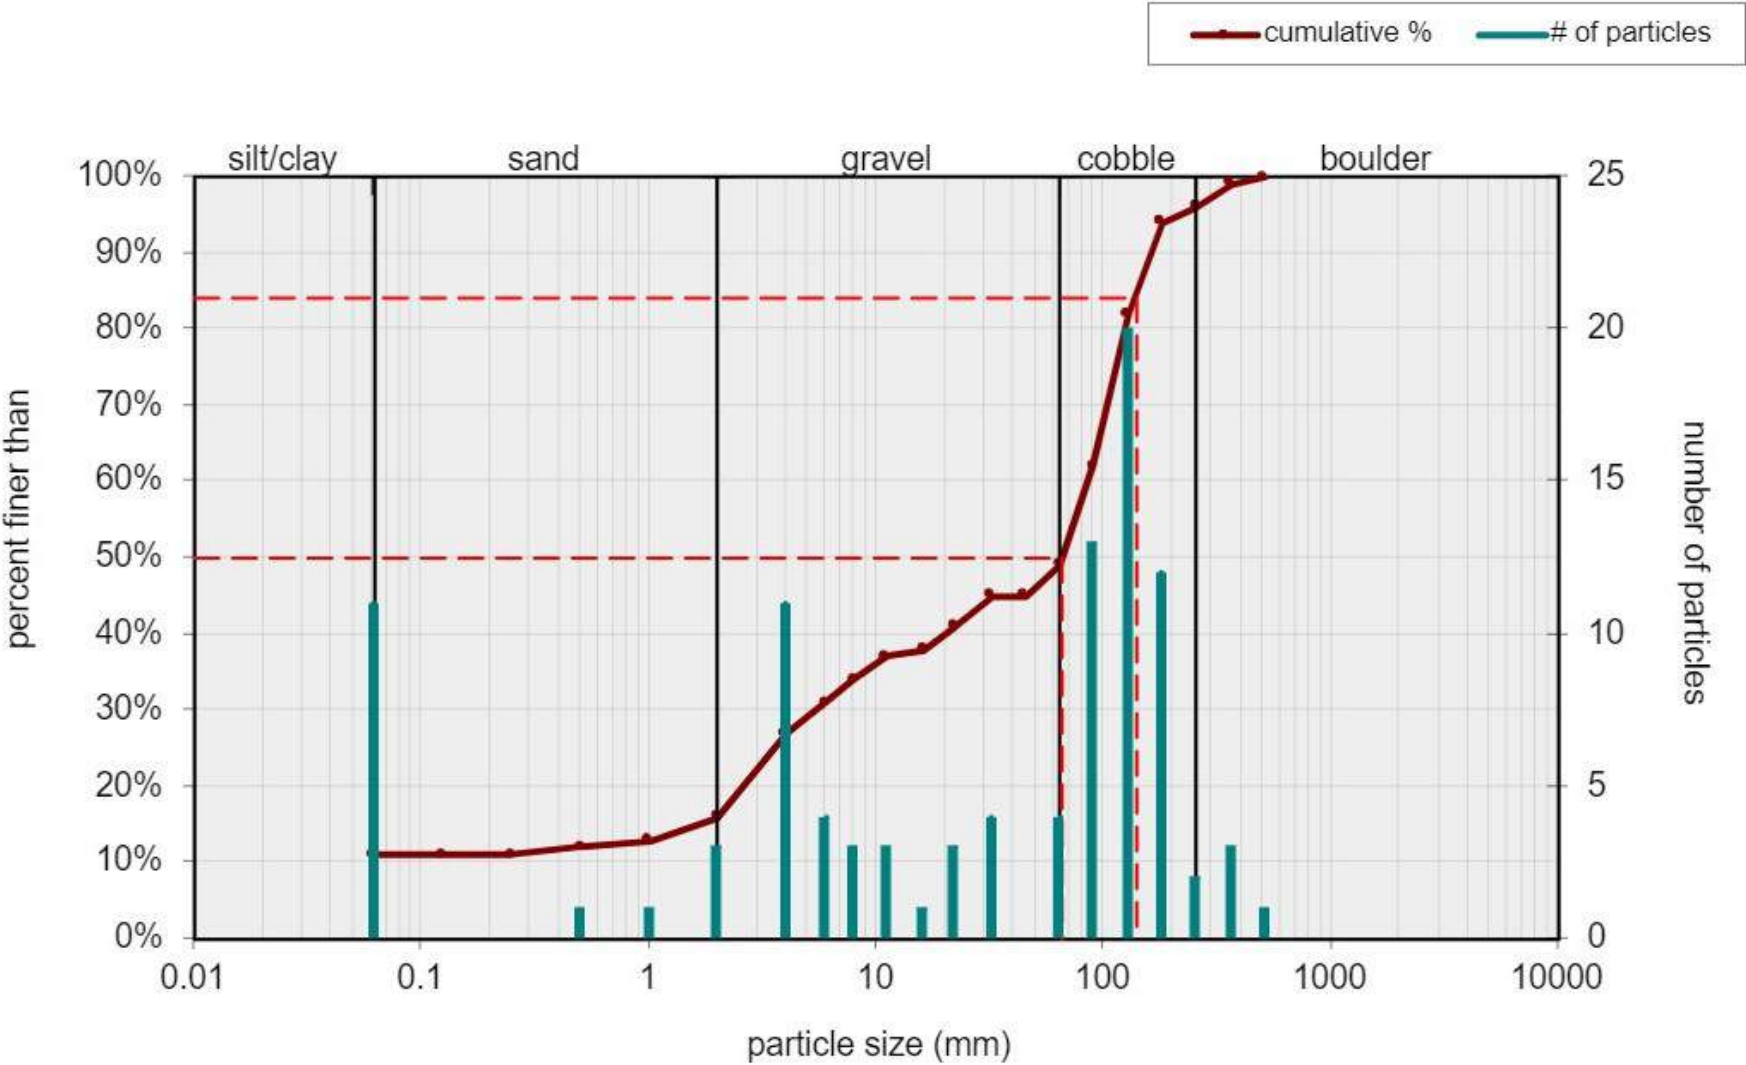
Bankfull Channel Pebble Count, S-K46, UNT to Left Fork Freemans Creek

Size (mm)	
D16	2
D35	8.9
D50	66
D65	95
D84	140
D95	210

Size Distribution	
mean	16.7
dispersion	17.6
skewness	-0.44

Type	
silt/clay	11%
sand	5%
gravel	33%
cobble	47%
boulder	4%

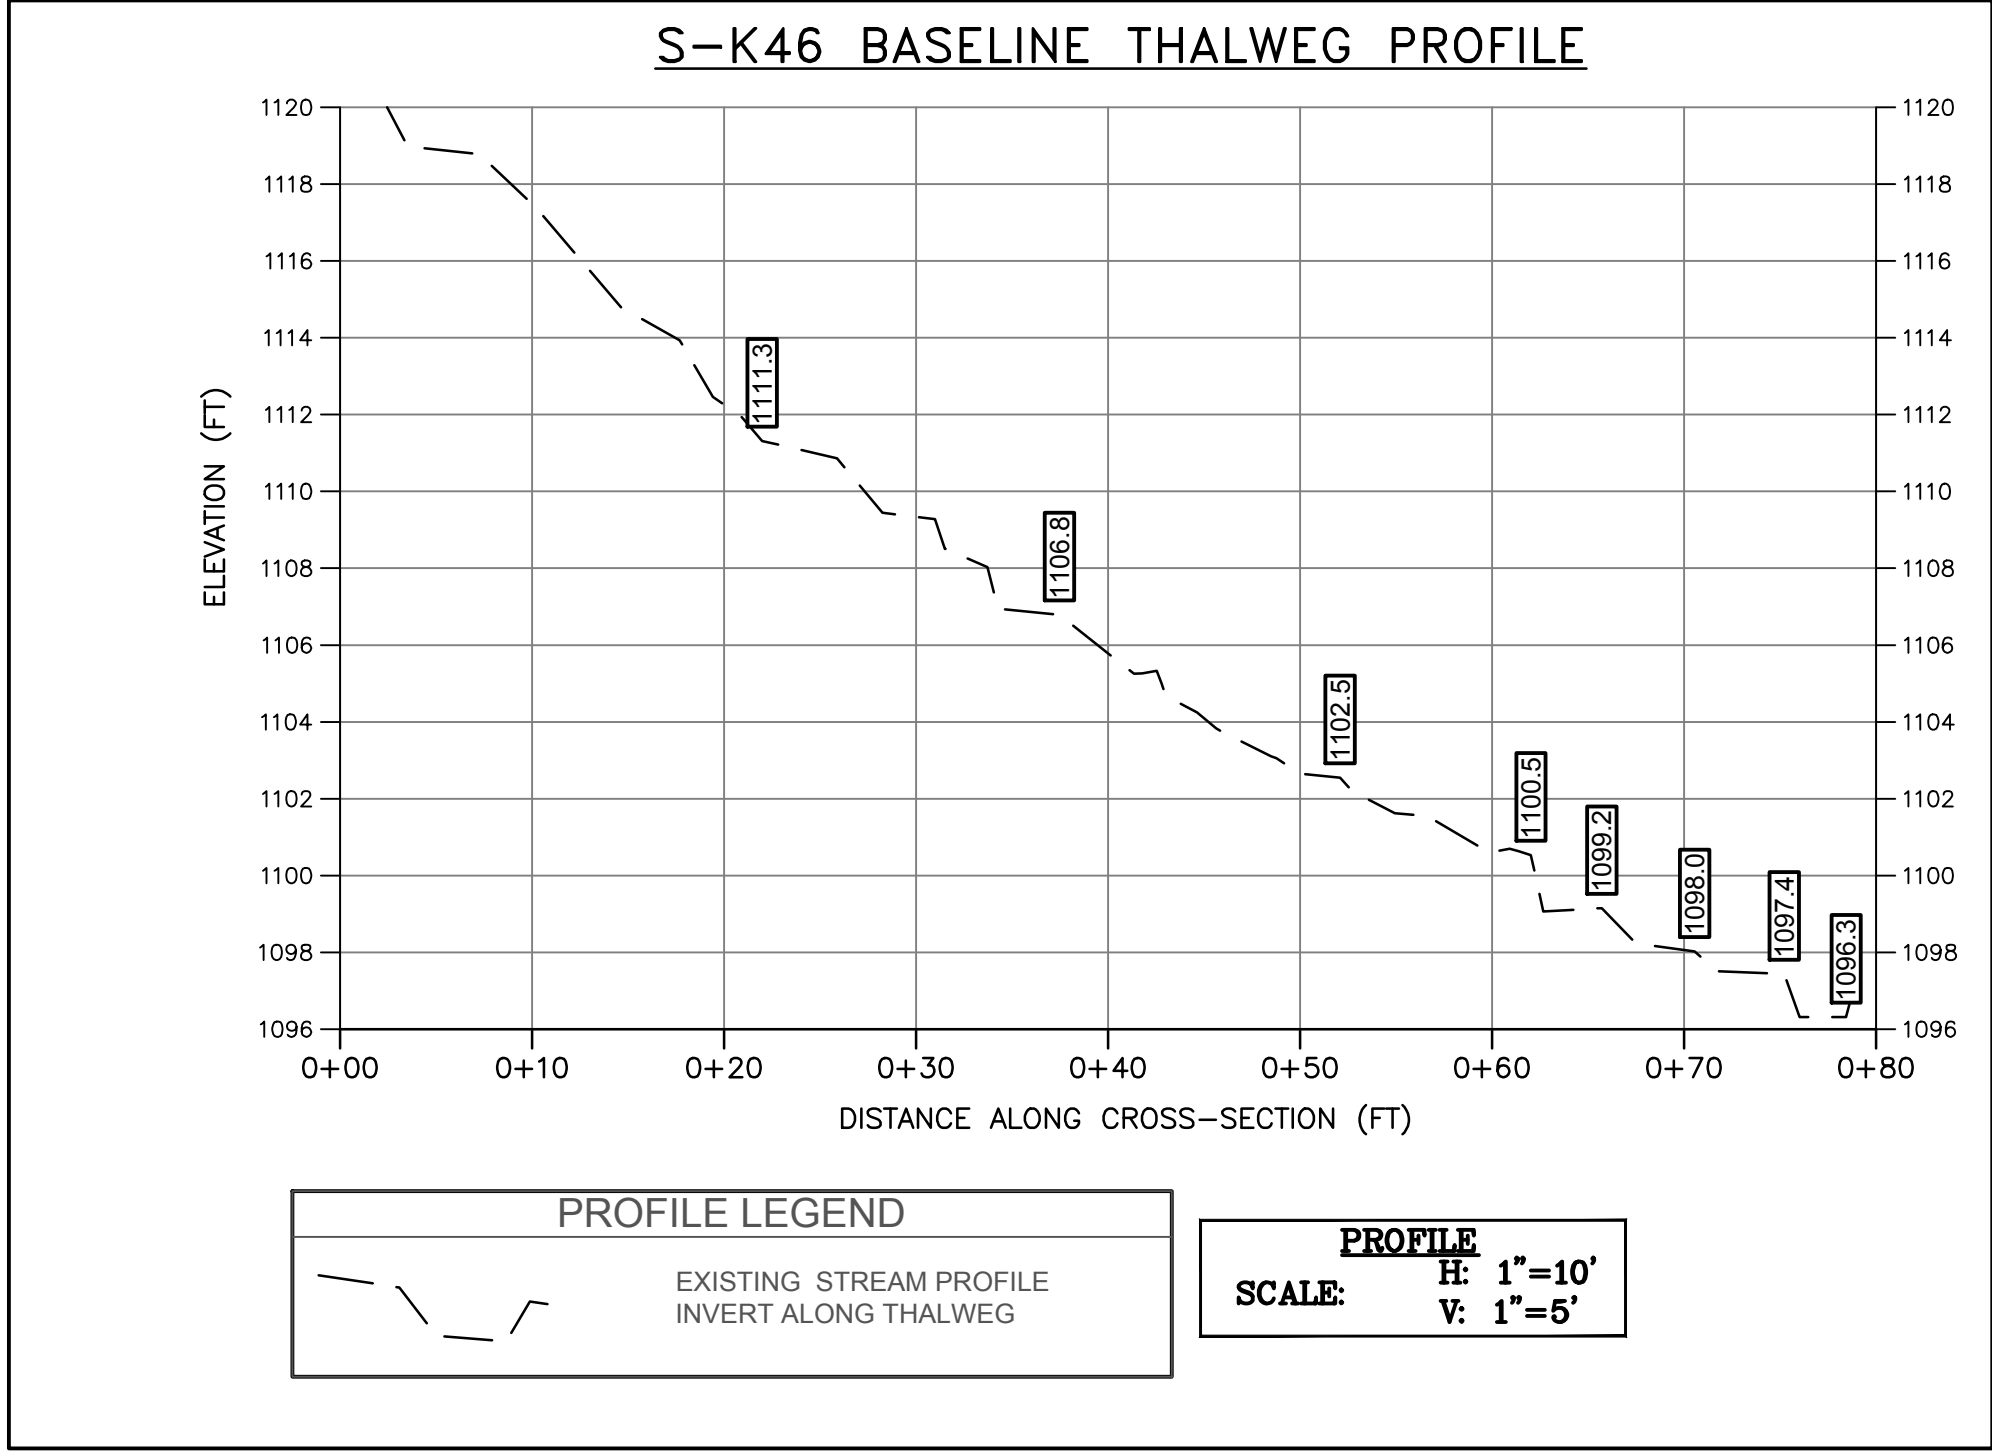
4. ALL SECTION VIEWS SHOWN LEFT TO RIGHT FACING DOWNSTREAM.
 5. POST-CROSSING SURVEY INFORMATION SHOWN IN RED. DATA PENDING.
 6. POST-CROSSING SURVEY POINTS FOR CROSS SECTIONS AND THALWEG ARE PROJECTED ONTO PRE-CROSSING SECTION AND PROFILE VIEWS FOR COMPARISON.

AS-BUILT TABLE: S-K46 CROSS SECTION					
PT. LOC.	PRE-CROSSING			AS-BUILT	
	NORTHING	EASTING	ELEV.	VERT. DIFF.	HORZ. DIFF.
TS-L	14192084.81	1759213.23	1099.23		
TWL	14192085.09	1759210.06	1098.44		
TS-R	14192085.24	1759207.61	1099.09
