Baseline Assessment – Stream Attributes

Reach S-K60 (Timber Mat Crossing) Ephemeral Spread A Doddridge County, West Virginia

Spread A Stream S-K60 (Timber Mat Crossing) Doddridge County

Title	Client
PROFILE AND CROSS-SECTIONS BASELINE SURVEY	M/C
CROSSING S-K60 - UNNAMED TRIB. TO BIG ISAAC CREEK CREEK (MP 34.62) DODDING COUNTY, WV	222

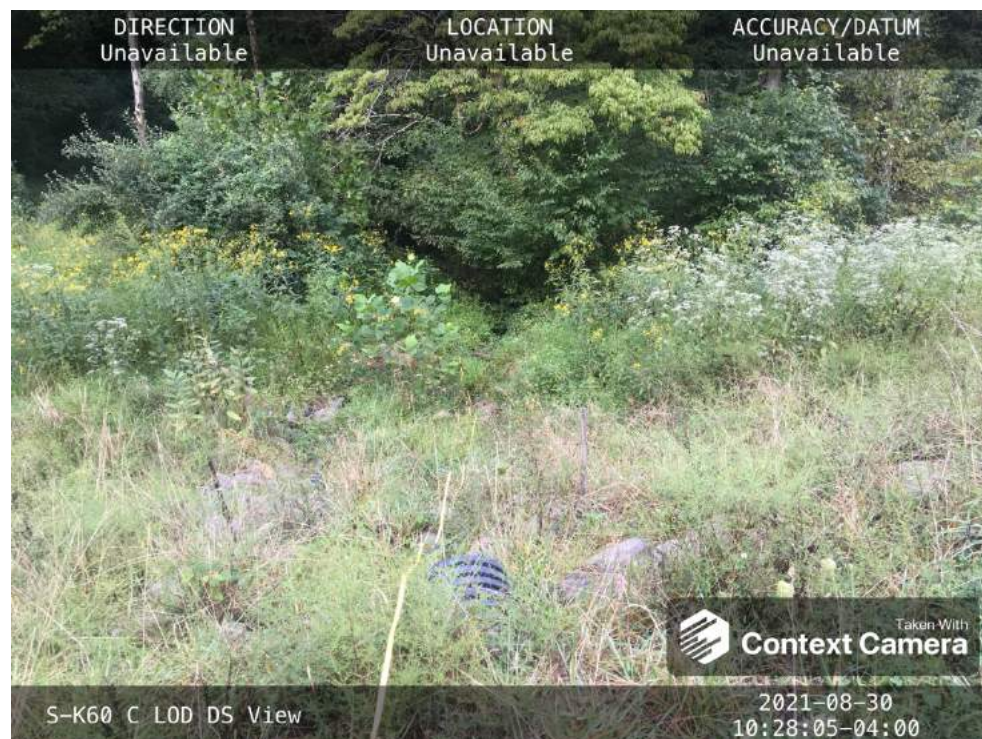
Photo Type: DS View at Center
Location, Orientation, Photographer Initials: Center ROW, Downstream View, VM/HK/DP
Lat: 39.203779 Long: -80.55341

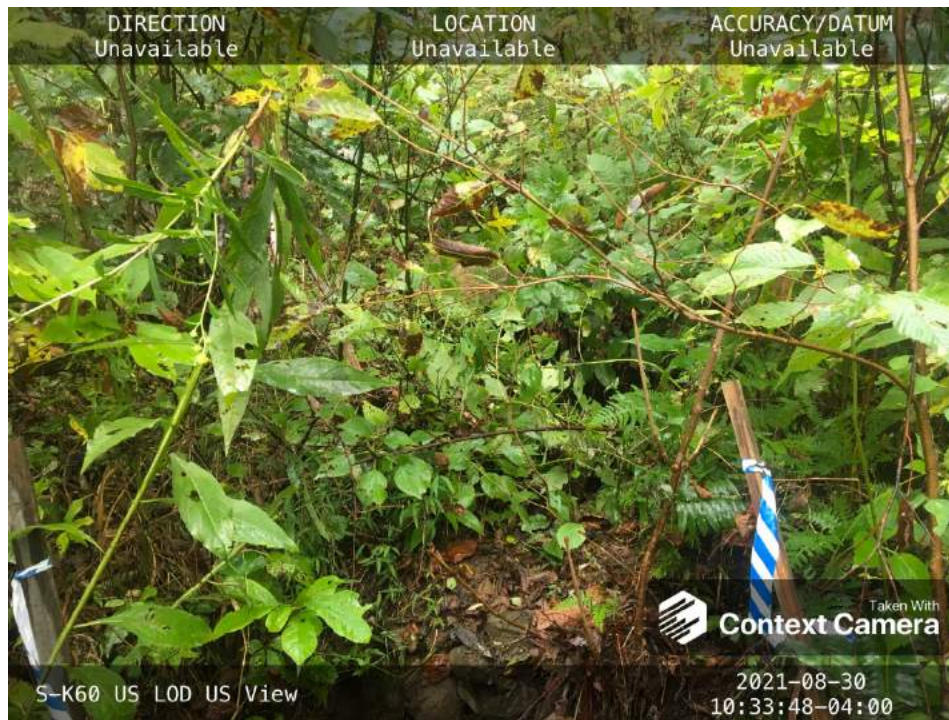
Photo Type: US, US View
Location, Orientation, Photographer Initials: Upstream Edge of ROW, Upstream View, VM/HK/DP
Lat: 39.203779 Long: -80.55341

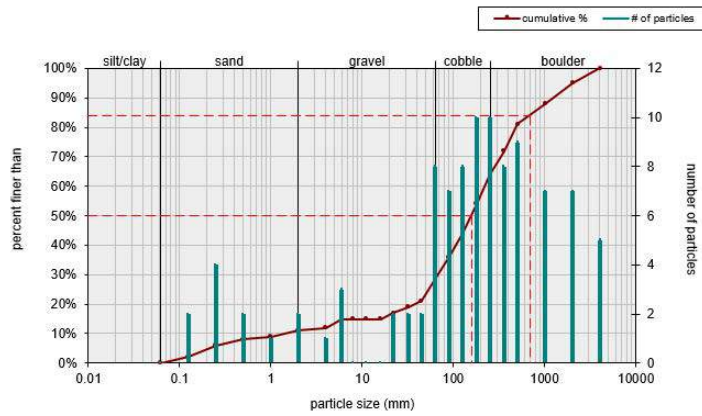
Riffle Surface Pebble Count, S-K60

Size (mm)		Size Distribution		Type	
D16	19	mean	114.5	silt/clay	0%
D35	86	dispersion	6.4	sand	11%
D50	160	skewness	-0.12	gravel	18%
D65	270			cobble	35%
D84	690			boulder	36%
D95	2000

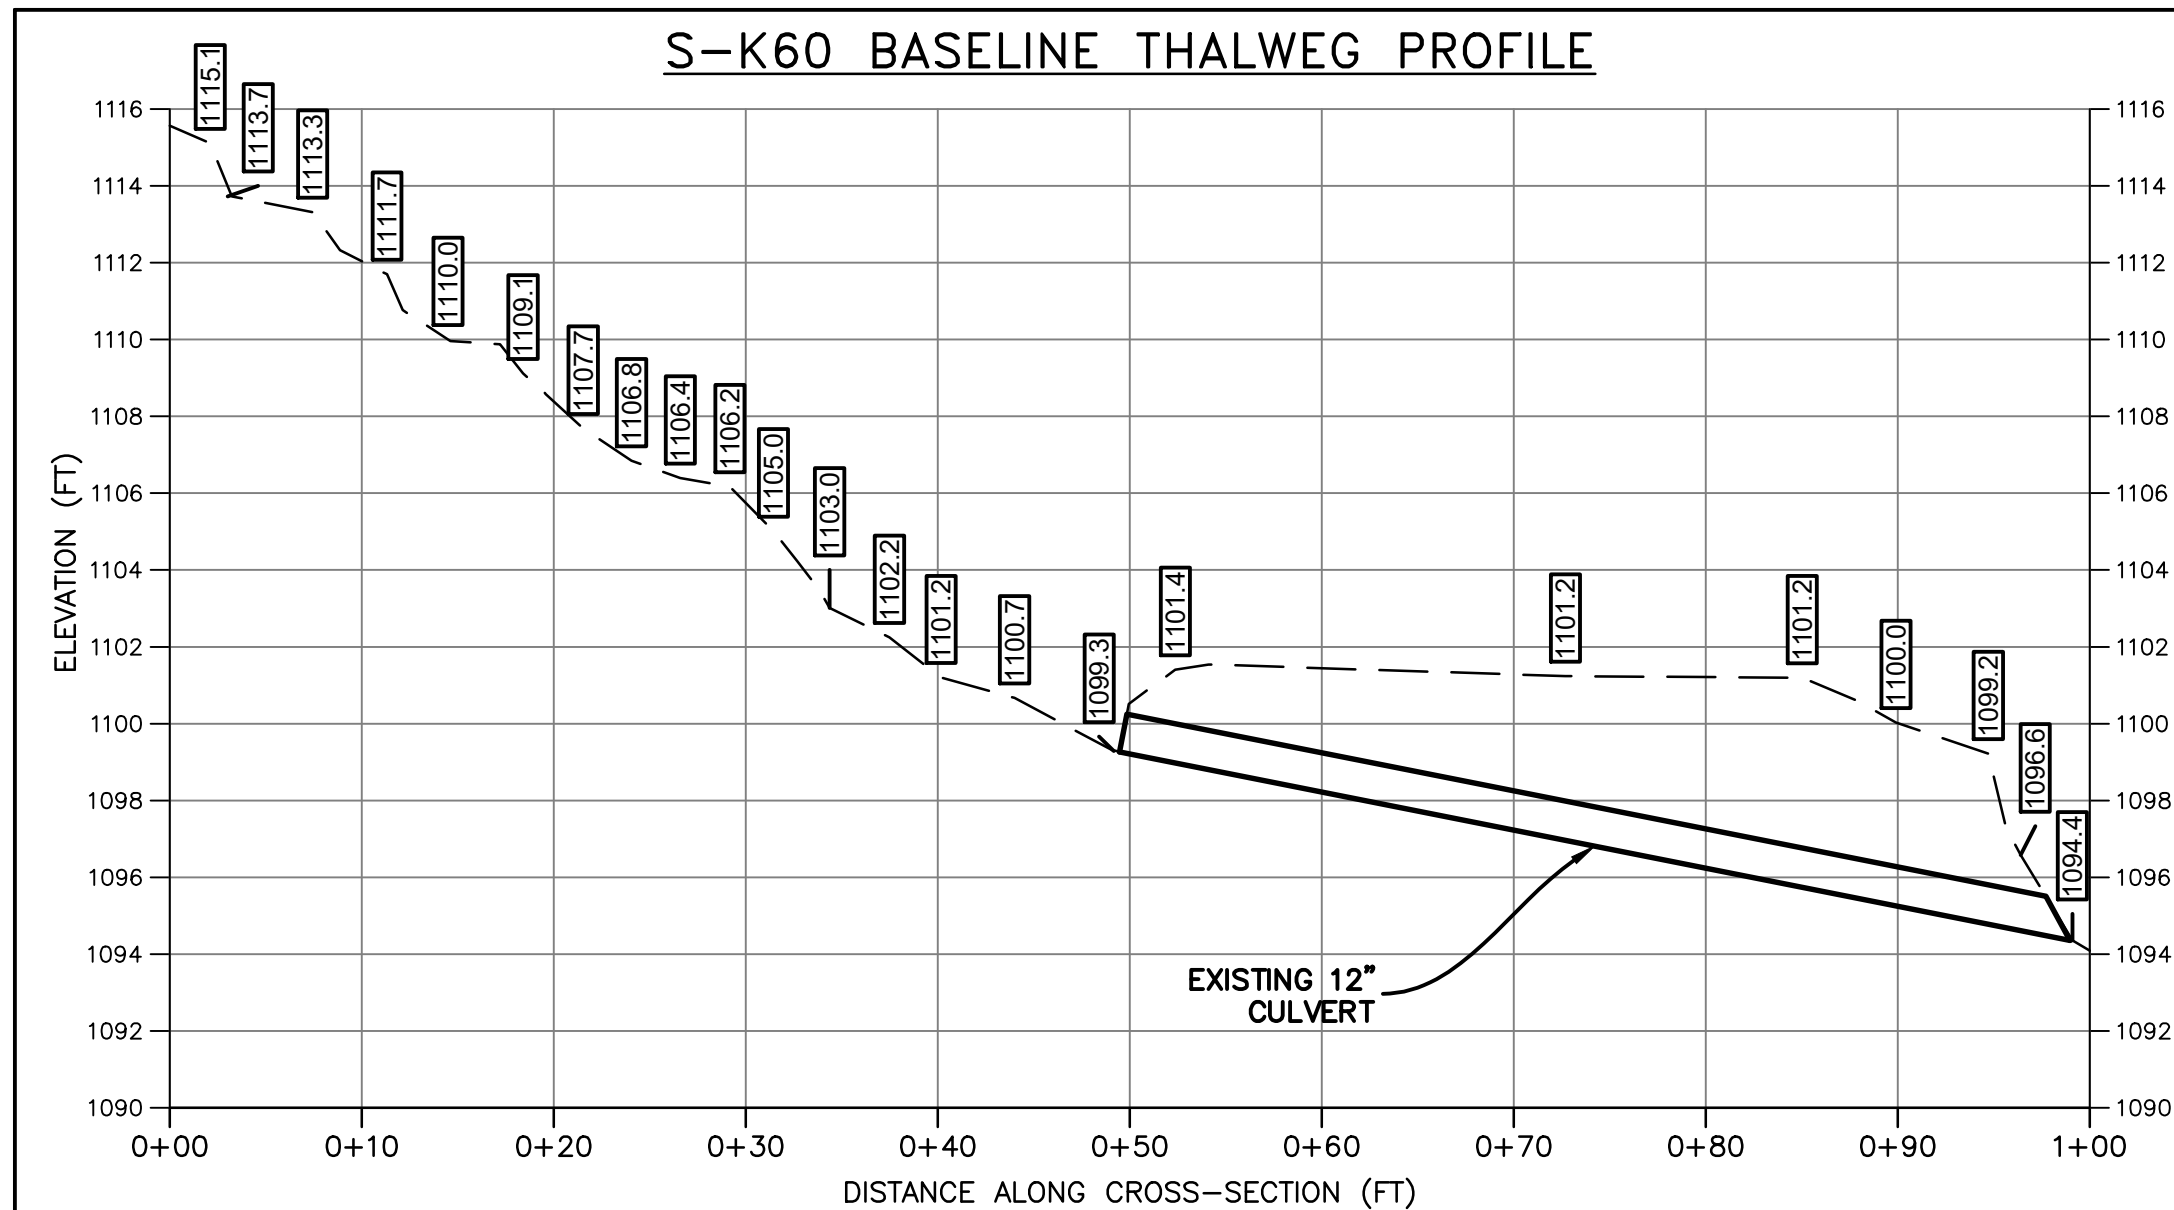
4. ALL SECTION VIEWS SHOWN LEFT TO RIGHT FACING DOWNSTREAM.
5. POST-CROSSING SURVEY INFORMATION SHOWN IN RED. DATA PENDING.
6. POST-CROSSING SURVEY POINTS FOR CROSS SECTIONS AND THALWEG ARE PROJECTED ONTO PRE-CROSSING SECTION AND PROFILE VIEWS FOR COMPARISON.

NOTE: ALL SECTIONS VIEWS SHOWN LEFT TO RIGHT FACING DOWNSTREAM.

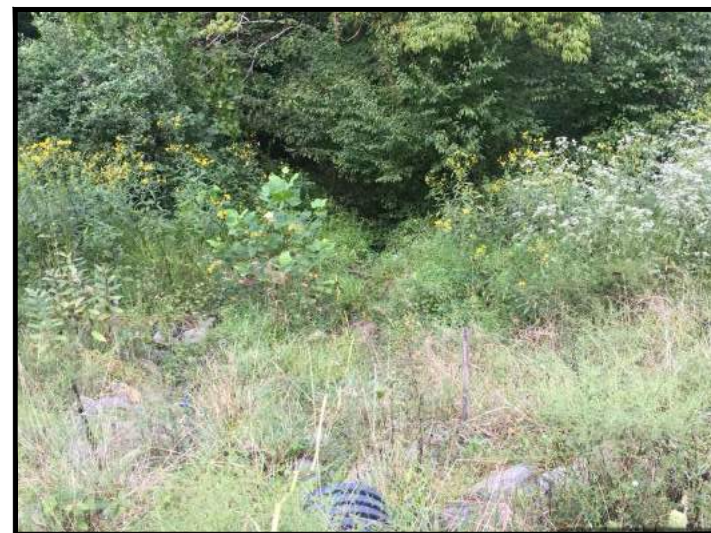
PHOTO TAKEN LOOKING DOWNSTREAM
FROM UPSTREAM IMPACT LIMITS

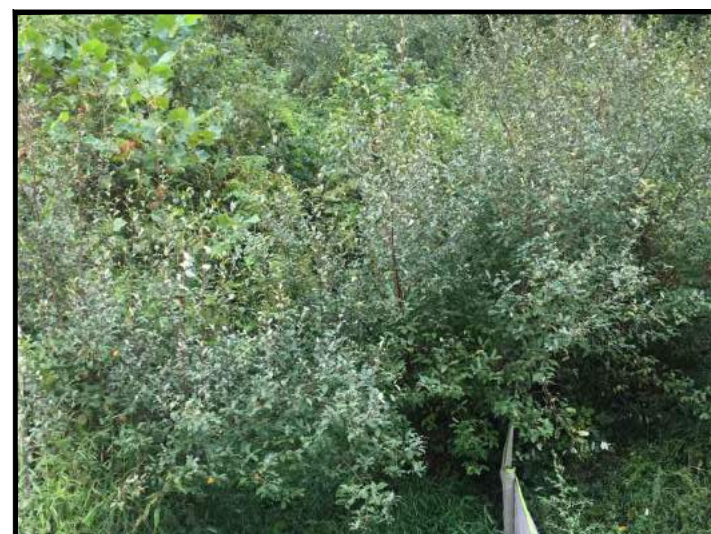
PHOTO TAKEN LOOKING UPSTREAM FROM
DOWNSTREAM IMPACT LIMITS
