Baseline Assessment – Stream Attributes

Reach S-K73 (Pipeline ROW)
Perennial
Spread A
Harrison County, West Virginia

Table PROFILE AND CROSS-SECTIONS
BASELINE SURVEY
CROSSING S-K73 – COBURN FORK
31.25)

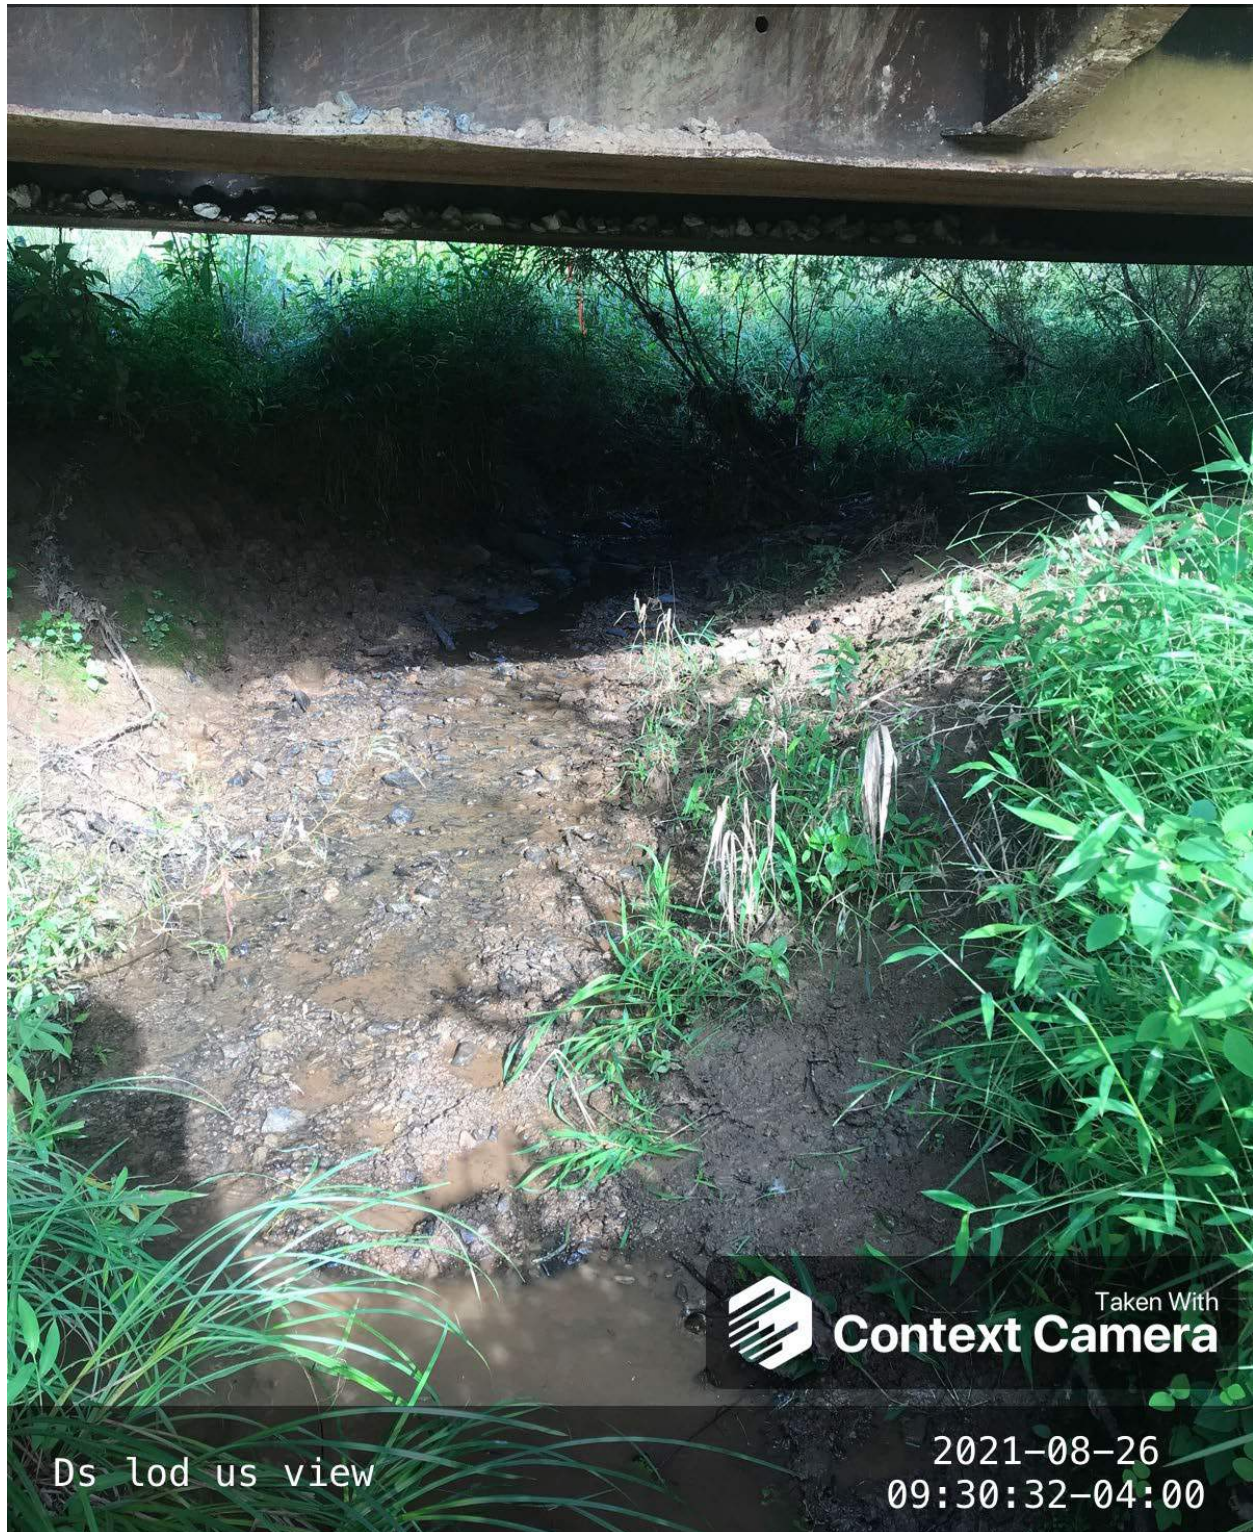
Photo Type: DS, US View
Location, Orientation, Photographer Initials: Downstream Edge of ROW, Upstream View, JM/CC
Lat: 39.243691 Long: -80.553966

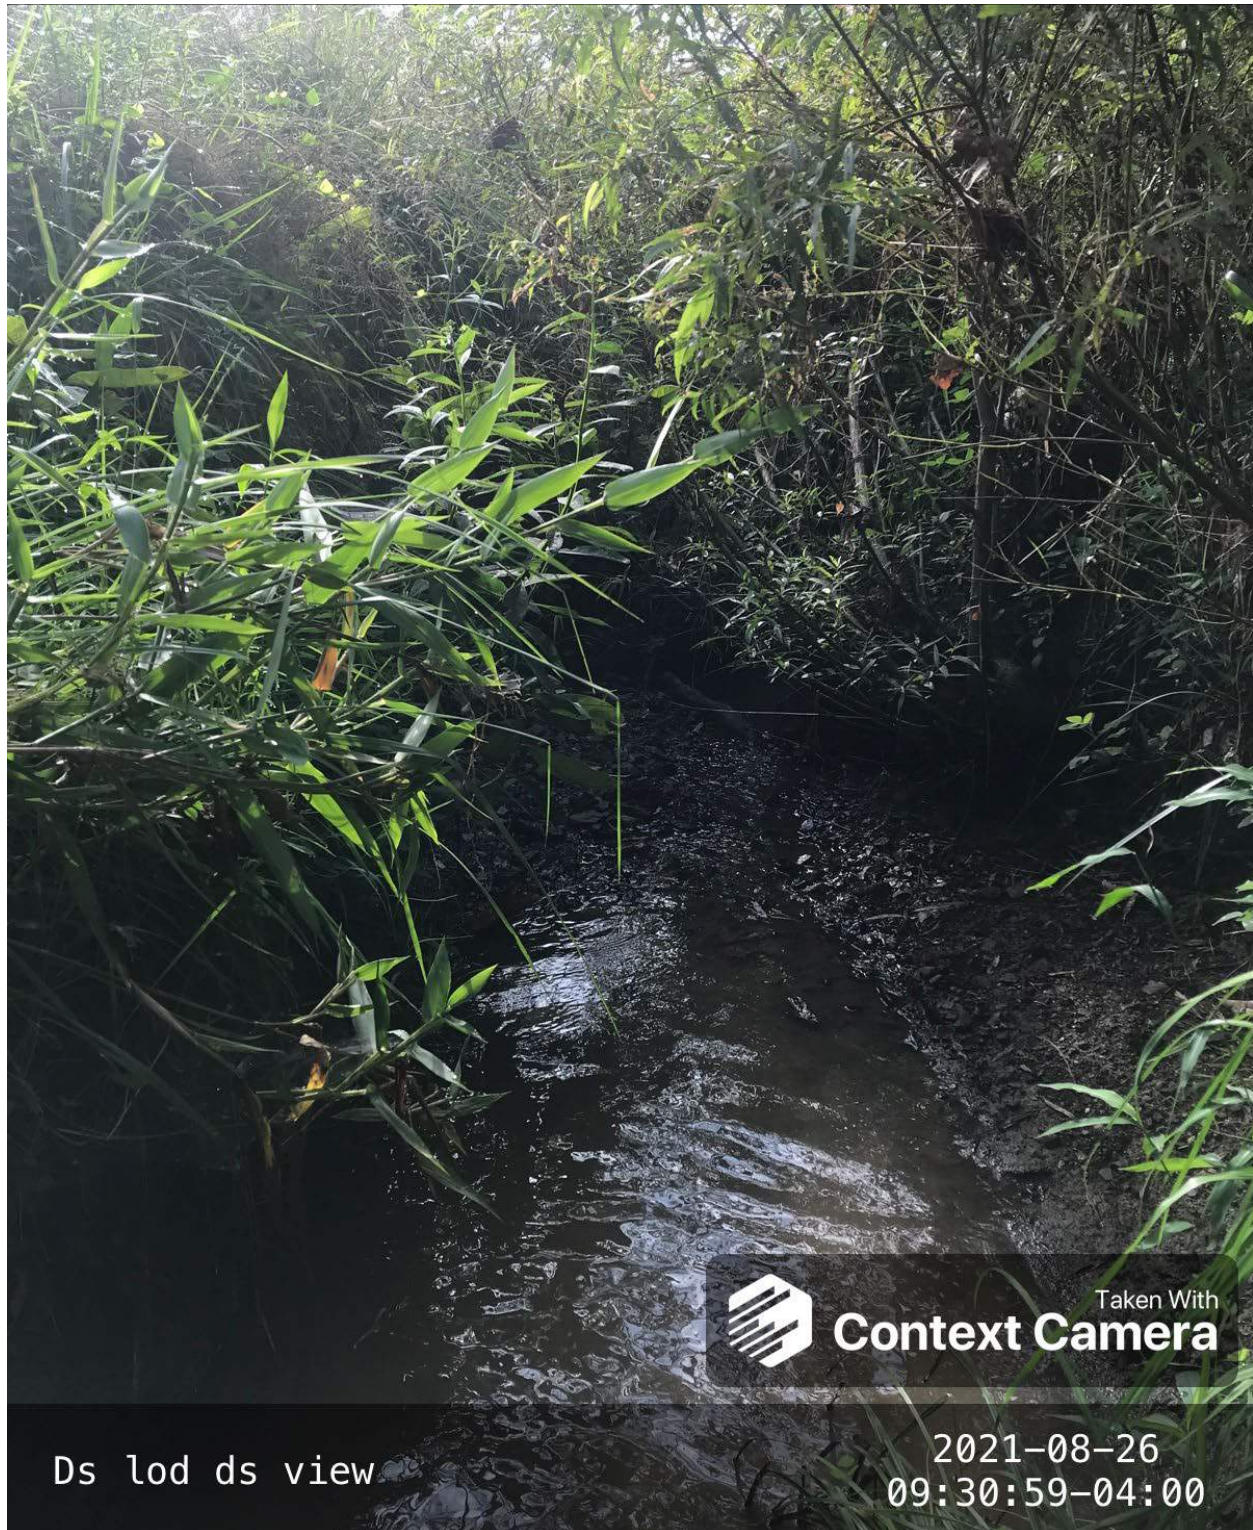
Photo Type: DS, DS View
Location, Orientation, Photographer Initials: Downstream Edge of ROW, Downstream View, JM/CC
Lat: 39.243691 Long: -80.553966

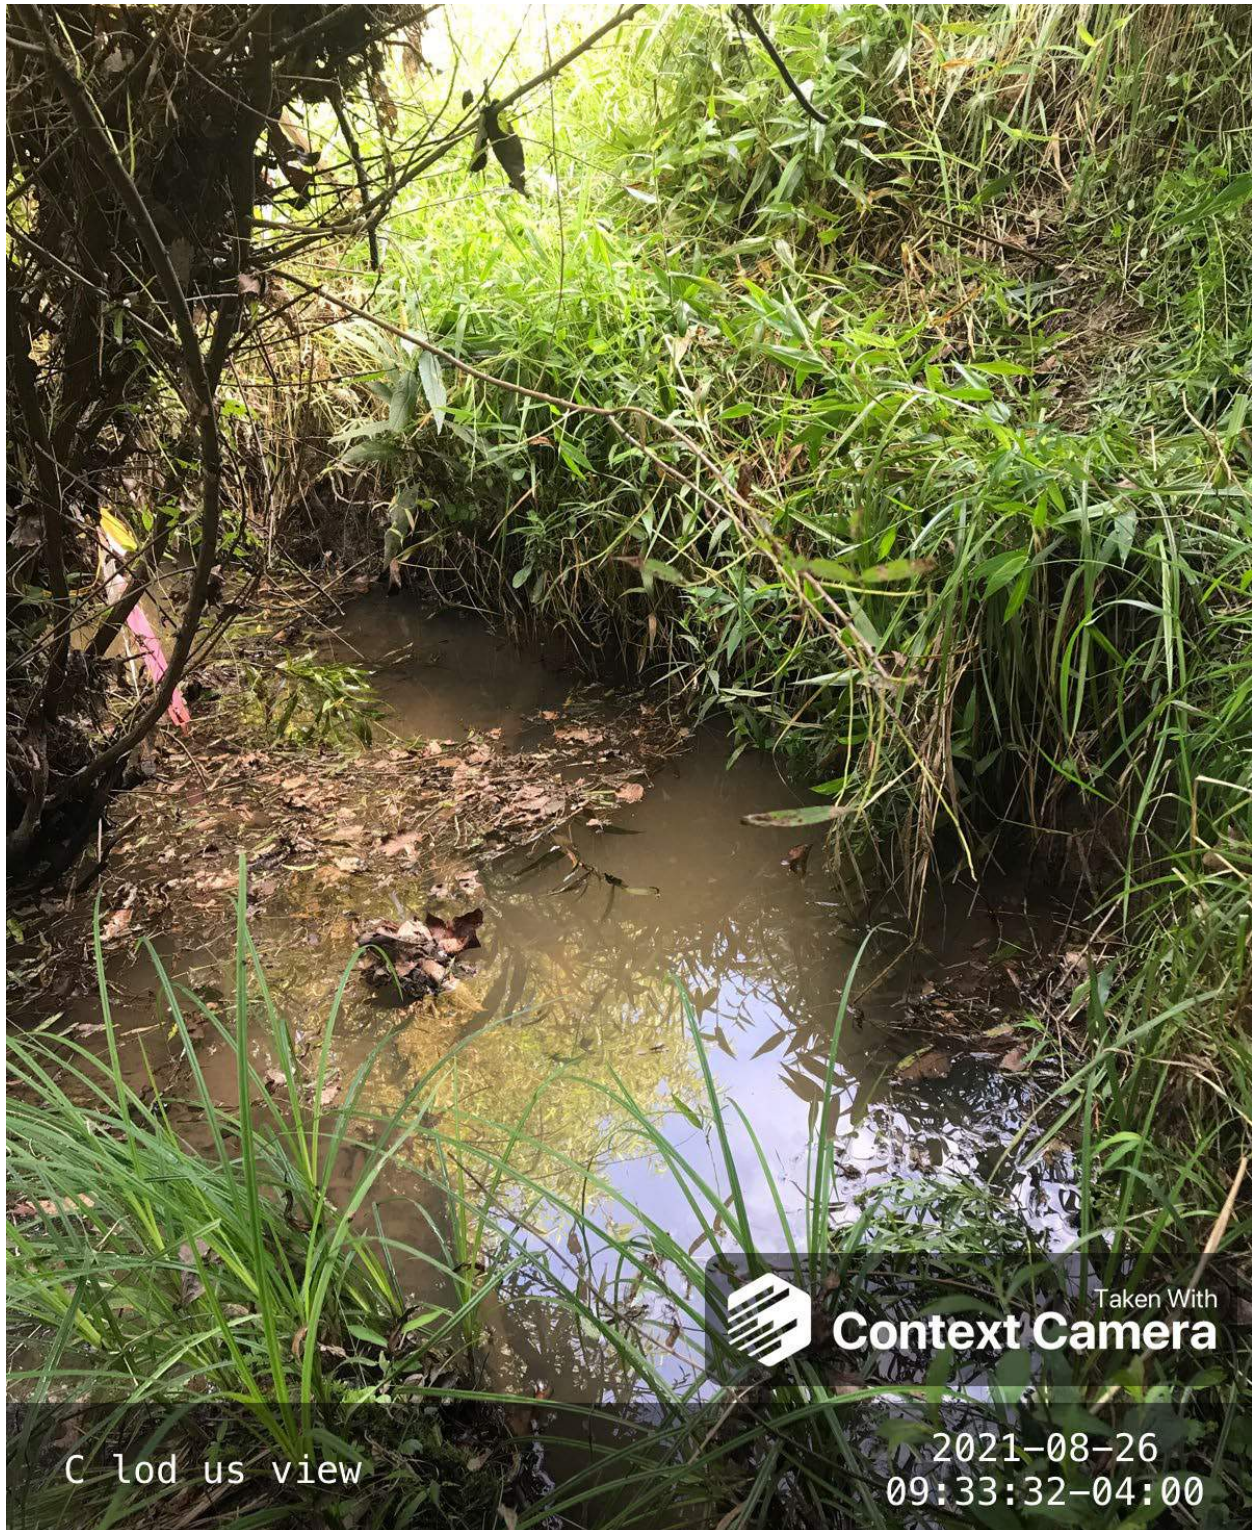
Photo Type: US View at Center
Location, Orientation, Photographer Initials: Center ROW, Upstream View, JM/CC
Lat: 39.243691 Long: -80.553966

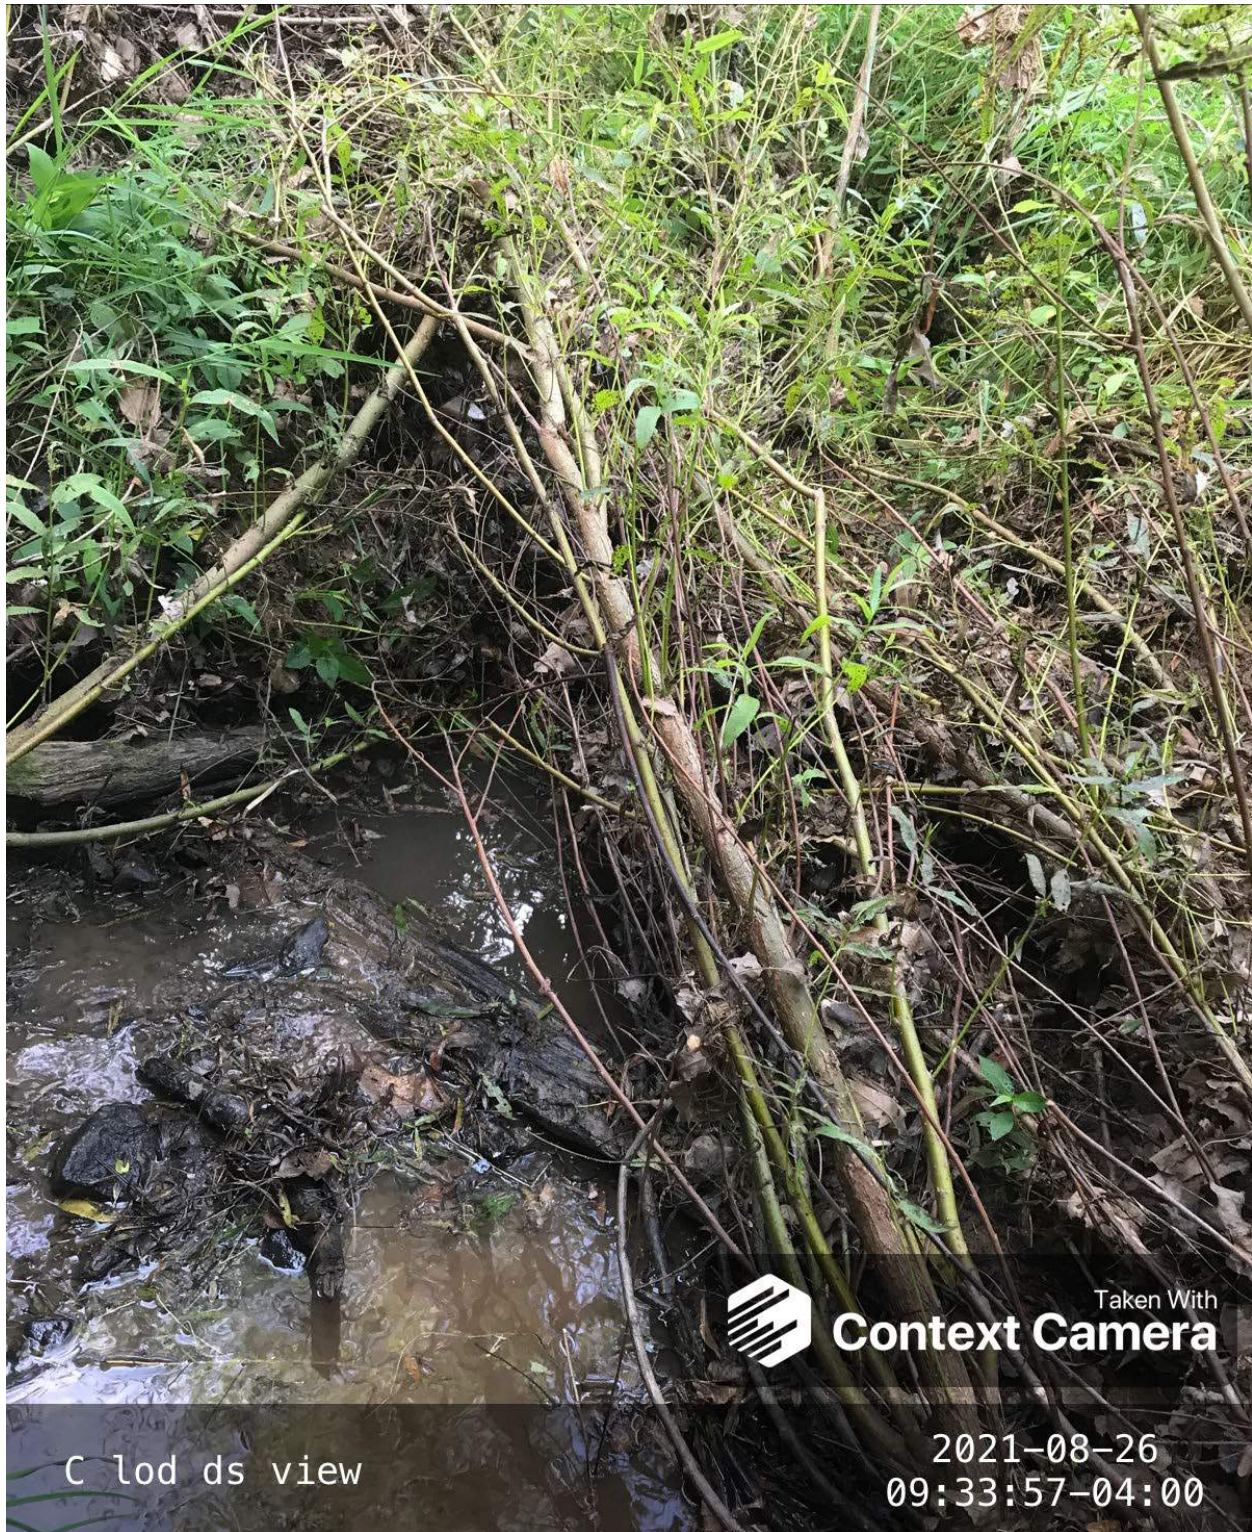
Photo Type: DS View at Center
Location, Orientation, Photographer Initials: ROW Center, Downstream View, JM/CC
Lat: 39.243691 Long: -80.553966

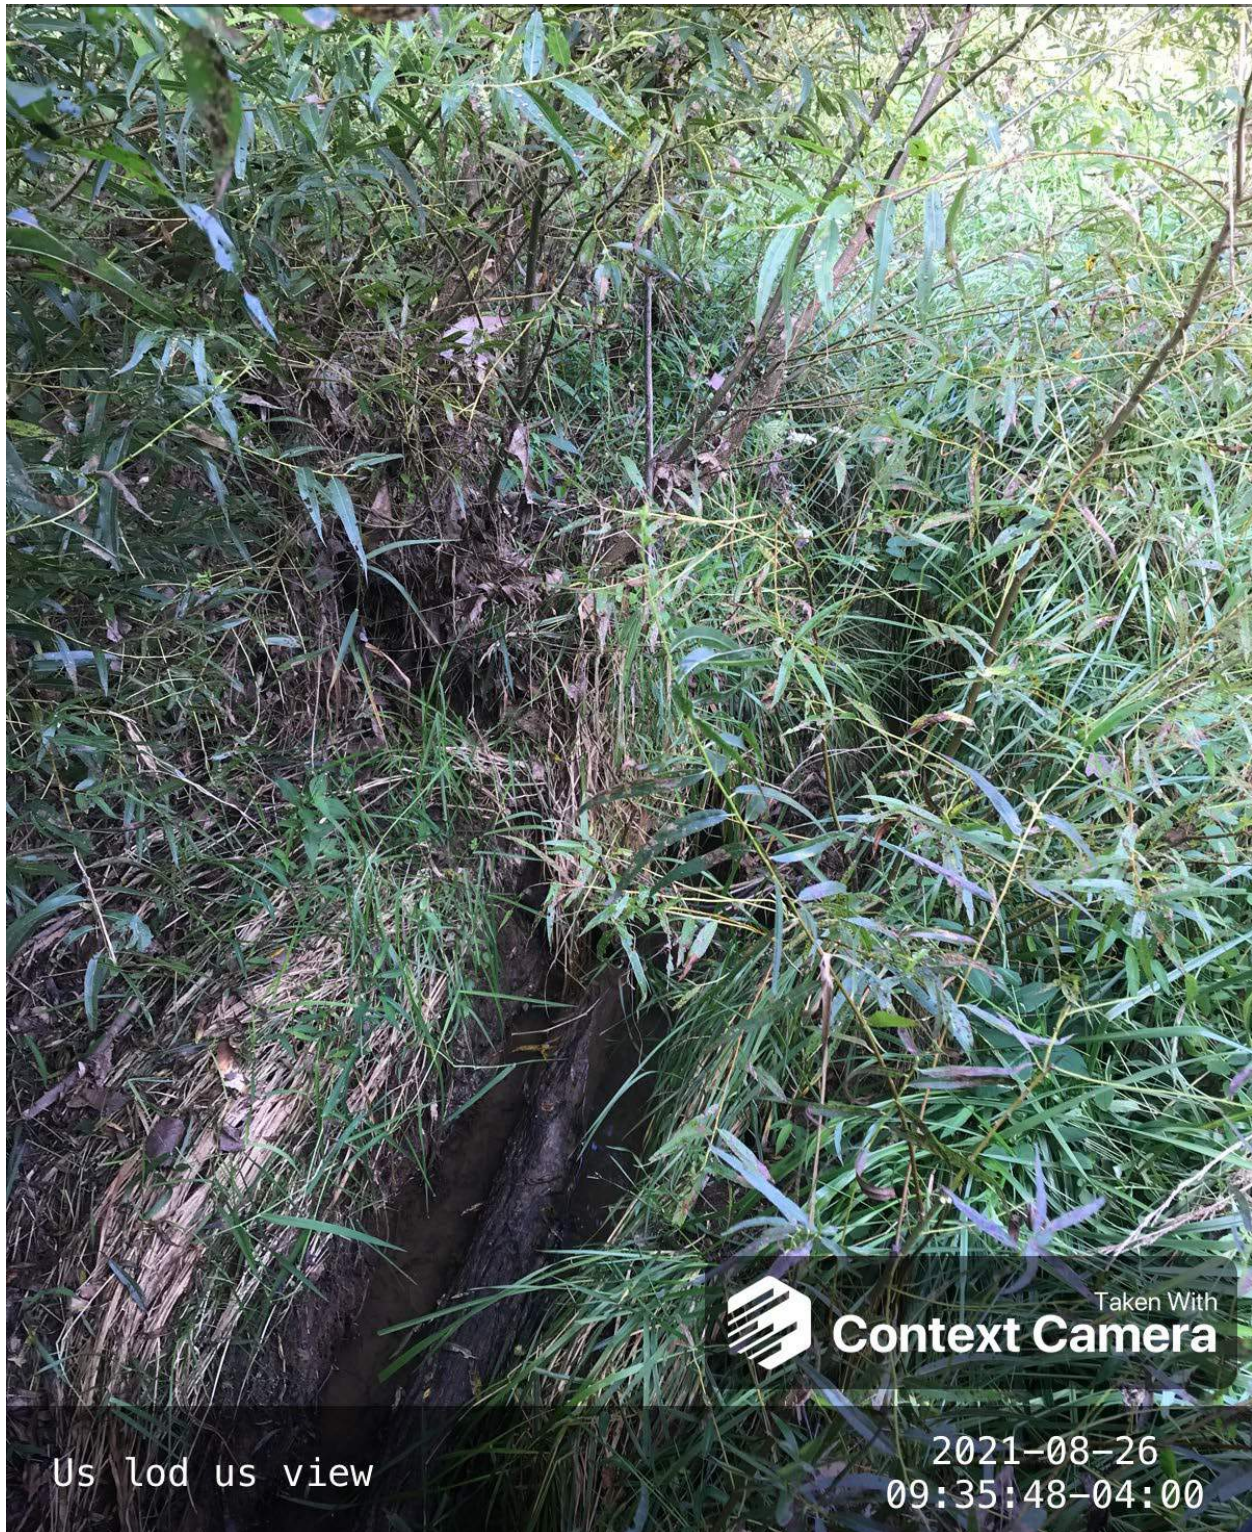
Photo Type: US, US View
Location, Orientation, Photographer Initials: Upstream Edge of ROW, Upstream View, JM/CC
Lat: 39.243691 Long: -80.553966

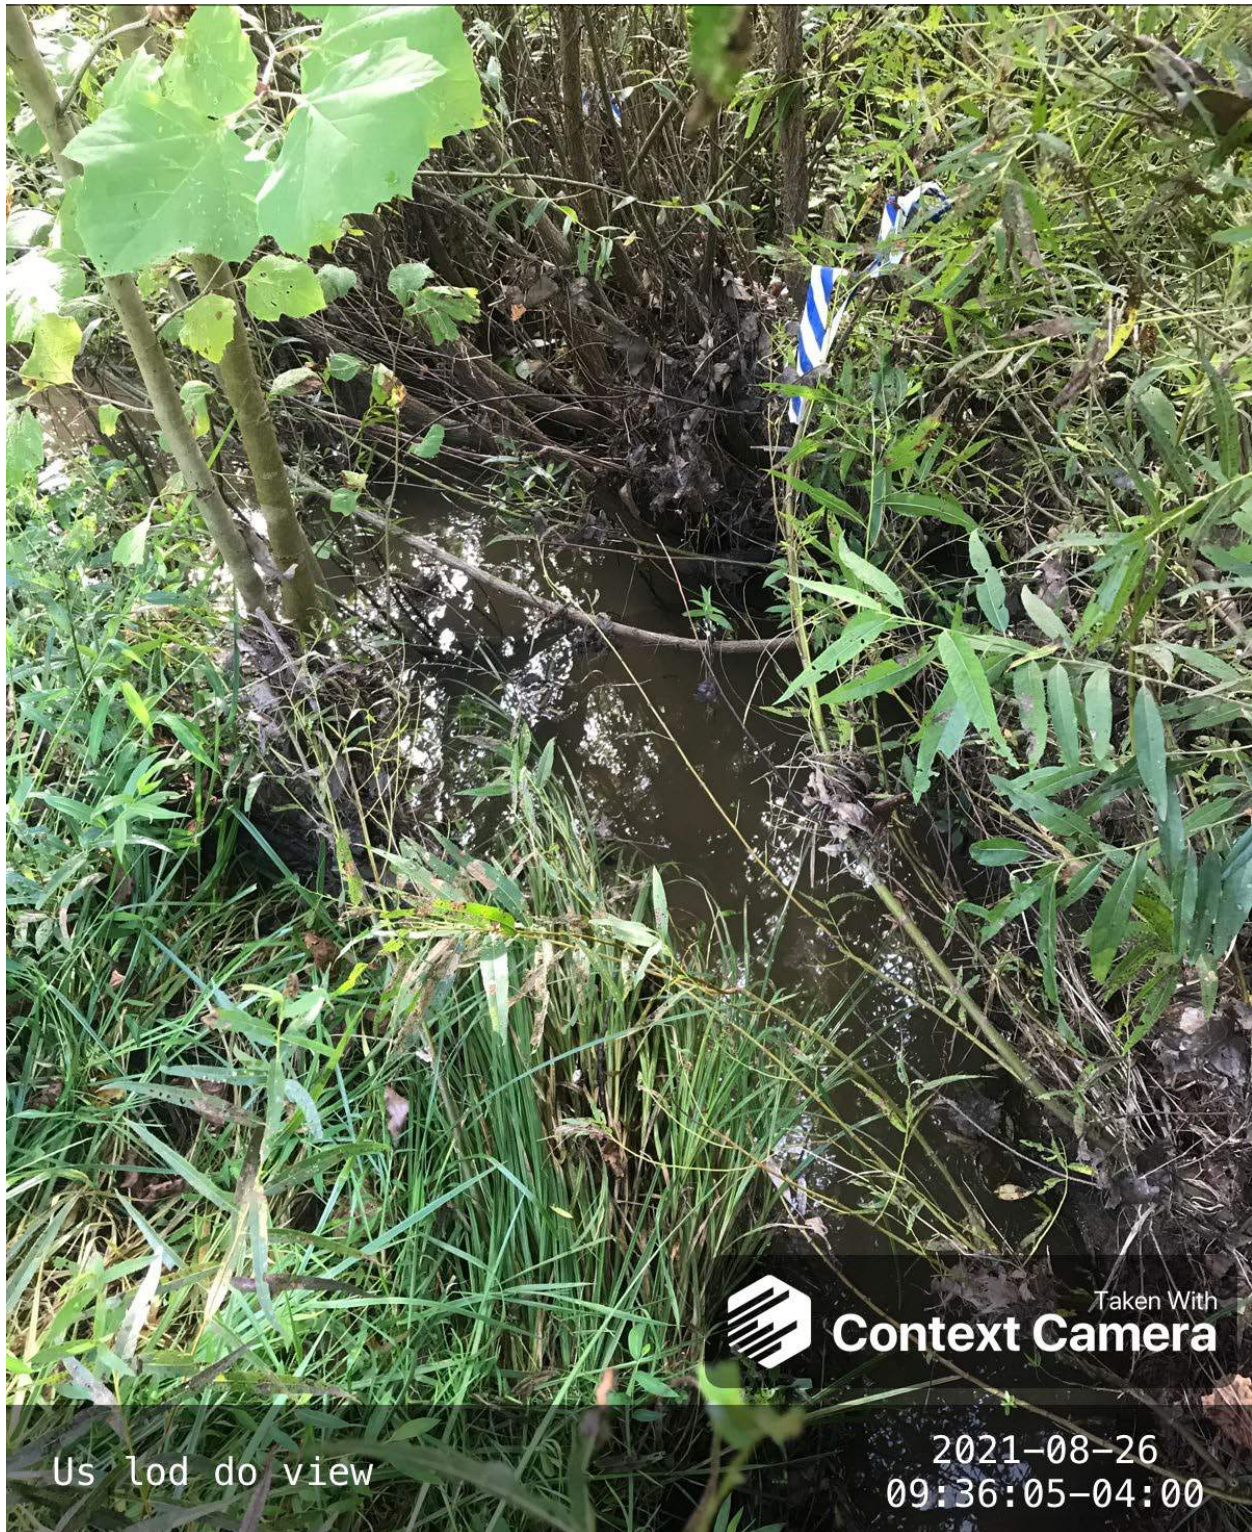
Photo Type: US, DS View
Location, Orientation, Photographer Initials: Upstream Edge of ROW, Downstream View, JM/CC
Lat: 39.243691 Long: -80.553966

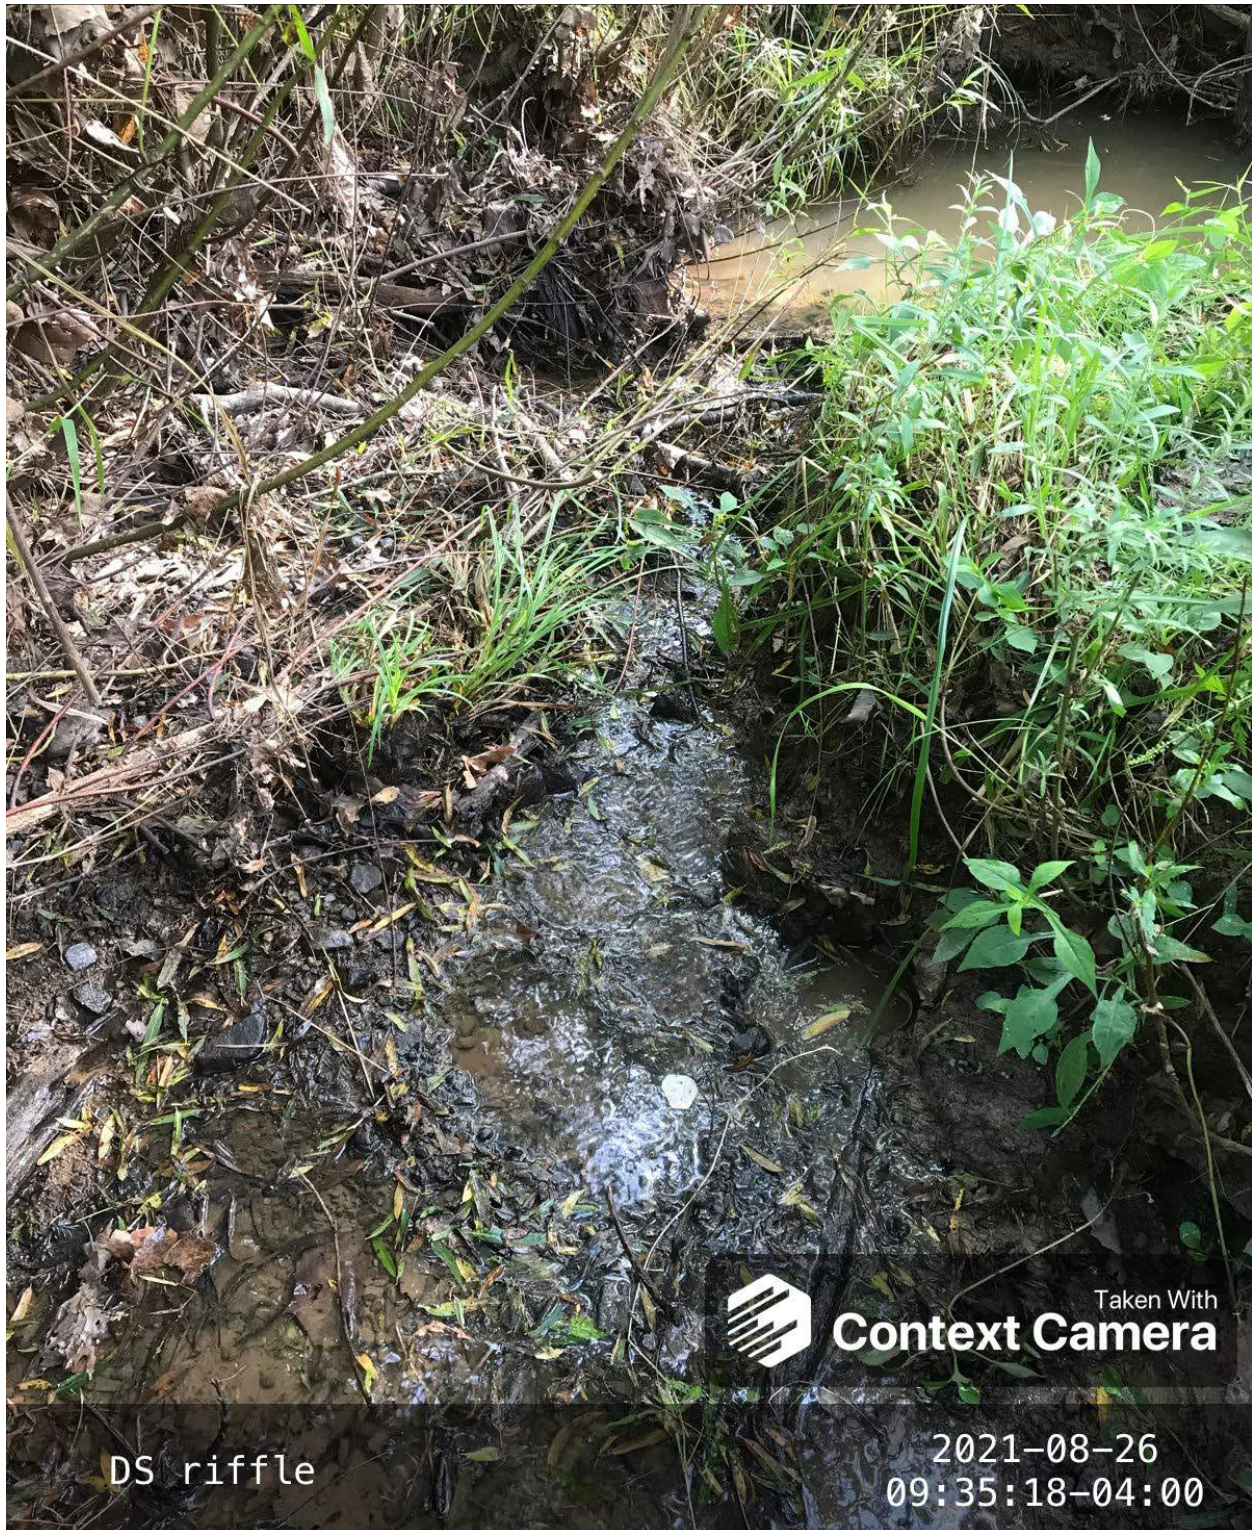
Photo Type: Riffle, DS View
Location, Orientation, Photographer Initials: Upstream of Riffle, Downstream View, JM/CC
Lat: 39.243691 Long: -80.553966

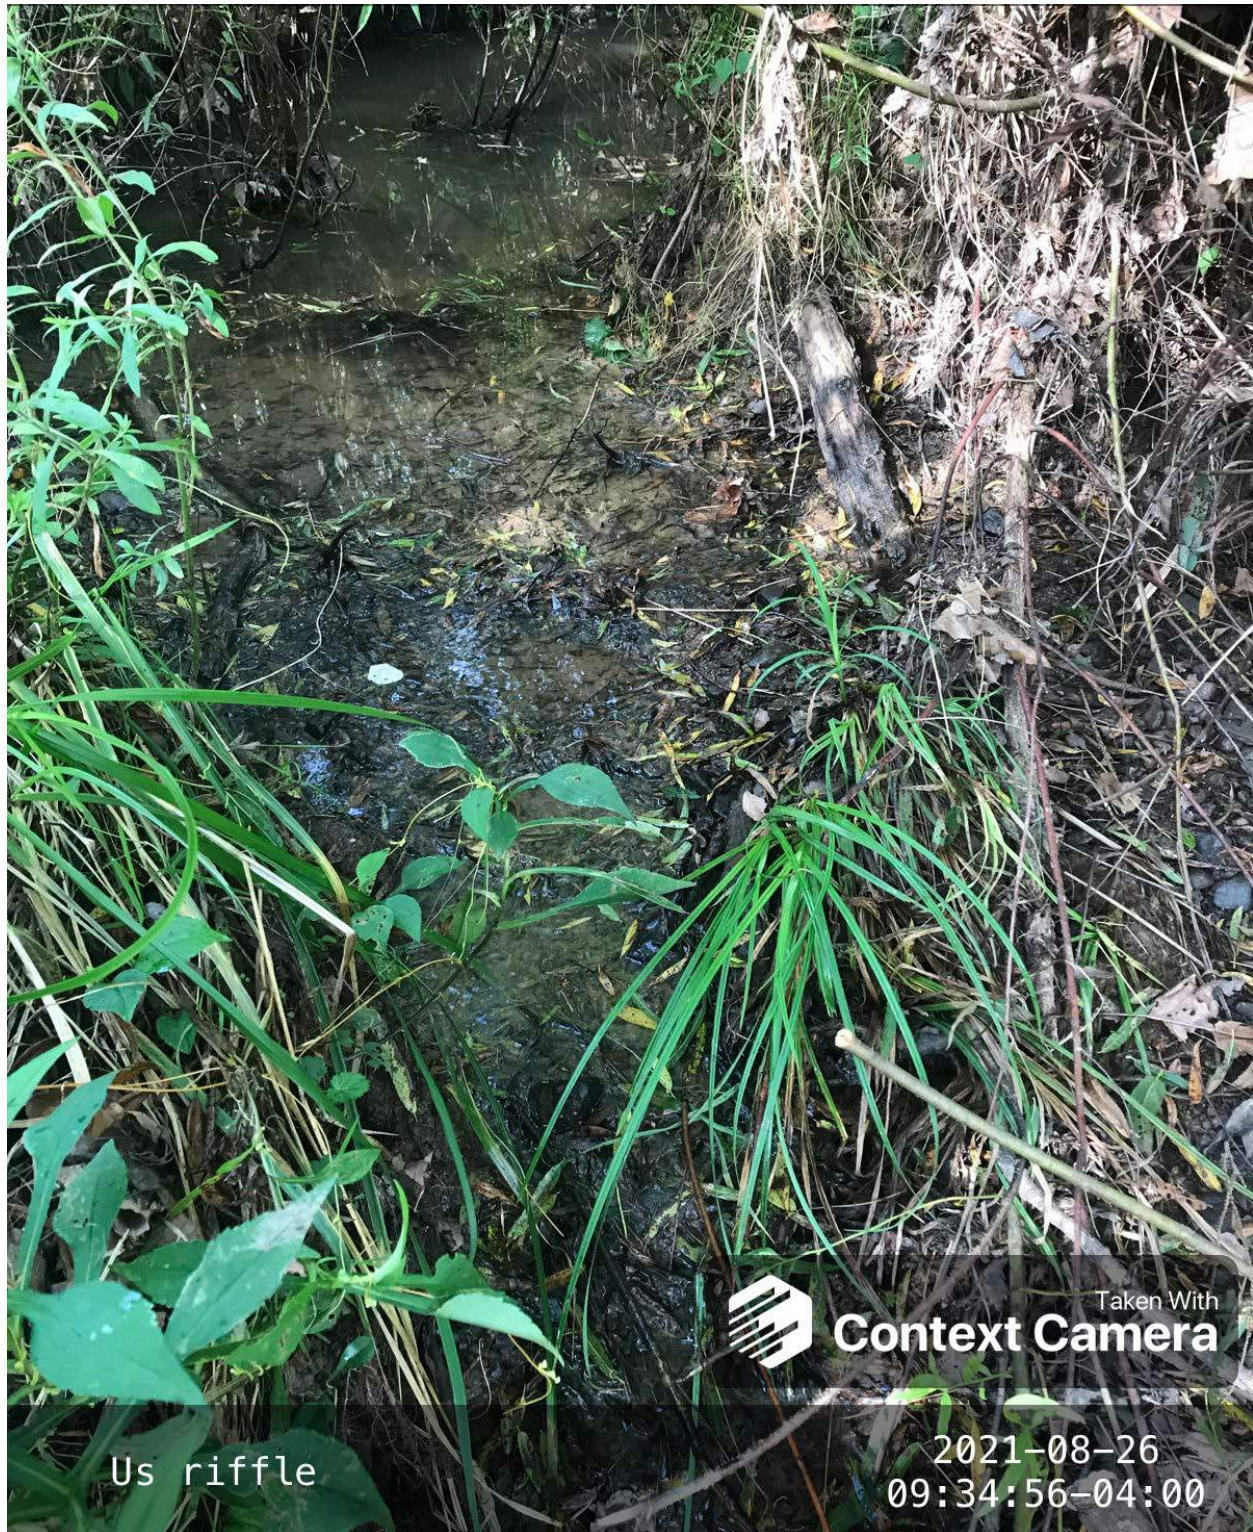
Photo Type: Riffle, US View
Location, Orientation, Photographer Initials: Downstream of Riffle, Upstream View, JM/CC
Lat: 39.243691 Long: -80.553966

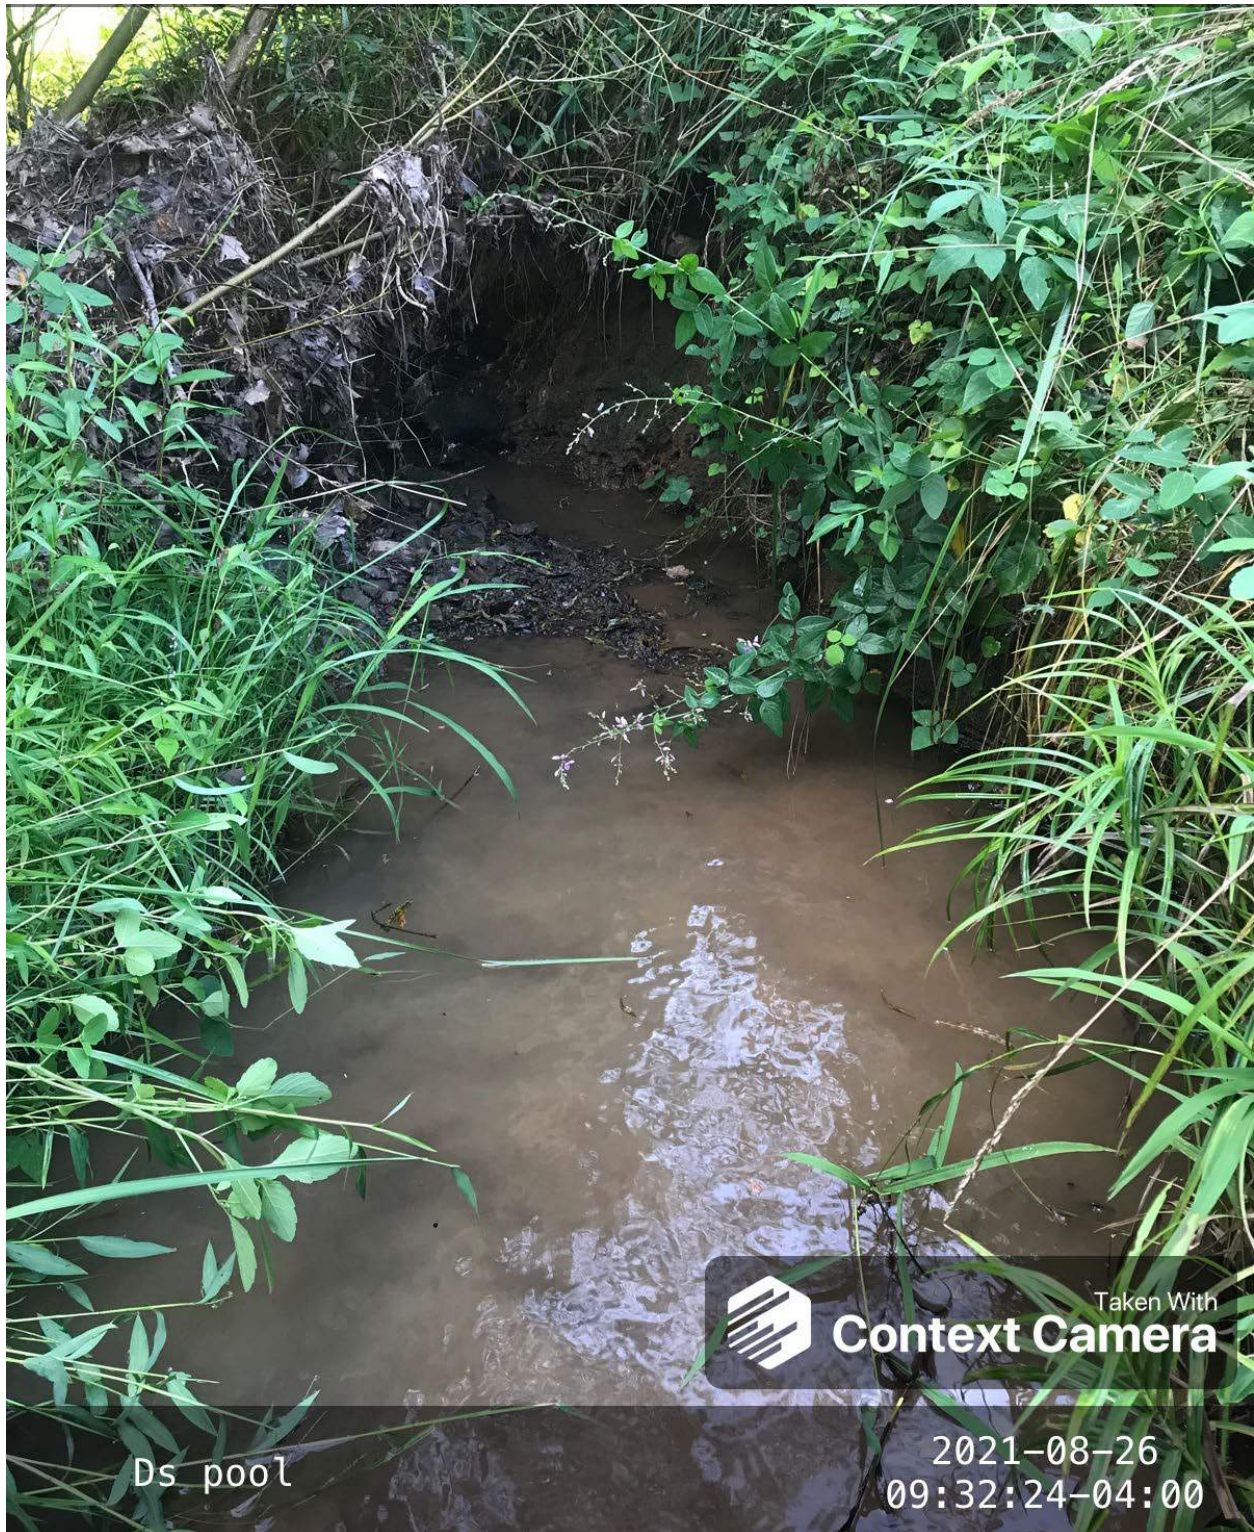
Photo Type: Pool, DS View
Location, Orientation, Photographer Initials: Upstream of Pool, Downstream View, JM/CC
Lat: 39.243691 Long: -80.553966

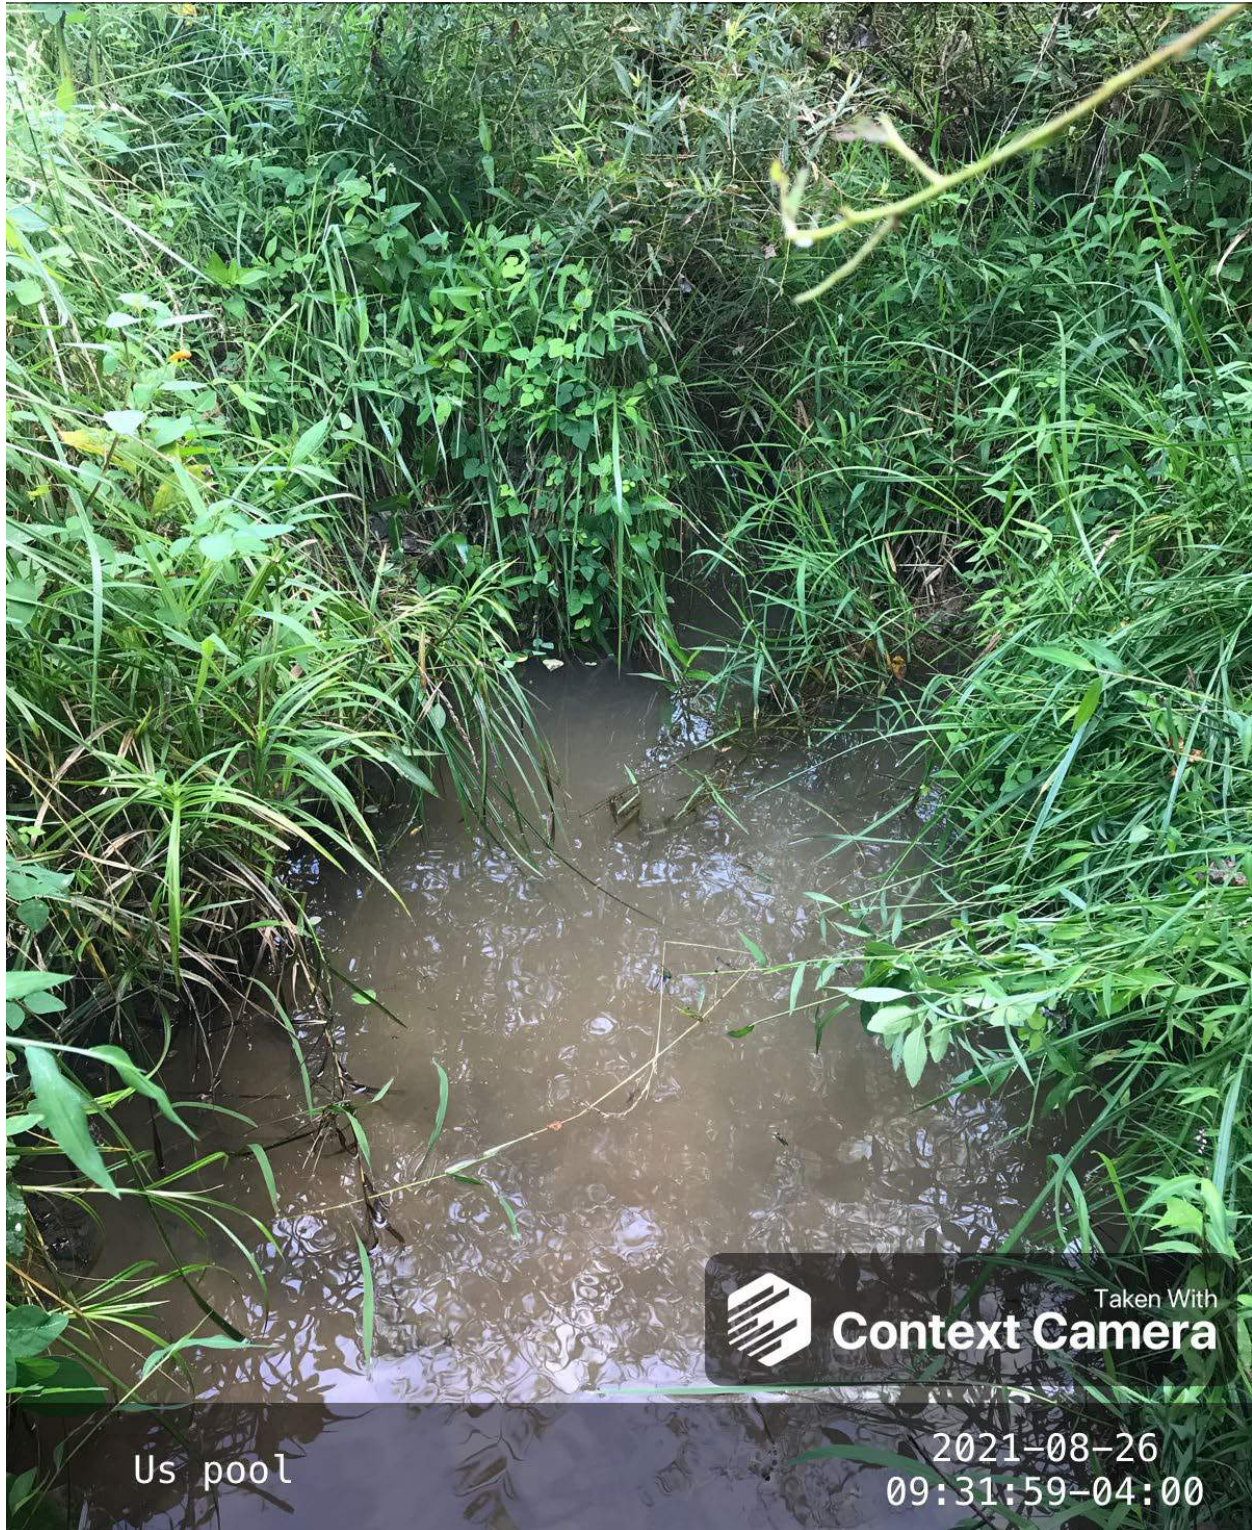
Photo Type: Pool, US View
Location, Orientation, Photographer Initials: Downstream of Pool, Upstream View, JM/CC
Lat: 39.243691 Long: -80.553966

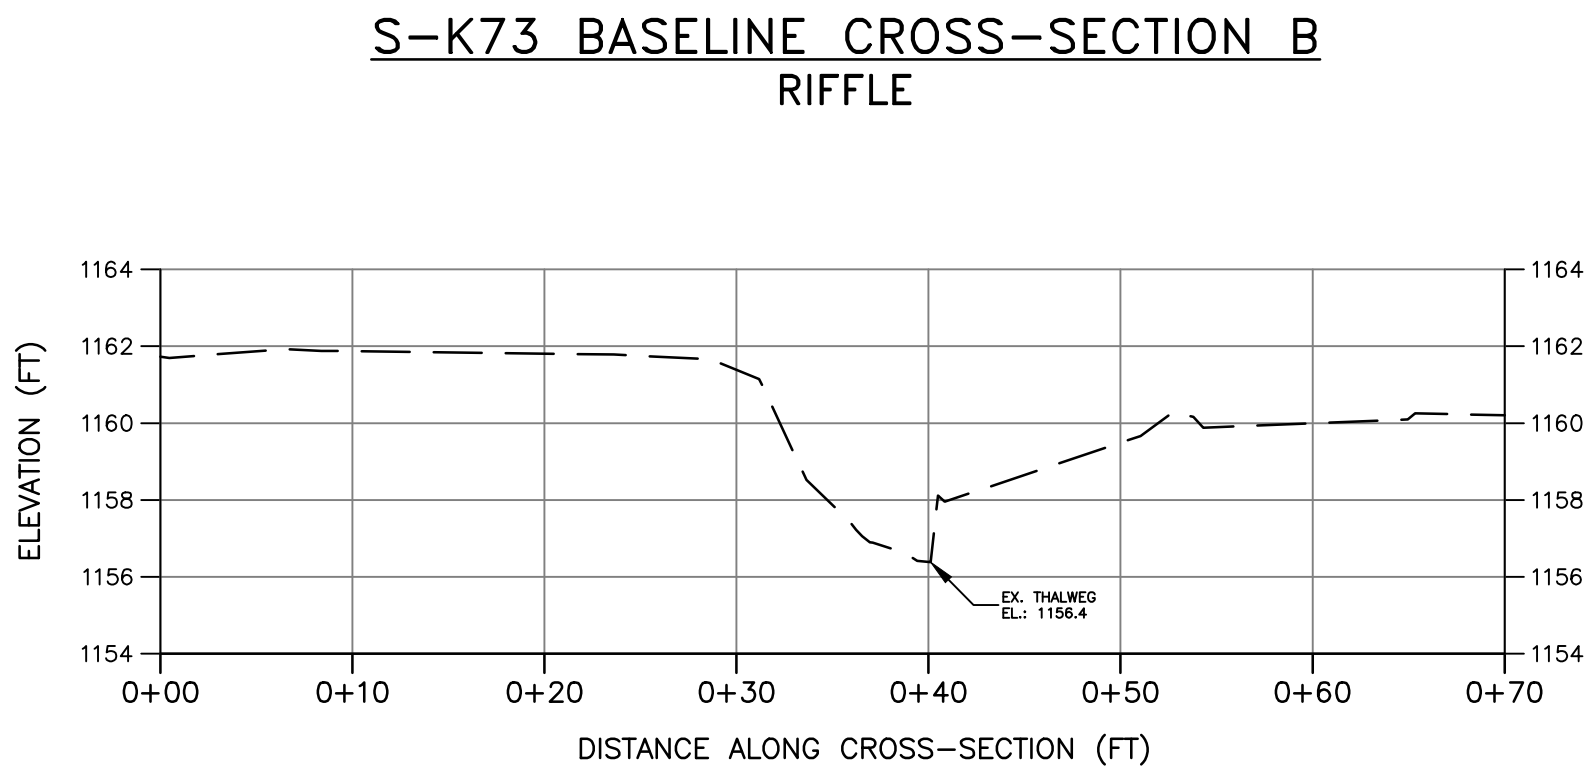
AS-BUILT TABLE: S-K73 CROSS SECTION B					
PRE-CROSSING				AS-BUILT	
PT. LOC.	NORTHING	EASTING	ELEV	VERT. DIFF.	HORZ. DIFF.
TS-L	14251667.47	1766692.69	1161.38		
BS-L	14251660.09	1766690.66	1156.79		
THW	14251658.43	1766690.20	1156.41		
BS-R	14251656.91	1766689.79	1157.98		
TS-R	14251654.33	1766689.07	1158.43

CROSS SECTION
SCALE: H: 1"=10' V: 1"=5'

NOTE: ALL SECTIONS VIEWS SHOWN LEFT TO RIGHT FACING DOWNSTREAM.
