## Baseline Assessment – Stream Attributes

### Reach S-K75 (Pipeline ROW) Intermittent Spread A Harrison County, West Virginia

Site PROFILE AND CROSS-SECTIONS  
BASELINE SURVEY  
CROSSING S-K75 - UNNAMED TRIB.  
COBURN FORK (MP 31.26)  
HARRISON COUNTY, WV

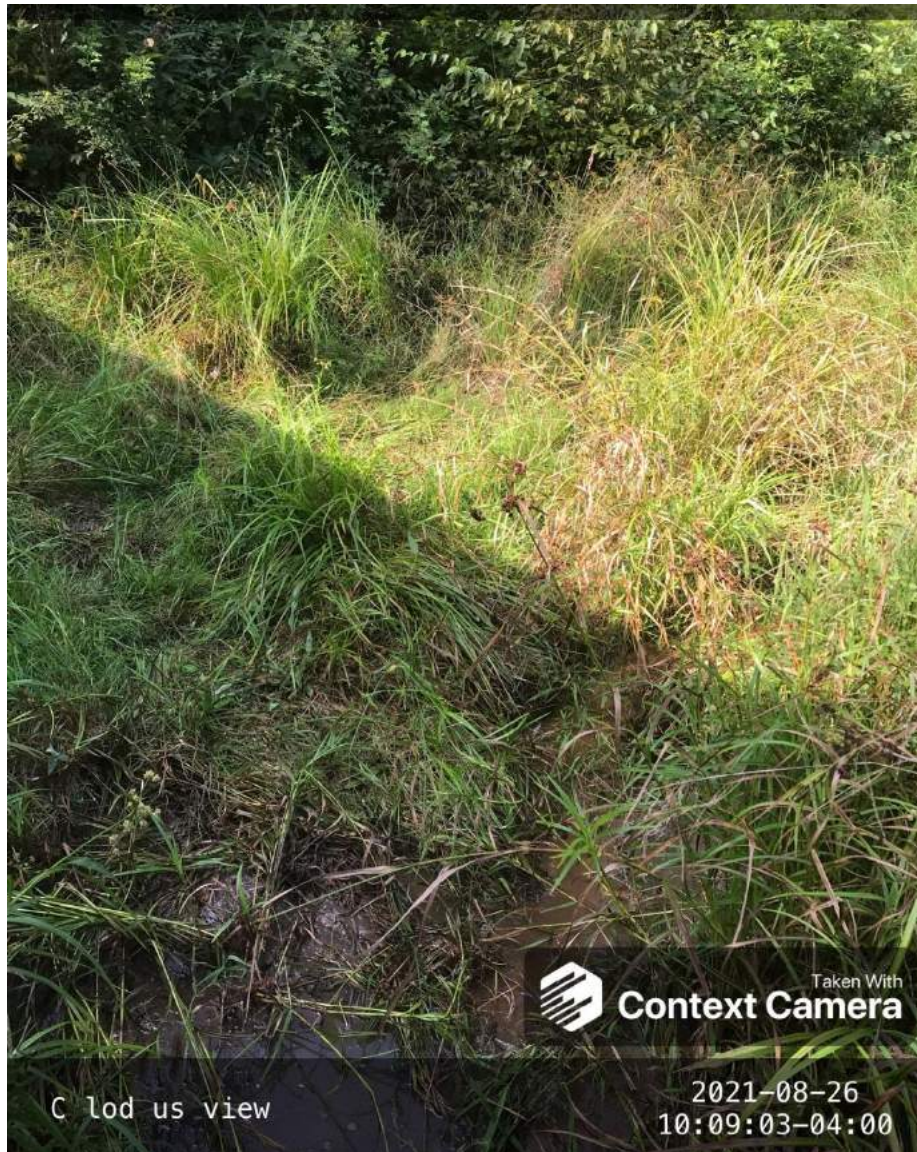
Photo Type: US View at Center  
Location, Orientation, Photographer Initials: Center ROW, Upstream View, SM/JM/CC  
Lat: 39.243509 Long: -80.554028

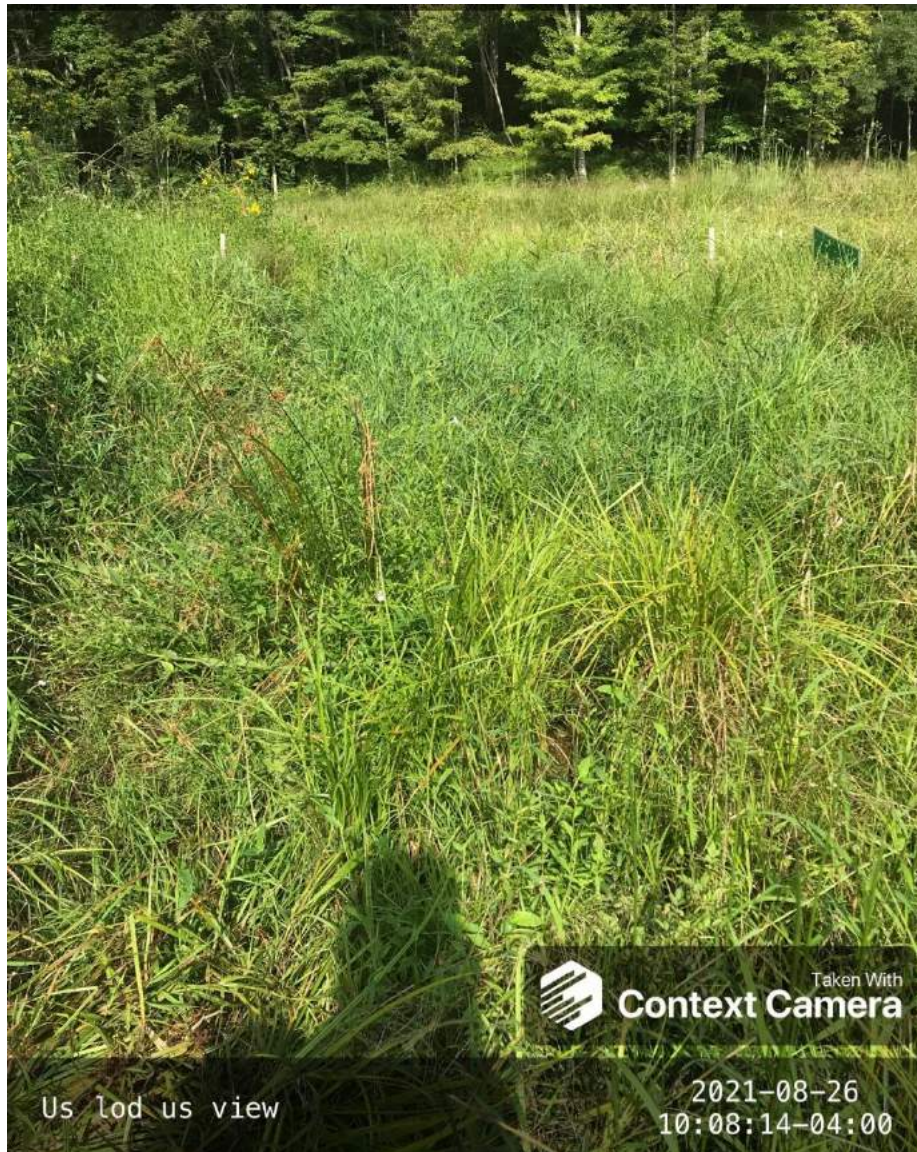
Photo Type: US, US View

Location, Orientation, Photographer Initials: Upstream Edge of ROW, Upstream View, SM/JM/CC  
Lat: 39.243509 Long: -80.554028

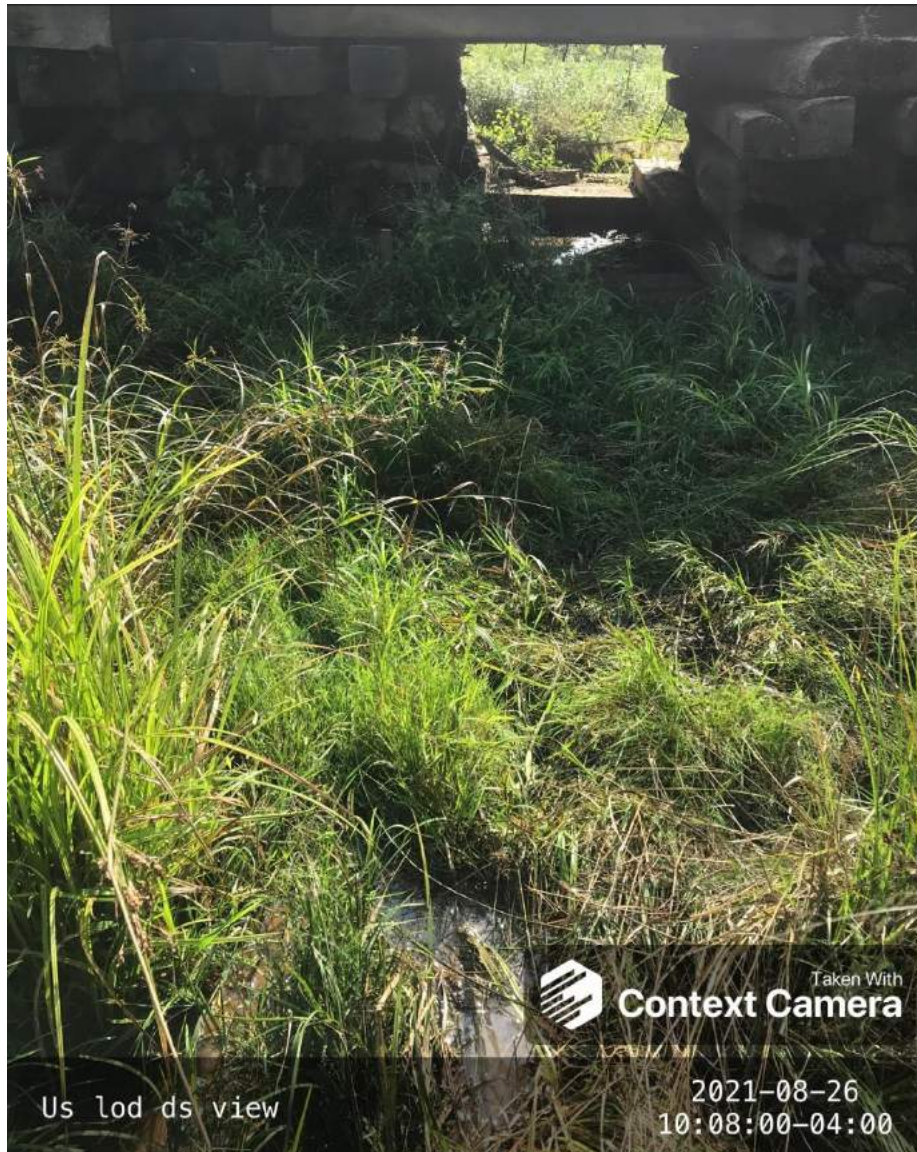
Photo Type: US, DS View

Location, Orientation, Photographer Initials: Upstream Edge of ROW, Downstream View, SM/JM/CC  
Lat: 39.243509 Long: -80.554028

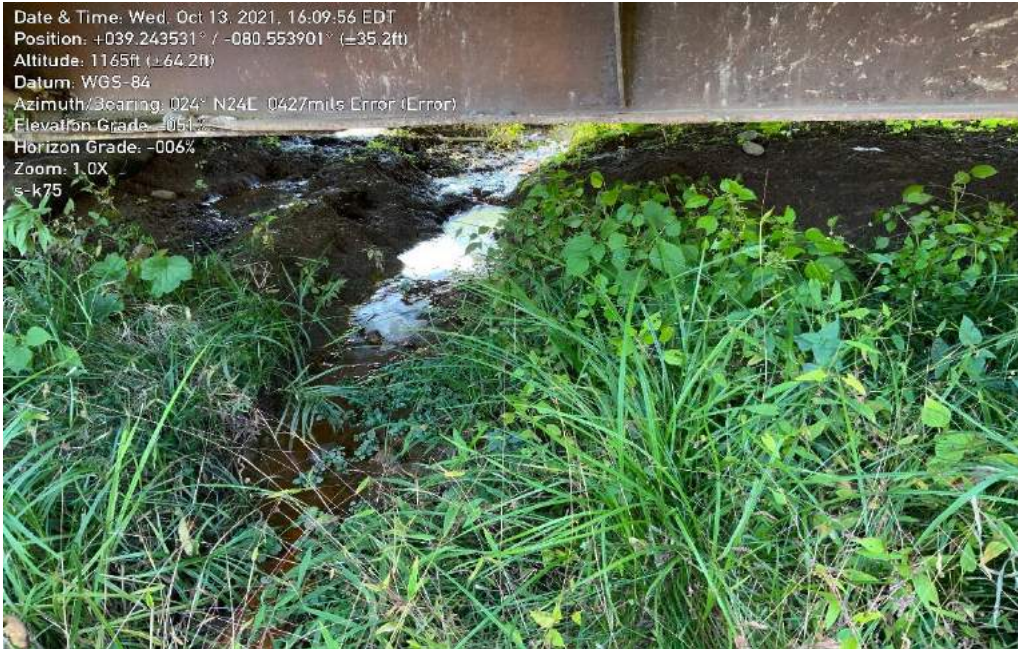
Photo Type: US View  
Location, Orientation, Photographer Initials: Upstream View of ROW  
Lat: 39.243531 Long: -80.553901

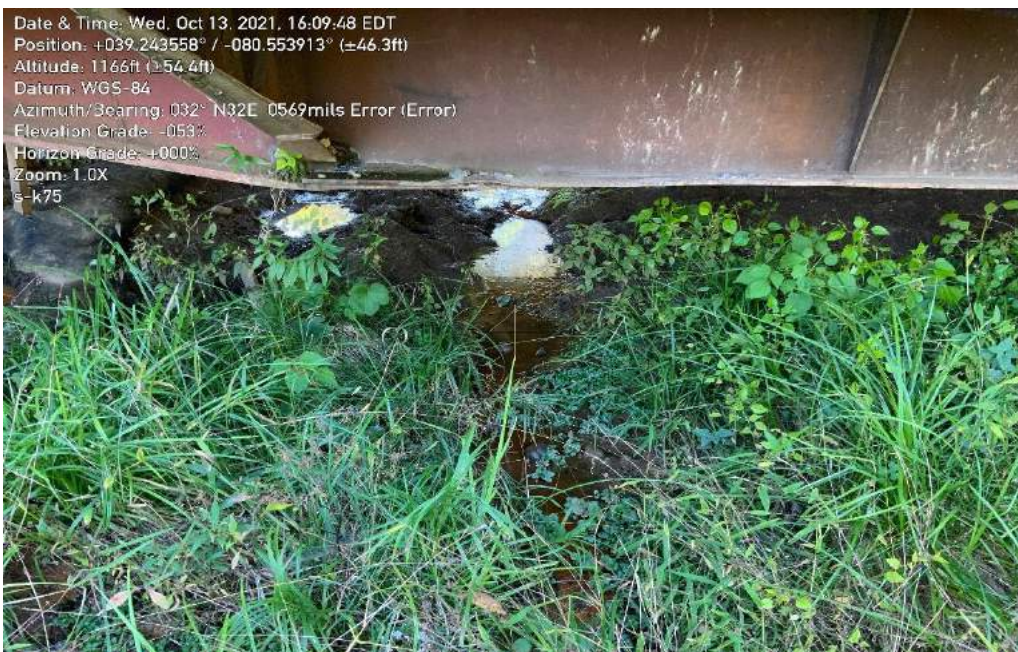
Photo Type: US View  
Location, Orientation, Photographer Initials: Upstream View of ROW  
Lat: 39.243558 Long: -80.553913

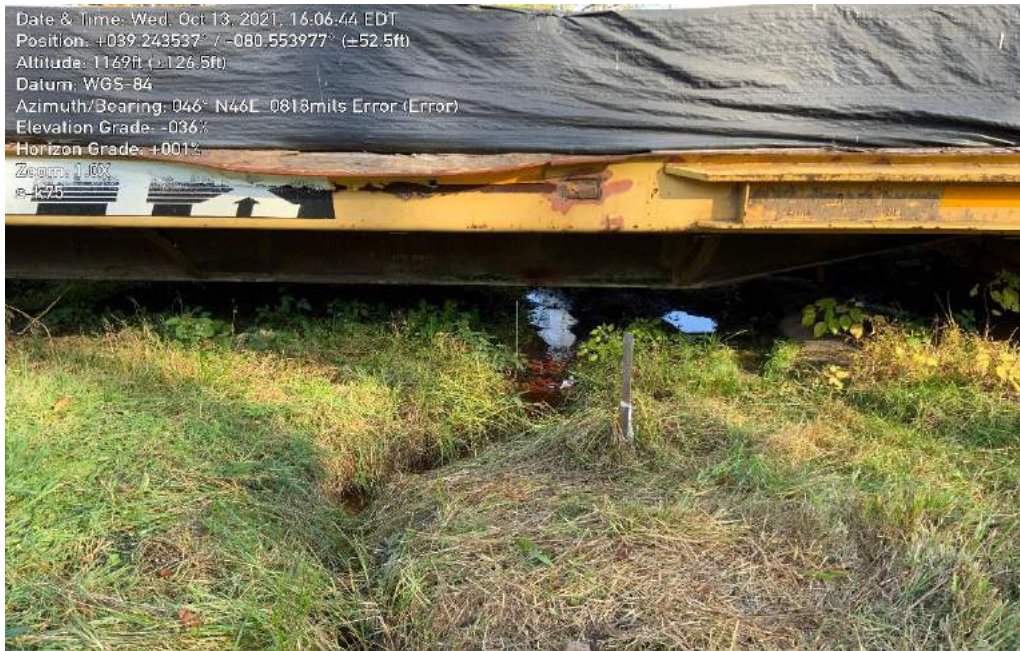
Photo Type: DS View  
Location, Orientation, Photographer Initials: Downstream View of ROW  
Lat: 39.243537 Long: -80.553977

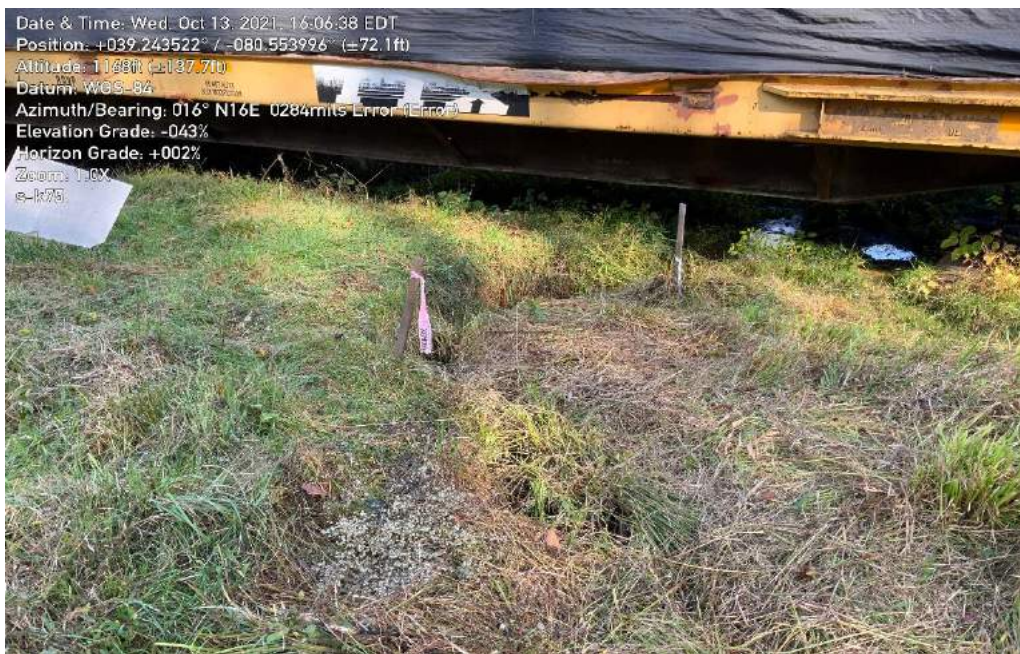
Photo Type: DS View  
Location, Orientation, Photographer Initials: Downstream View of ROW  
Lat: 39.243522 Long: -80.553996

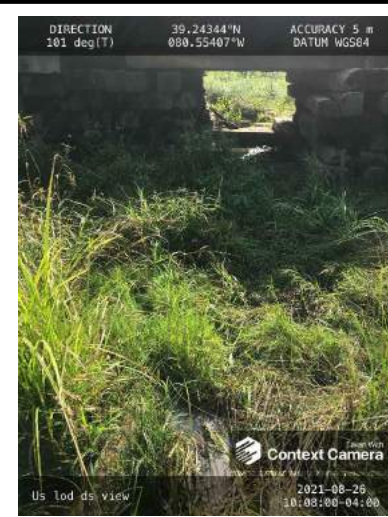
PHOTO TAKEN LOOKING DOWNSTREAM  
FROM UPSTREAM IMPACT LIMITS

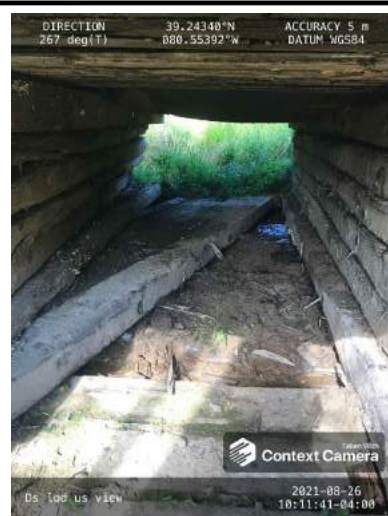
PHOTO TAKEN LOOKING UPSTREAM FROM  
DOWNSTREAM IMPACT LIMITS
