Baseline Assessment – Stream Attributes

Reach S-K94 Temp AR (Temporary Access Road)

Lewis County, West Virginia

title PROFILE AND CROSS-SECTIONS
BASELINE SURVEY
CROSSING S-K94 TEMP AR - KINCH
CREEK (MP 38.02)
LEWIS COUNTY, WV

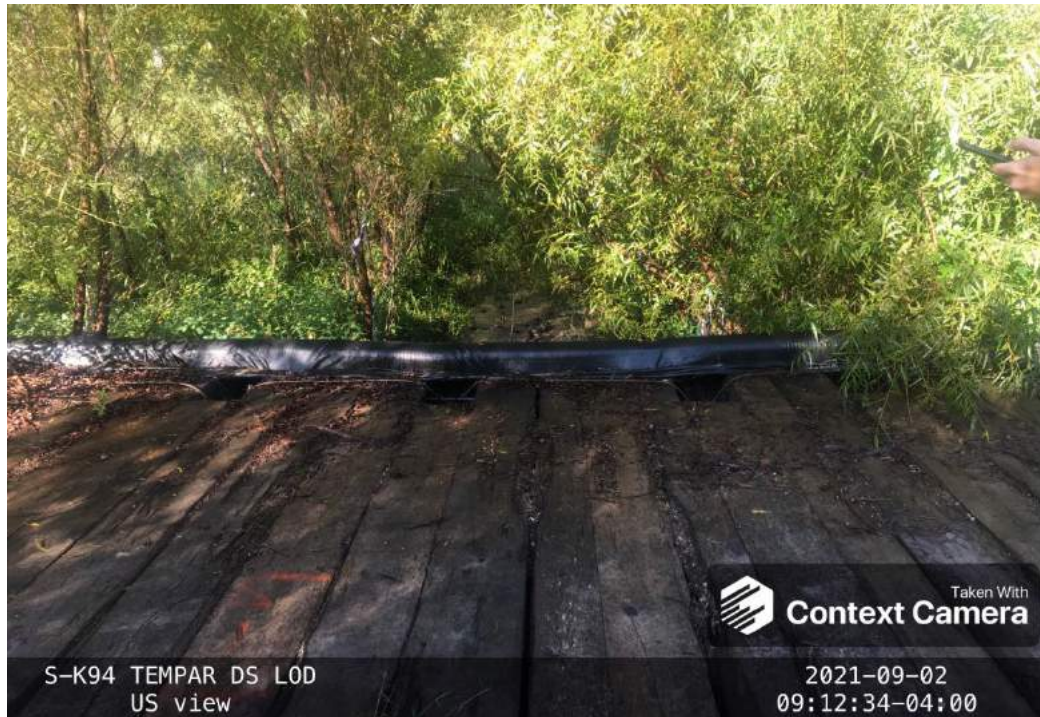
Photo Type: DS, US View
Location, Orientation, Photographer Initials: Downstream Edge of ROW, Upstream View, DP HK VM
Lat: 39.167831 Long: -80.578867

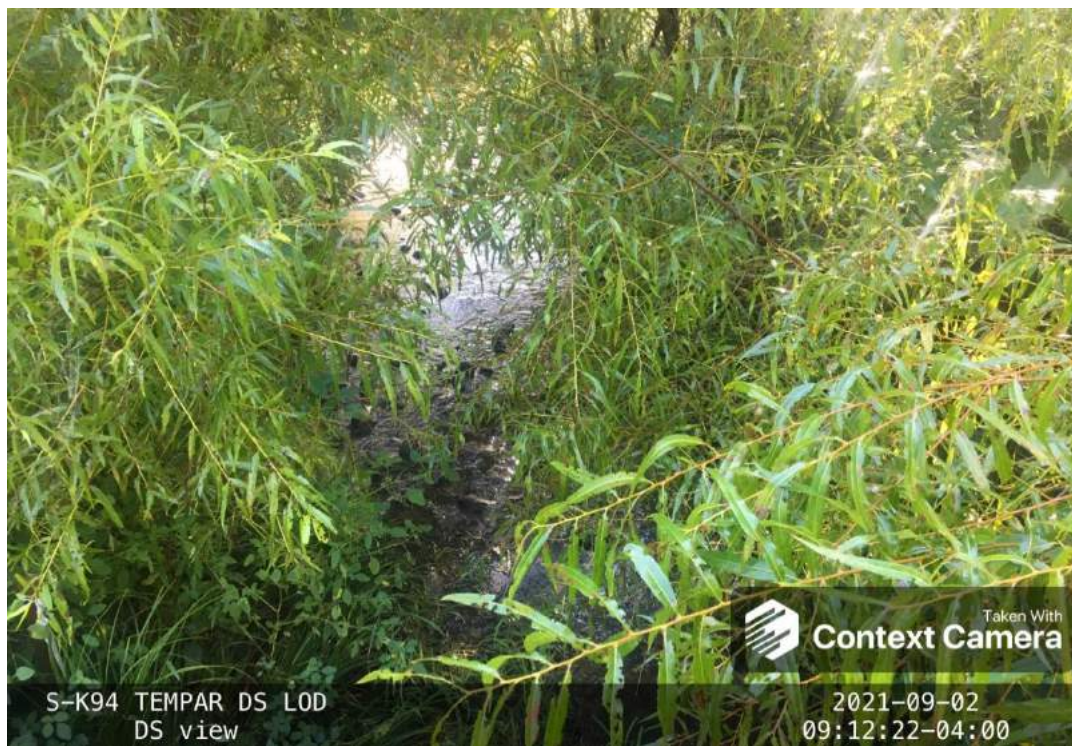
Photo Type: DS, DS View
Location, Orientation, Photographer Initials: Downstream Edge of ROW, Upstream View, DP HK VM
Lat: 39.167831 Long: -80.578867

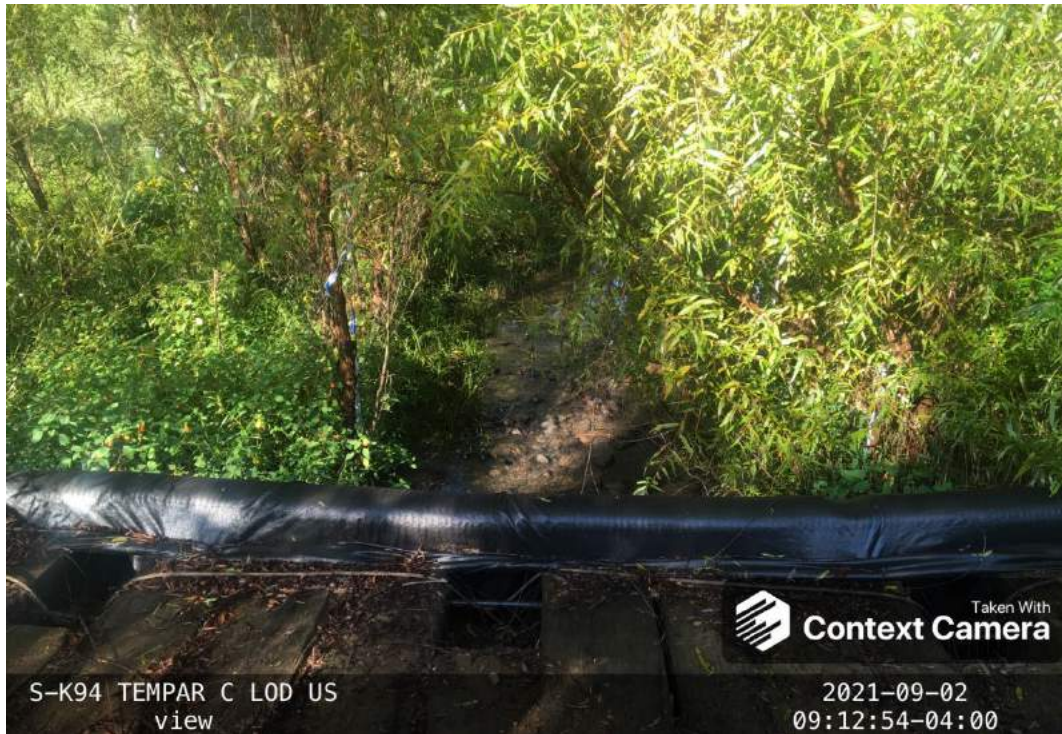
Photo Type: US View at Center
Location, Orientation, Photographer Initials: Downstream Edge of ROW, Upstream View, DP HK VM
Lat: 39.167831 Long: -80.578867

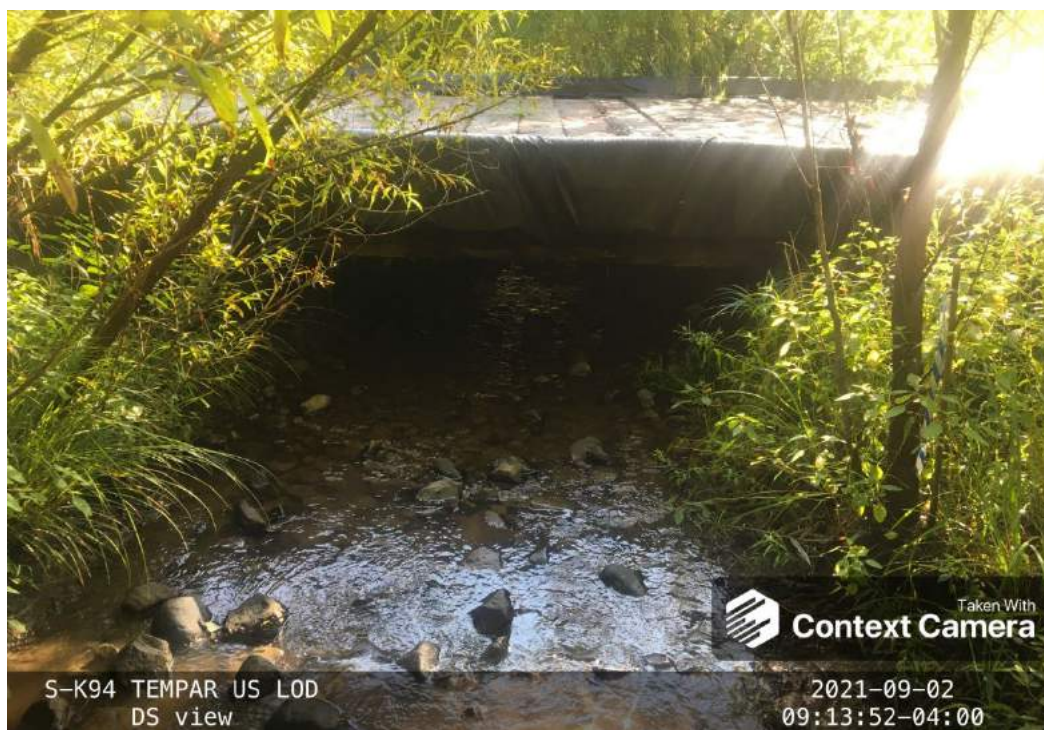
Photo Type: US, DS View
Location, Orientation, Photographer Initials: Downstream Edge of ROW, Upstream View, DP HK VM
Lat: 39.167831 Long: -80.578867

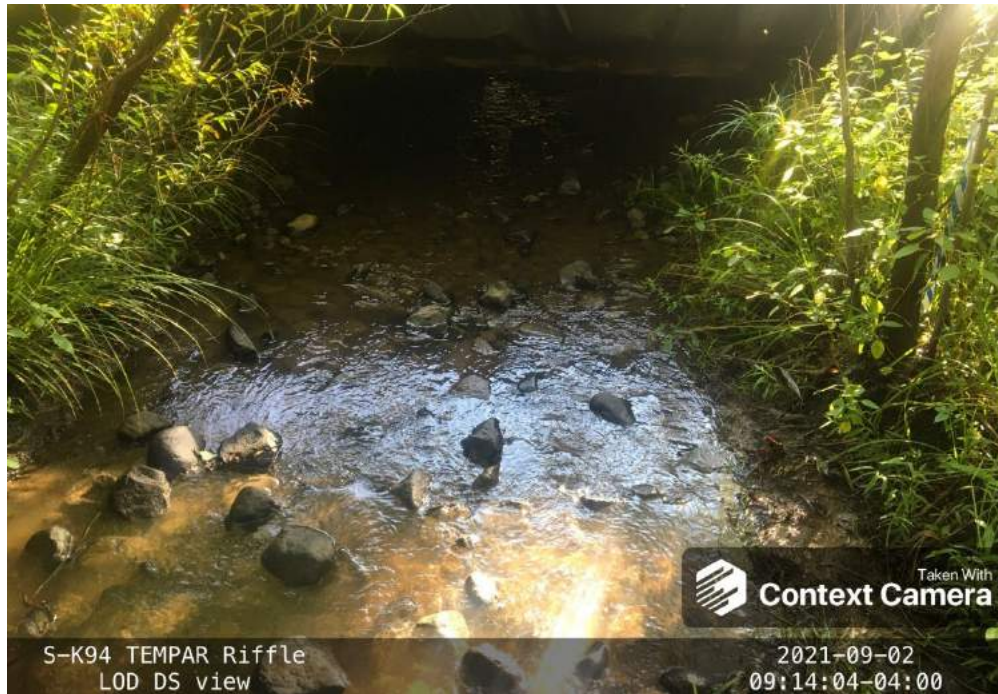
Photo Type: Riffle, DS View
Location, Orientation, Photographer Initials: Upstream of Riffle, Downstream View, DP HK VM
Lat: 39.167831 Long: -80.578867

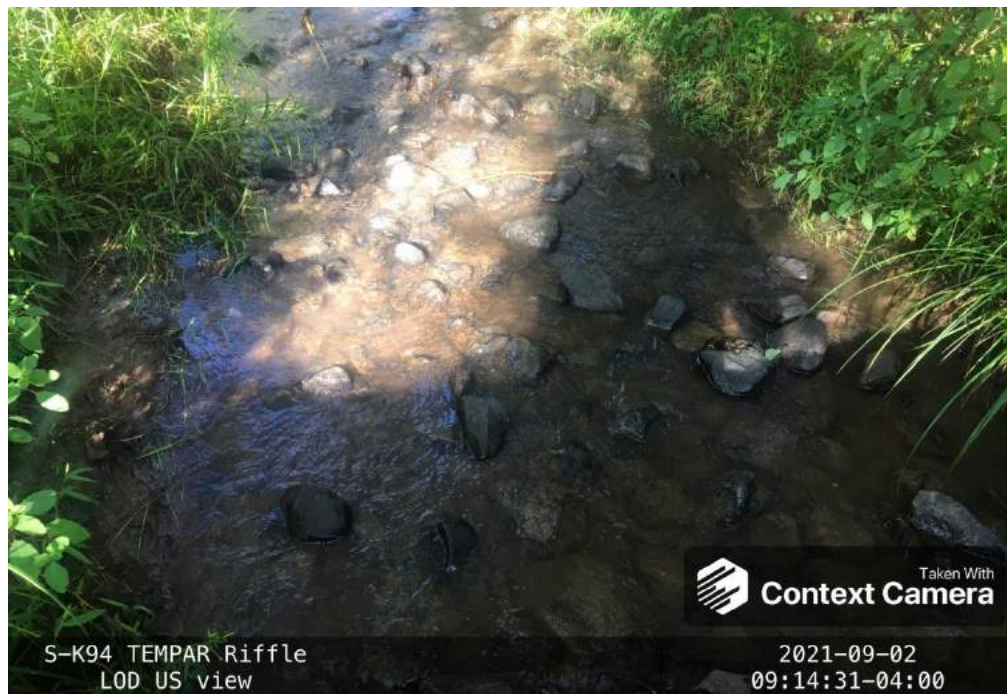
Photo Type: Riffle, US View
Location, Orientation, Photographer Initials: Downstream of Riffle, Upstream View, DP HK VM
Lat: 39.167831 Long: -80.578867

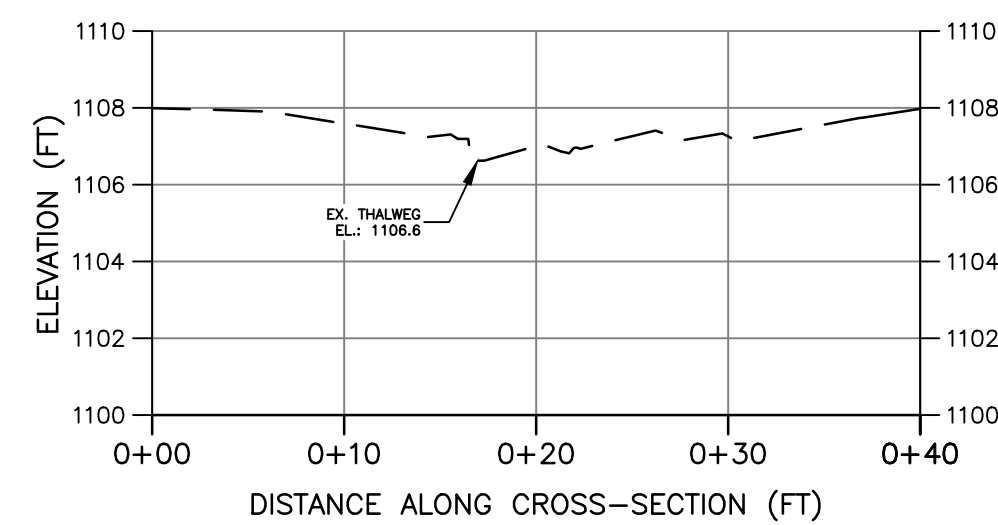
EXISTING STREAM PROFILE
INVERT ALONG THALWEG

TYPICAL 5-POINT CROSS-SECTION
(FACING DOWNSTREAM)
