# **Baseline Assessment – Stream Attributes**

# Reach S-KK2 (Pipeline ROW) Ephemeral Spread C Webster County, West Virginia

# Spread C Stream S-KK2 (Pipeline ROW) Webster County

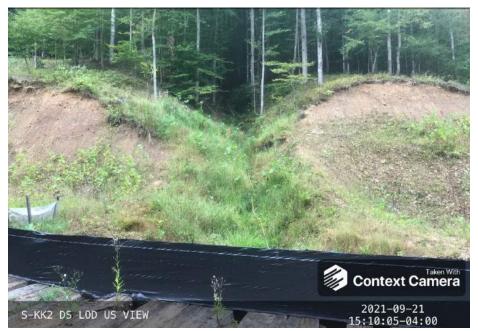
Photo Type: DS, US View Location, Orientation, Photographer Initials: Downstream Edge of ROW, Upstream View, RH/VM Lat: 38.672226 Long: -80.476315

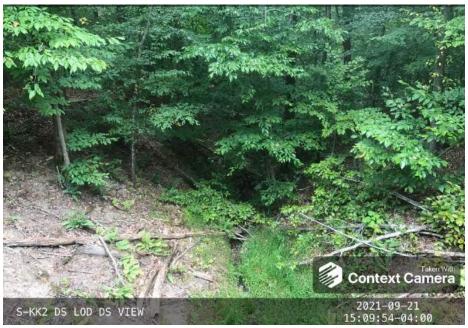
Photo Type: DS, DS View Location, Orientation, Photographer Initials: Downstream Edge of ROW, Downstream View, RH/VM Lat: 38.672226 Long: -80.476315

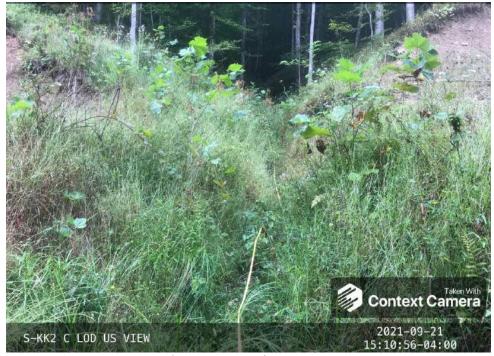
Photo Type: US View at Center Location, Orientation, Photographer Initials: Center ROW, Upstream View, RH/VM Lat: 38.672226 Long: -80.476315

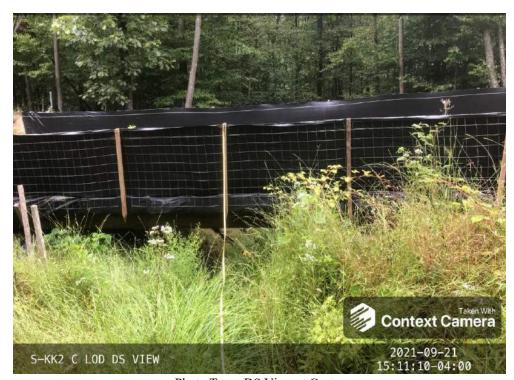
Photo Type: DS View at Center Location, Orientation, Photographer Initials: ROW Center, Downstream View, RH/VM Lat: 38.672226 Long: -80.476315

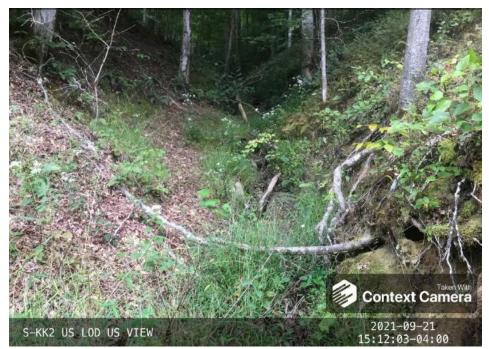
Photo Type: US, US View
Location, Orientation, Photographer Initials: Upstream Edge of ROW, Upstream View, RH/VM
Lat: 38.672226 Long: -80.476315

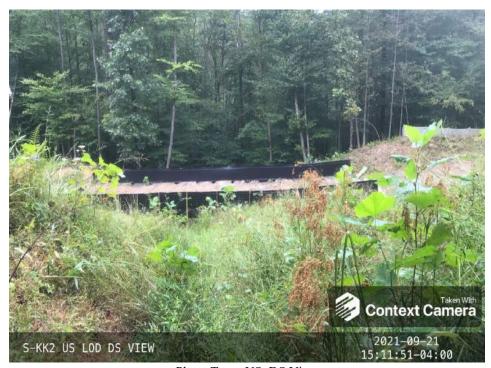
Photo Type: US, DS View
Location, Orientation, Photographer Initials: Upstream Edge of ROW, Downstream View, RH/VM
Lat: 38.672226 Long: -80.476315

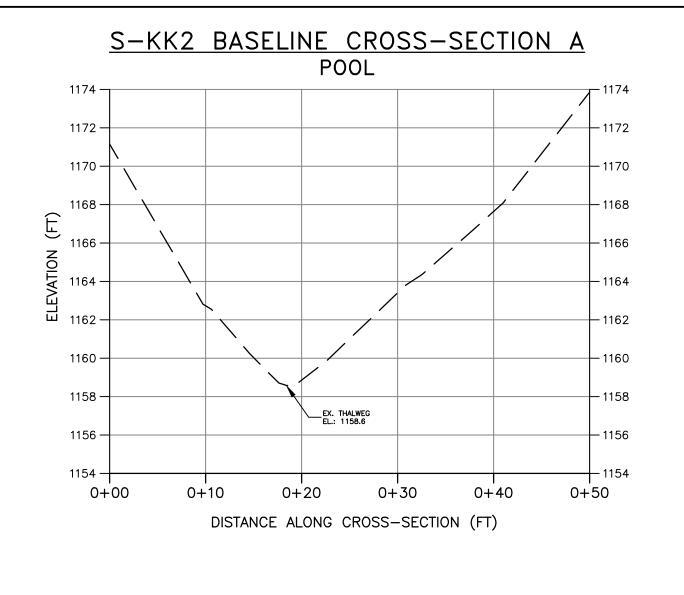
CROSS SECTION
H: 1"=10'
V: 1"=5'

CROSS SECTION LEGEND — EXISTING GRADE

NOTE: ALL SECTIONS VIEWS SHOWN LEFT TO RIGHT FACING DOWNSTREAM.
