**Reach S-L20 (Pipeline ROW)**  
**Perennial**  
**Spread E**  
**Greenbrier County, West Virginia**

**Spread E      Stream S-L20 (Pipeline ROW)      Greenbrier County**

Client  
MOUNTAIN VALLEY PIPELINE, LLC  
2200 ENERGY DRIVE, 2ND FLOOR  
CANONSBURG, PA 15317  
Title  
PROFILE AND CROSS-SECTIONS  
BASELINE SURVEY  
CROSSING S-L20 - UNNAMED TRIB. TO  
LITTLE SEWELL CREEK (MP 147.35)  
GREENBRIER COUNTY, WV

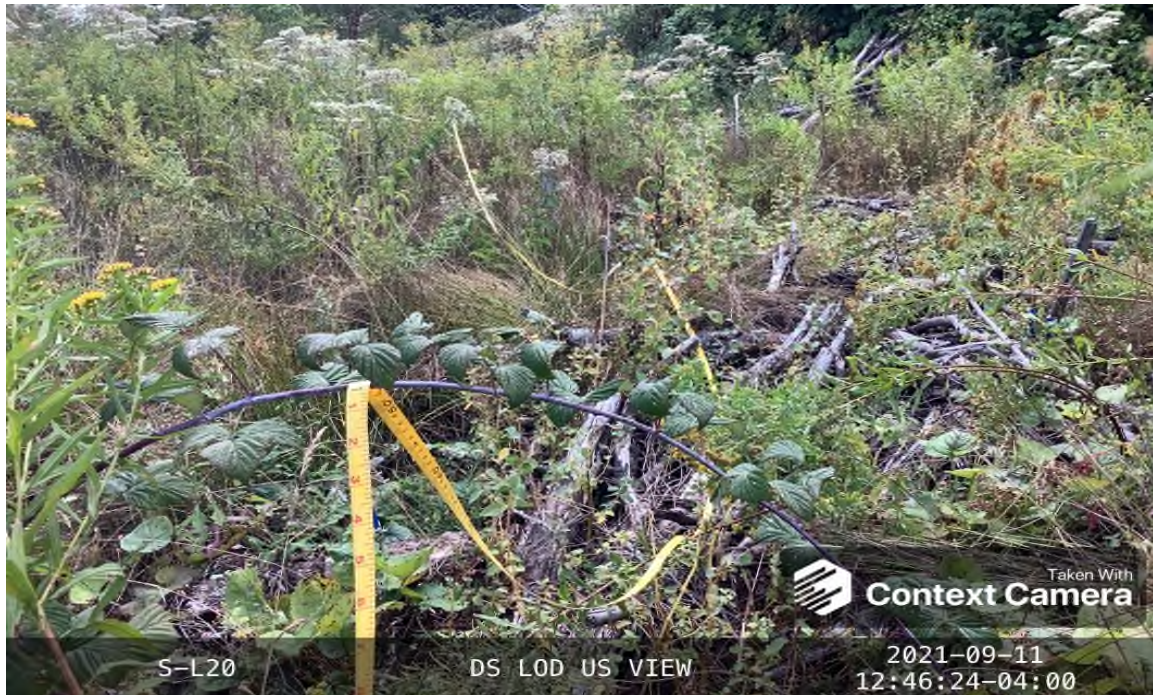
Photo Type: DS, US View

Location, Orientation, Photographer Initials: Downstream Edge of ROW, Upstream View, MD, CCC, CNJ  
Lat: 37.949579 Long: -80.742646

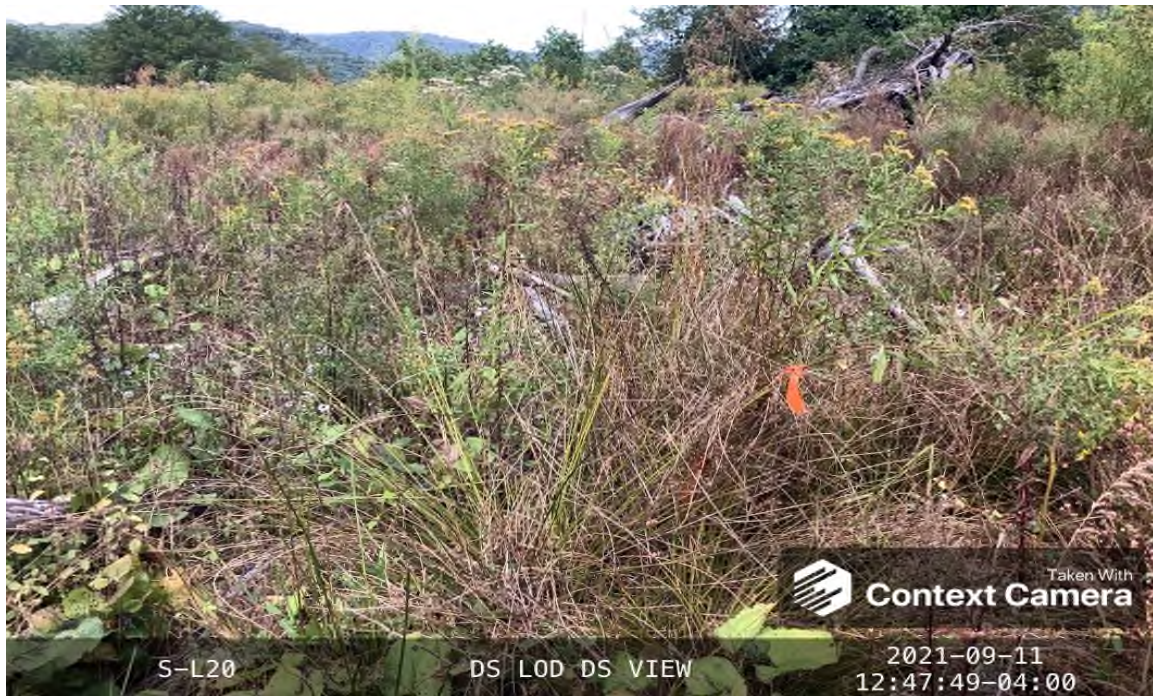
Photo Type: DS, DS View

Location, Orientation, Photographer Initials: Downstream Edge of ROW, Downstream View, MD, CCC, CNJ  
Lat: 37.949579 Long: -80.742646

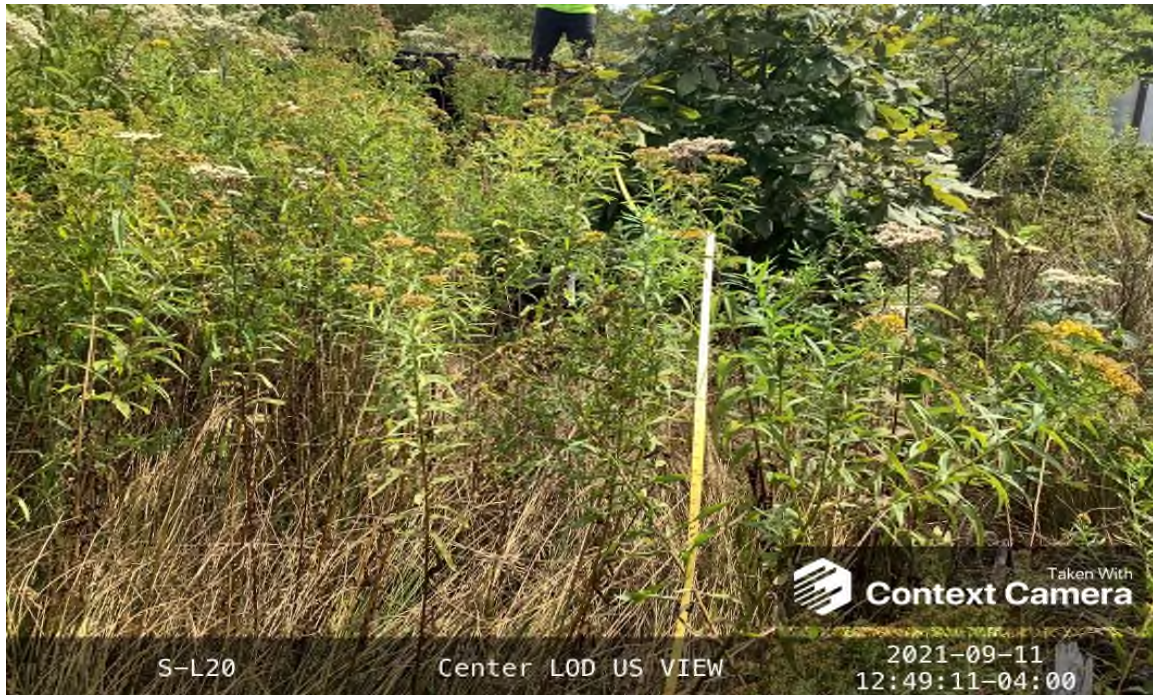
Photo Type: US View at Center  
Location, Orientation, Photographer Initials: Center ROW, Upstream View, MD, CCC, CNJ  
Lat: 37.949579 Long: -80.742646

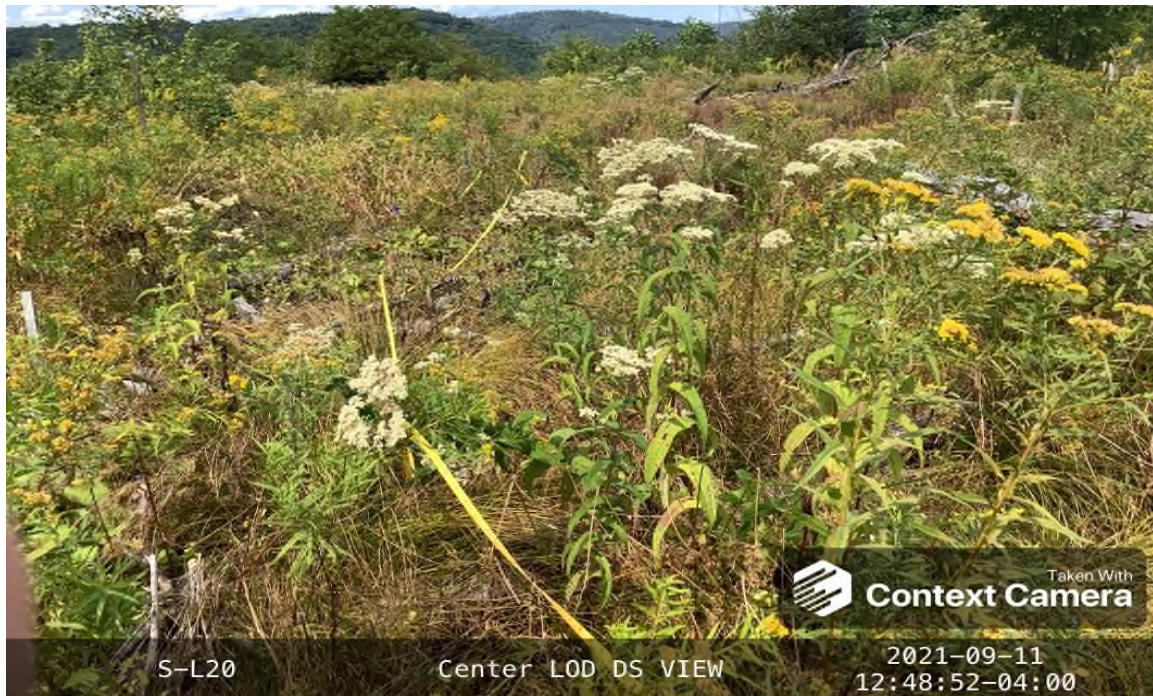
Photo Type: DS View at Center  
Location, Orientation, Photographer Initials: Center ROW, Downstream View, MD, CCC, CNJ  
Lat: 37.949579 Long: -80.742646

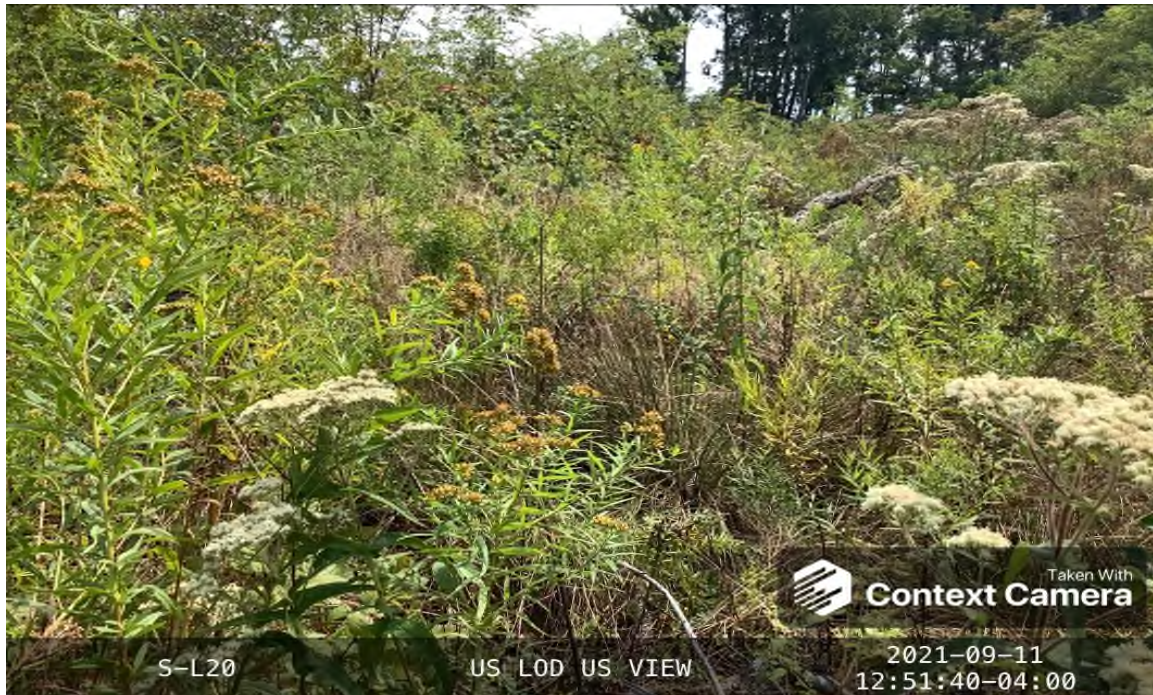
Photo Type: US, US View  
Location, Orientation, Photographer Initials: Upstream Edge of ROW, Upstream View, MD, CCC, CNJ  
Lat: 37.949579 Long: -80.742646

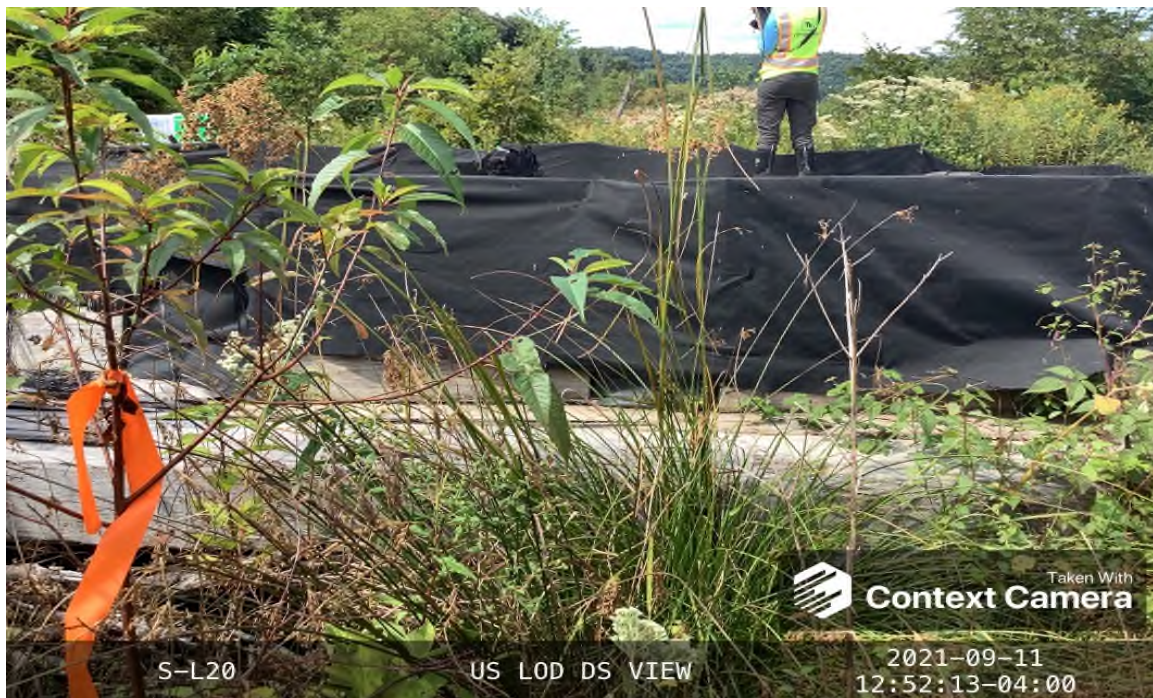
Photo Type: US, DS View  
Location, Orientation, Photographer Initials: Upstream Edge of ROW, Downstream View, MD, CCC, CNJ  
Lat: 37.949579 Long: -80.742646

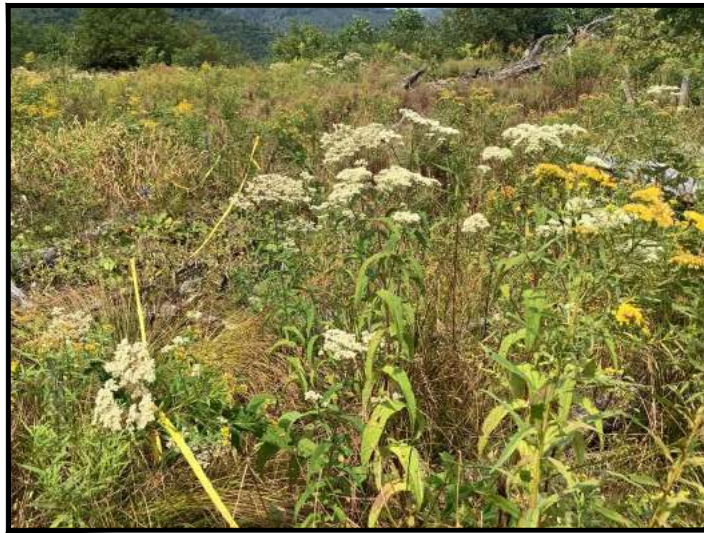
PHOTO TAKEN LOOKING DOWNSTREAM FROM UPSTREAM IMPACT LIMITS

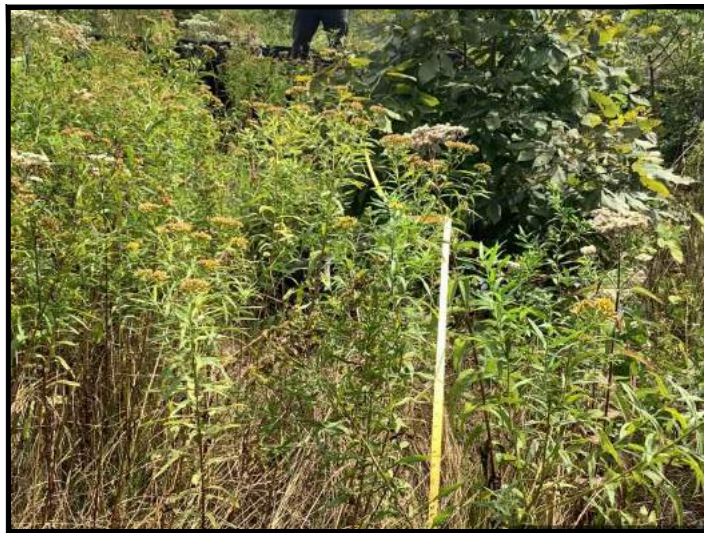
PHOTO TAKEN LOOKING UPSTREAM FROM DOWNSTREAM IMPACT LIMITS
