Baseline Assessment – Stream Attributes

Reach S-M6 (Pipeline ROW) Intermittent Spread F Summers County, West Virginia

Title PROFILE AND CROSS-SECTIONS
 BASELINE SURVEY
 CROSSING S-M6 - UNNAMED TRIB. TO
 SPRING BRANCH (MP 159.39)
 SUMMERS COUNTY WV

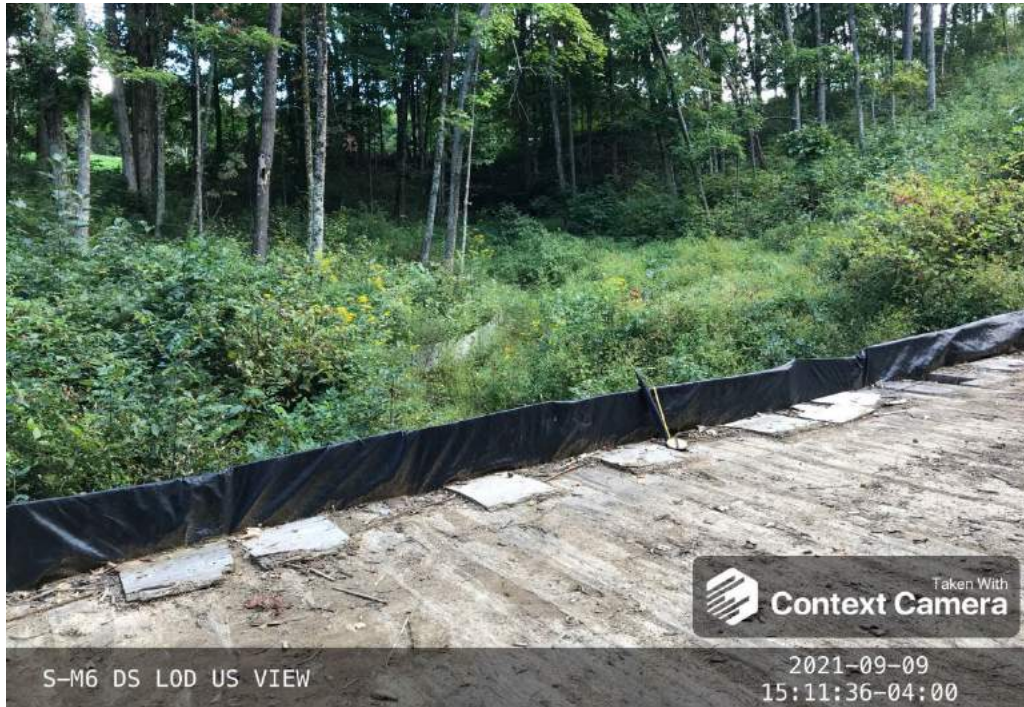
Photo Type: DS, US View

Location, Orientation, Photographer Initials: Downstream Edge of ROW, Upstream View, RH/AR
Lat: 37.80765 Long: -80.746173

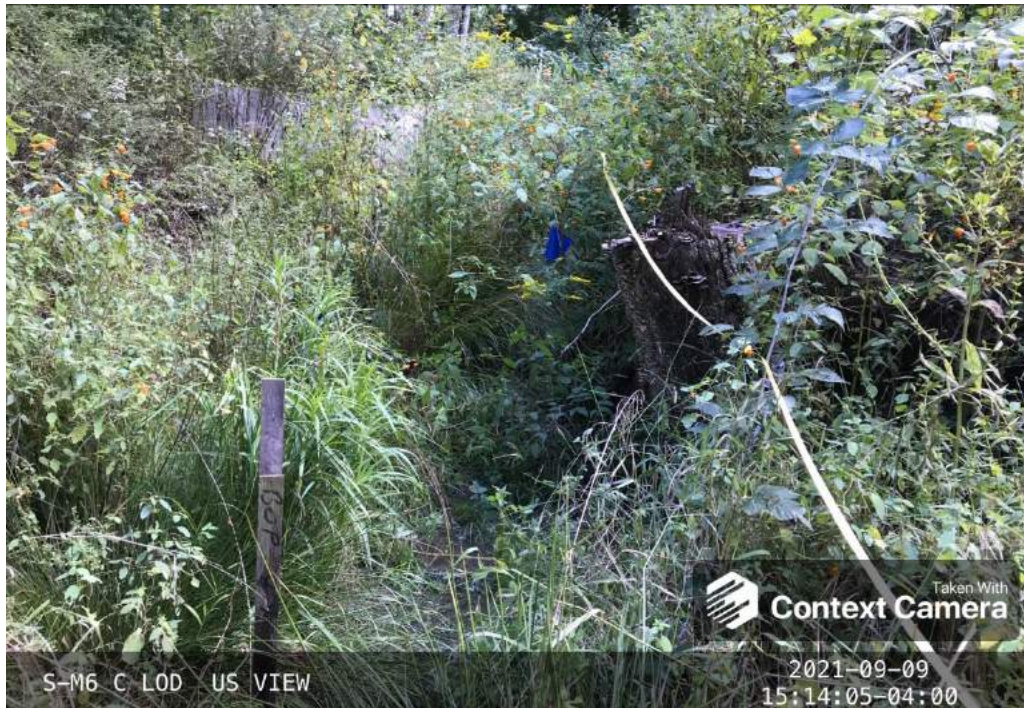
Photo Type: US View at Center
Location, Orientation, Photographer Initials: Center ROW, Upstream View, RH/AR
Lat: 37.80765 Long: -80.746173

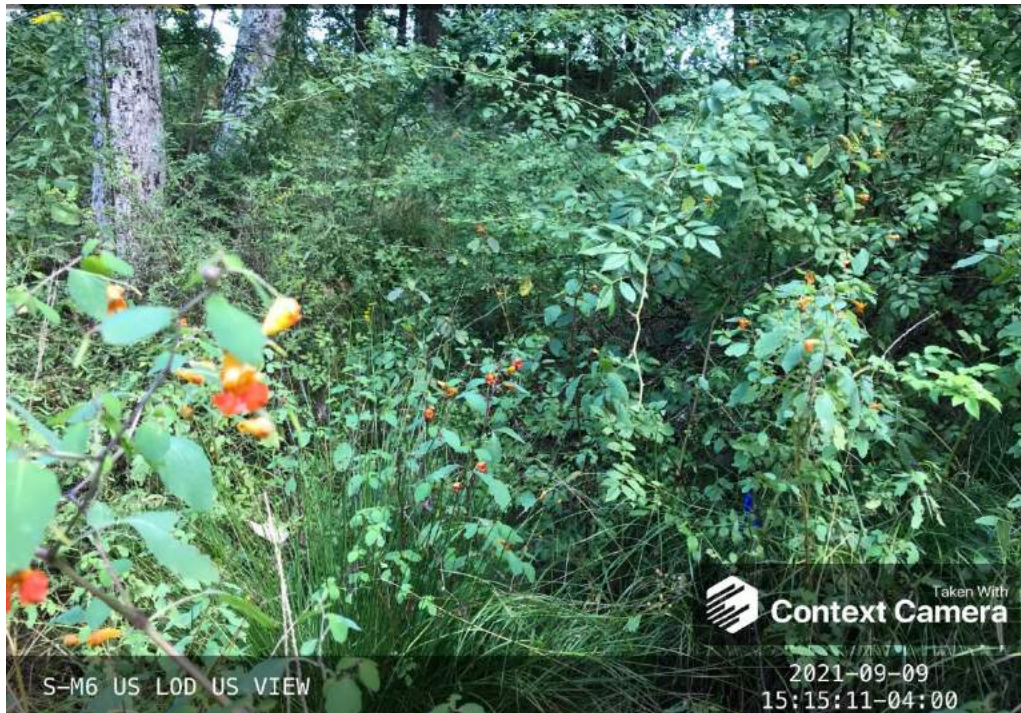
Photo Type: US, US View

Location, Orientation, Photographer Initials: Upstream Edge of ROW, Upstream View, RH/AR
Lat: 37.80765 Long: -80.746173

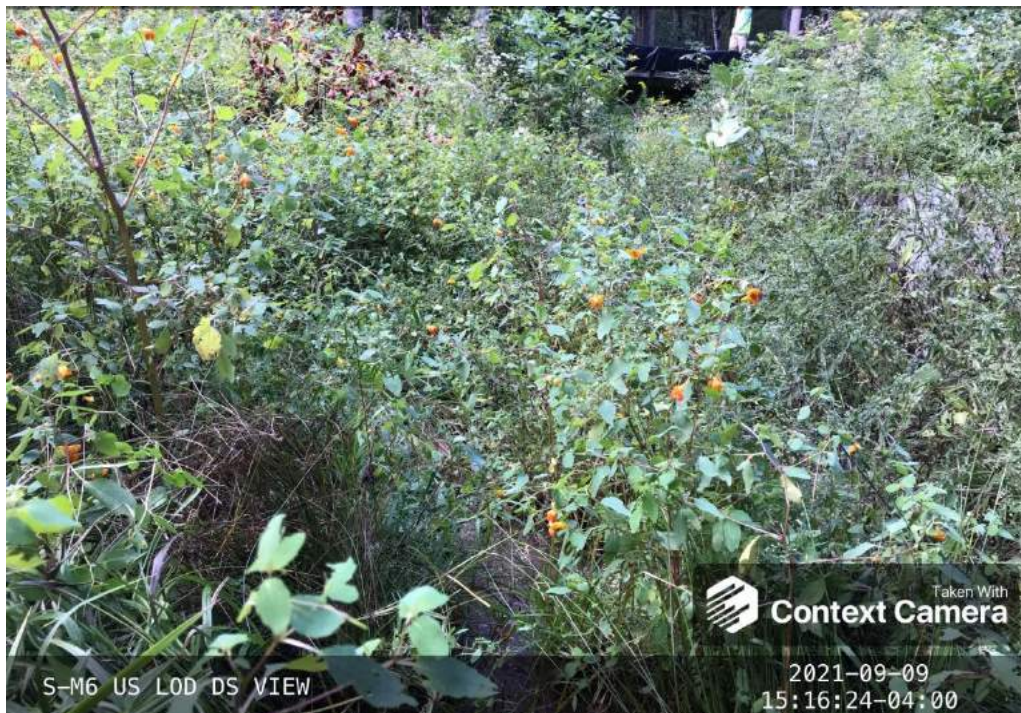
Photo Type: US, DS View

Location, Orientation, Photographer Initials: Upstream Edge of ROW, Downstream View, RH/AR
Lat: 37.80765 Long: -80.746173

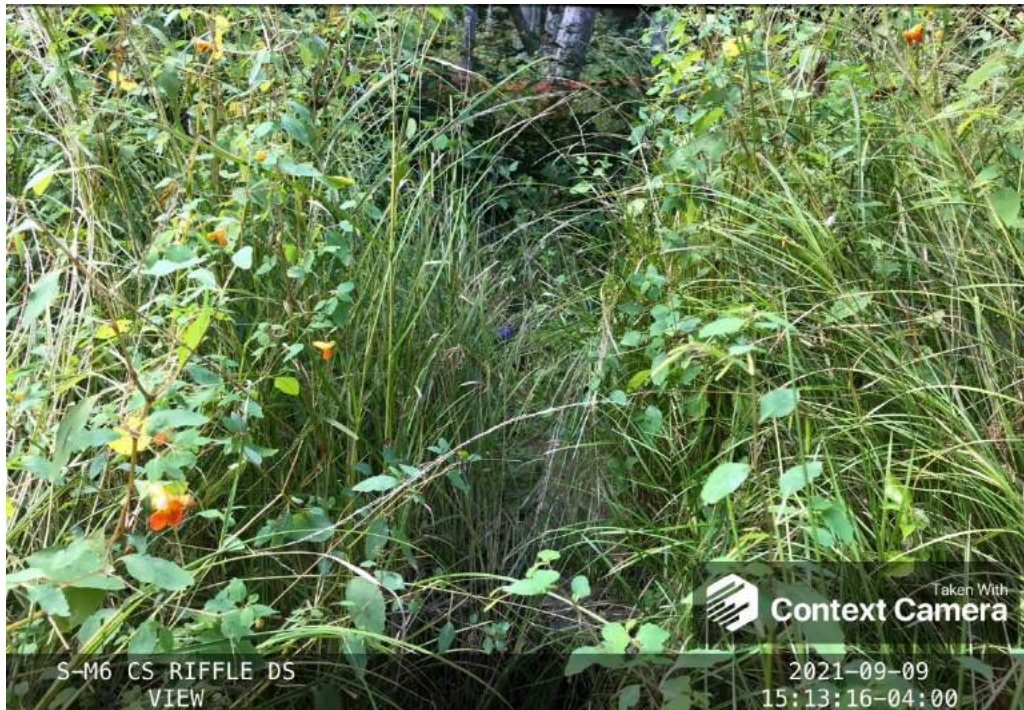
Photo Type: Riffle, DS View
Location, Orientation, Photographer Initials: Upstream of Riffle, Downstream View, RH/AR
Lat: 37.80765 Long: -80.746173

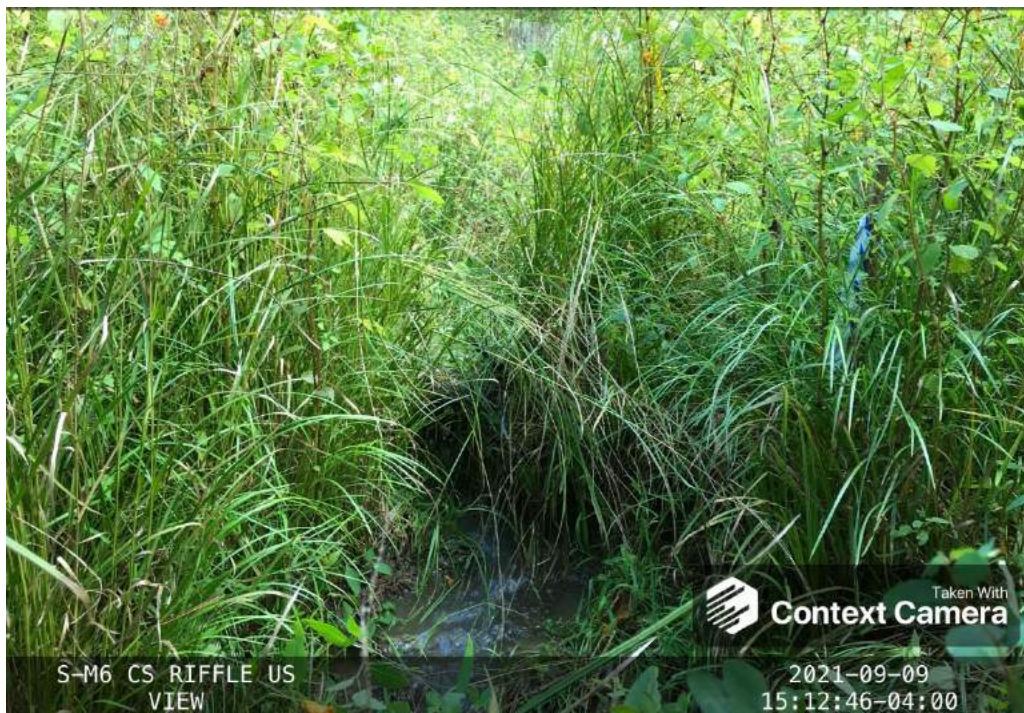
Photo Type: Riffle, US View
Location, Orientation, Photographer Initials: Downstream of Riffle, Upstream View, RH/AR
Lat: 37.80765 Long: -80.746173

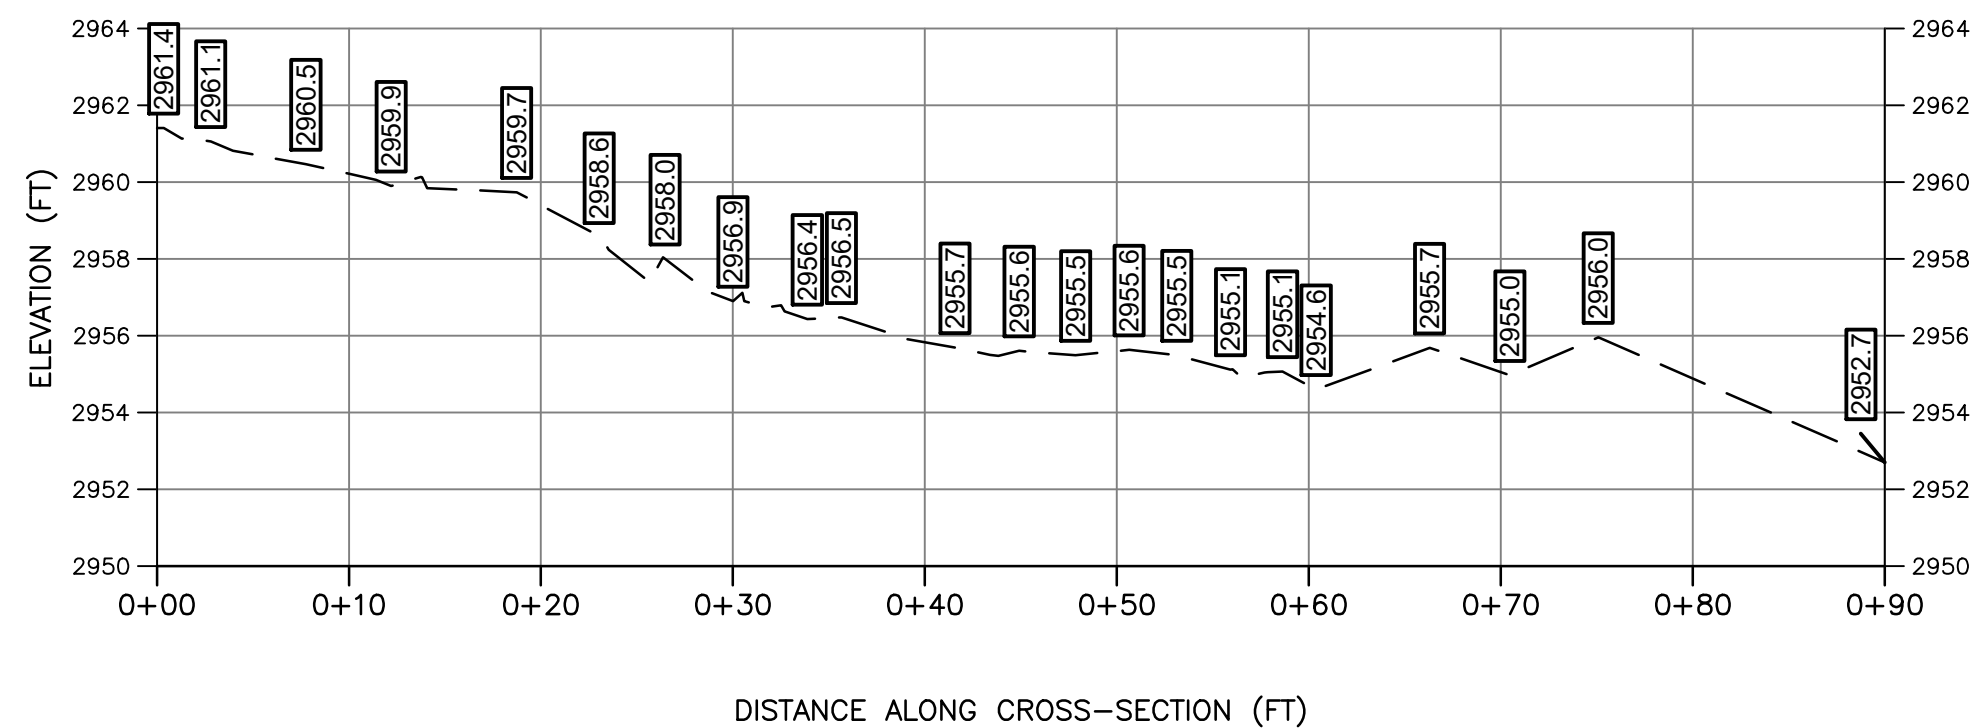
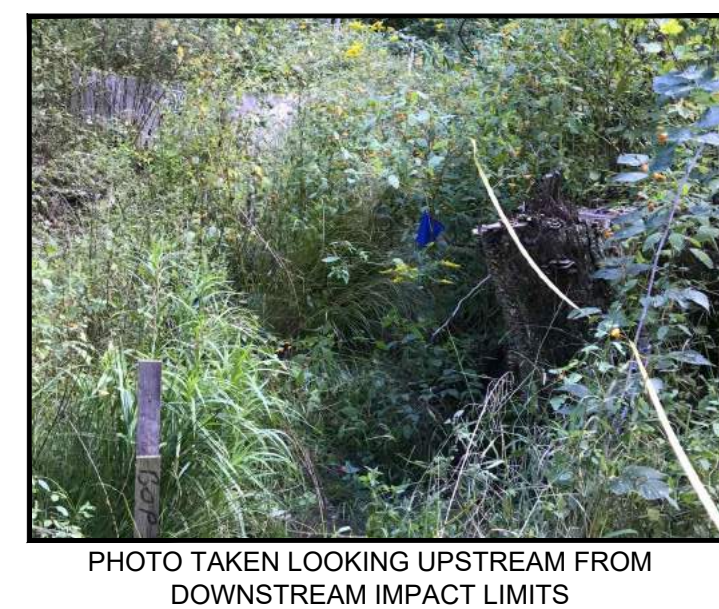
4. ALL SECTION VIEWS SHOWN LEFT TO RIGHT FACING DOWNSTREAM.
5. POST-CROSSING SURVEY INFORMATION SHOWN IN RED. DATA PENDING.
6. POST-CROSSING SURVEY POINTS FOR CROSS SECTIONS AND THALWEG ARE PROJECTED ONTO PRE-CROSSING SECTION AND PROFILE VIEWS FOR COMPARISON.
