Baseline Assessment – Stream Attributes

Reach S-N10 Braid (Pipeline ROW) Intermittent Spread D Nicholas County, West Virginia

Client
MOUNTAIN VALLEY PIPELINE, LLC
2200 ENERGY DRIVE, 2ND FLOOR
CANONSBURG, PA 15317
Title
PROFILE AND CROSS-SECTIONS
BASELINE SURVEY
CROSSING S-N10 - SKELT RUN (MP 122.5)
NICHOLAS COUNTY, WV

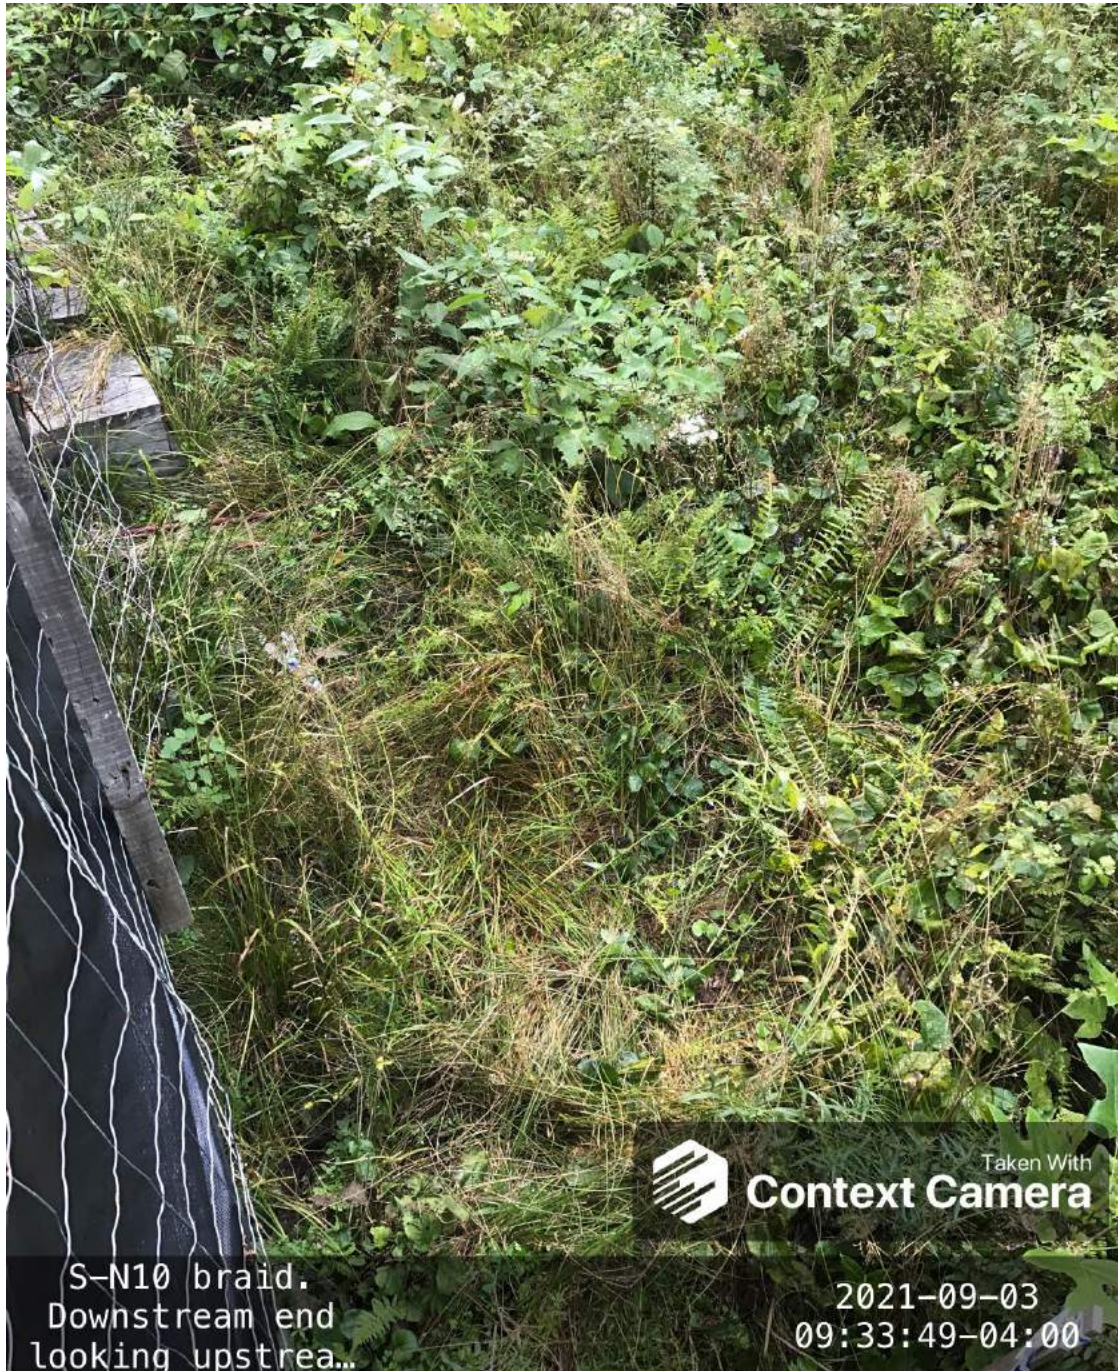
Photo Type: DS, US View
Location, Orientation, Photographer Initials: Downstream Edge of ROW, Upstream View, SM
Lat: 38.230934 Long: -80.710804

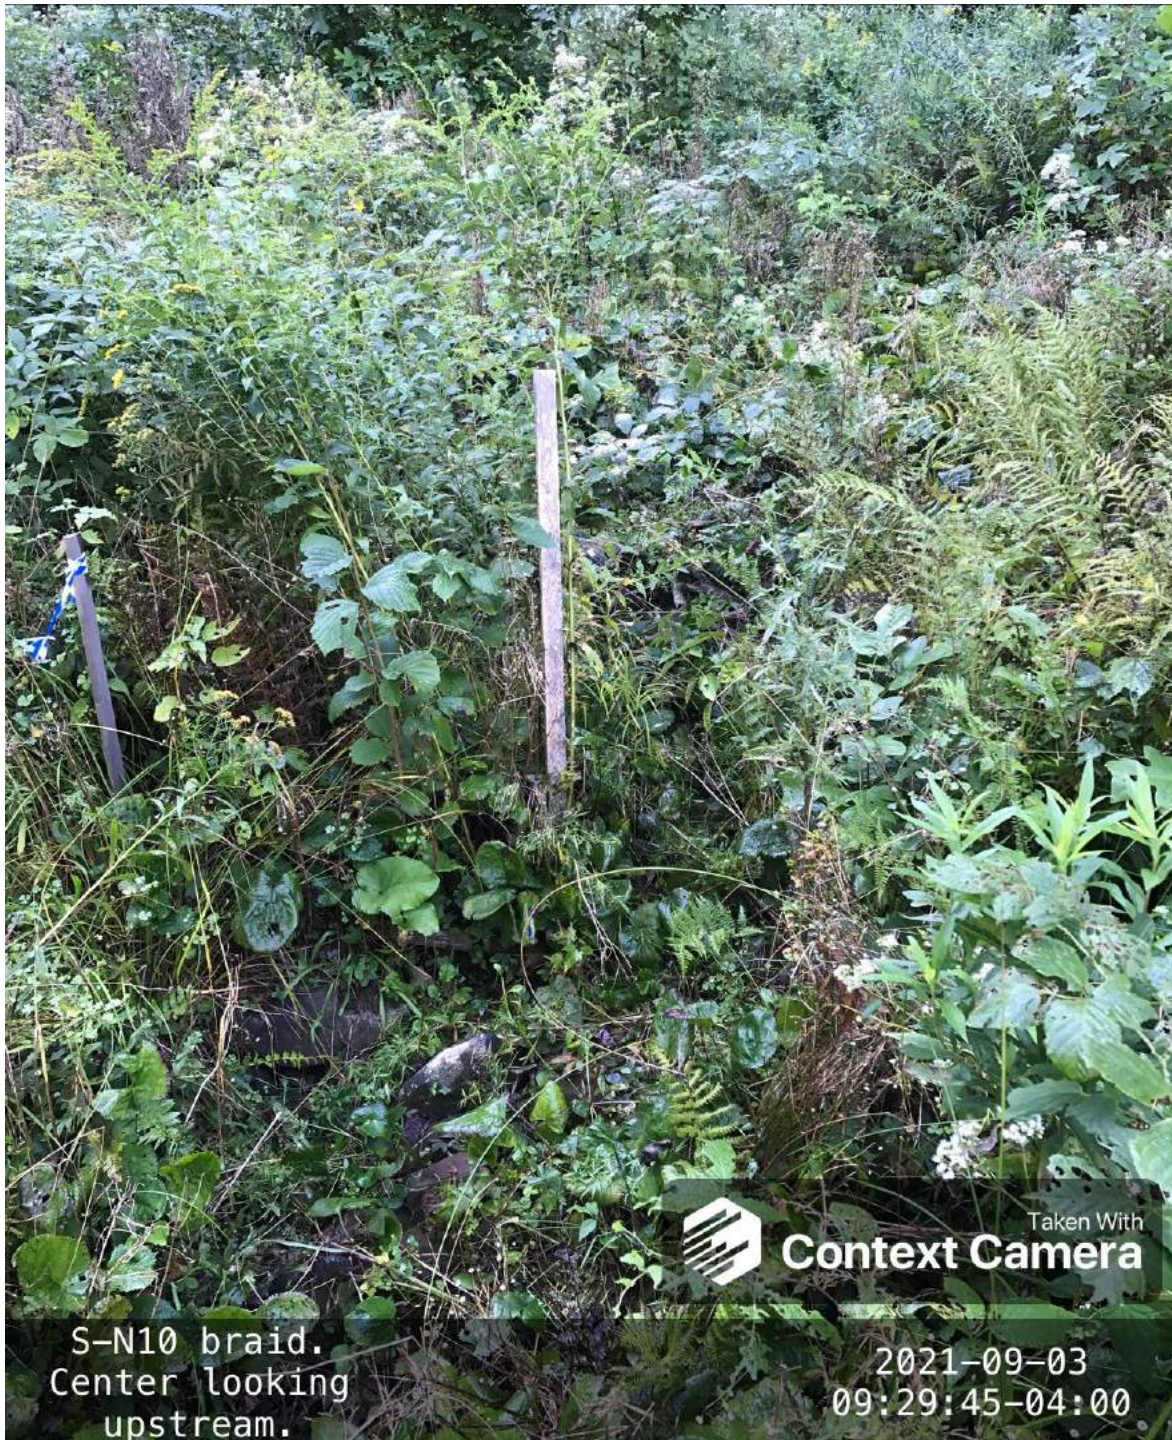
Photo Type: US View at Center
Location, Orientation, Photographer Initials: Center ROW, Upstream View, SM
Lat: 38.230934 Long: -80.710804

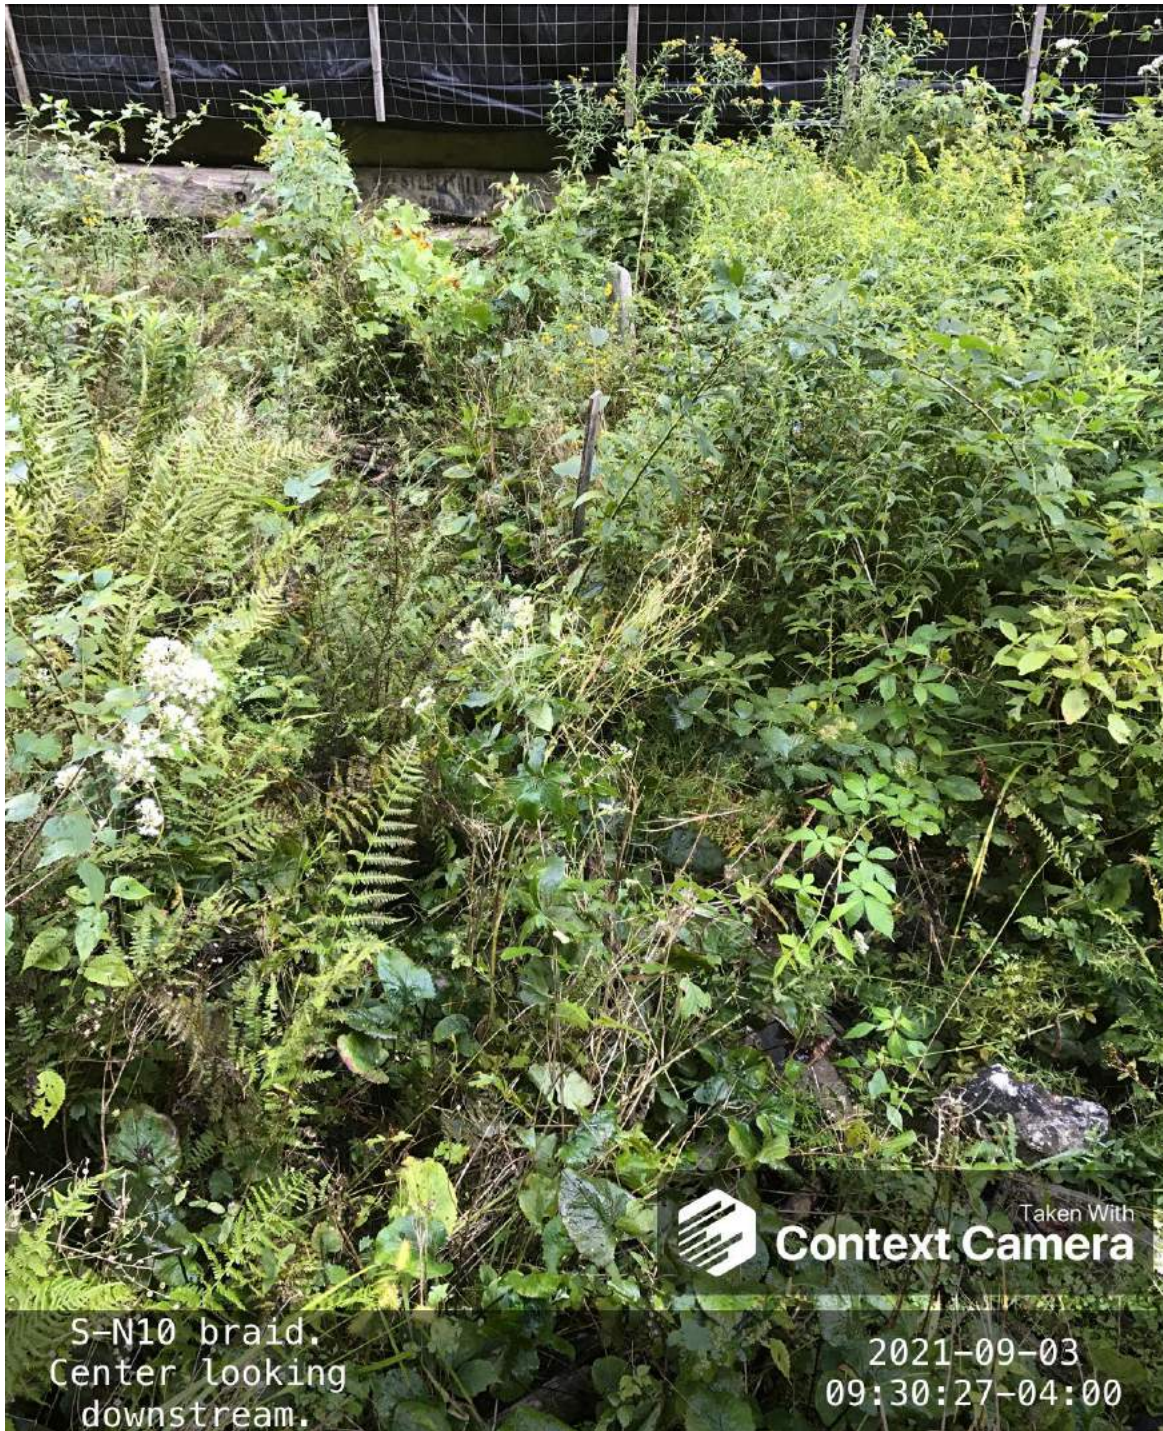
Photo Type: DS View at Center
Location, Orientation, Photographer Initials: ROW Center, Downstream View, SM
Lat: 38.230934 Long: -80.710804

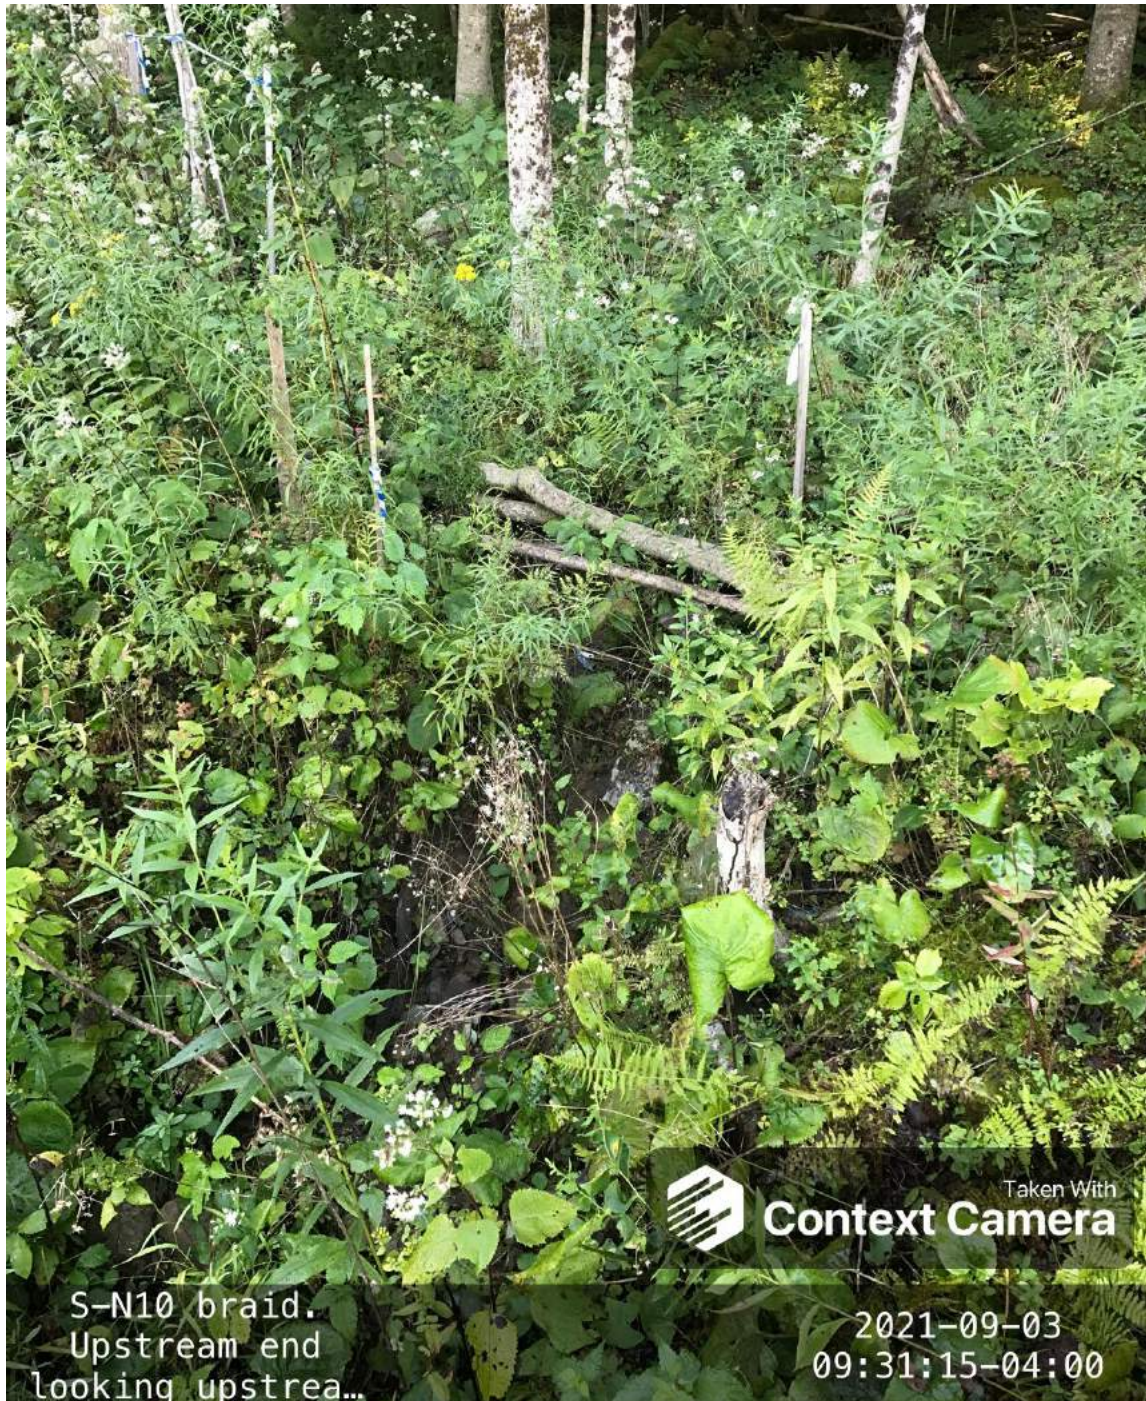
Photo Type: US, US View
Location, Orientation, Photographer Initials: Upstream Edge of ROW, Upstream View, SM
Lat: 38.230934 Long: -80.710804

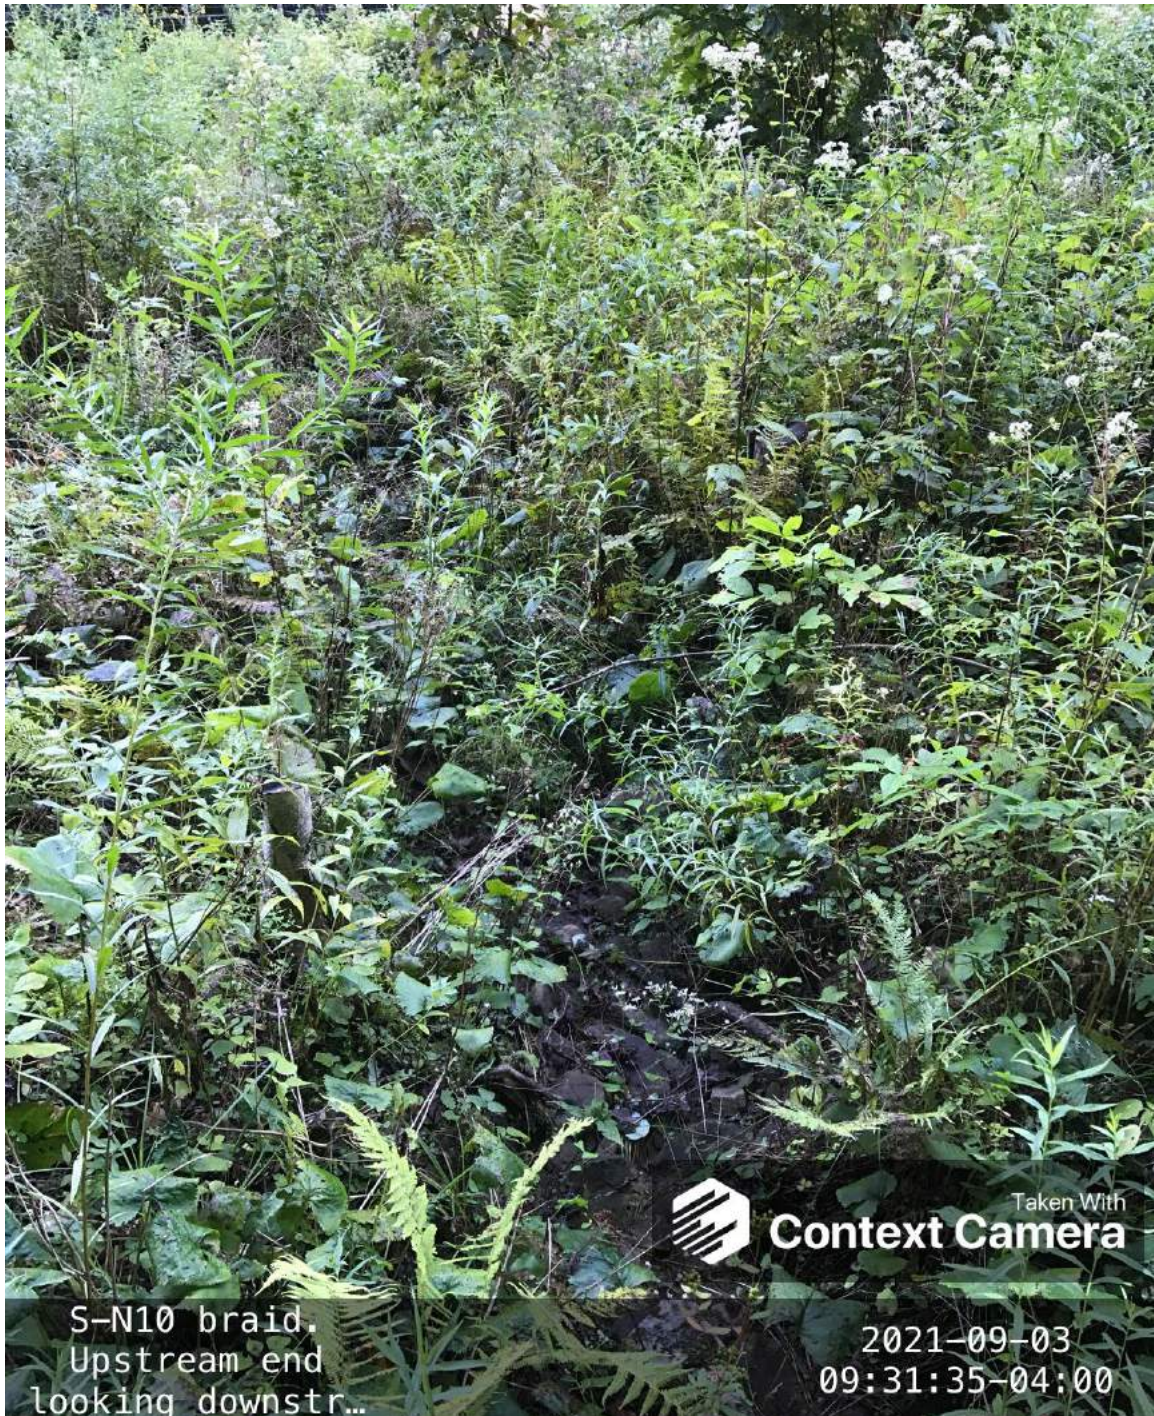
Photo Type: US, DS View
Location, Orientation, Photographer Initials: Upstream Edge of ROW, Downstream View, SM
Lat: 38.230934 Long: -80.710804

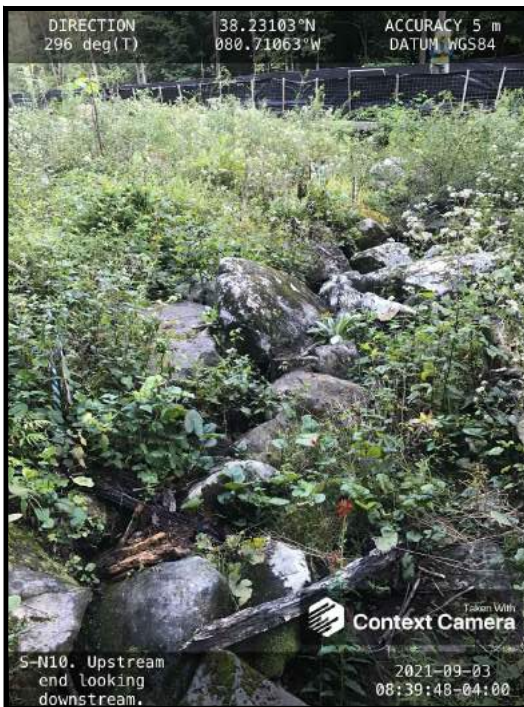
PHOTO TAKEN LOOKING DOWNSTREAM FROM UPSTREAM IMPACT LIMITS

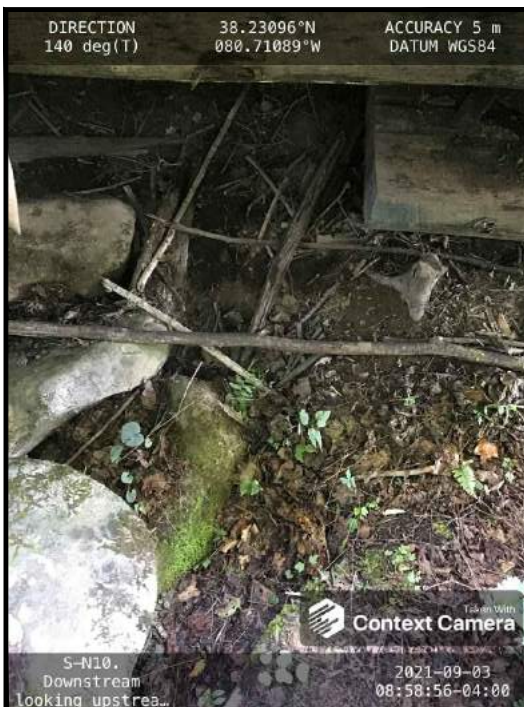
PHOTO TAKEN LOOKING UPSTREAM FROM DOWNSTREAM IMPACT LIMITS
