Baseline Assessment – Stream Attributes

Reach S-O5 (Timber Mat Crossing) Ephemeral Spread D Webster County, West Virginia

Client: MOUNTAIN VALLEY PIPELINE, LLC
Title: PROFILE AND CROSS-SECTIONS
BASELINE SURVEY
CROSSING S-05 - UNNAMED TRIBUTARY
TO LAUREL CREEK (MP 98.66)
WEBSTER COUNTY, WV

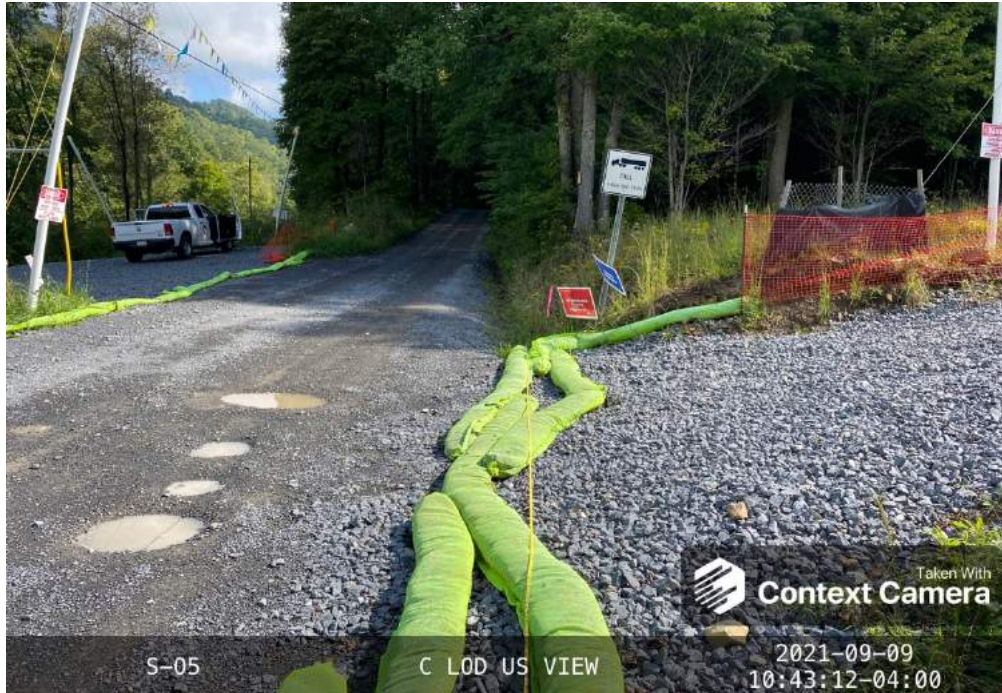
Photo Type: US View at Center
Location, Orientation, Photographer Initials: Center ROW, Upstream View, RC/CC
Lat: 38.482251 Long: -80.555499

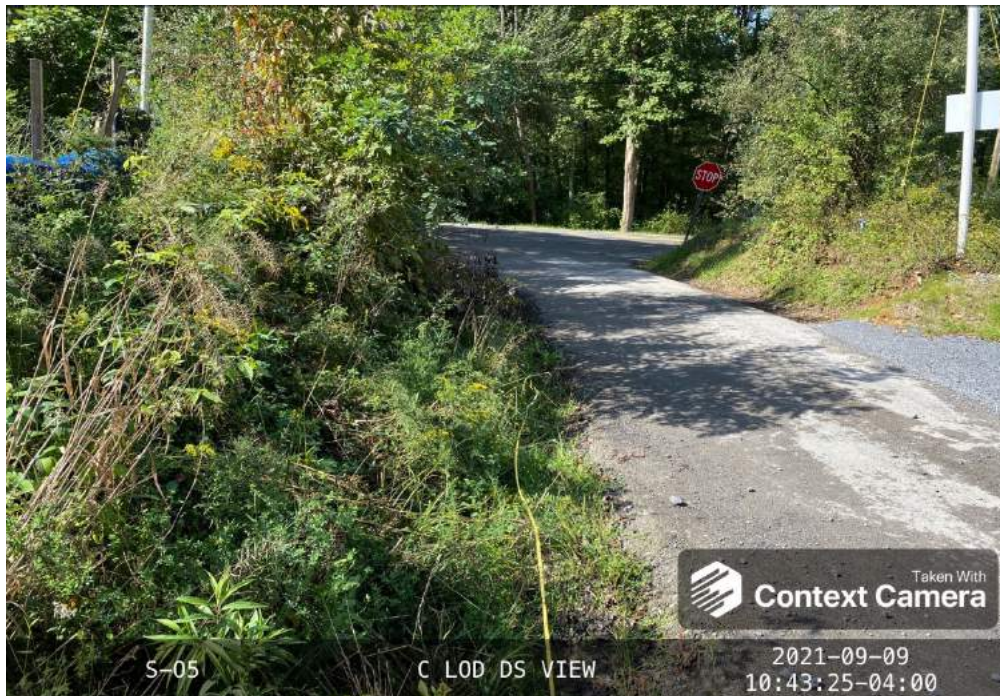
Photo Type: DS View at Center
Location, Orientation, Photographer Initials: ROW Center, Downstream View, RC/CC
Lat: 38.482251 Long: -80.555499

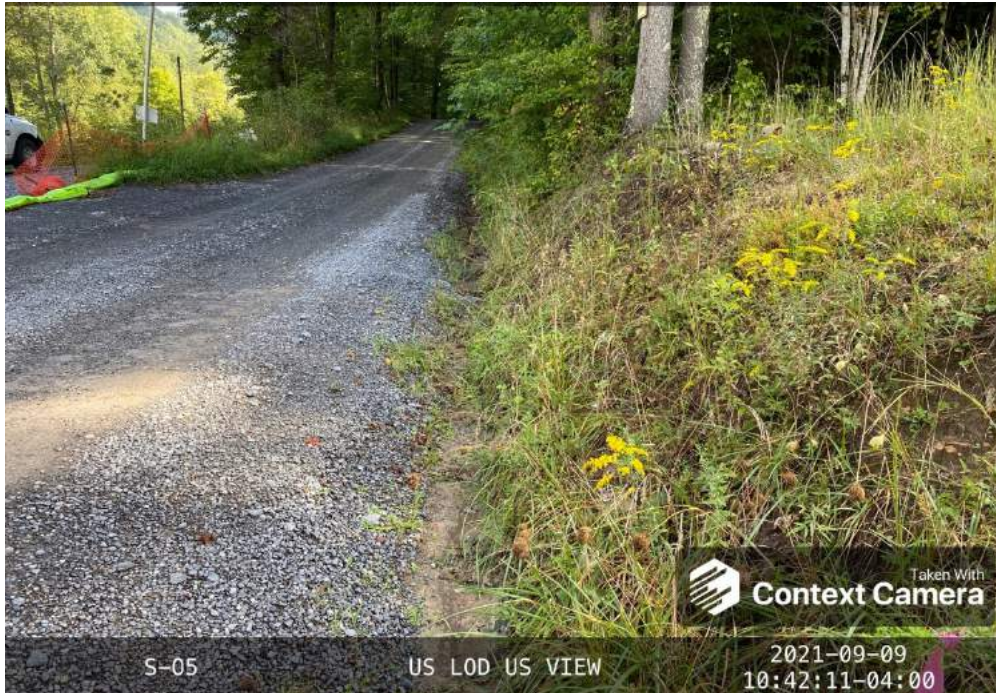
Photo Type: US, US View

Location, Orientation, Photographer Initials: Upstream Edge of ROW, Upstream View, RC/CC
Lat: 38.482251 Long: -80.555499

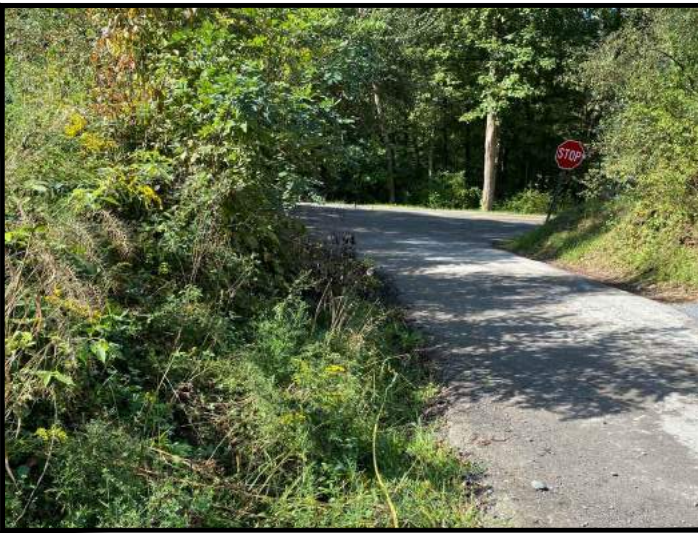
PHOTO TAKEN LOOKING DOWNSTREAM FROM UPSTREAM IMPACT LIMITS

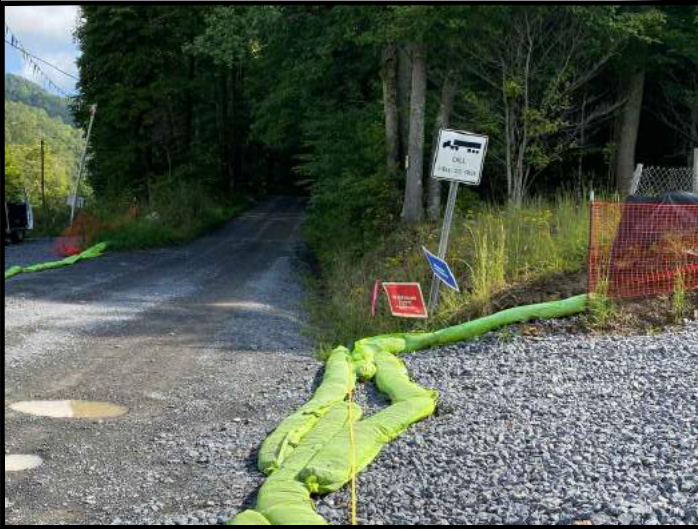
PHOTO TAKEN LOOKING UPSTREAM FROM DOWNSTREAM IMPACT LIMITS
