#### **Baseline Assessment – Stream Attributes**

# Reach S-S4 (Temporary Access Road) Ephemeral Spread C Webster County, West Virginia

#### Spread C Stream S-S4 (Temporary Access Road) Webster County

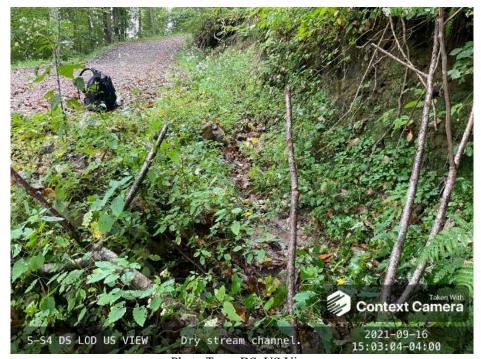
Photo Type: DS, US View Location, Orientation, Photographer Initials: Downstream Edge of ROW, Upstream View, KY/ZS Lat: 38.664389 Long: -80.484709

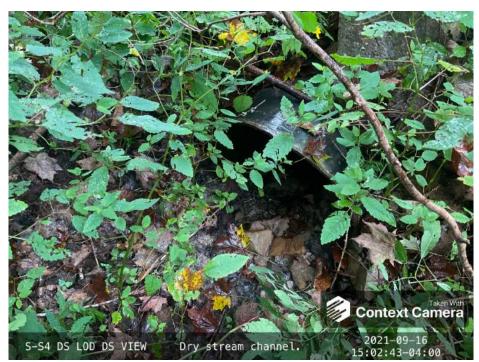
Photo Type: DS, DS View
Location, Orientation, Photographer Initials: Downstream Edge of ROW, Downstream View, KY/ZS
Lat: 38.664389 Long: -80.484709

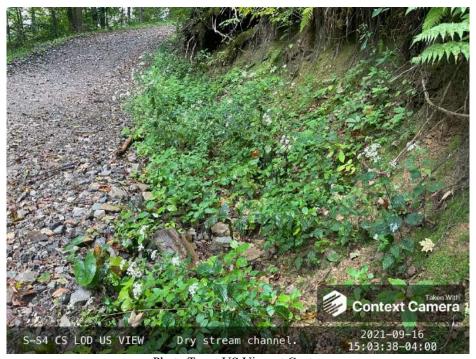
Photo Type: US View at Center Location, Orientation, Photographer Initials: Center ROW, Upstream View, KY/ZS Lat: 38.664389 Long: -80.484709

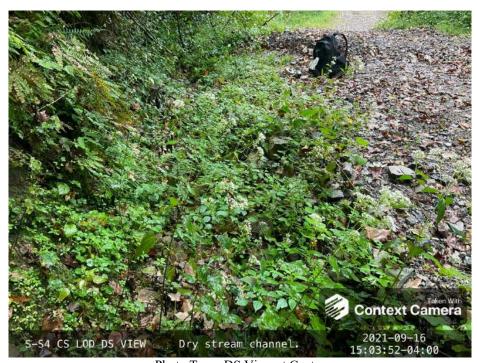
Photo Type: DS View at Center Location, Orientation, Photographer Initials: ROW Center, Downstream View, KY/ZS Lat: 38.664389 Long: -80.484709

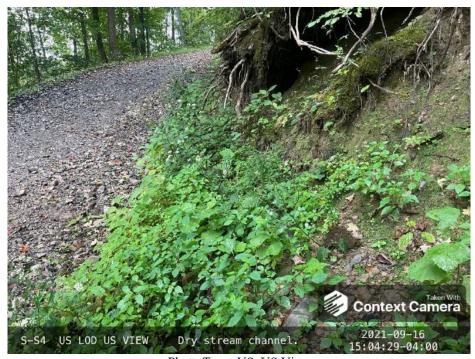
Photo Type: US, US View
Location, Orientation, Photographer Initials: Upstream Edge of ROW, Upstream View, KY/ZS
Lat: 38.664389 Long: -80.484709

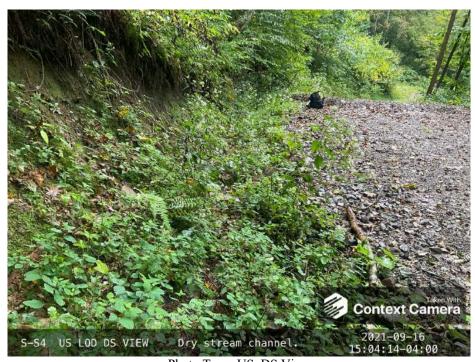
Photo Type: US, DS View Location, Orientation, Photographer Initials: Upstream Edge of ROW, Downstream View, KY/ZS Lat: 38.664389 Long: -80.484709

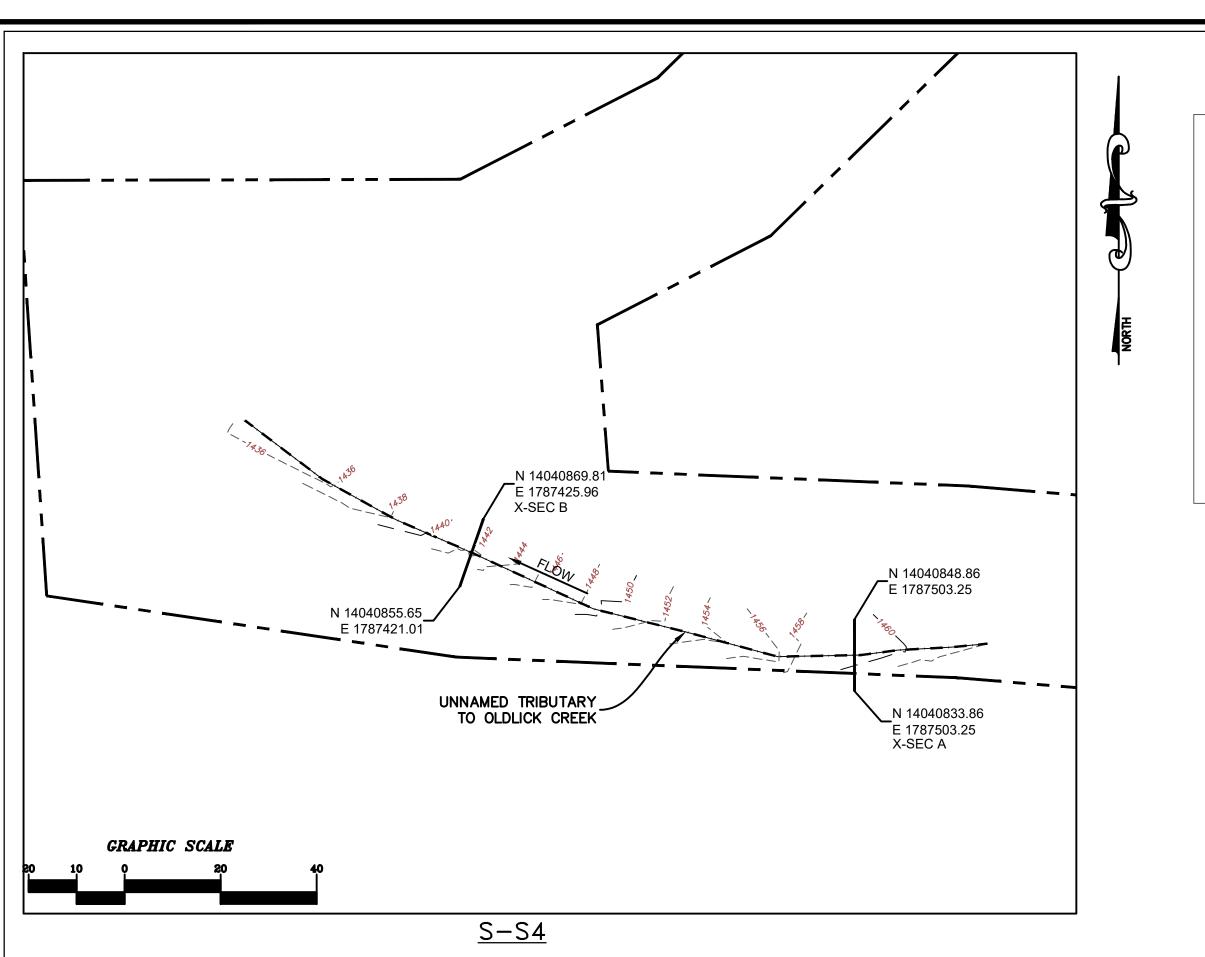
S-S4 BASELINE THALWEG

- 4. ALL SECTION VIEWS SHOWN LEFT TO RIGHT FACING DOWNSTREAM.
- 5. POST-CROSSING SURVEY INFORMATION SHOWN IN RED. DATA PENDING.
- 6. POST-CROSSING SURVEY POINTS FOR CROSS SECTIONS AND THALWEG ARE PROJECTED ONTO PRE-CROSSING SECTION AND PROFILE VIEWS FOR COMPARISON.

NOTE: ALL SECTIONS VIEWS SHOWN LEFT TO RIGHT FACING DOWNSTREAM.

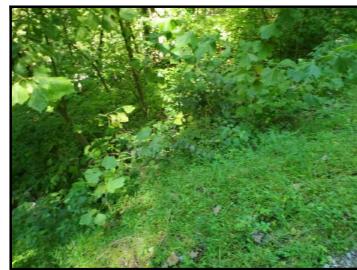
PHOTO TAKEN LOOKING DOWNSTREAM FROM UPSTREAM IMPACT LIMITS

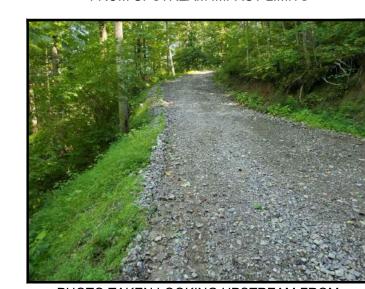
PHOTO TAKEN LOOKING UPSTREAM FROM DOWNSTREAM IMPACT LIMITS
