Baseline Assessment – Stream Attributes

Reach S-ST18 (Permanent Access Road) Intermittent Spread A Wetzel County, West Virginia

title PROFILE AND CROSS-SECTIONS
BASELINE SURVEY
CROSSING S-ST18 - UNNAMED TRIBUTARY
MOBLEY RUN (MP 0.5)
WETZEL COUNTY, WV

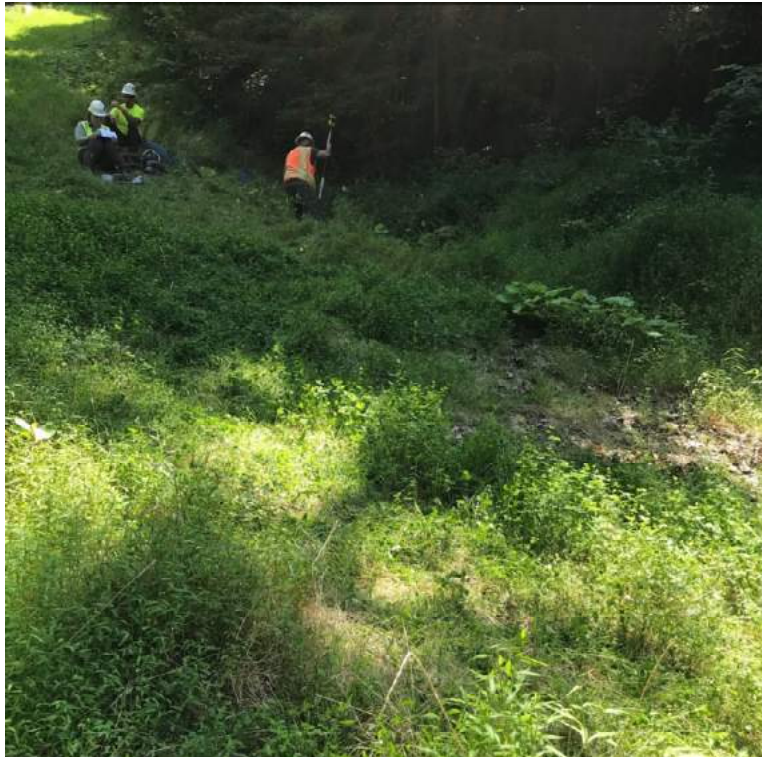
Photo Type: DS, US View

Location, Orientation, Photographer Initials: Downstream Edge of ROW, Upstream View, DD/PL/LC/KP
Latitude, Longitude: 39.561766, -80.540136

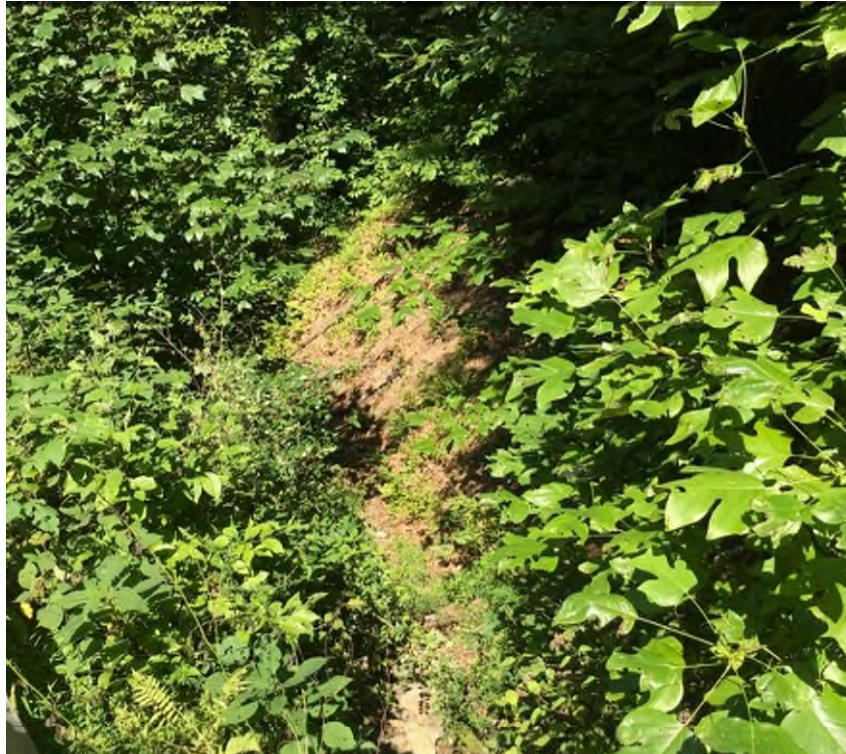
Photo Type: DS, DS View

Location, Orientation, Photographer Initials: Downstream Edge of ROW, Downstream View, DD/PL/LC/KP
Latitude, Longitude: 39.561766, -80.540136

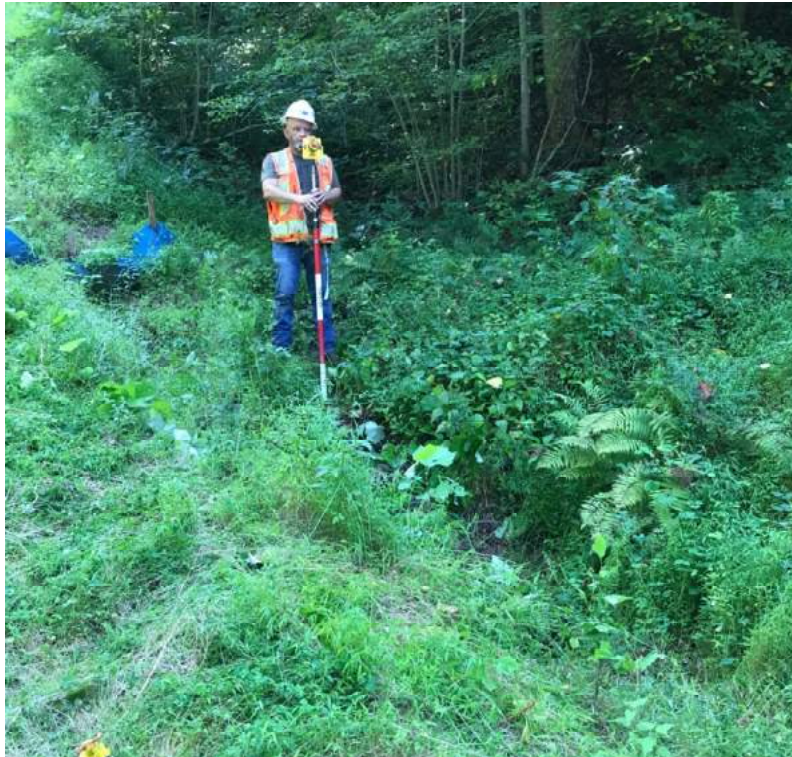
Photo Type: US View at Center

Location, Orientation, Photographer Initials: Center ROW, Upstream View, DD/PL/LC/KP
Latitude, Longitude: 39.561766, -80.540136

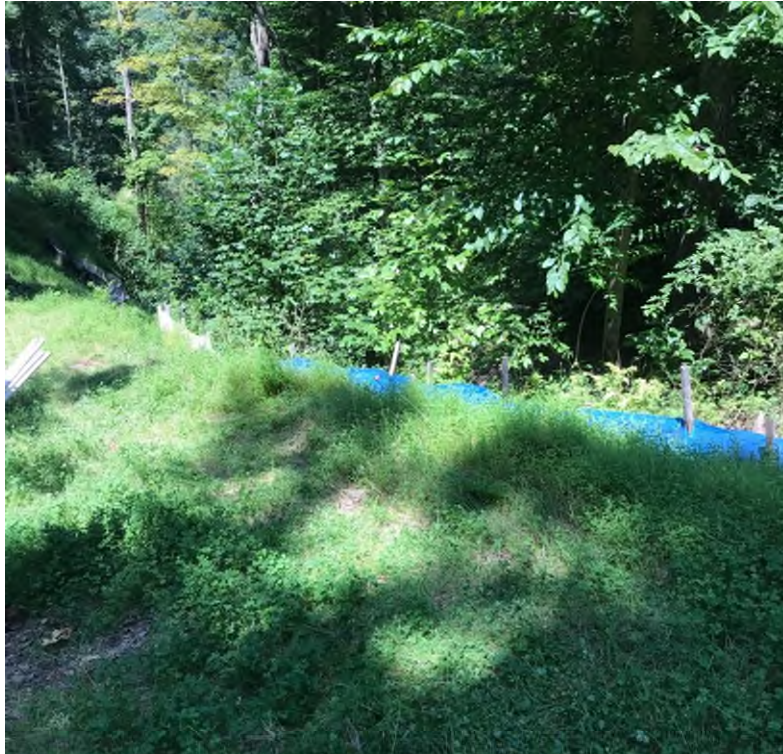
Photo Type: DS View at Center

Location, Orientation, Photographer Initials: ROW Center, Downstream View, DD/PL/LC/KP
Latitude, Longitude: 39.561766, -80.540136

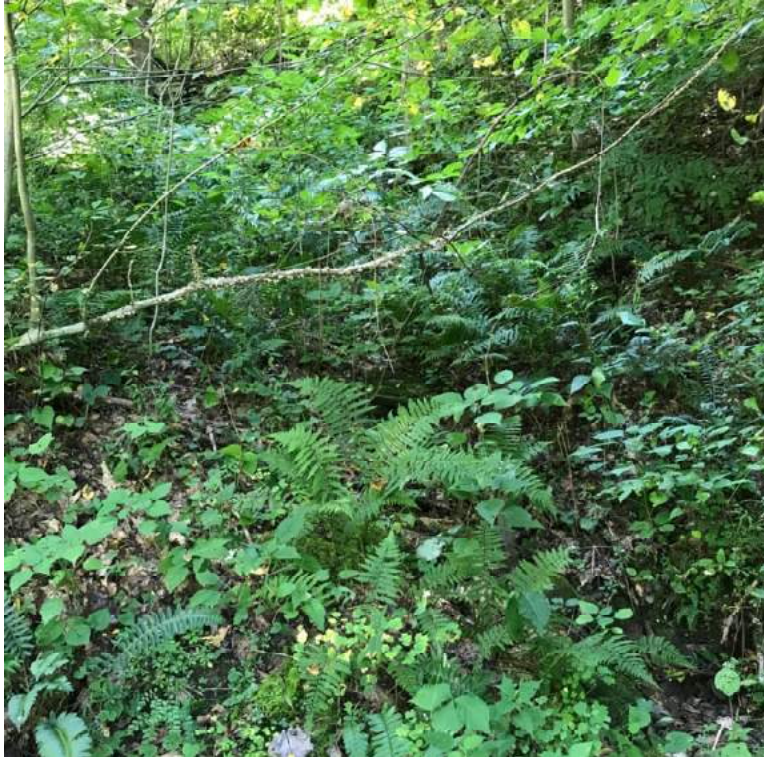
Photo Type: US, US View

Location, Orientation, Photographer Initials: Upstream Edge of ROW, Upstream View, DD/PL/LC/KP
Latitude, Longitude: 39.561766, -80.540136

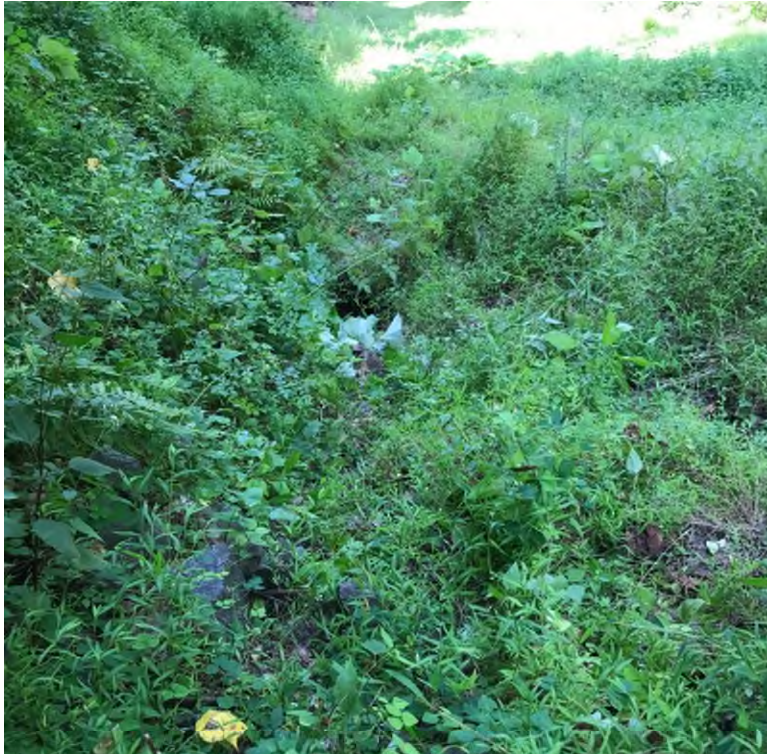
Photo Type: US, DS View

Location, Orientation, Photographer Initials: Upstream Edge of ROW, Downstream View, DD/PL/LC/KP
Latitude, Longitude: 39.561766, -80.540136
