Baseline Assessment – Stream Attributes

Reach S-VV16 (1) (Temporary Access Road) Ephemeral Spread B Lewis County, West Virginia

Spread B Stream S-VV16 (1) (Temporary Access Road) Lewis County

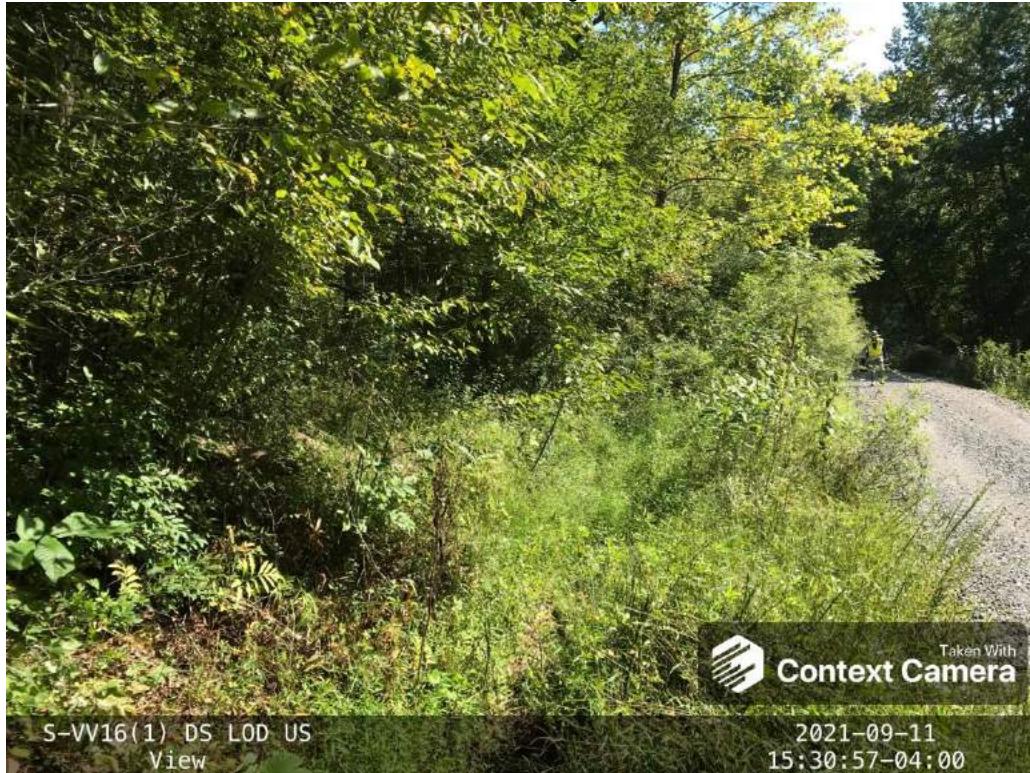
Photo Type: DS, US View

Location, Orientation, Photographer Initials: Downstream Edge of ROW, Upstream View, AJE/MAG
Lat: 38.896271 Long: -80.566551

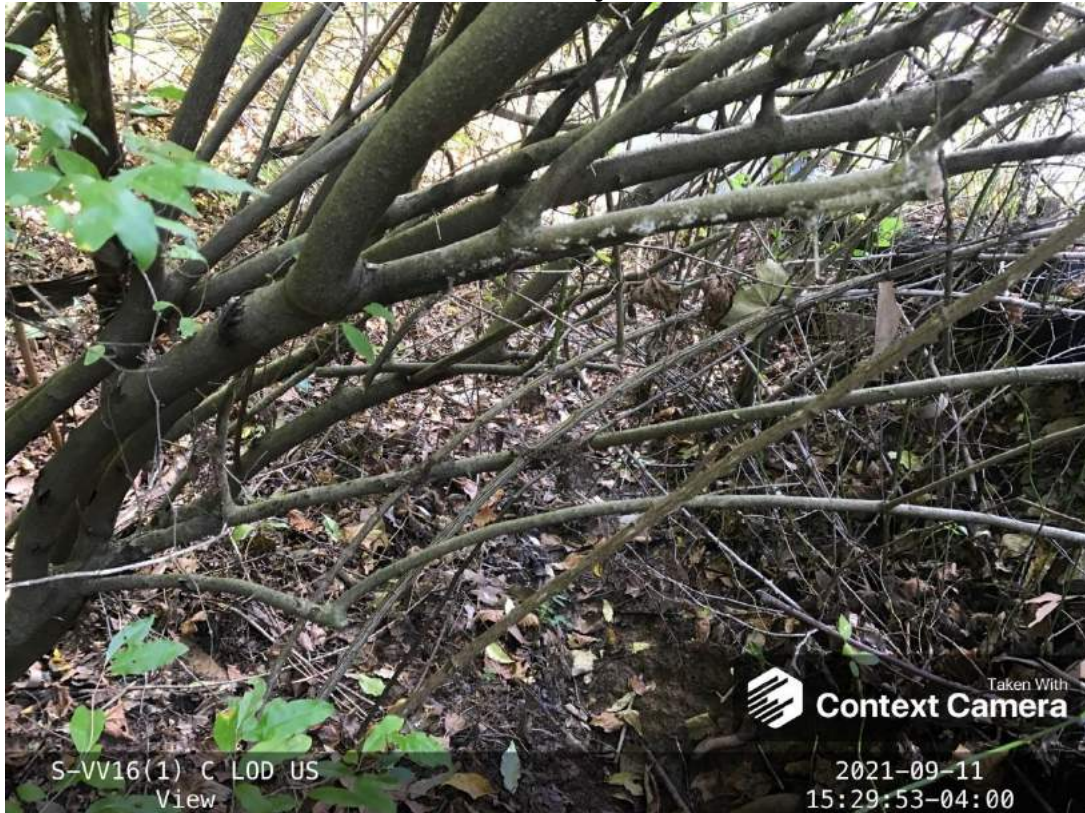
Photo Type: US View at Center
Location, Orientation, Photographer Initials: Center ROW, Upstream View, AJE/MAG
Lat: 38.896271 Long: -80.566551

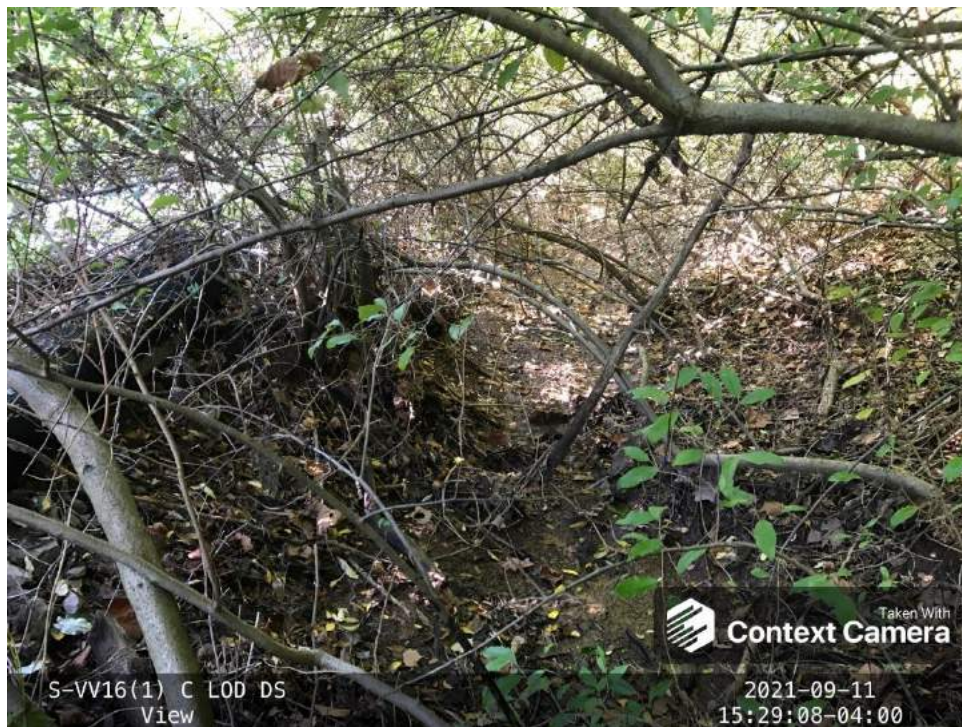
Photo Type: DS View at Center
Location, Orientation, Photographer Initials: ROW Center, Downstream View, AJE/MAG
Lat: 38.896271 Long: -80.566551

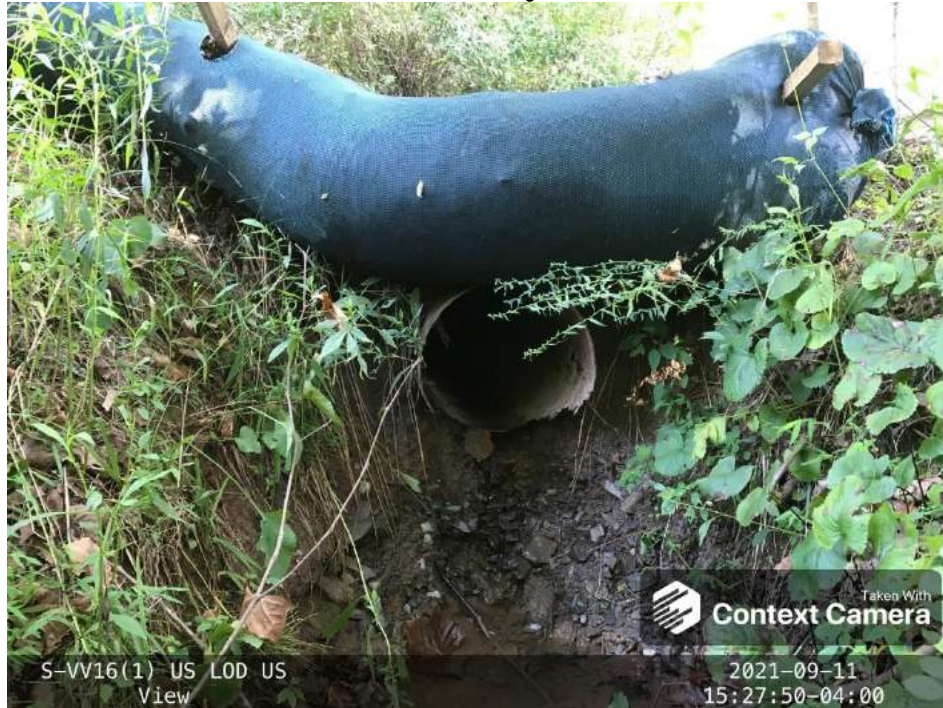
Photo Type: US, US View

Location, Orientation, Photographer Initials: Upstream Edge of ROW, Upstream View, AJE/MAG
Lat: 38.896271 Long: -80.566551

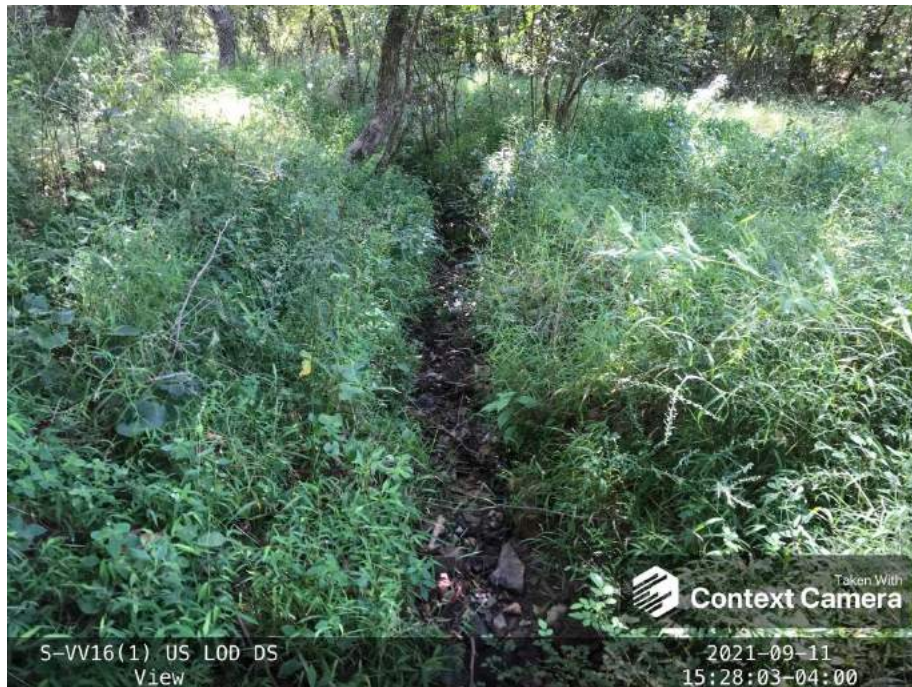
Photo Type: US, DS View

Location, Orientation, Photographer Initials: Upstream Edge of ROW, Downstream View, AJE/MAG
Lat: 38.896271 Long: -80.566551
