Baseline Assessment – Stream Attributes

Reach S-EF62 (Pipeline ROW) Perennial Spread G Montgomery County, Virginia

Stream S-EF62 (ROW) Montgomery County

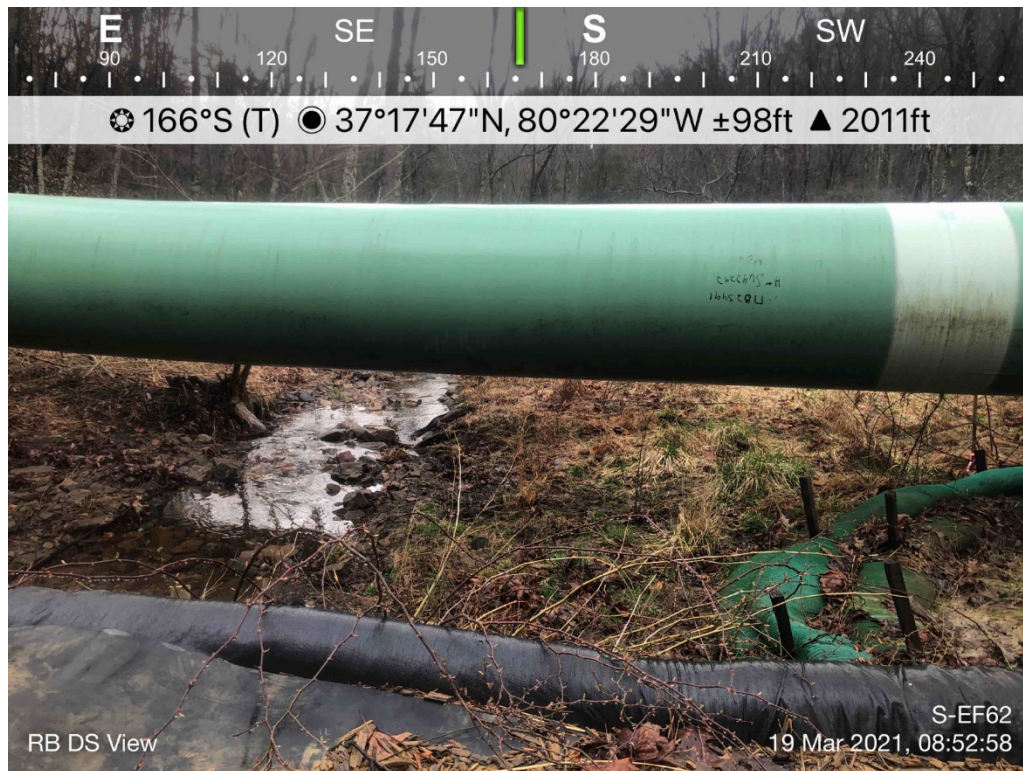
Photo Type: RB DS VIEW

Location, Orientation, Photographer Initials: Standing on RB looking downstream along the ROW looking S, KB

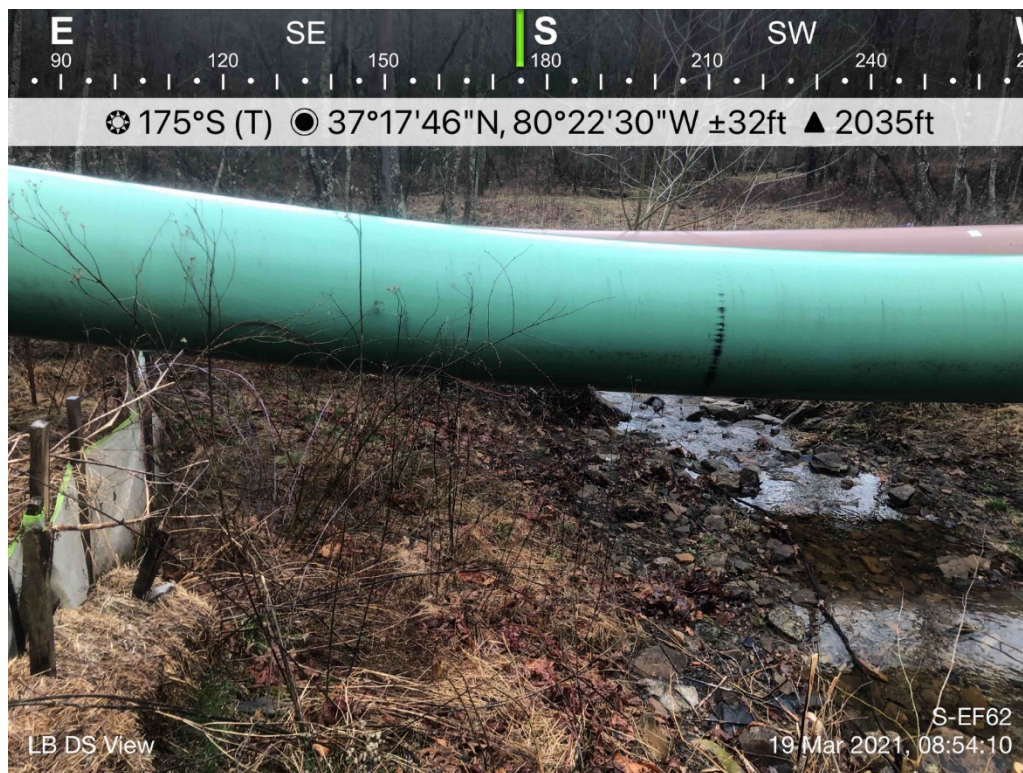
Photo Type: LB DS VIEW

Location, Orientation, Photographer Initials: Standing on LB looking downstream along the ROW looking S, KB

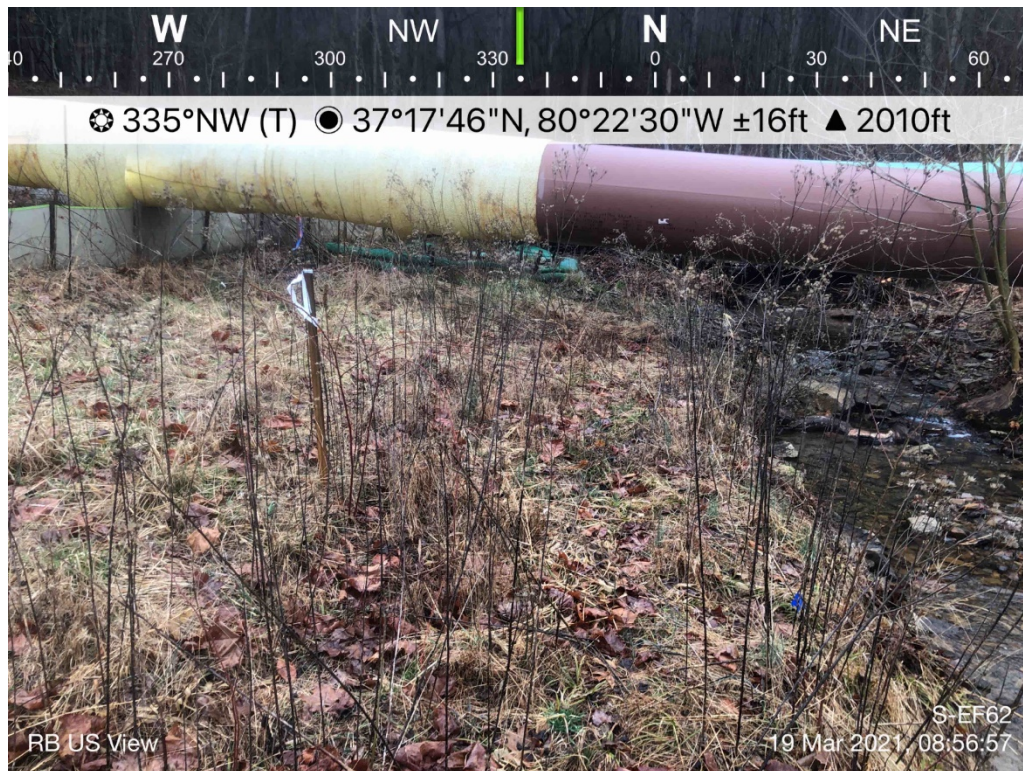
Photo Type: RB US VIEW

Location, Orientation, Photographer Initials: Standing on RB looking upstream along the ROW looking NW, KB

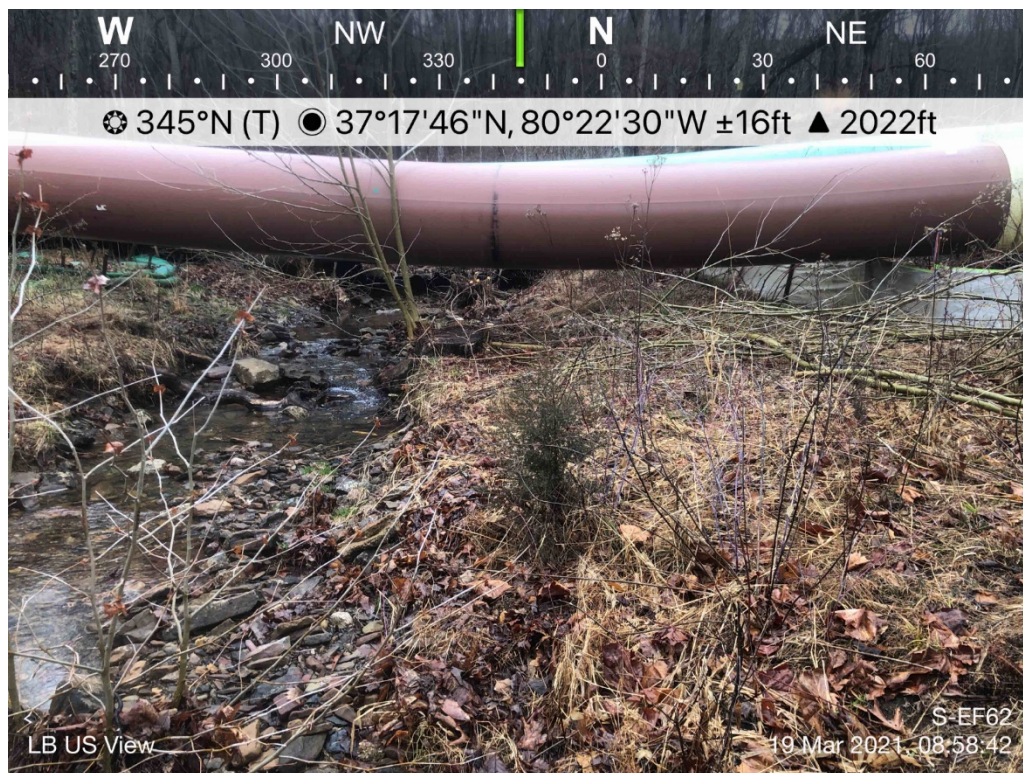
Photo Type: LB US VIEW

Location, Orientation, Photographer Initials: Standing on LB looking upstream along the ROW looking N, KB

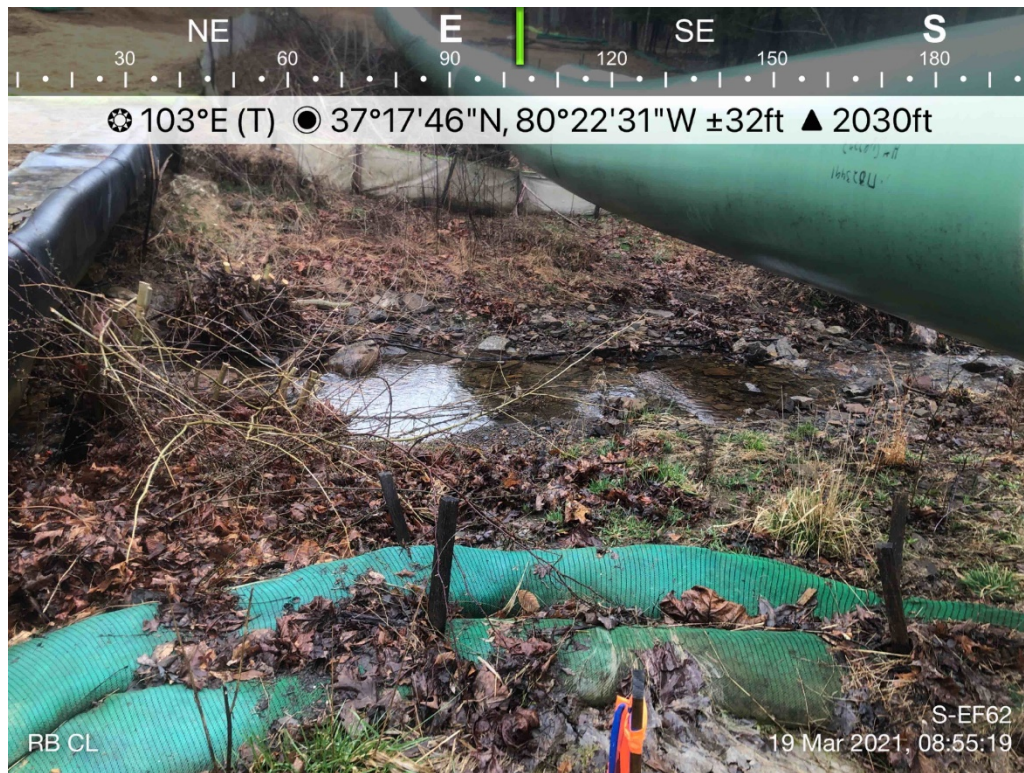
Photo Type: RB CL

Location, Orientation, Photographer Initials: Standing on RB looking at LB along pipe centerline looking E, KB

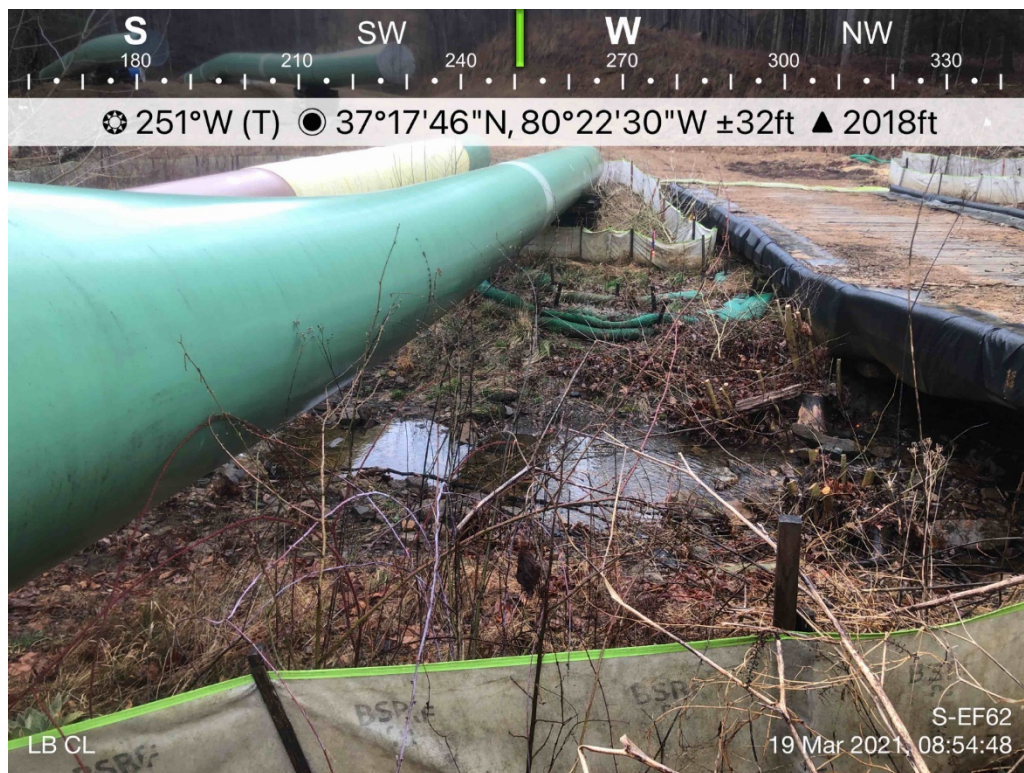
Photo Type: LB CL

Location, Orientation, Photographer Initials: Standing on LB looking at RB along pipe centerline looking W, KB

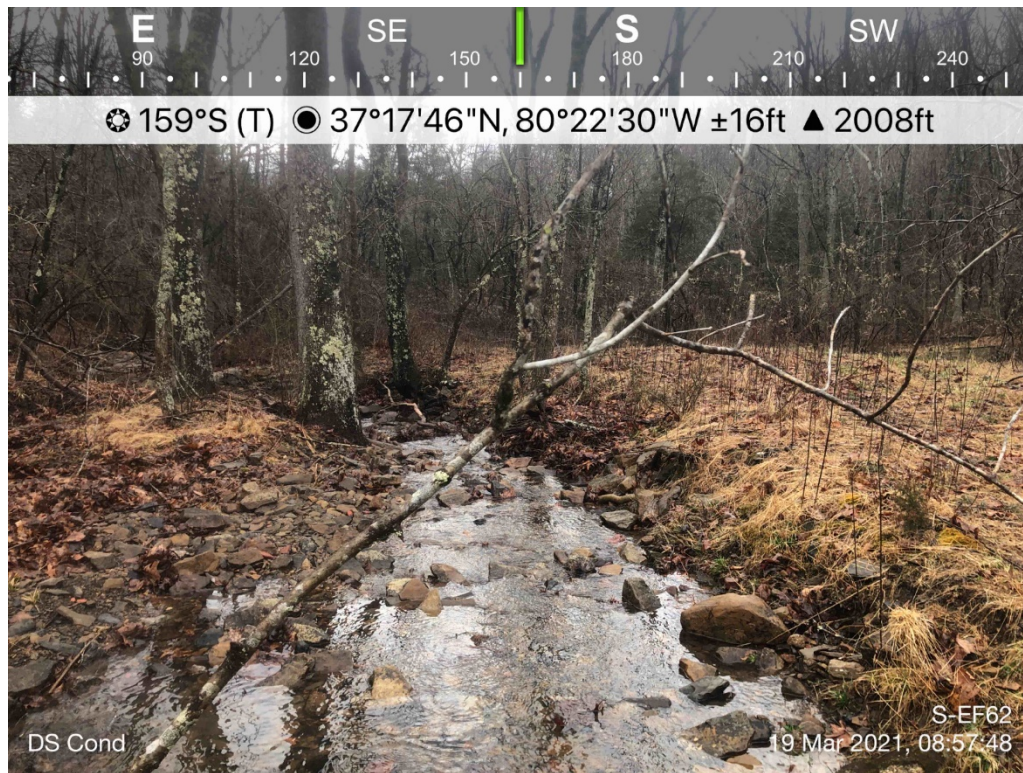
Photo Type: DS COND

Location, Orientation, Photographer Initials: Downstream conditions outside of ROW looking S, KB

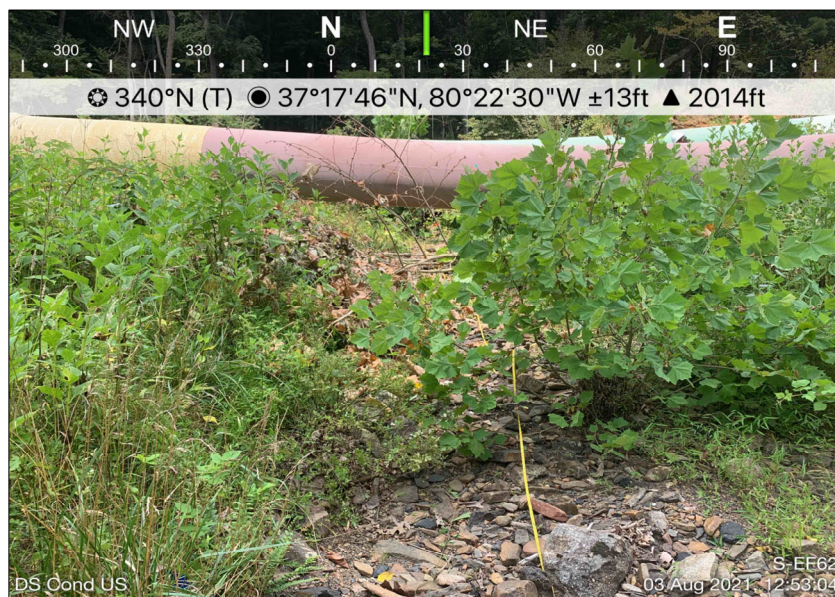
Looking upstream within ROW. Assessment is limited to areas within the temporary ROW.
