# Reach S-IJ18-EPH (Pipeline ROW) Ephemeral Spread G Giles County, Virginia

## Stream S-IJ18-EPH (ROW)

## **DEQ Permit #21-0416**

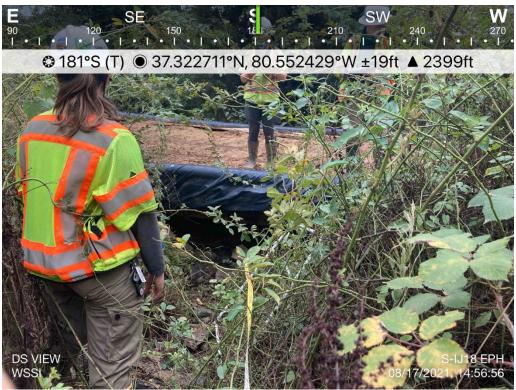
Photo Type: DS VIEW Location, Orientation, Photographer Initials: Downstream view of ROW looking S, AW

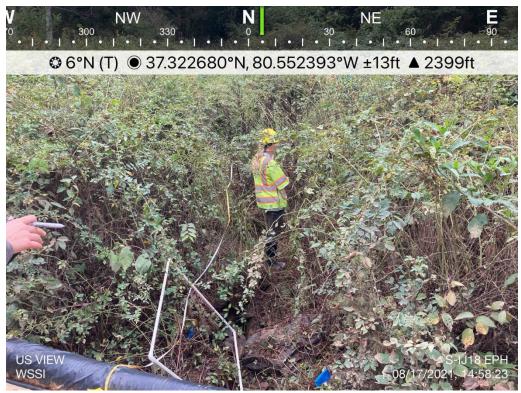
Photo Type: US VIEW Location, Orientation, Photographer Initials: Upstream view of ROW looking NE, ES

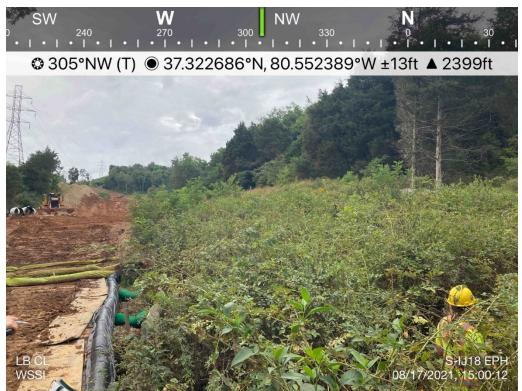
Photo Type: LB CL Location, Orientation, Photographer Initials: Standing on LB looking at RB along pipe centerline looking W, ES

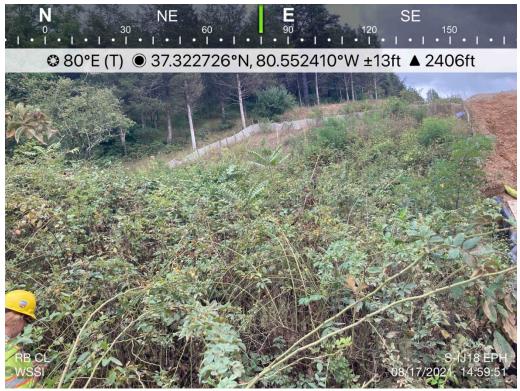
Photo Type: RB CL Location, Orientation, Photographer Initials: Standing on RB looking at LB along pipe centerline looking E, ES

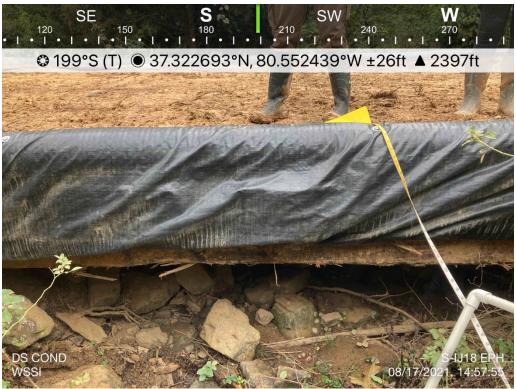
Photo Type: DS COND Location, Orientation, Photographer Initials: Downstream conditions outside of ROW looking SW, ES

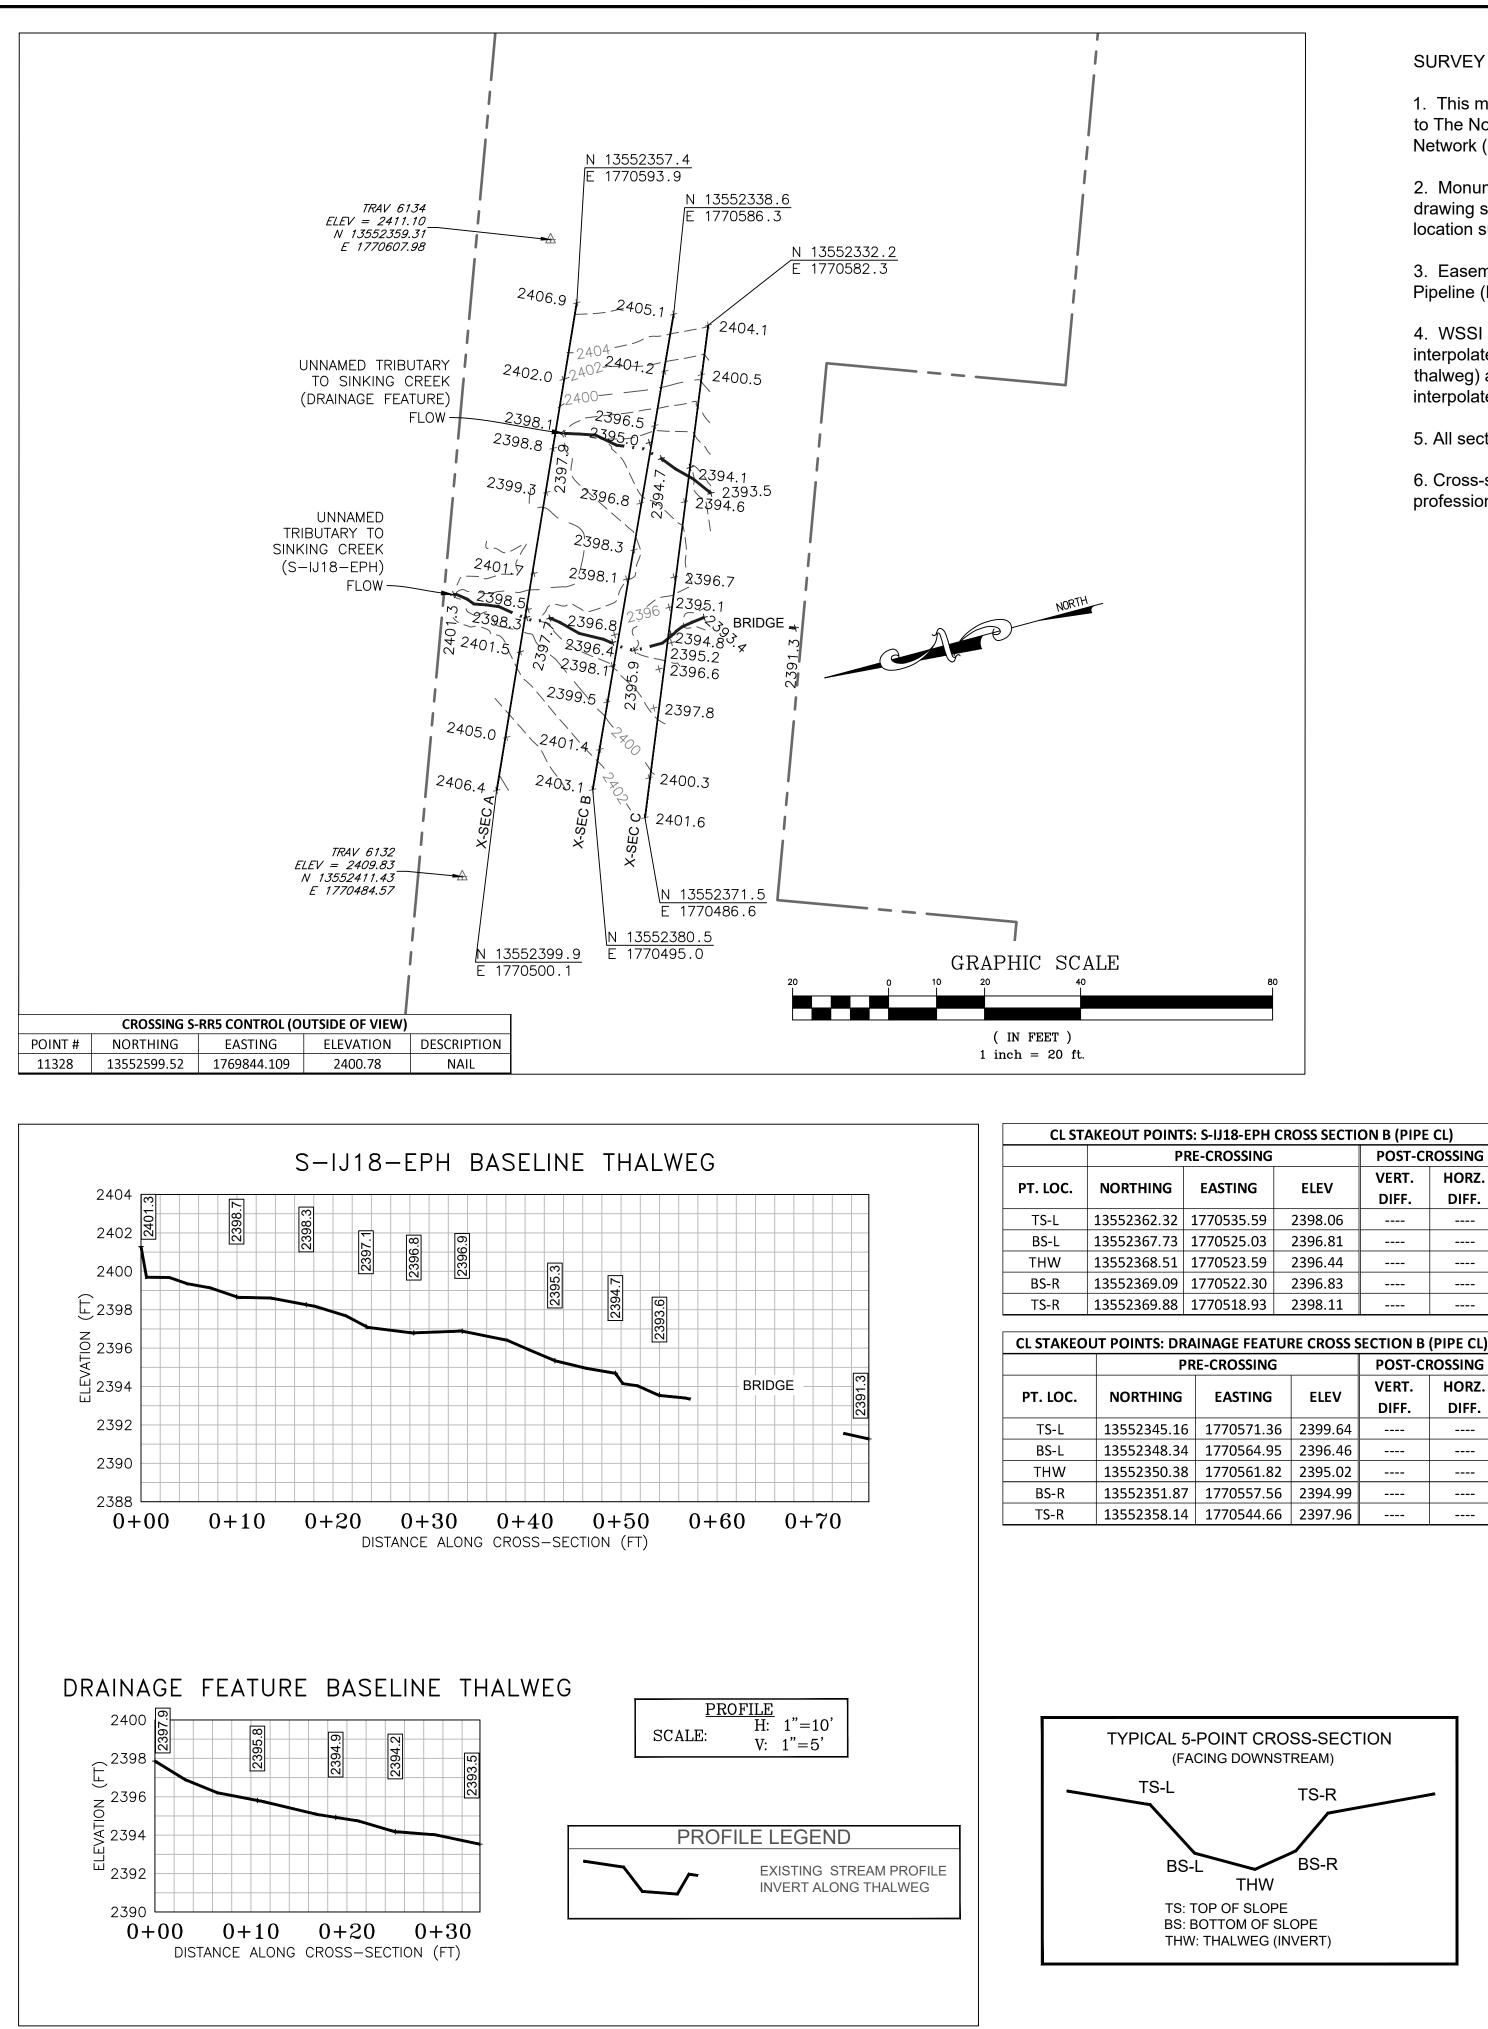
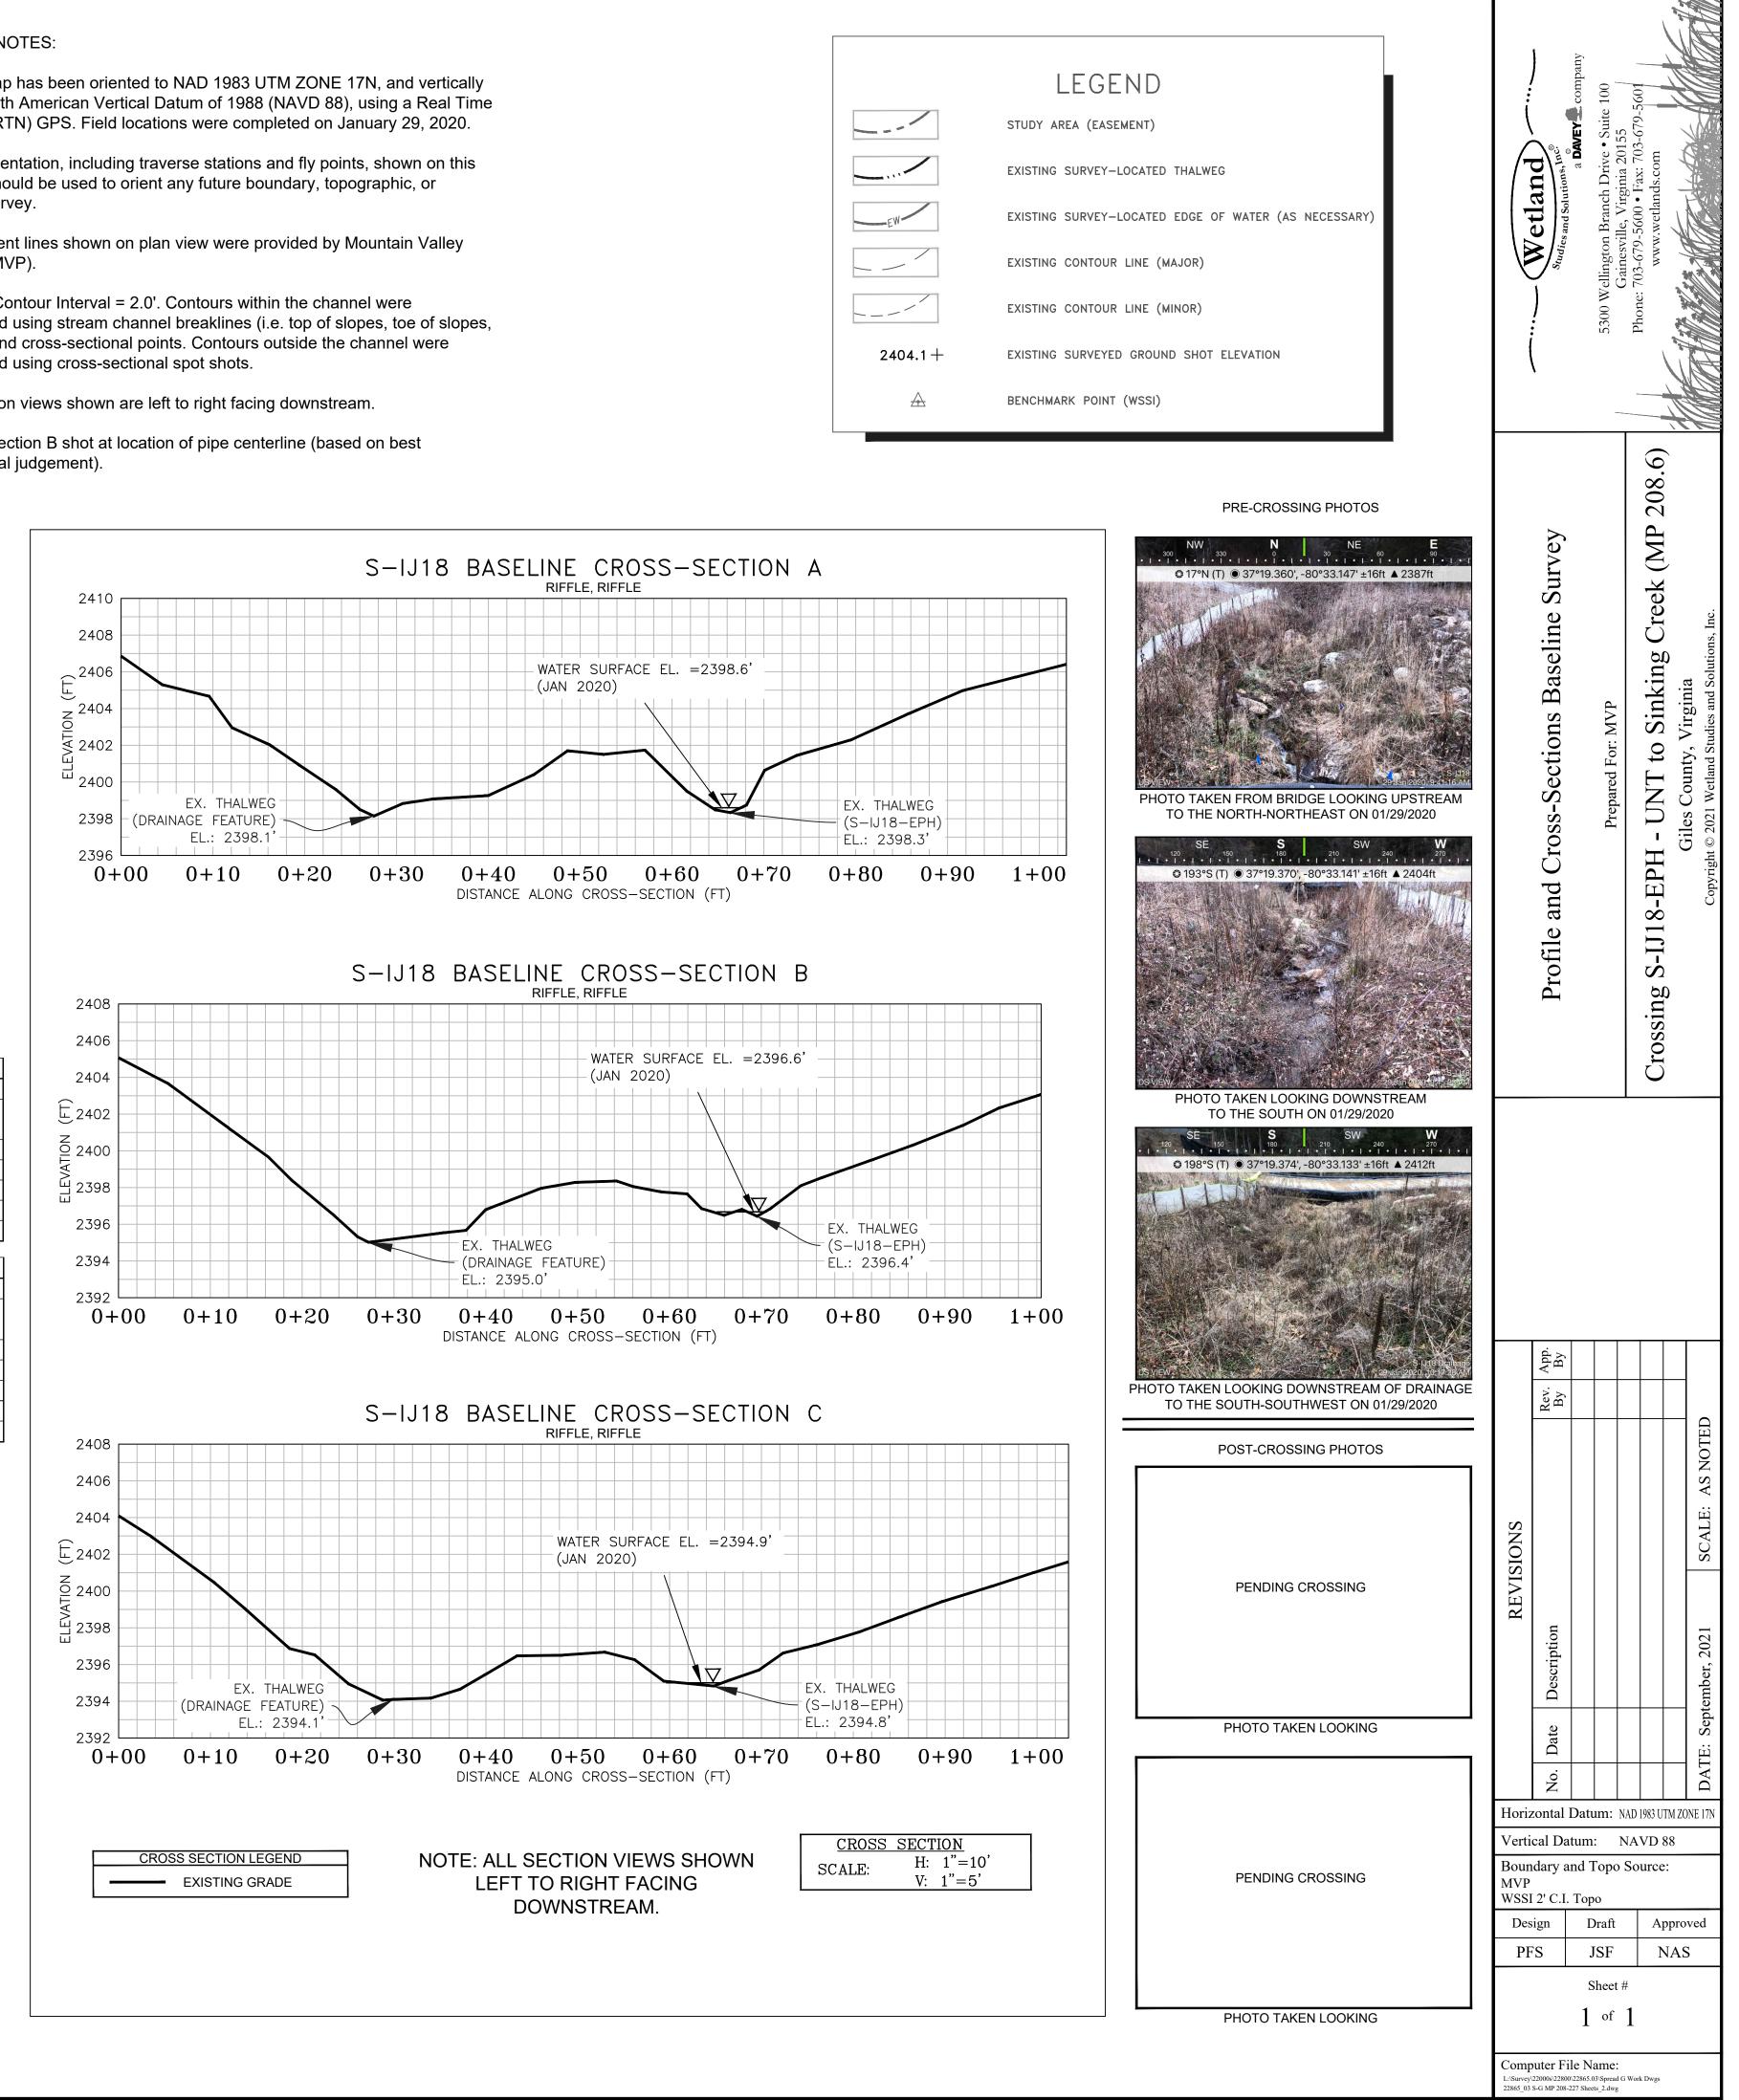
4. WSSI Contour Interval = 2.0'. Contours within the channel were interpolated using stream channel breaklines (i.e. top of slopes, toe of slopes, thalweg) and cross-sectional points. Contours outside the channel were interpolated using cross-sectional spot shots.

5. All section views shown are left to right facing downstream.

6. Cross-section B shot at location of pipe centerline (based on best professional judgement).

EOUT POINTS: S-IJ18-EPH CROSS SECTION B (PIPE CL)									
Р	<b>RE-CROSSING</b>	POST-CROSSING							
	FACTING	VERT.	HORZ.						
NORTHING	EASTING	ELEV	DIFF.	DIFF.					
3552362.32	1770535.59	2398.06							
3552367.73	1770525.03	2396.81							
3552368.51	1770523.59	2396.44							
3552369.09	1770522.30	2396.83

POINTS: DRAINAGE FEATURE CROSS SECTION B (PIPE CL)										
PR	E-CROSSING	POST-CROSSING								
NORTHING	EASTING	ELEV	VERT.	HORZ.						
NORTHING	EASTING	ELEV	DIFF.	DIFF.						
13552345.16	1770571.36	2399.64								
13552348.34	1770564.95	2396.46								
13552350.38	1770561.82	2395.02								
13552351.87	1770557.56	2394.99								
13552358.14	1770544.66	2397.96
