Baseline Assessment – Stream Attributes

Reach S-NN12 (Pipeline ROW)

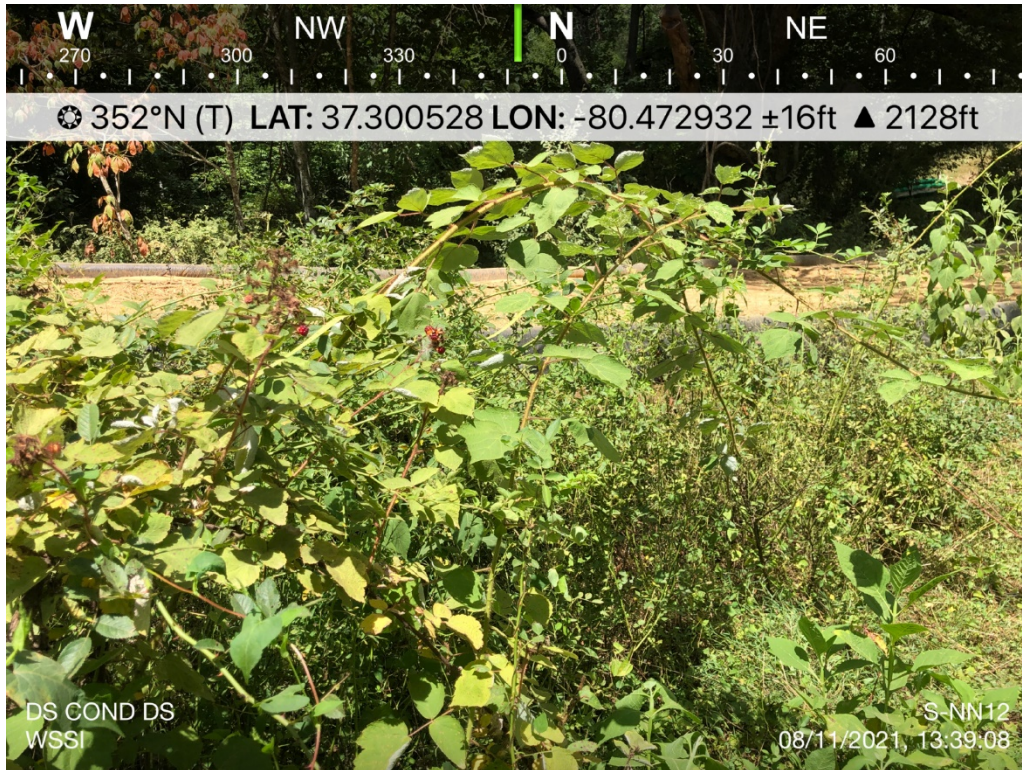
Location, Orientation, Photographer Initials: Standing on RB looking at LB along pipe centerline looking W, AO
