Baseline Assessment - Stream Attributes

Reach S-D14 (ROW) Intermittent Spread H Franklin County, Virginia

Profile and Cross-Sections Baseline Survey

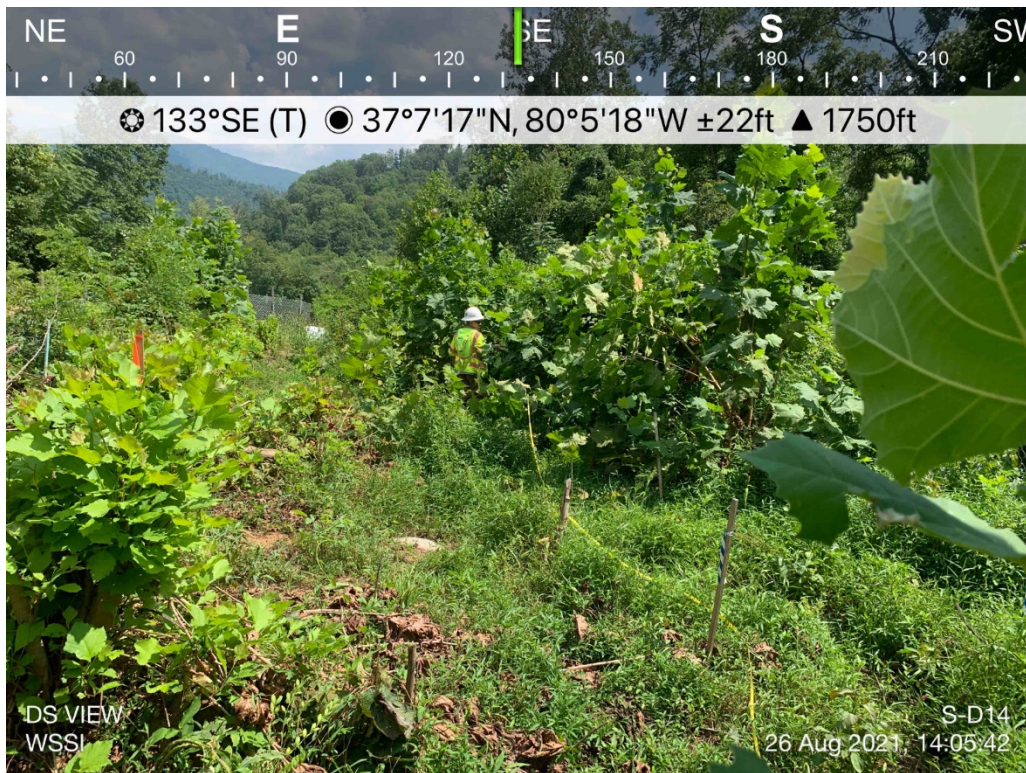
Photo Type: DS VIEW

Location, Orientation, Photographer Initials: Downstream view of ROW looking SE, JB

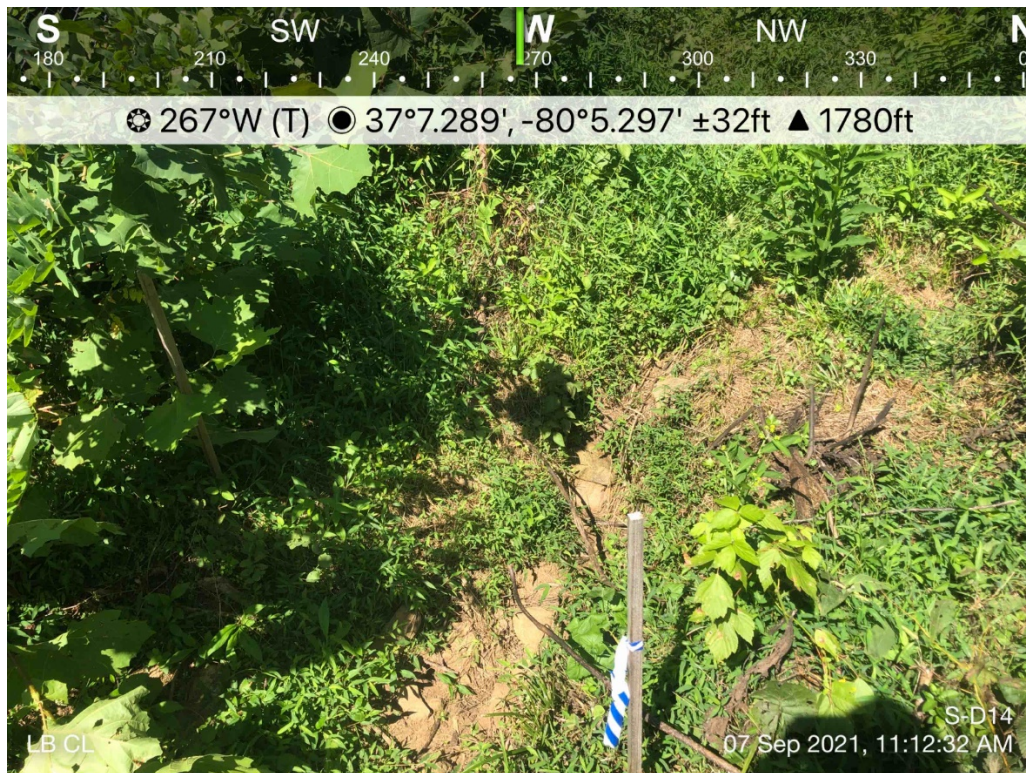
Photo Type: LB CL

Location, Orientation, Photographer Initials: Standing on LB looking at RB along pipe centerline looking SW, AW

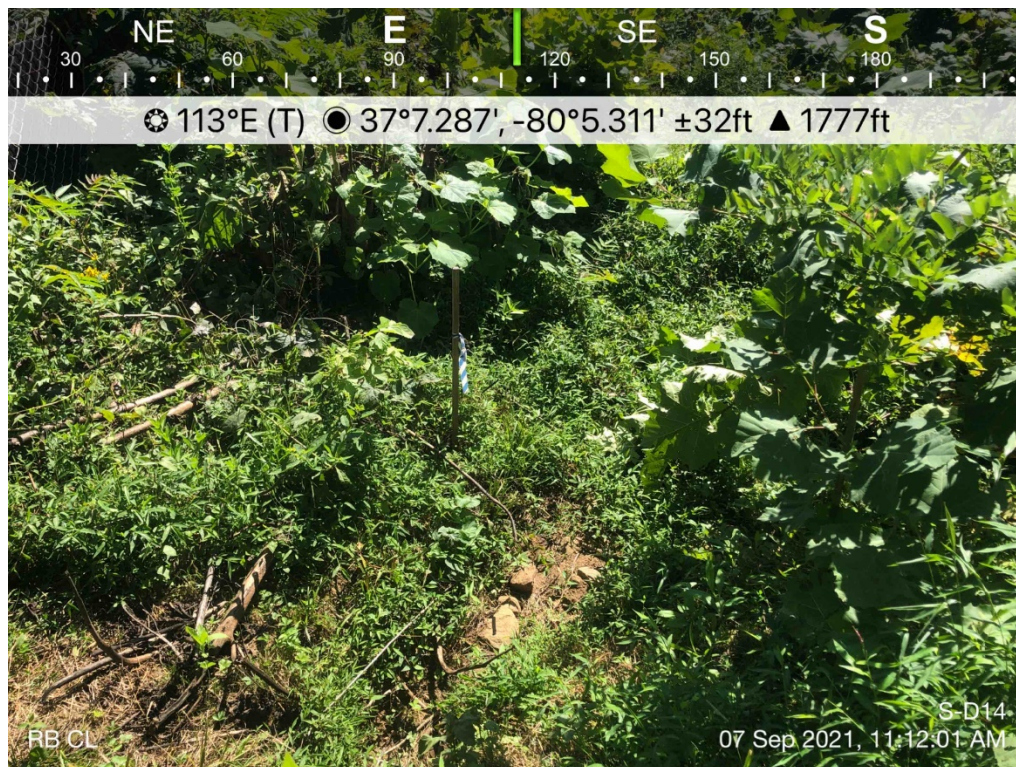
Photo Type: RB CL

Location, Orientation, Photographer Initials: Standing on RB looking at LB along pipe centerline looking NE, JB

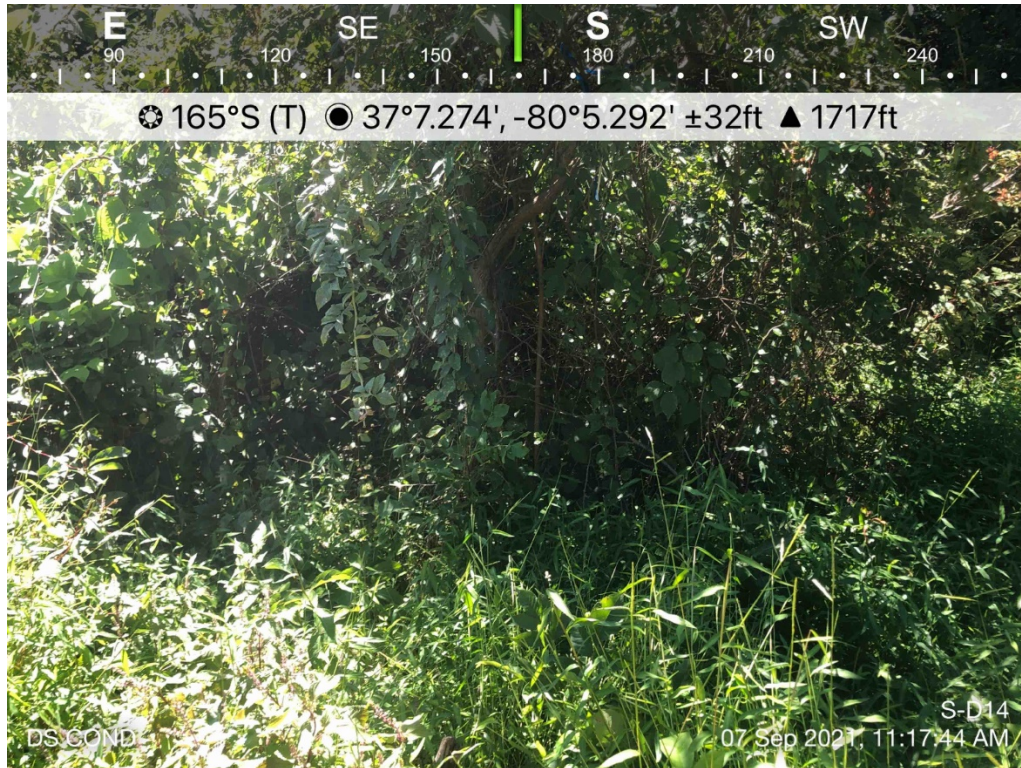
Photo Type: DS COND

Location, Orientation, Photographer Initials: Downstream conditions outside of ROW looking SE, AE

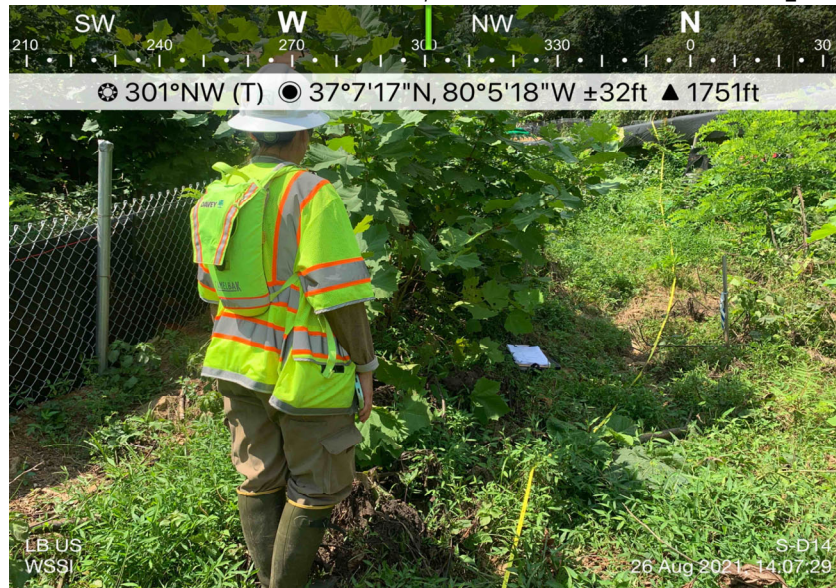
Reach S-D14 looking upstream within ROW; stream previously relocated on 6/21/21 per NWP NAO-2015-00898. Assessment is limited to areas within the temporary ROW.
