Baseline Assessment - Stream Attributes

Reach S-D8 (Pipeline ROW)

Spread H

Franklin County, Virginia

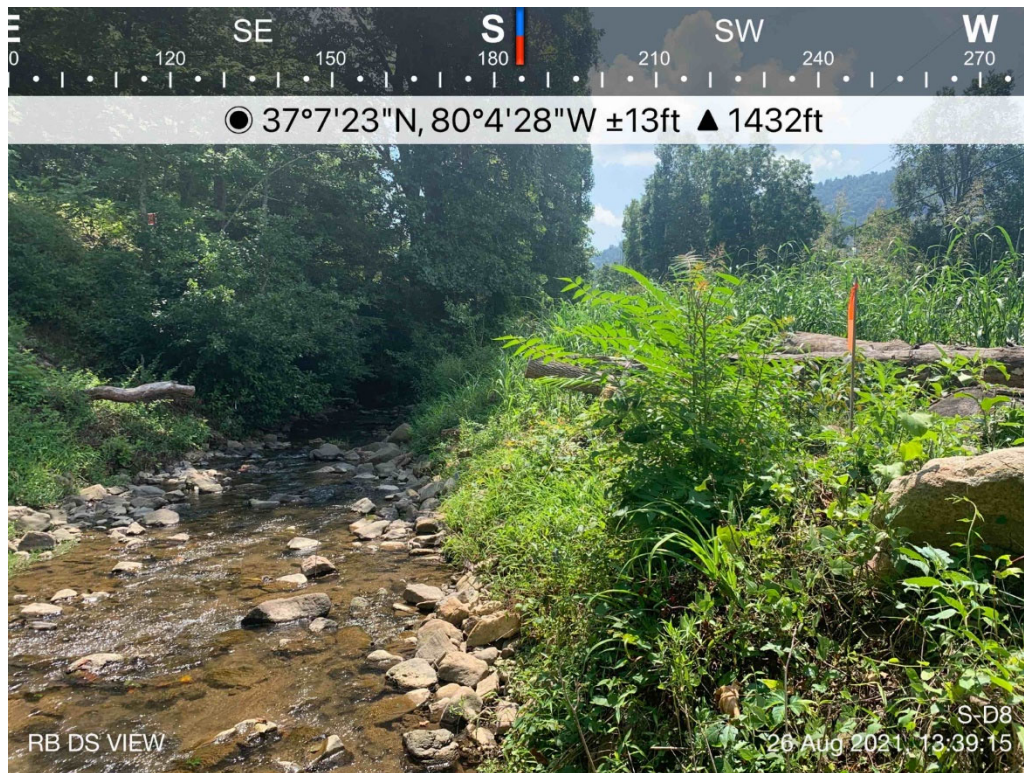
Photo Type: RB DS VIEW

Location, Orientation, Photographer Initials: Standing on RB looking downstream along the ROW looking S, SB

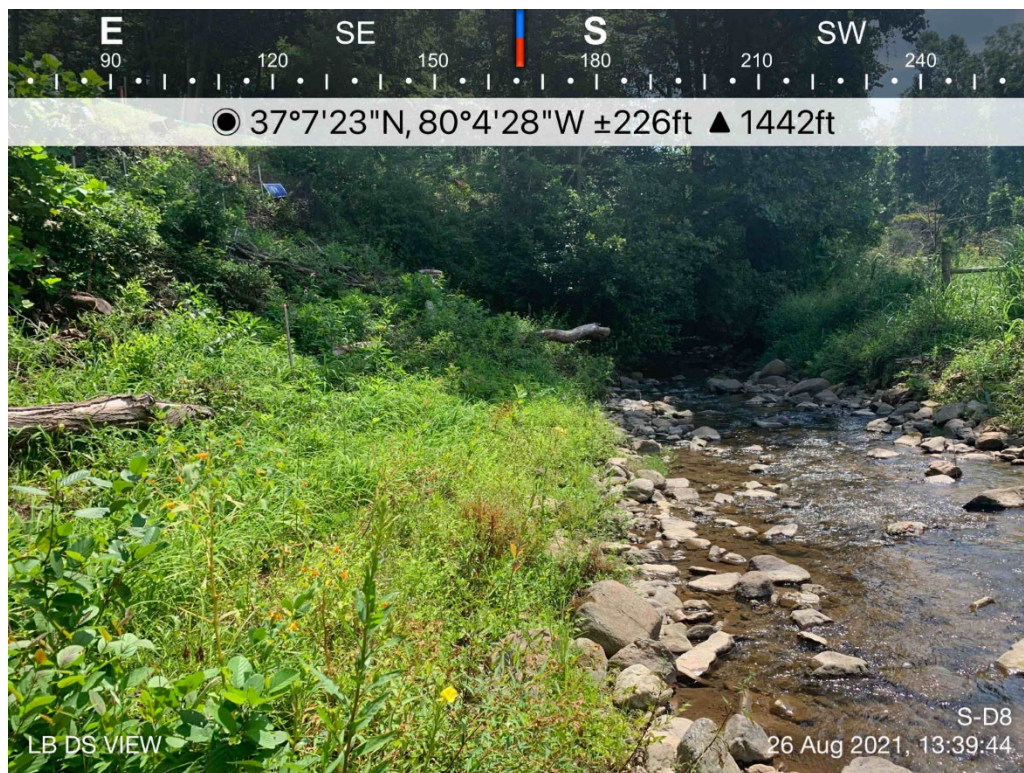
Photo Type: LB DS VIEW

Location, Orientation, Photographer Initials: Standing on LB looking downstream along the ROW looking S, SB

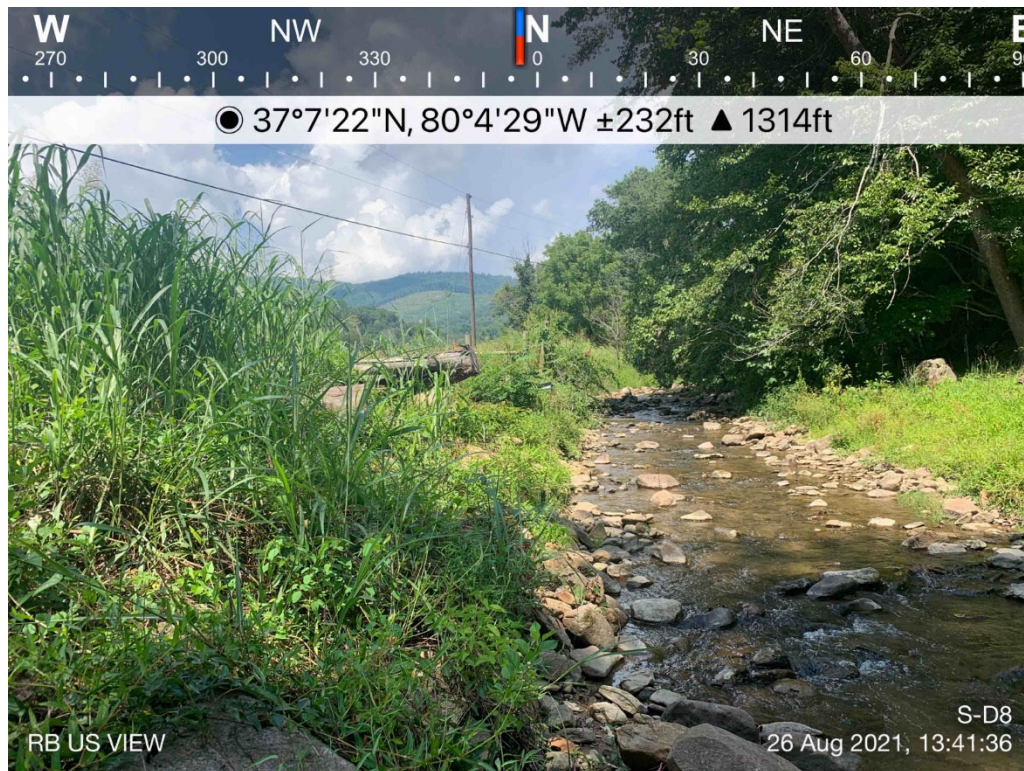
Photo Type: RB US VIEW

Location, Orientation, Photographer Initials: Standing on RB looking upstream along the ROW looking N, SB

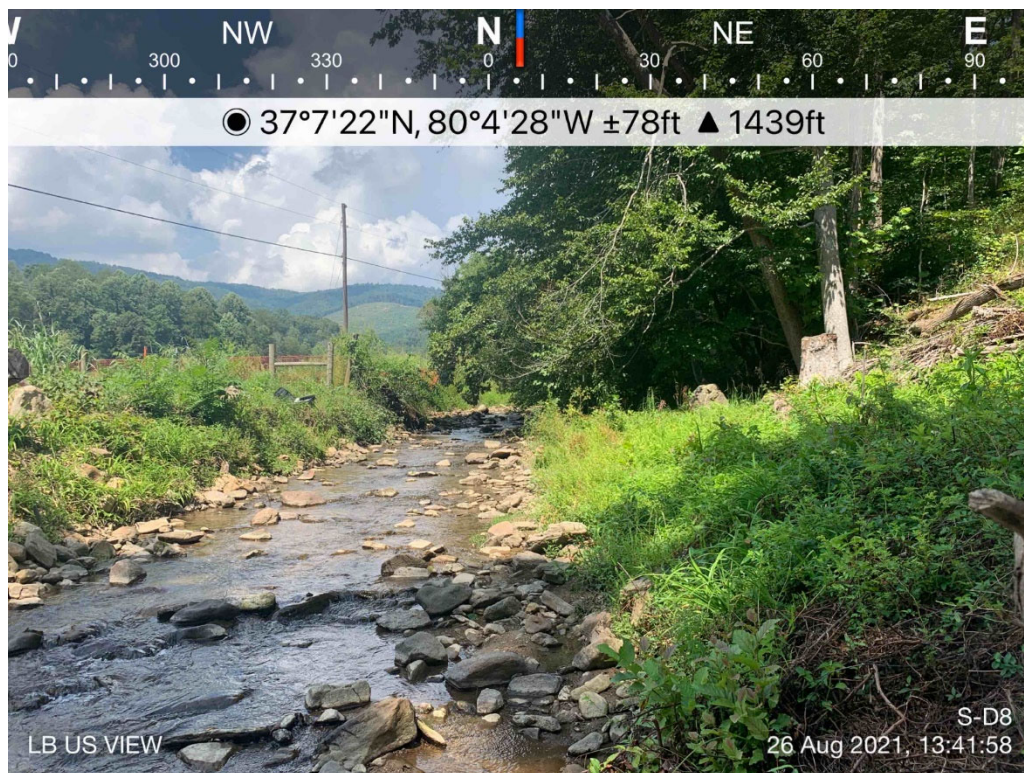
Photo Type: LB US VIEW

Location, Orientation, Photographer Initials: Standing on LB looking upstream along the ROW looking N, SB

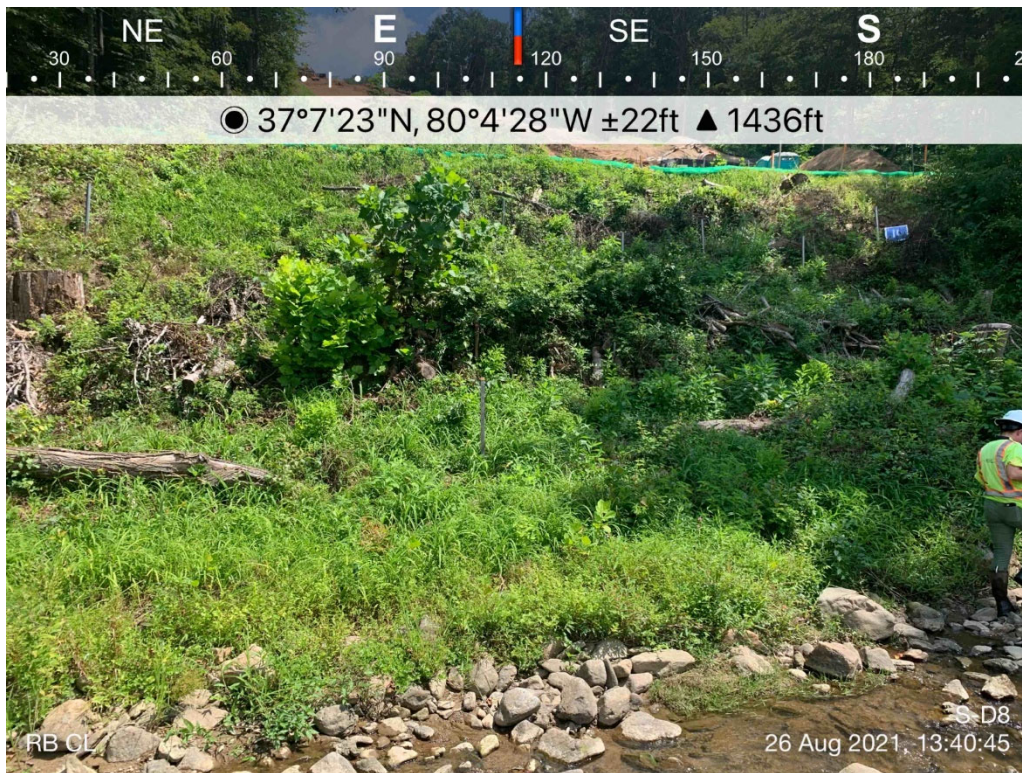
Photo Type: RB CL

Location, Orientation, Photographer Initials: Standing on RB looking at LB along pipe centerline looking E, SB

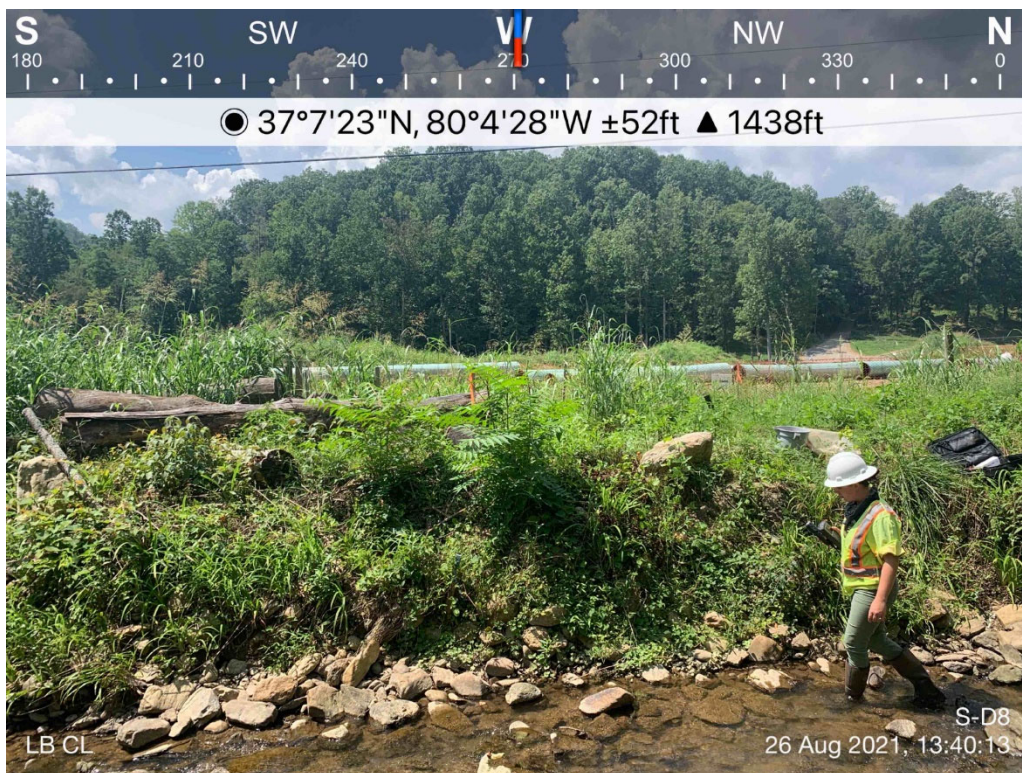
Photo Type: LB CL

Location, Orientation, Photographer Initials: Standing on LB looking at RB along pipe centerline looking W, SB

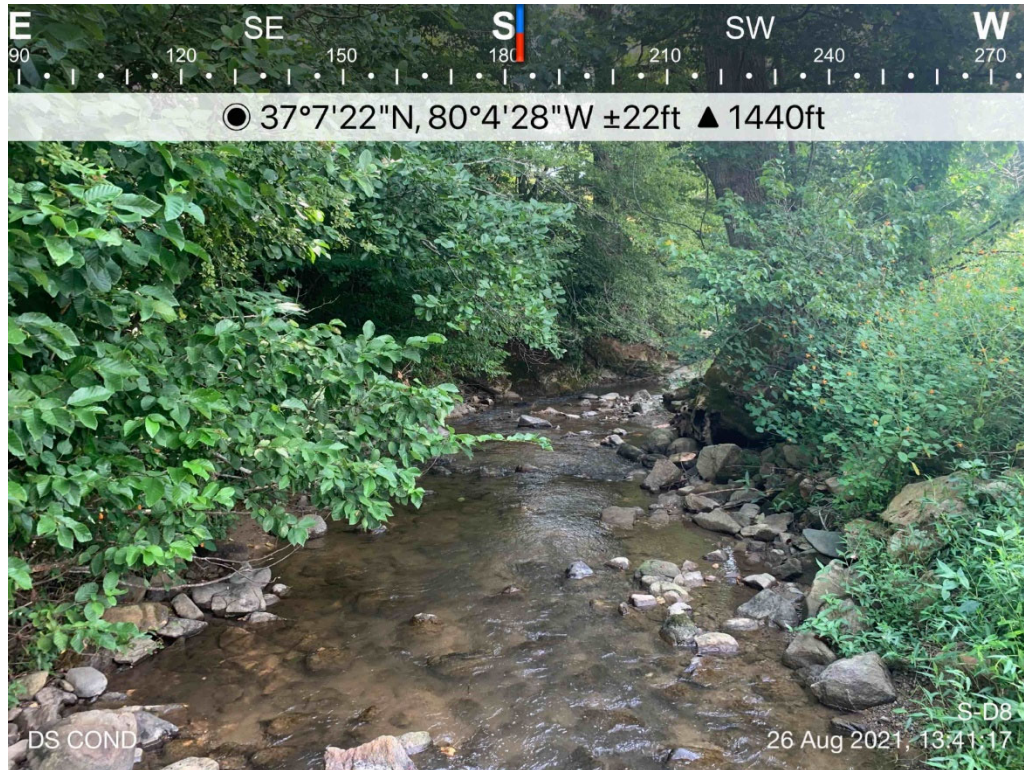
Photo Type: DS COND

Location, Orientation, Photographer Initials: Downstream conditions outside of ROW looking S, SB

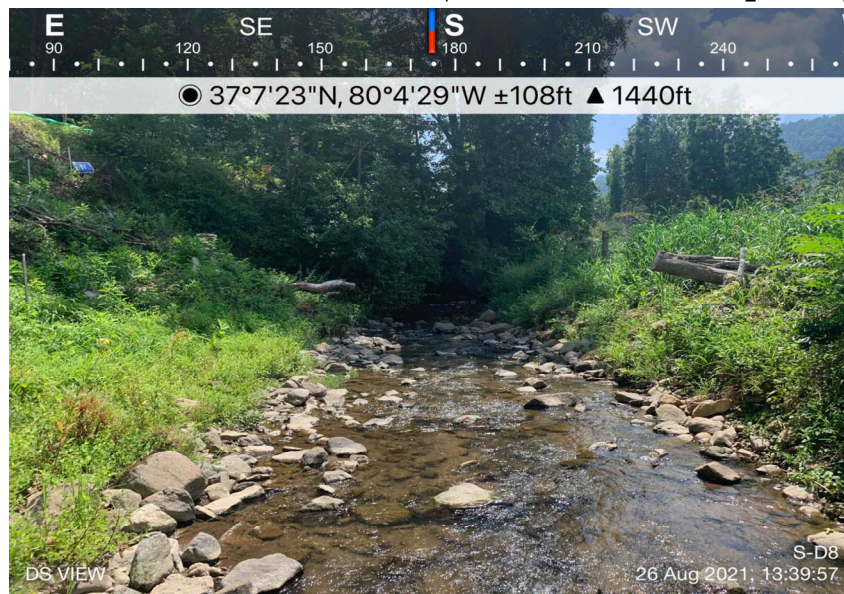
Downstream view facing S within ROW. Assessment is limited to areas within the temporary ROW.
