Baseline Assessment – Stream Attributes

Reach S-EF33 (Pipeline ROW)

Roanoke County, Virginia

USACE FILE NO./ Project Name: <small>(V2.1, Sept 2015)</small>		Mountain Valley Pipeline		IMPACT COORDINATES: (in Decimal Degrees)		Lat.	37.179186	Lon.	-80.141	WEATHER:		Sunny	DATE:		September 7, 2021		
IMPACT STREAM/SITE ID AND SITE DESCRIPTION: <small>(watershed size (acres), unaltered or impaired)</small>				S-EF33		MITIGATION STREAM CLASS/SITE ID AND SITE DESCRIPTION: <small>(watershed size (acres), unaltered or impaired)</small>						Comments:					
STREAM IMPACT LENGTH:		148	FORM OF MITIGATION:		RESTORATION (Levels I-III)		MIT COORDINATES: (in Decimal Degrees)		Lat.		Lon.		PRECIPITATION PAST 48 HRS:		0.05"	Mitigation Length:	
Column No. 1- Impact Existing Condition (Debit)			Column No. 2- Mitigation Existing Condition - Baseline (Credit)			Column No. 3- Mitigation Projected at Five Years Post Completion (Credit)			Column No. 4- Mitigation Projected at Ten Years Post Completion (Credit)			Column No. 5- Mitigation Projected at Maturity (Credit)

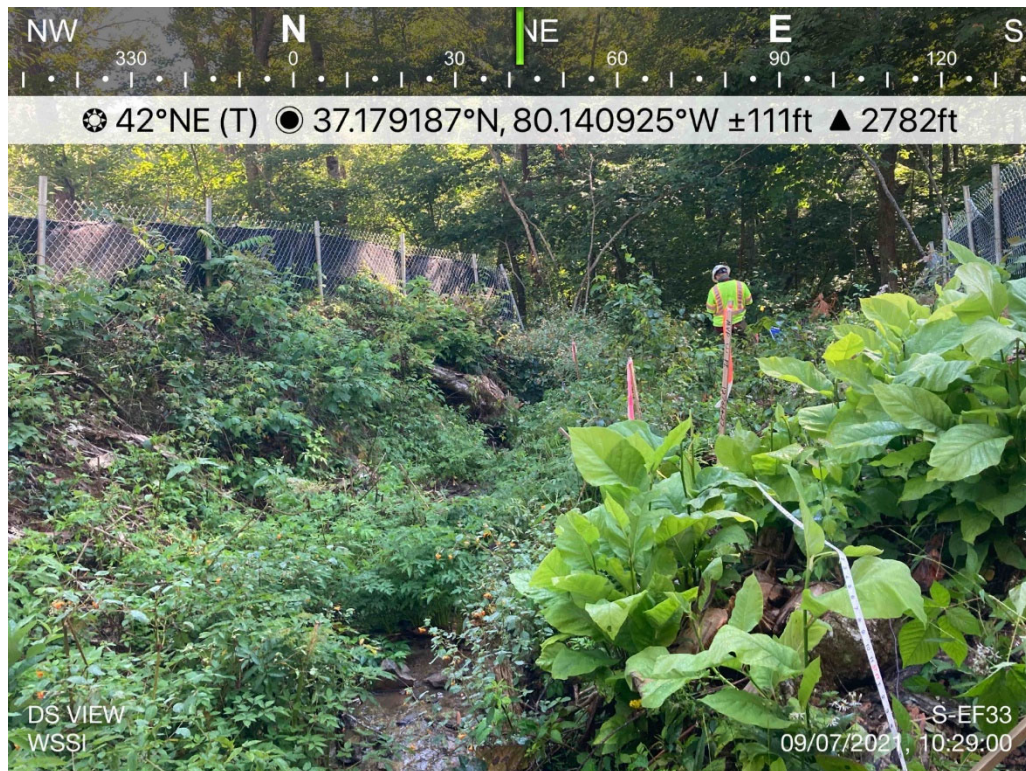
Photo Type: DS VIEW

Location, Orientation, Photographer Initials: Downstream view of ROW looking NE, ES

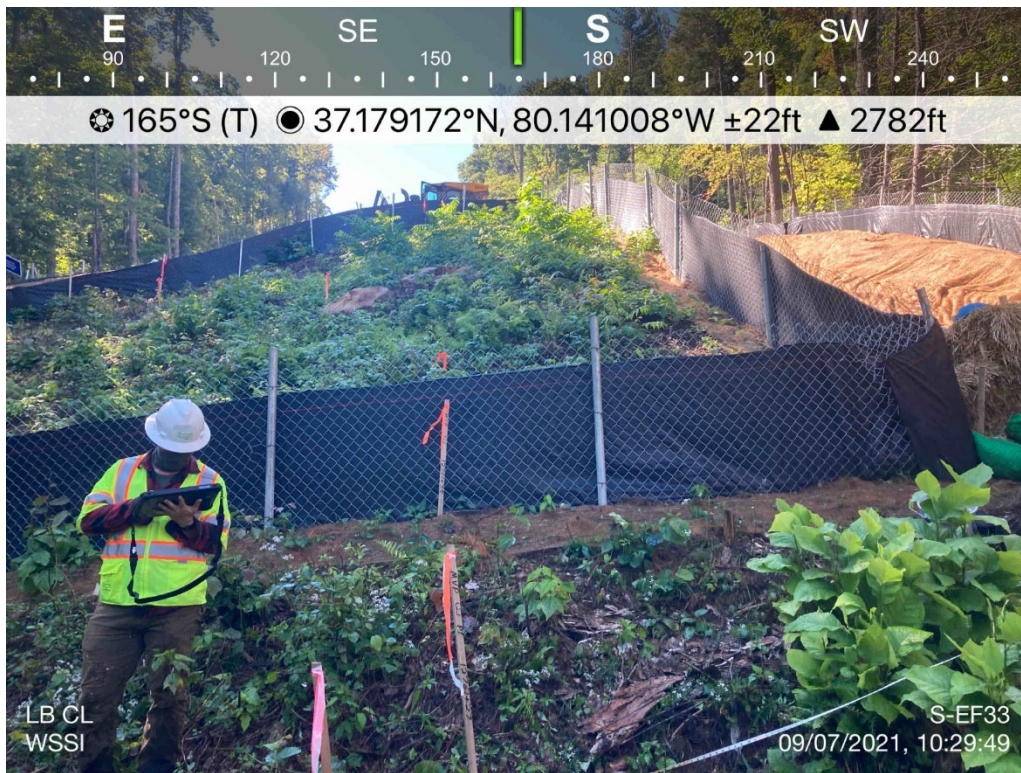
Photo Type: LB CL

Location, Orientation, Photographer Initials: Standing on LB looking at RB along pipe centerline looking S, ES

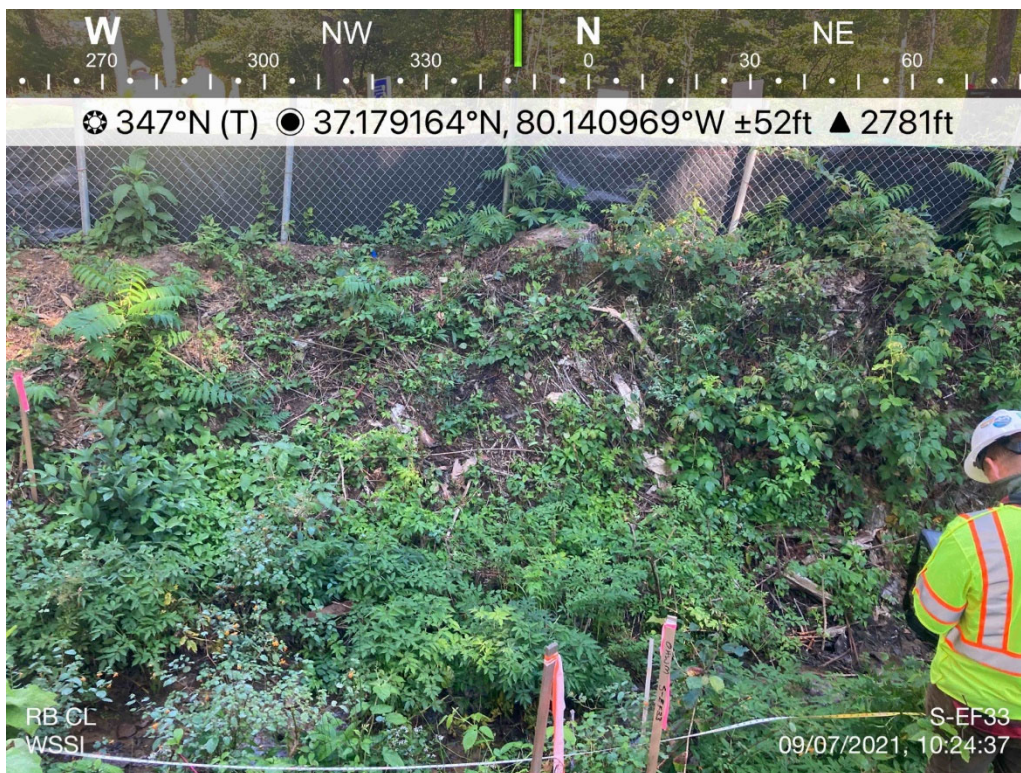
Photo Type: RB CL

Location, Orientation, Photographer Initials: Standing on RB looking at LB along pipe centerline looking N, ES

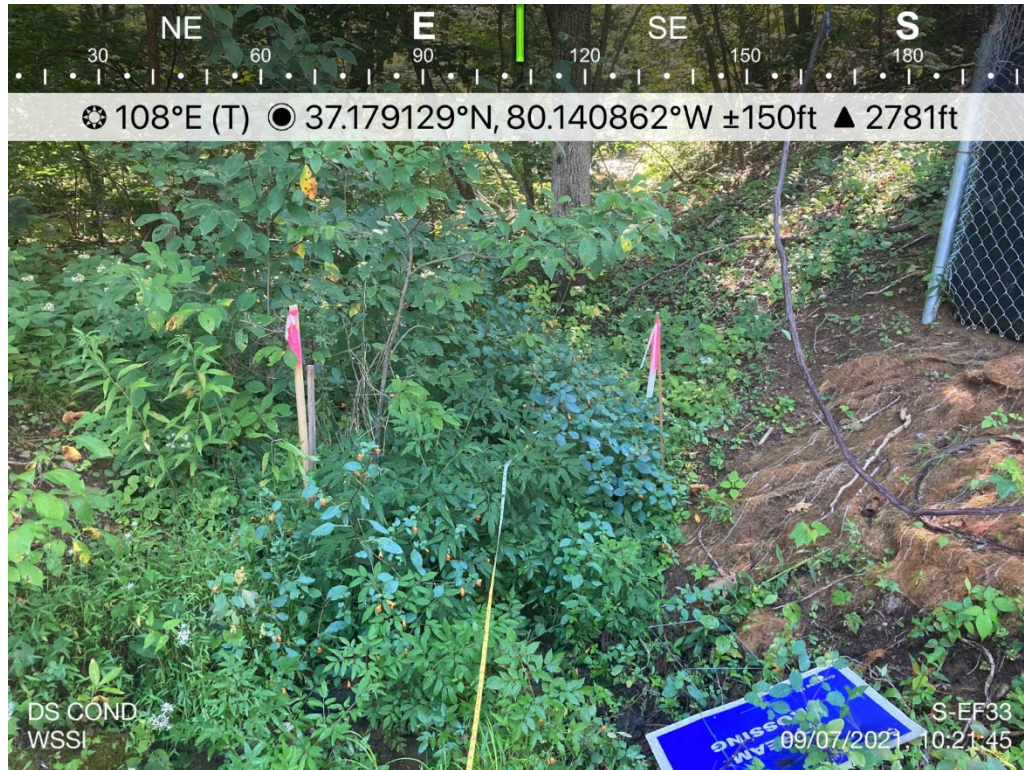
Photo Type: DS COND

Location, Orientation, Photographer Initials: Downstream conditions outside of ROW looking E, ES

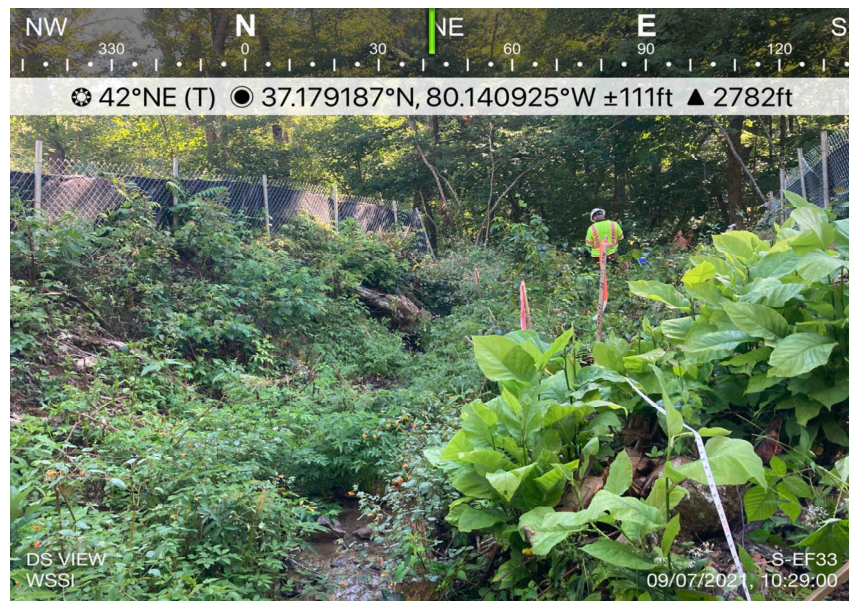
(WSSI Photo Location L:\22000s\22800\22865.06\Admin\05-ENVR\Field Data\Spread H\Field Forms\S-EF33\Photos\DS VIEW.jpeg)

Downstream view facing NE. Assessment is limited to areas within the temporary ROW.

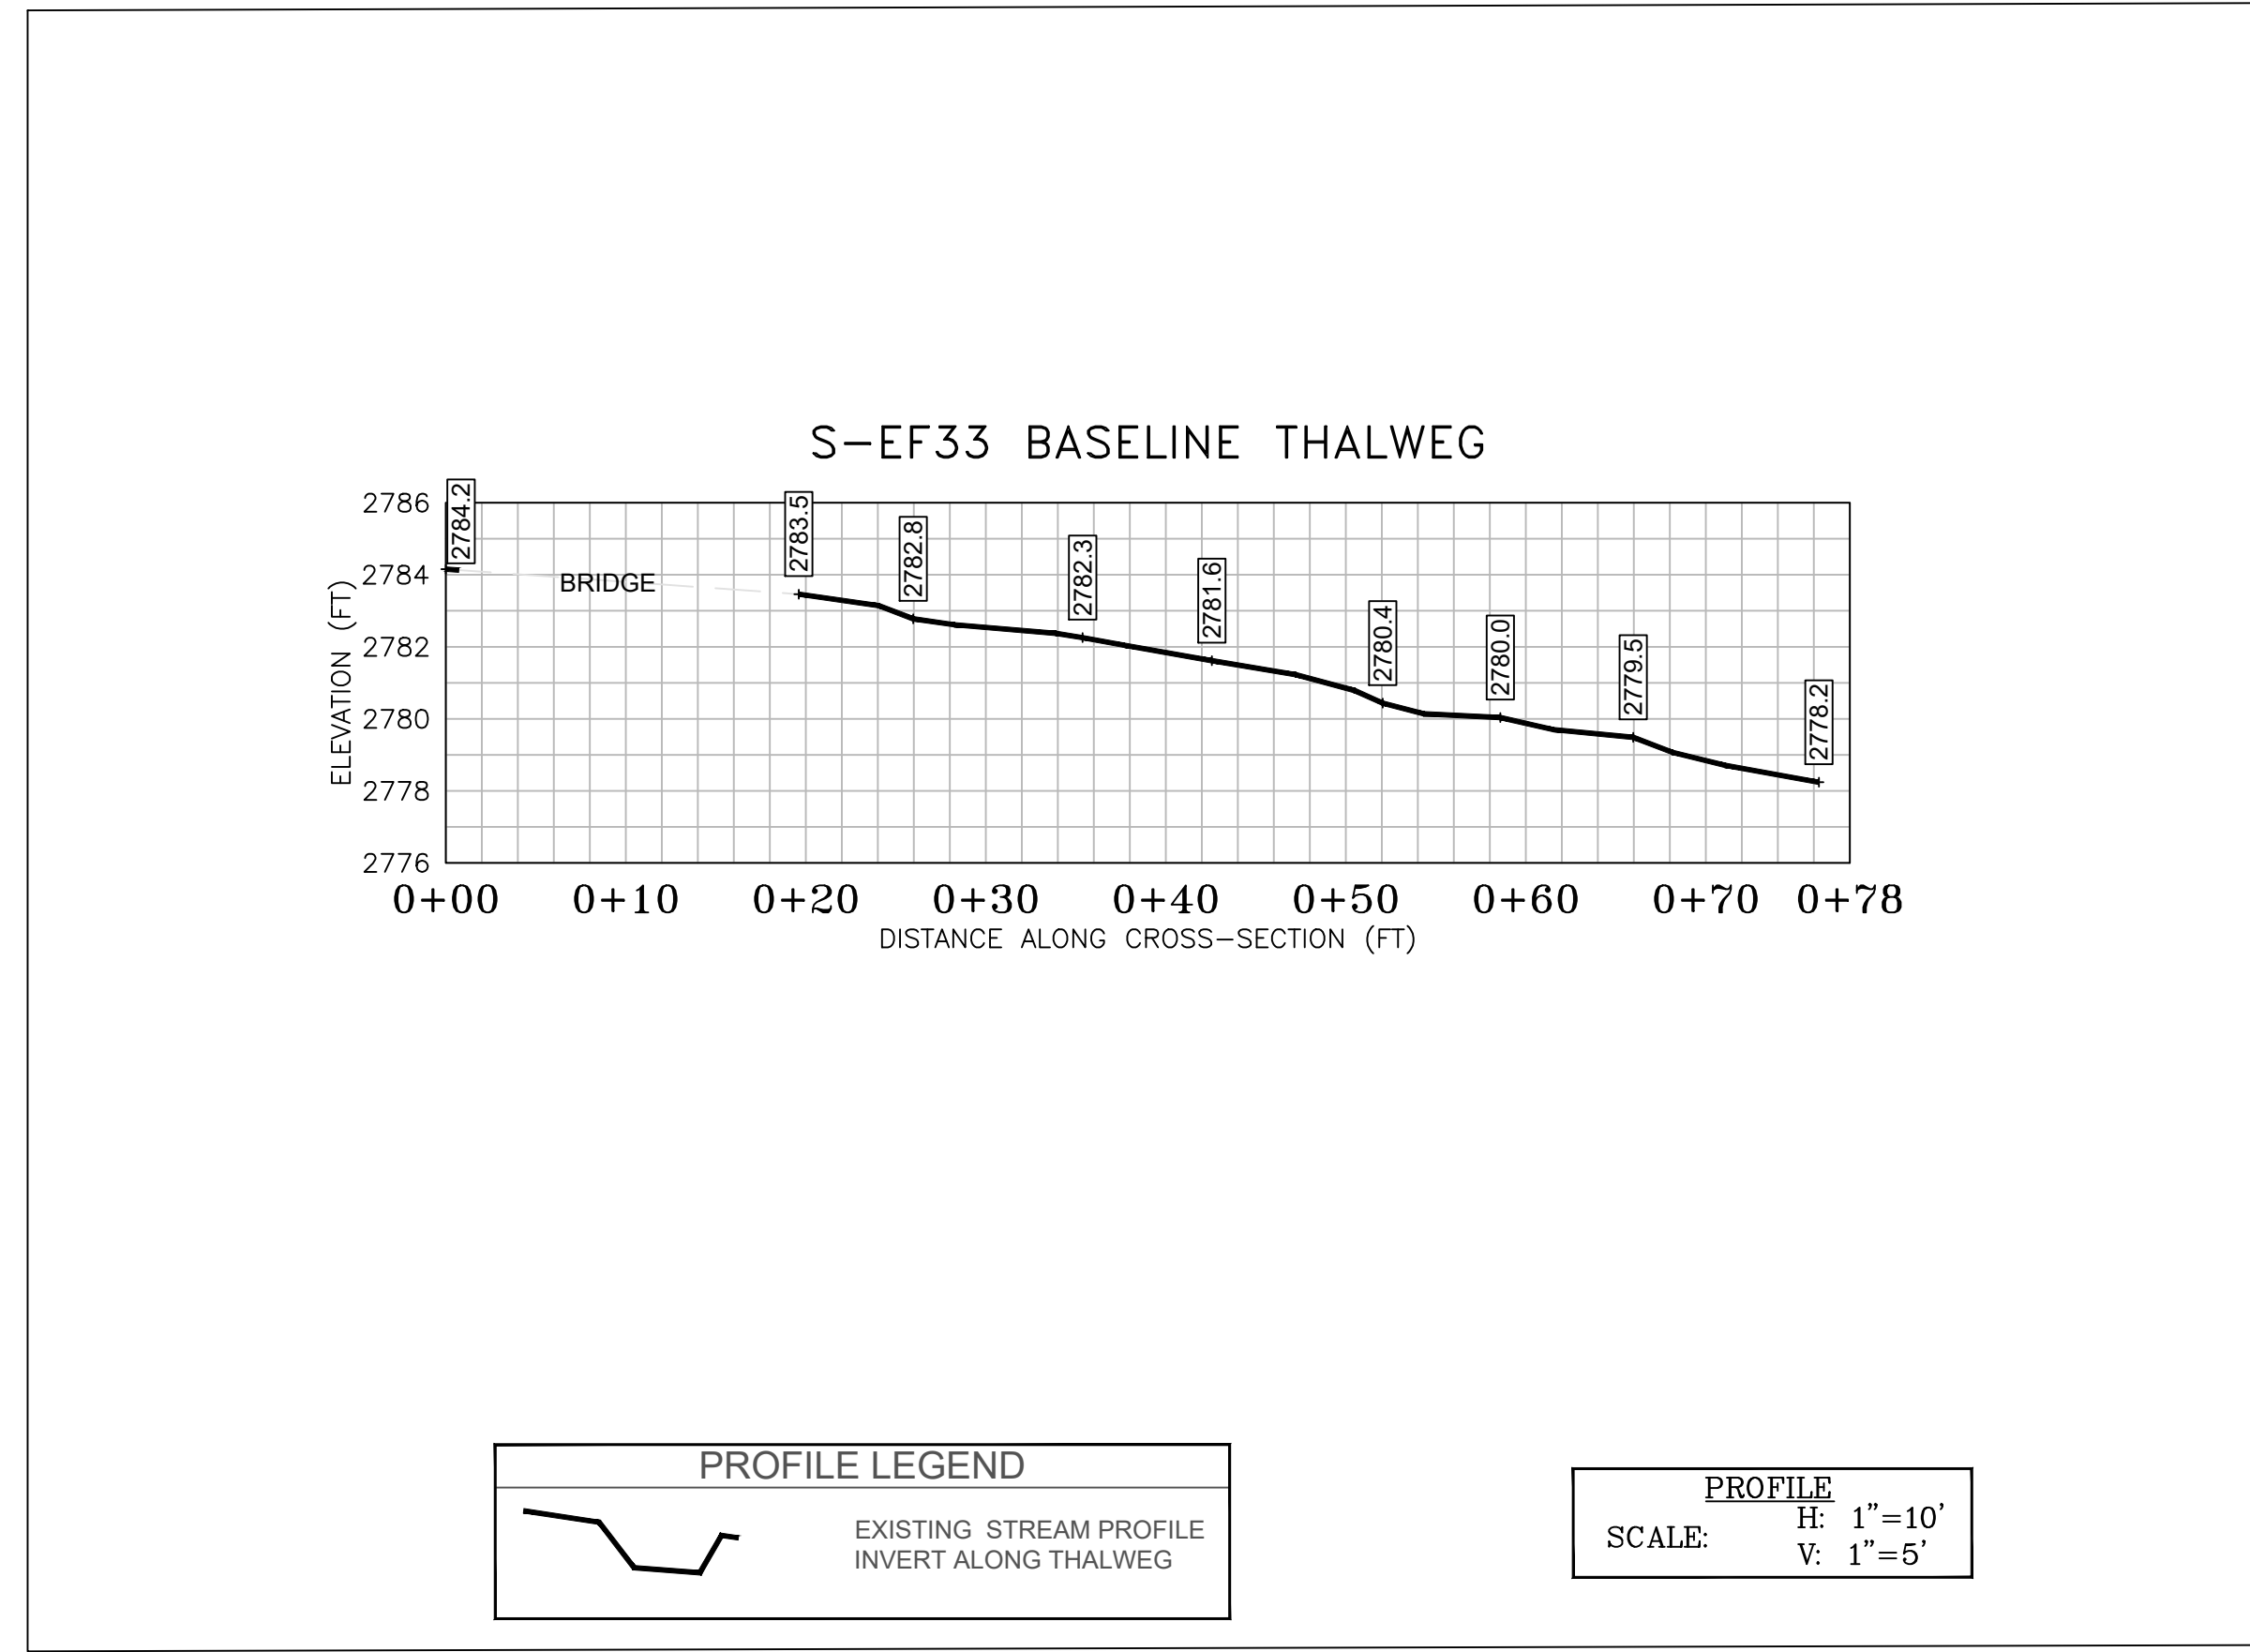
1. This map has been oriented to NAD 1983 UTM ZONE 17N, and vertically to The North American Vertical Datum of 1988 (NAVD 88), using a Real Time Network (RTN) GPS. Field locations were completed on August 31, 2021.
2. Monumentation, including traverse stations and fly points, shown on this drawing should be used to orient any future boundary, topographic, or location survey.
3. Easement lines shown on plan view were provided by Mountain Valley Pipeline (MVP).
4. WSSI Contour Interval = 2.0'. Contours within the channel were interpolated using stream channel breaklines (i.e. top of slopes, toe of slopes, thalweg) and cross-sectional points. Contours outside the channel were interpolated using cross-sectional spot shots.
5. All section views shown are left to right facing downstream.
6. Cross section B shot at location of pipe centerline (based on field stakes).

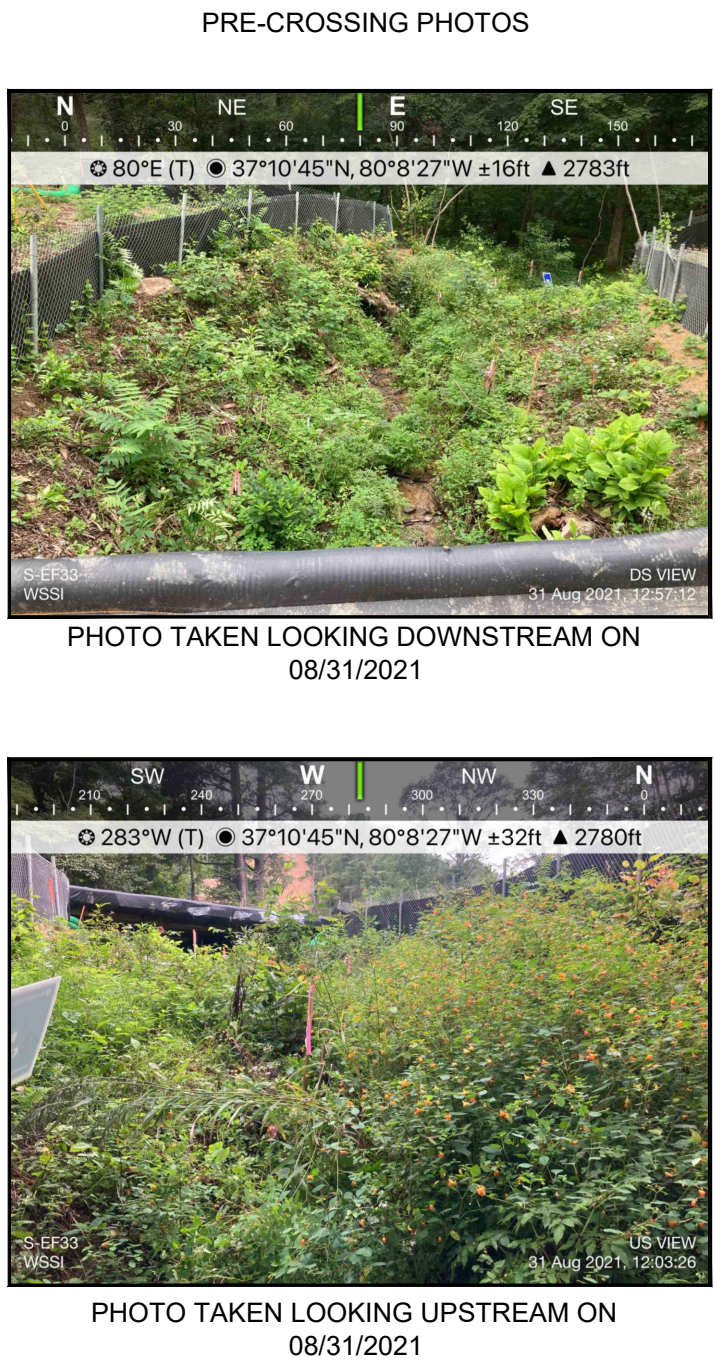
NOTE: ALL SECTION VIEWS SHOWN LEFT TO RIGHT FACING DOWNSTREAM.
