Baseline Assessment – Stream Attributes

Reach S-EF55 (Pipeline ROW)

Roanoke County, Virginia

Profile and Cross-Sections Baseline Survey

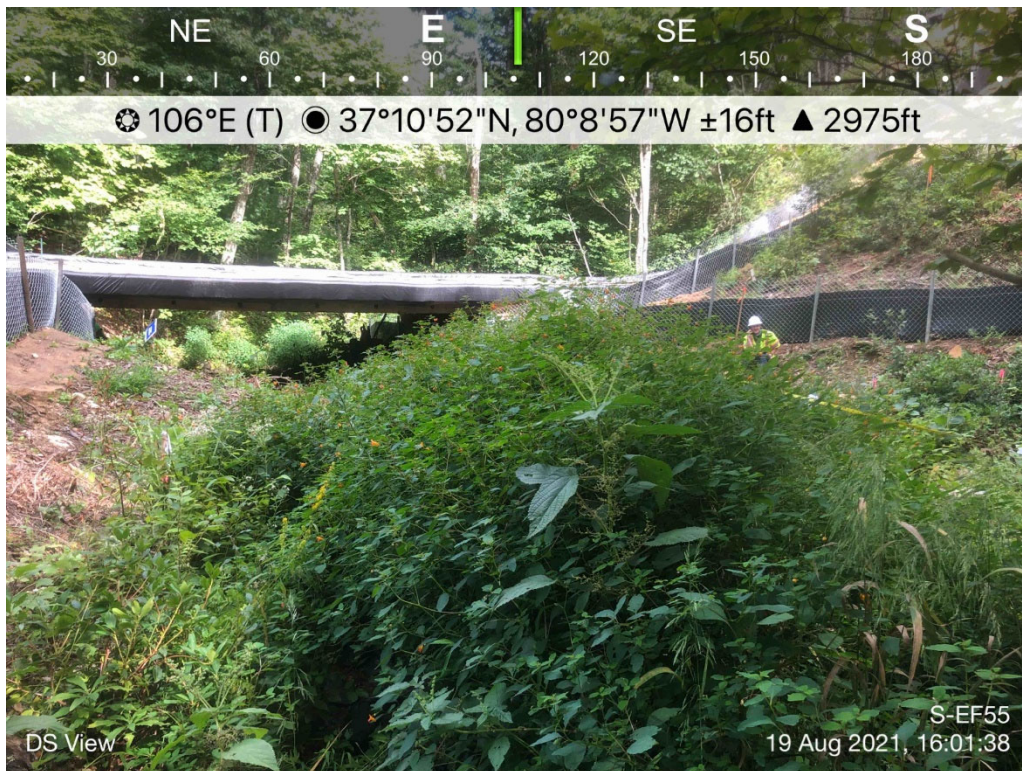
Photo Type: DS VIEW

Location, Orientation, Photographer Initials: Downstream view of ROW looking E, KB

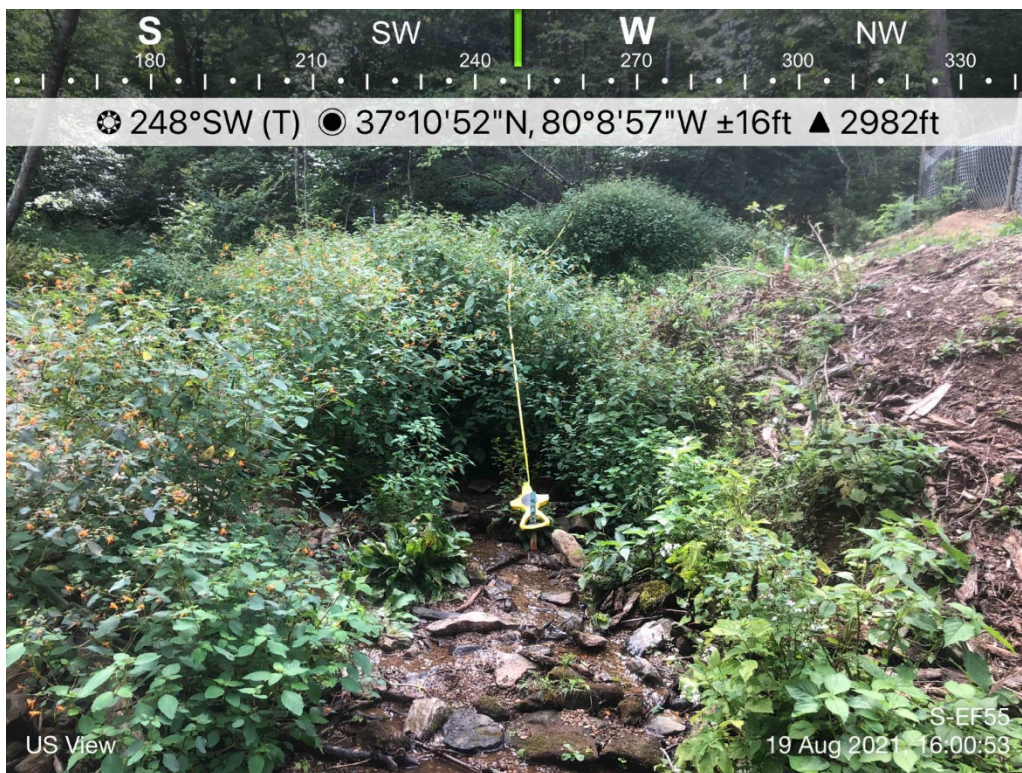
Photo Type: US VIEW

Location, Orientation, Photographer Initials: Upstream view of ROW looking W, KB

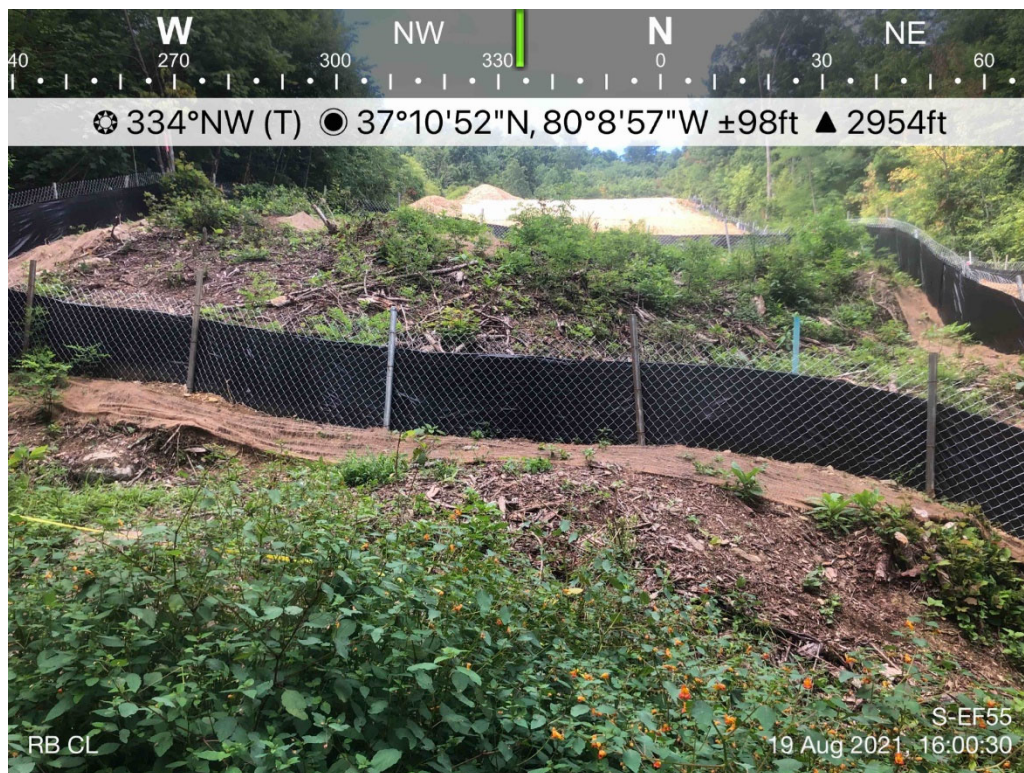
Photo Type: RB CL

Location, Orientation, Photographer Initials: Standing on RB looking at LB along pipe centerline looking N, KB

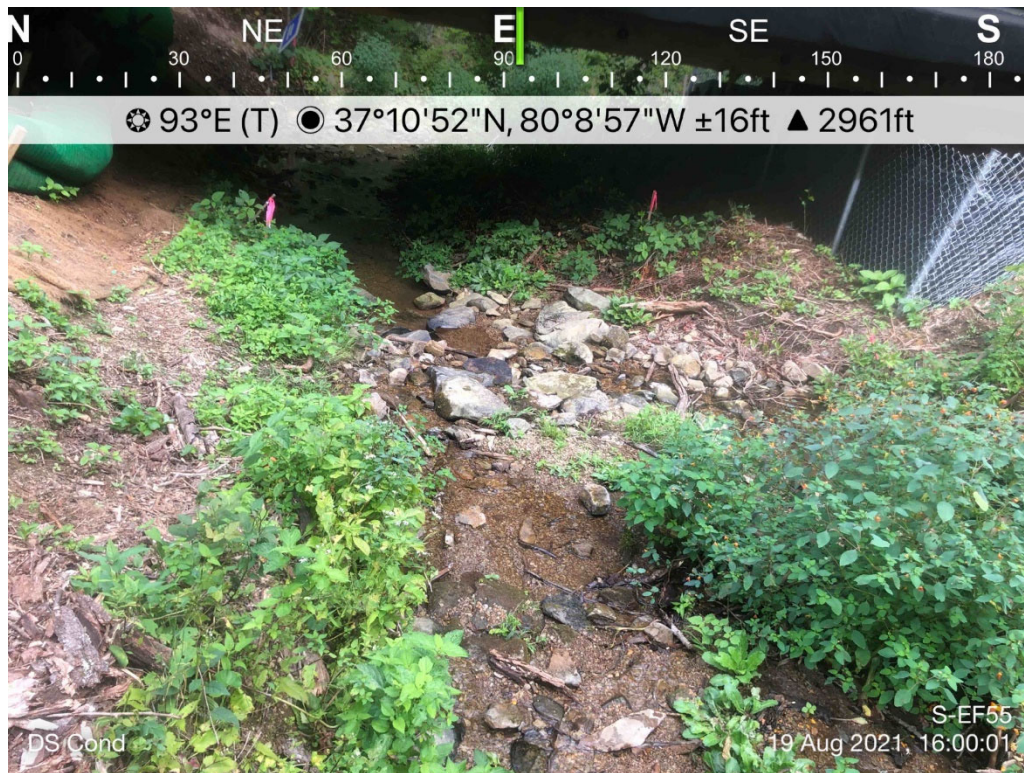
Photo Type: DS COND

Location, Orientation, Photographer Initials: Downstream conditions outside of ROW looking E, KB

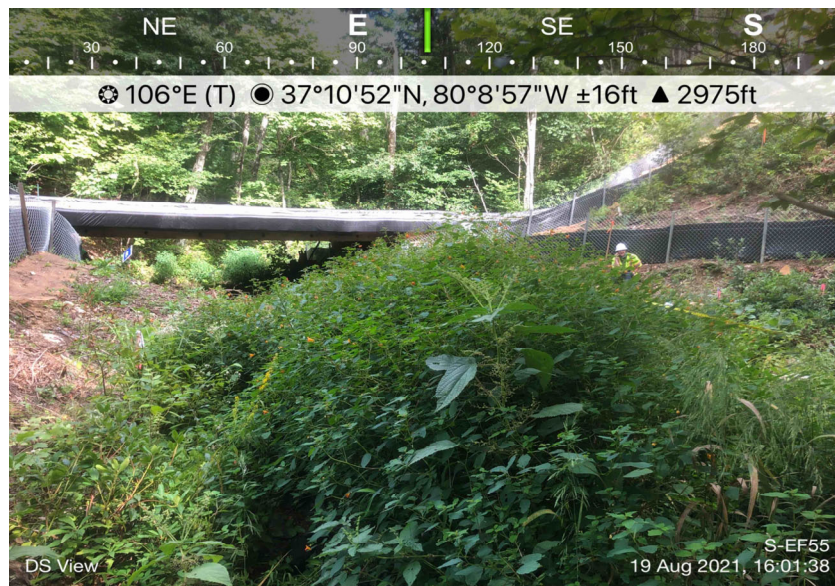
(WSSI Photo Location "L:\22000s\22800\22865.06\Admin\05-ENVR\Field Data\Spread H\Field Forms\S-EF55\Photos\S-EF55_DS VIEW.jpg")

Downstream view facing E inside the ROW. Assessment is limited to areas within the temporary ROW.

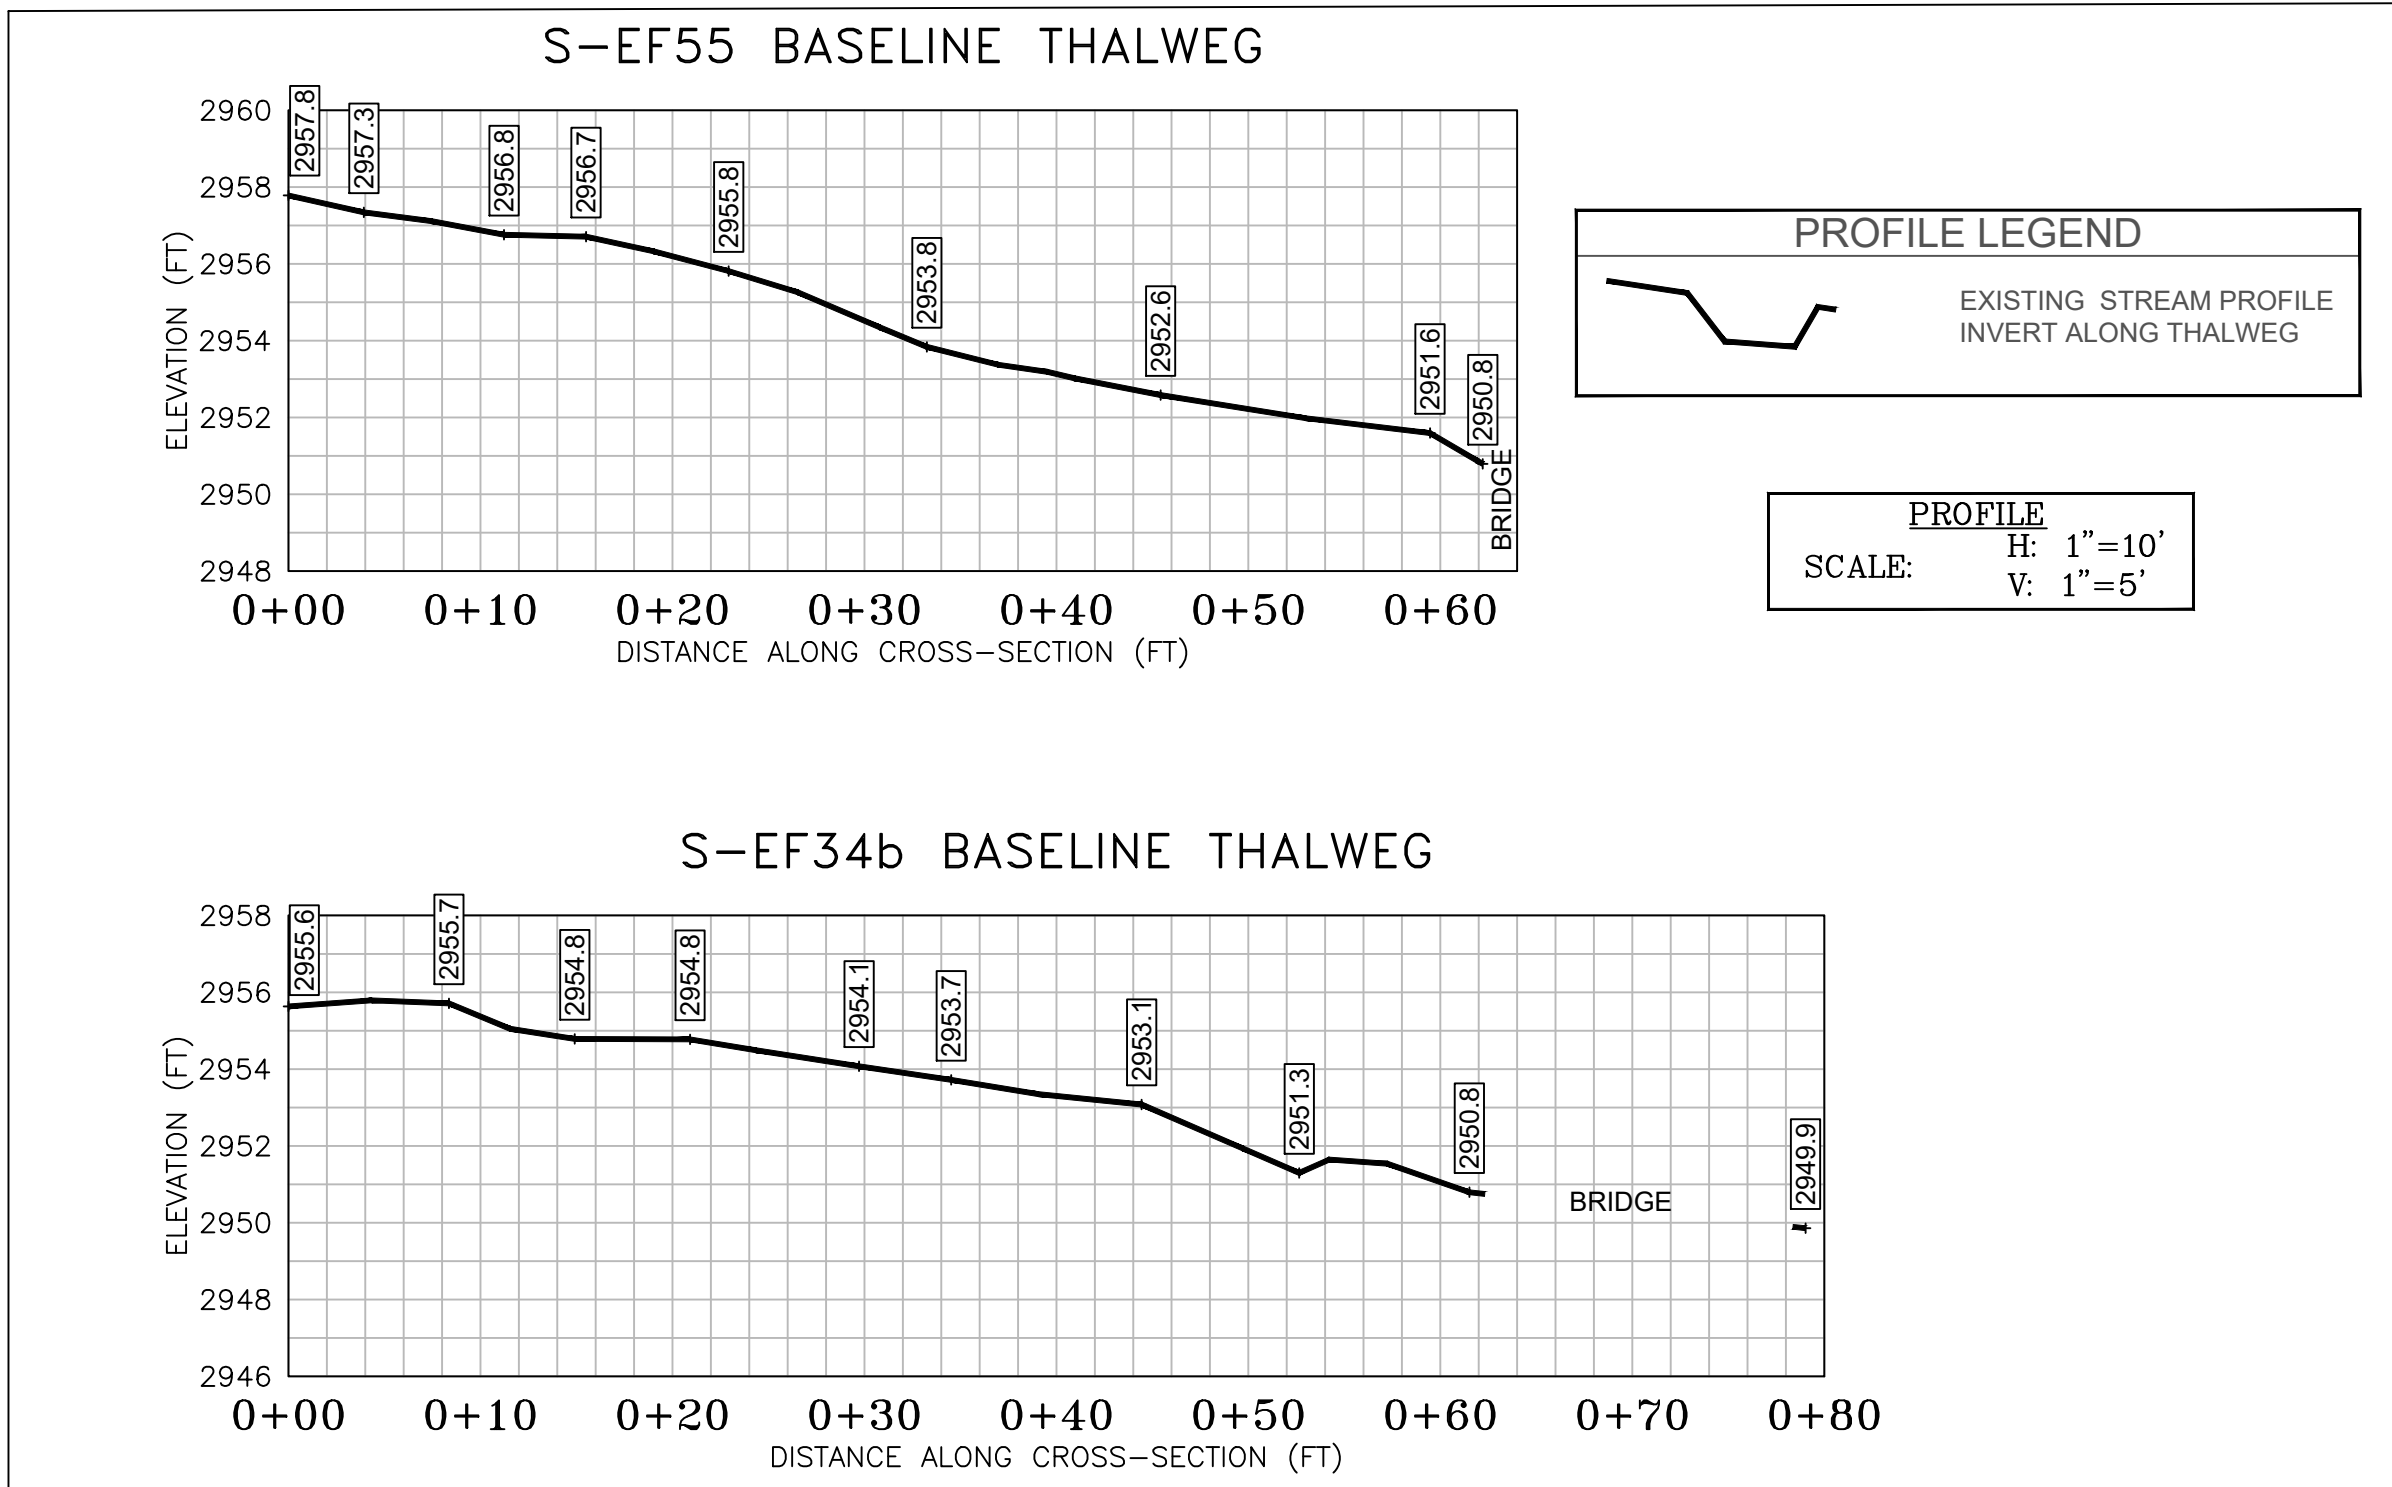
CL STAKEOUT POINTS: S-EF55 & S-EF34b CROSS SECTION B (PIPE CL)					
PRE-CROSSING			POST-CROSSING		
PT. LOC.	NORTHING	EASTING	ELEV.	VERT. DIFF.	HORZ. DIFF.
TS-L	13501726.56	1888209.18	2955.18	----	----
BS-L	13501724.06	1888209.75	2952.55	----	----
THW	13501721.47	1888210.53	2952.54	----	----
TS	13501715.86	1888212.31	2953.52	----	----
THW	13501712.01	1888213.57	2952.96	----	----
BS-R	13501710.64	1888213.86	2953.47	----	----
TS-R	13501700.99	1888217.07	2955.53	----	----

- This map has been oriented to NAD 1983 UTM ZONE 17N, and vertically to The North American Vertical Datum of 1988 (NAVD 88), using a Real Time Network (RTN) GPS. Field locations were completed on August 27, 2021.
- Monumentation, including traverse stations and fly points, shown on this drawing should be used to orient any future boundary, topographic, or location survey.
- Easement lines shown on plan view were provided by Mountain Valley Pipeline (MVP).
- WSSI Contour Interval = 2.0'. Contours within the channel were interpolated using stream channel breaklines (i.e. top of slopes, toe of slopes, thalweg) and cross-sectional points. Contours outside the channel were interpolated using cross-sectional spot shots.
- All section views shown are left to right facing downstream.
- Cross section B shot at location of pipe centerline (based on field stakes).

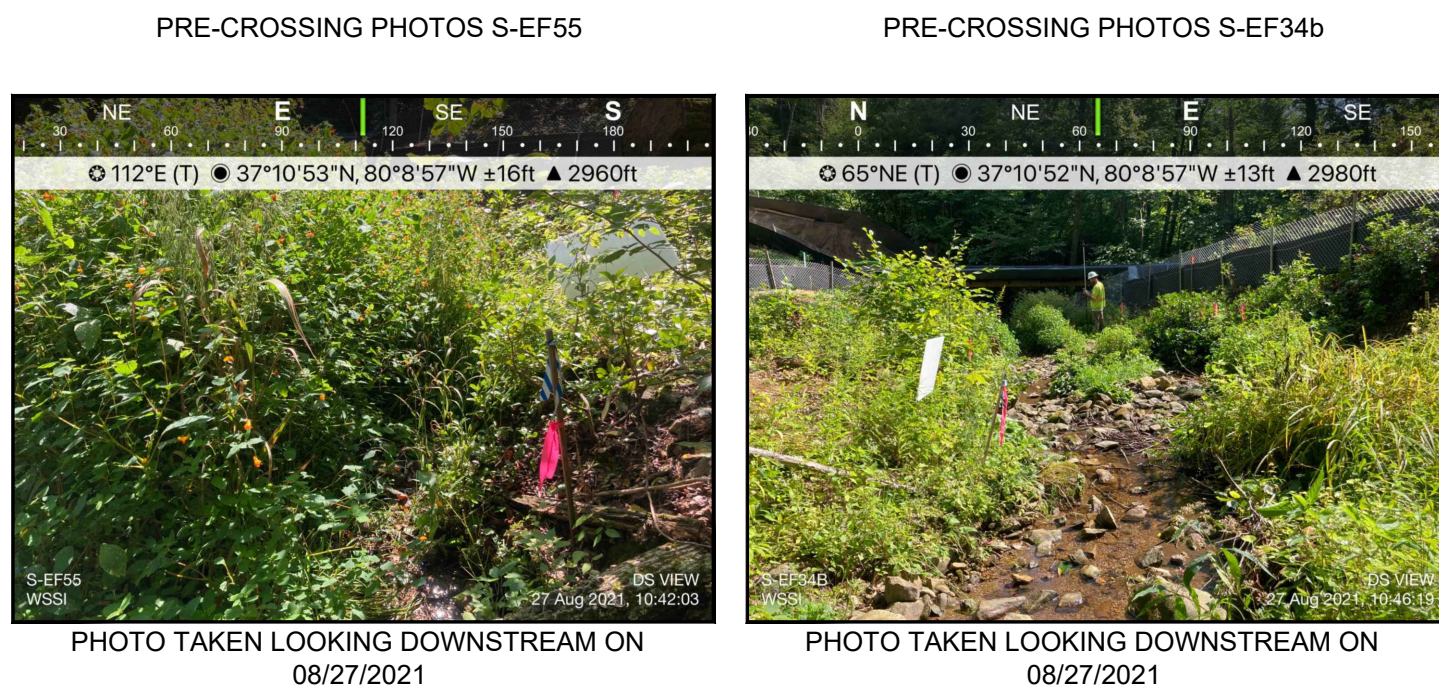
NOTE: ALL SECTION VIEWS SHOWN LEFT TO RIGHT FACING DOWNSTREAM.
