Baseline Assessment – Stream Attributes

Reach S-F16a/b (Pipeline ROW) Ephemeral Spread H Montgomery County, Virginia

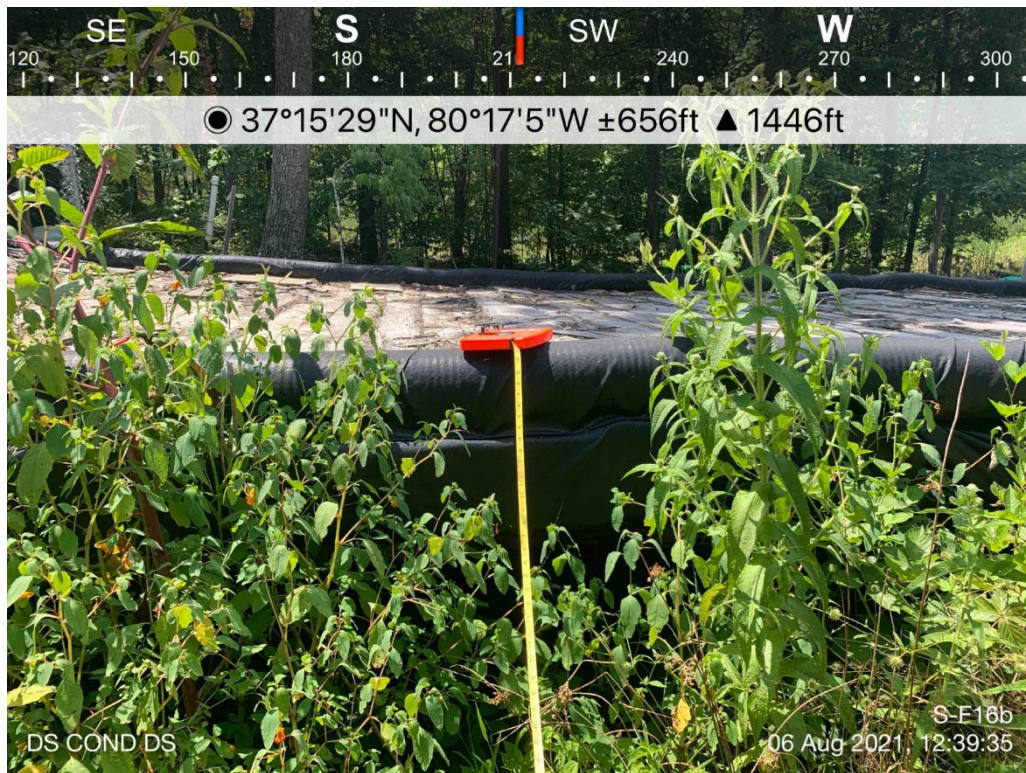
Location, Orientation, Photographer Initials: Standing on RB looking at LB along pipe centerline looking SE, SB
