Baseline Assessment – Stream Attributes

Reach S-G38 (Timber Mat Crossing) Ephemeral Spread H Montgomery County, Virginia

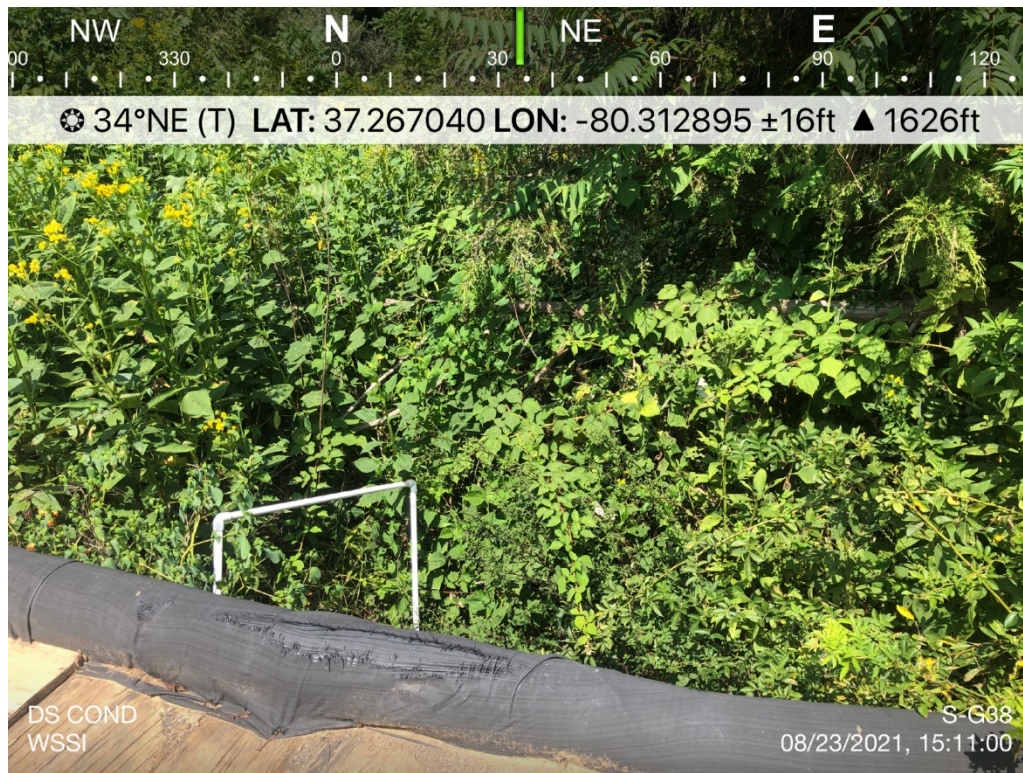
Location, Orientation, Photographer Initials: Standing on RB looking at LB along pipe centerline looking NW, AO

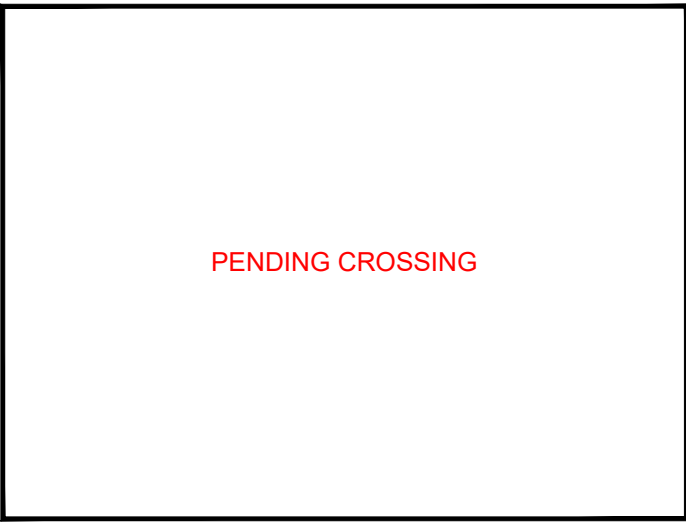
PHOTO TAKEN LOOKING UPSTREAM FROM
DOWNSTREAM IMPACT LIMITS
