## Baseline Assessment - Stream Attributes

### Reach S-GH11 (Pipeline ROW) Intermittent Spread H Franklin County, Virginia

Profile and Cross-Sections Baseline Survey

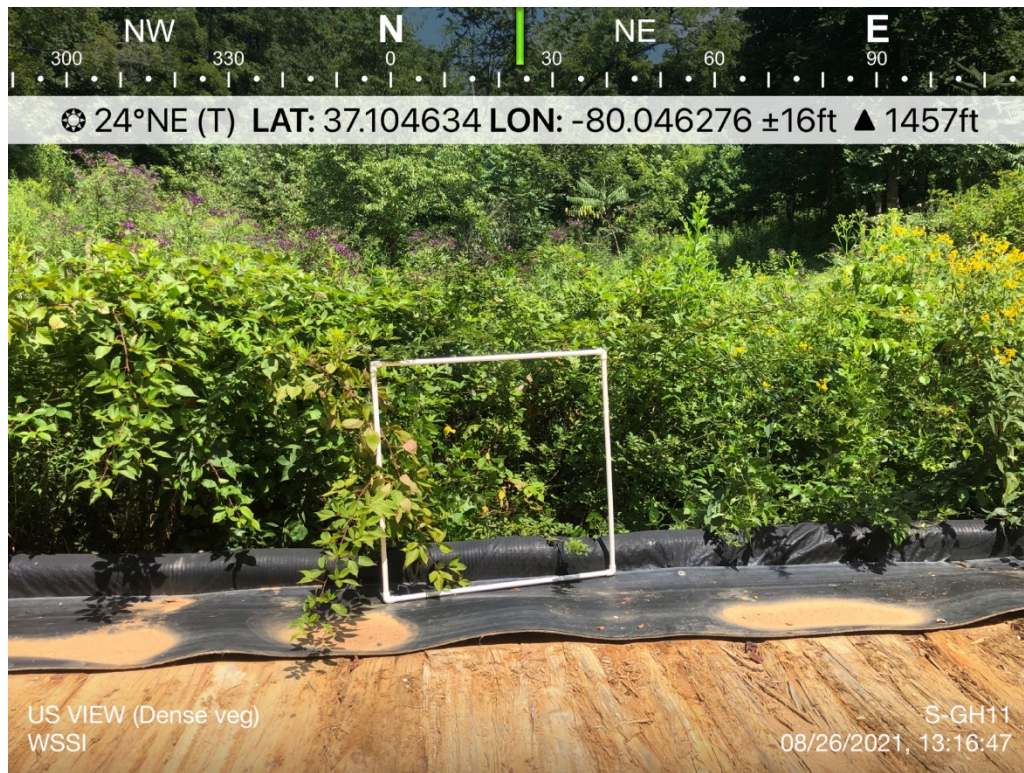
Photo Type: US VIEW

Location, Orientation, Photographer Initials: Upstream view of ROW looking NE at dense herbaceous vegetation, AO

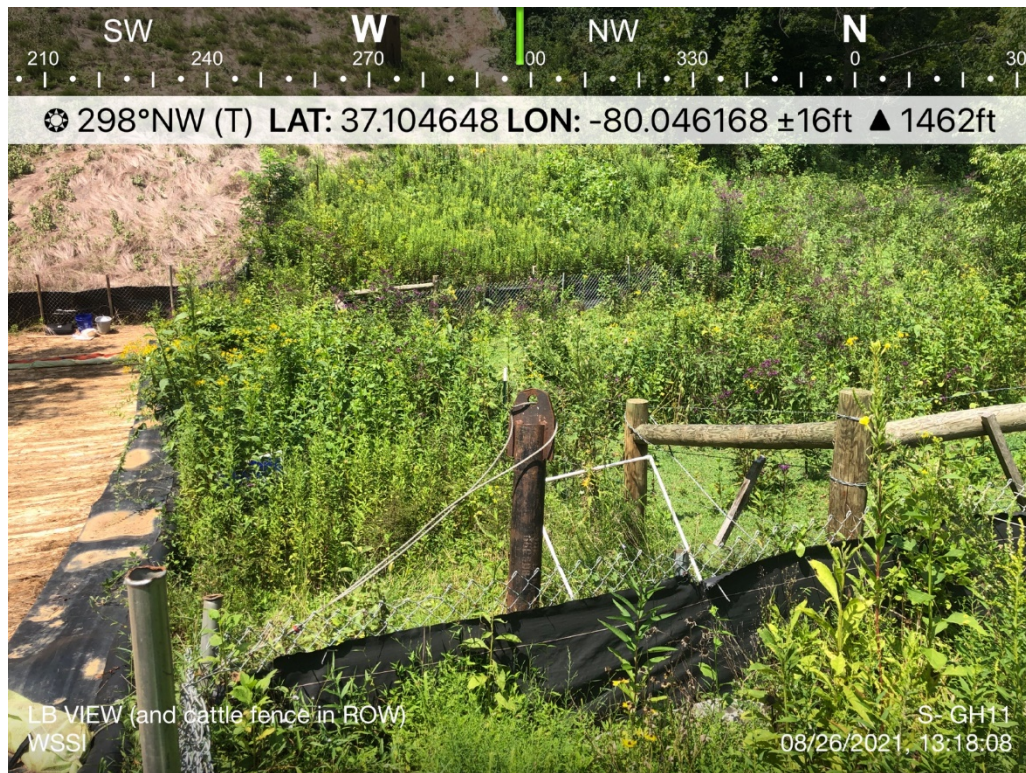
Photo Type: LB CL

Location, Orientation, Photographer Initials: Standing on LB looking at RB along pipe centerline and cattle fence looking NW, AO

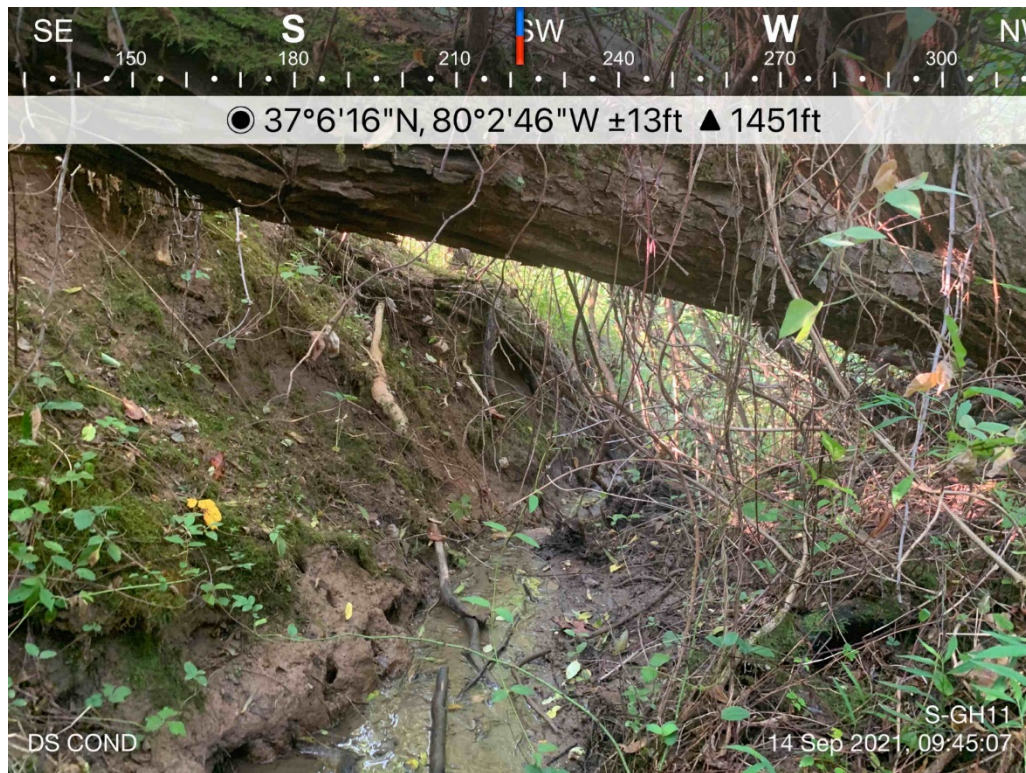
Photo Type: DS COND

Location, Orientation, Photographer Initials: Downstream conditions outside of ROW looking SW, SB

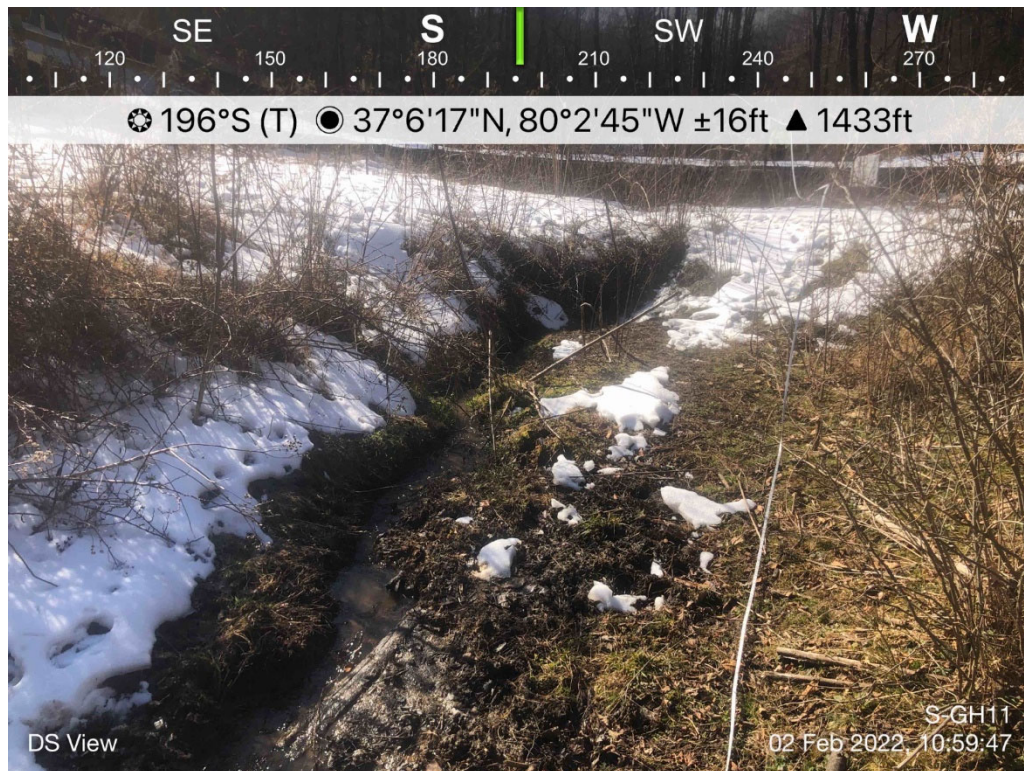
Photo Type: DS VIEW

Location, Orientation, Photographer Initials: Downstream view of ROW looking S/SW, KB

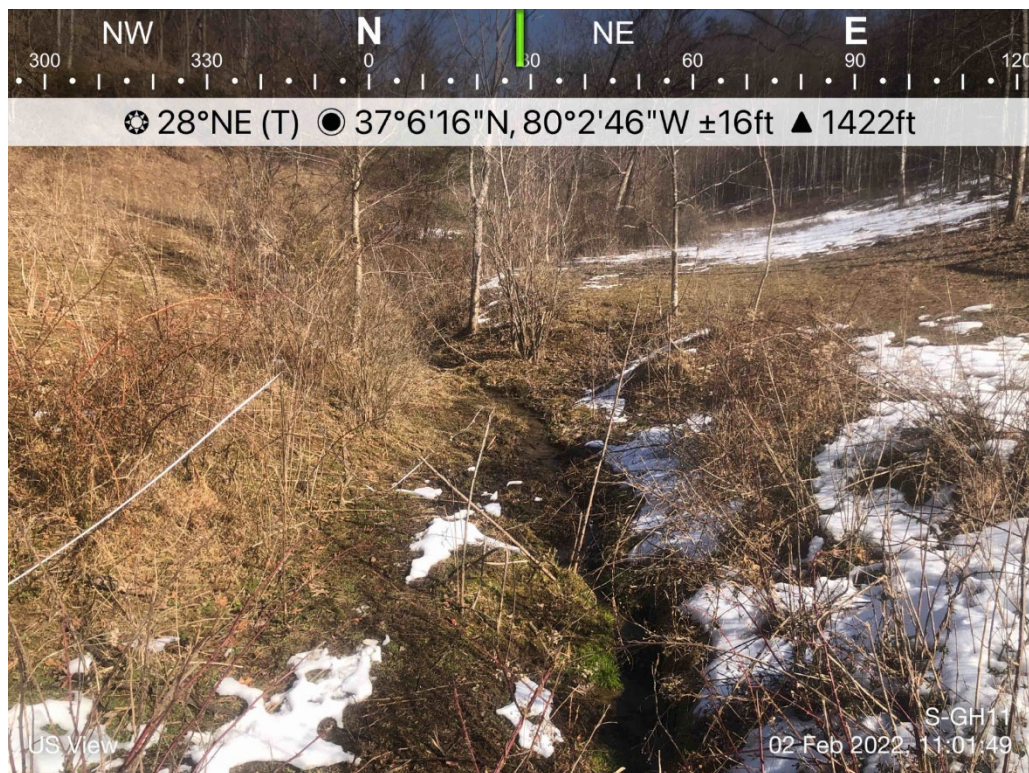
Photo Type: US VIEW

Location, Orientation, Photographer Initials: Upstream view of LOC looking N/NE, KB

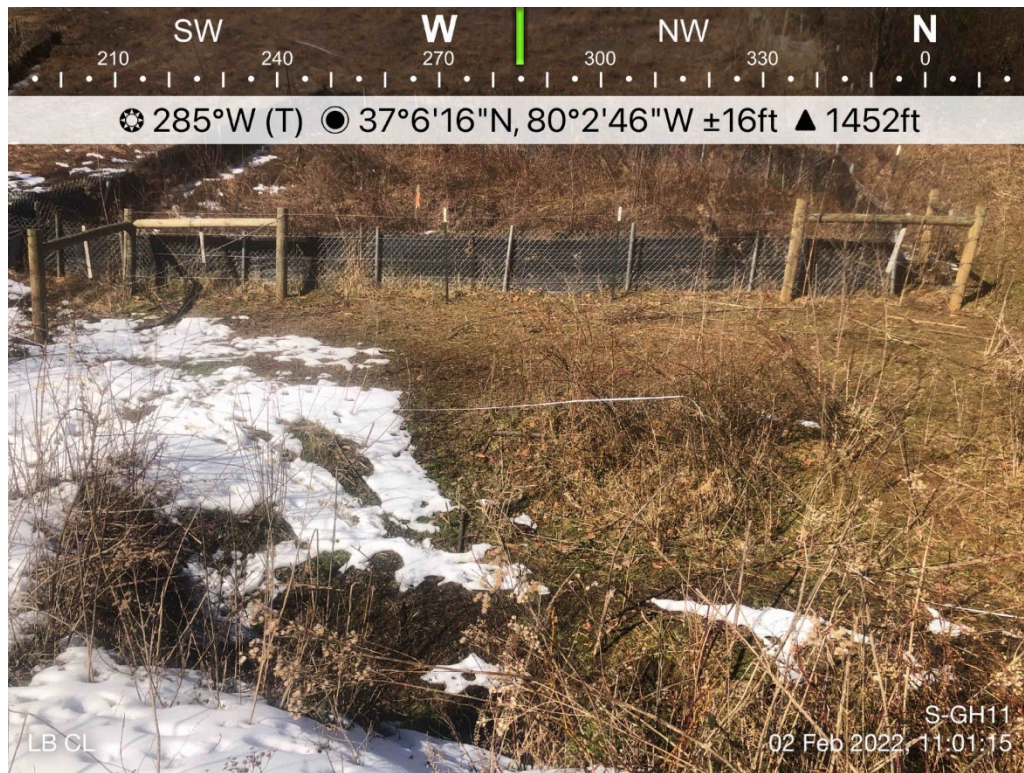
Photo Type: LB CL

Location, Orientation, Photographer Initials: Standing on LB looking at RB along pipe centerline looking W, KB

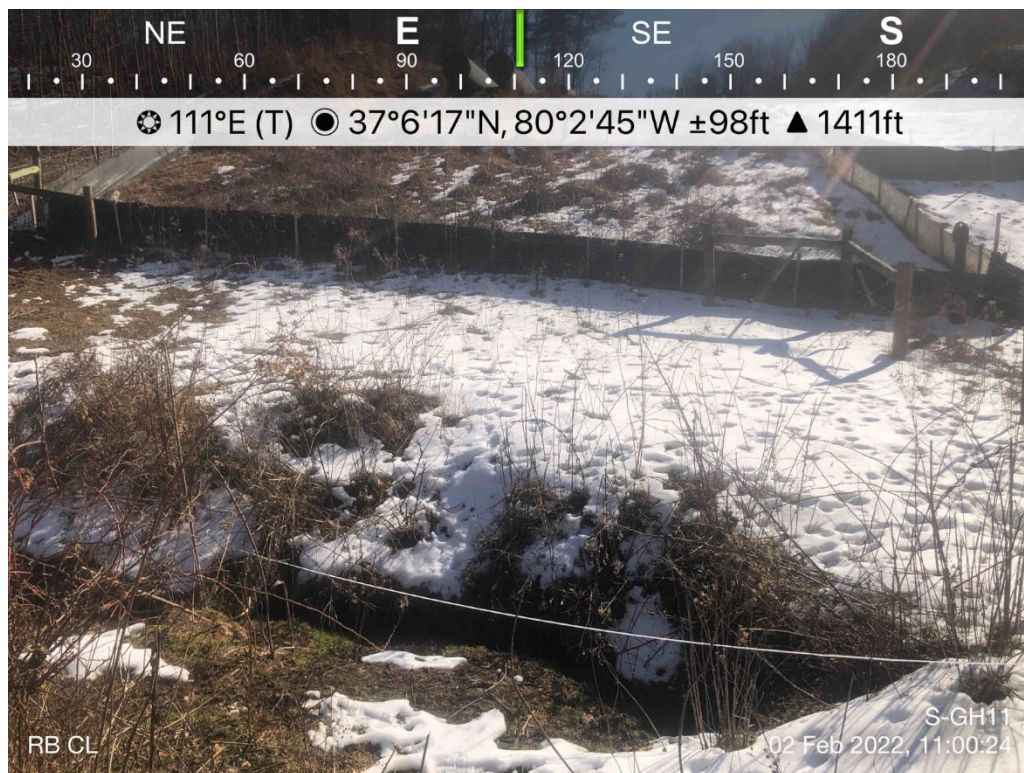
Photo Type: RB CL

Location, Orientation, Photographer Initials: Standing on RB looking at LB along pipe centerline looking E, KB

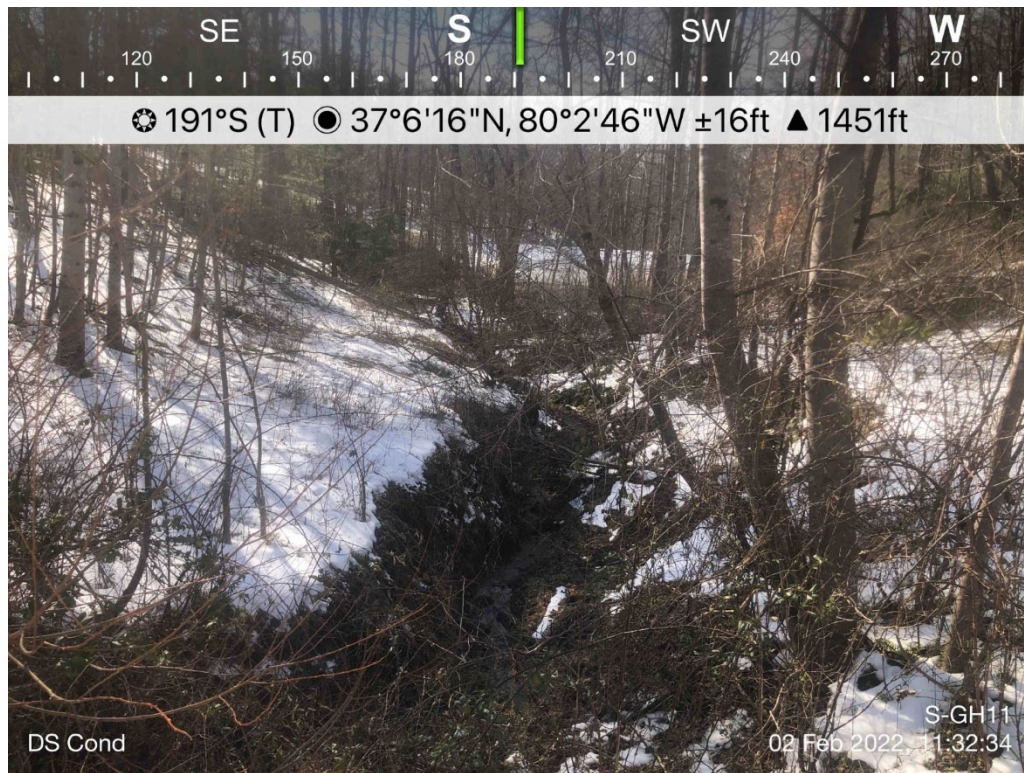
Photo Type: DS COND

Location, Orientation, Photographer Initials: Downstream conditions outside of ROW looking S/SW, KB

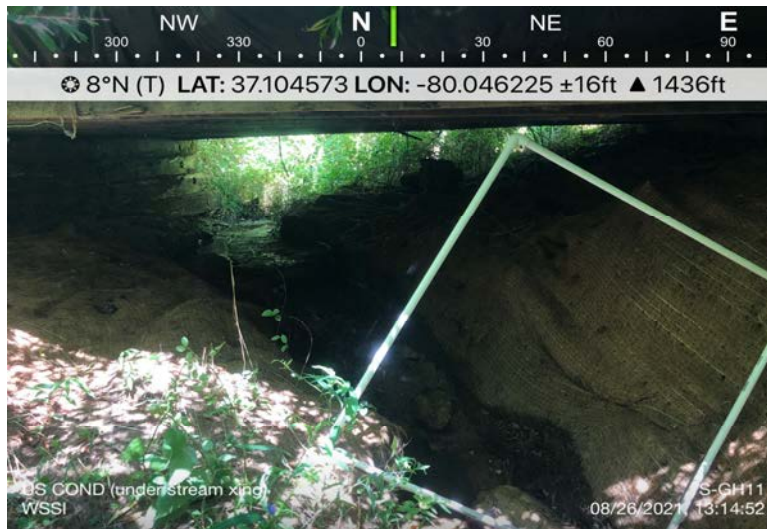
Looking upstream under equipment bridge in the ROW. Some erosion was observed at the base of the right bank bridge footer. Assessment is limited to areas within the temporary ROW.
