Baseline Assessment - Stream Attributes

Reach S-IJ83 (Timber Mat Crossing) Intermittent Spread H Roanoke County, Virginia

USACE FILE NO./ Project Name: (v2.1, Sept 2015)		Mountain Valley Pipeline		IMPACT COORDINATES: (In Decimal Degrees)		Lat.	37.169211	Lon.	-80.138258	WEATHER:		Cloudy	DATE:		September 7, 2021				
IMPACT STREAM/SITE ID AND SITE DESCRIPTION: (watershed size (acres), unaltered or impairments)				S-J83				MITIGATION STREAM CLASS./SITE ID AND SITE DESCRIPTION: (watershed size (acres), unaltered or impairments)				Comments:							
STREAM IMPACT LENGTH:		148	FORM OF MITIGATION:		RESTORATION (Levels I-III)		MIT COORDINATES: (In Decimal Degrees)		Lat.		Lon.		PRECIPITATION PAST 48 HRS:		0.05"; 9/6/2021	Mitigation Length:			
Column No. 1- Impact Existing Condition (Debit)				Column No. 2- Mitigation Existing Condition - Baseline (Credit)				Column No. 3- Mitigation Projected at Five Years Post Completion (Credit)				Column No. 4- Mitigation Projected at Ten Years Post Completion (Credit)				Column No. 5- Mitigation Projected at Maturity (Credit)

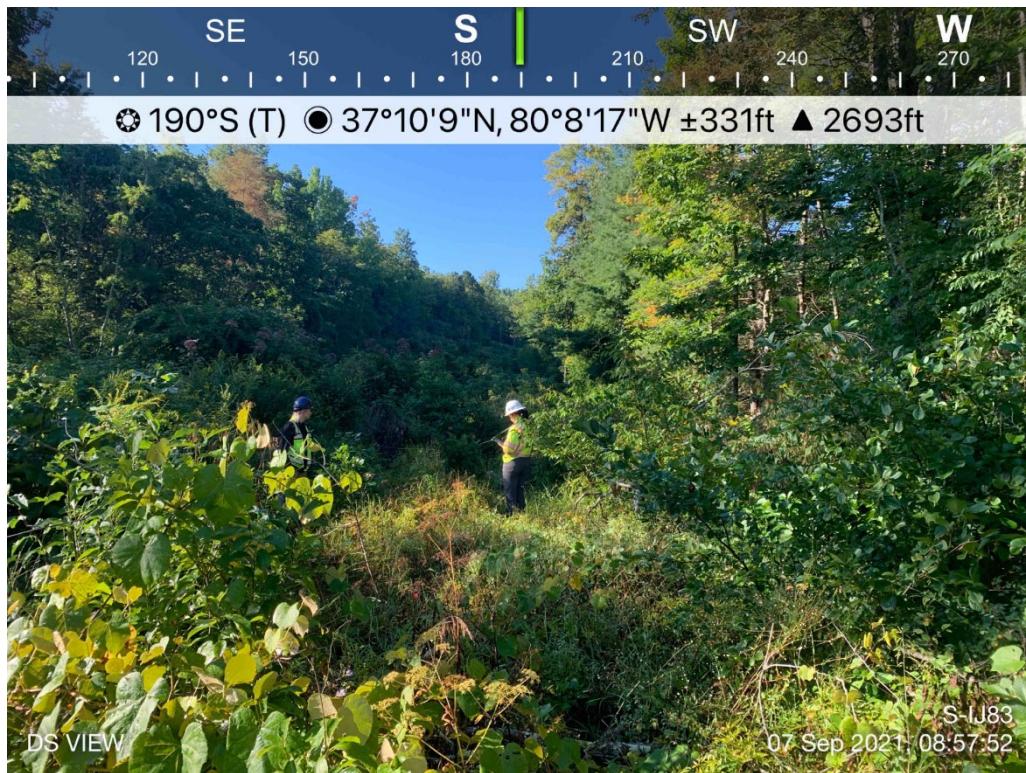
Photo Type: DS VIEW

Location, Orientation, Photographer Initials: Downstream view of ROW looking S, TC

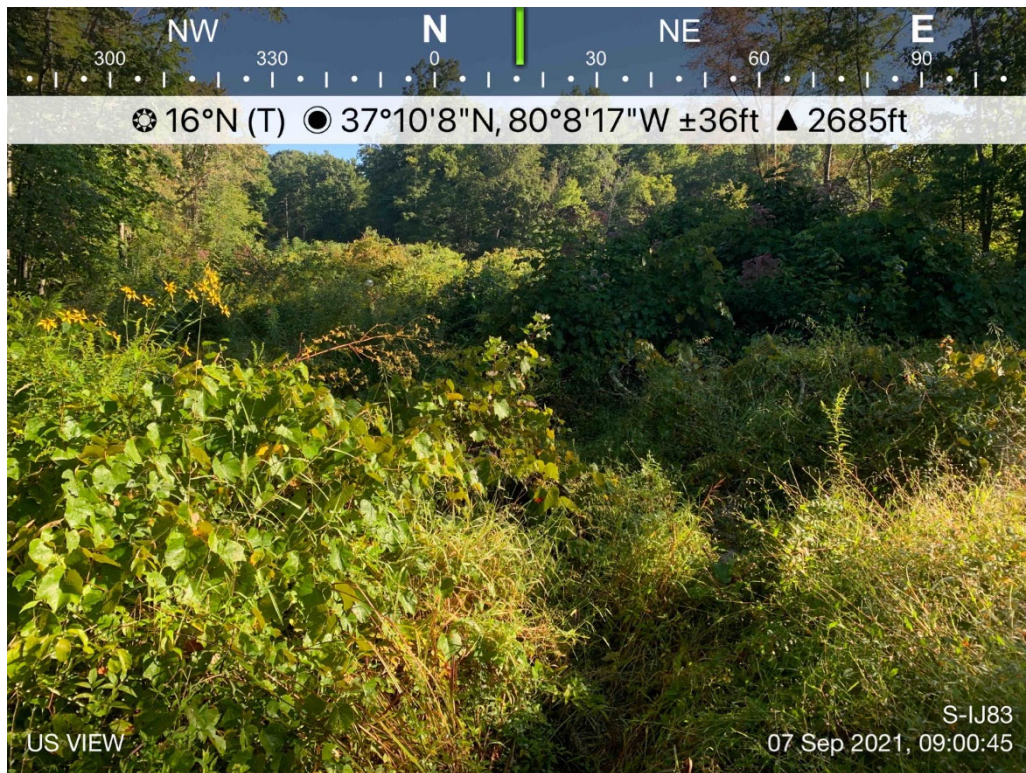
Photo Type: US VIEW

Location, Orientation, Photographer Initials: Upstream view of ROW looking N, TC

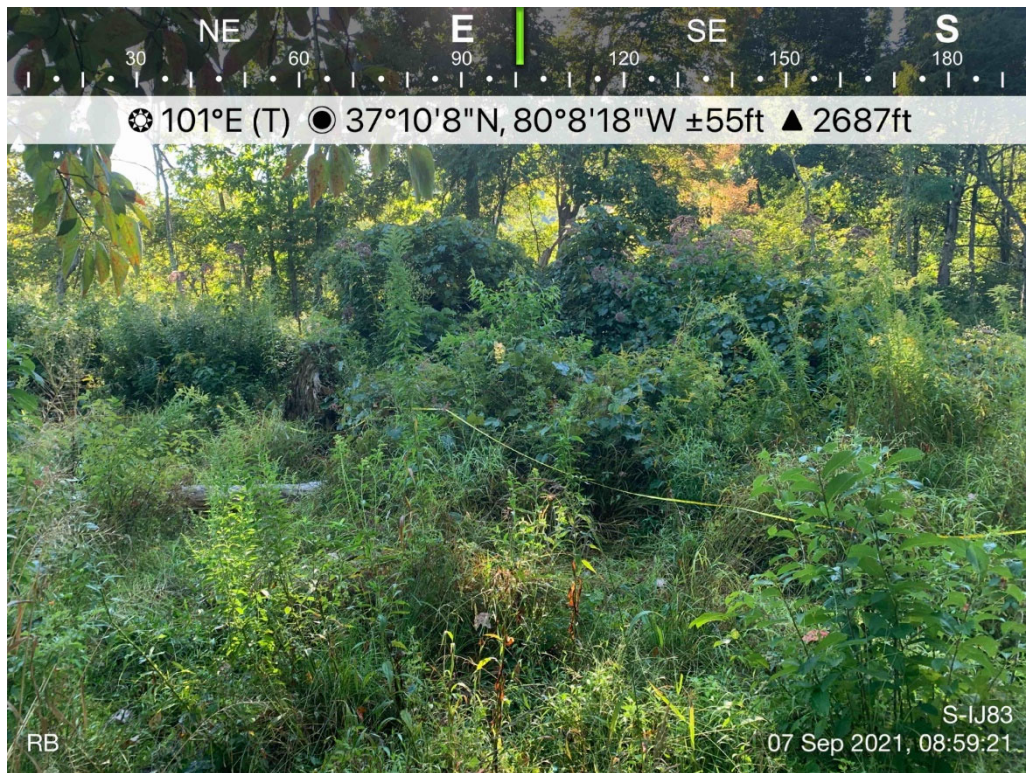
Photo Type: RB CL

Location, Orientation, Photographer Initials: Standing on RB looking at LB along pipe centerline looking E, TC

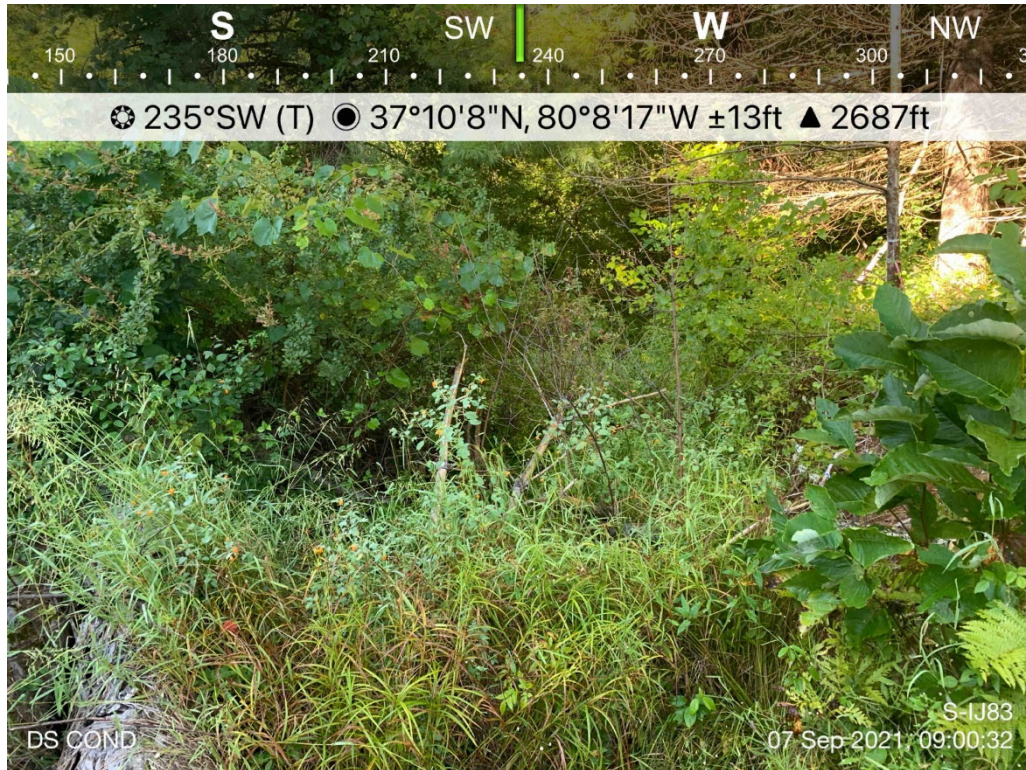
Photo Type: DS COND

Location, Orientation, Photographer Initials: Downstream conditions outside of ROW looking SW, TC

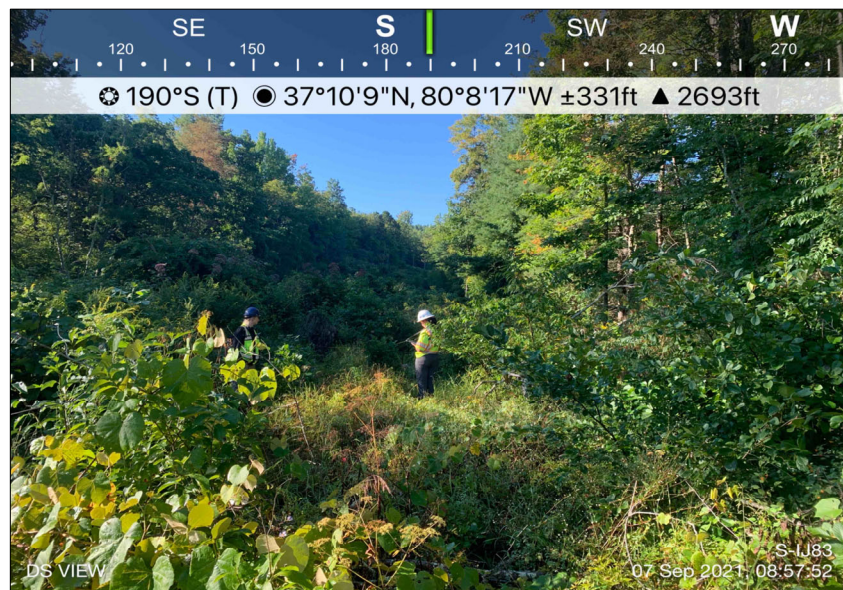
(WSSI Photo Location L:\22000s\22800\22865.06\Admin\05-ENVR\Field Data\Spread H\Field Forms\S-IJ83\Photos\DS VIEW.JPG)

Downstream view within the ROW. Assessment is limited to areas within the temporary ROW.
