Baseline Assessment - Stream Attributes

Reach S-RR09 (Pipeline ROW)

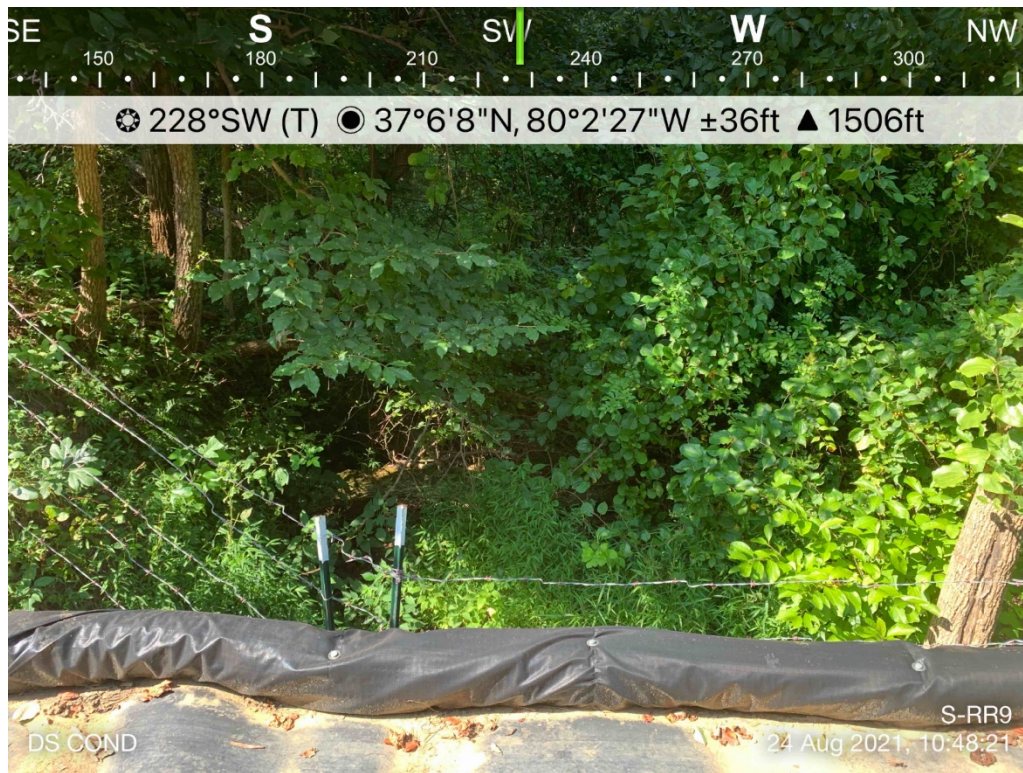
Location, Orientation, Photographer Initials: Standing on RB looking at LB along pipe centerline looking SE, TC
