Baseline Assessment - Stream Attributes

Reach S-Y14 (Pipeline ROW)

Perennial

Spread H

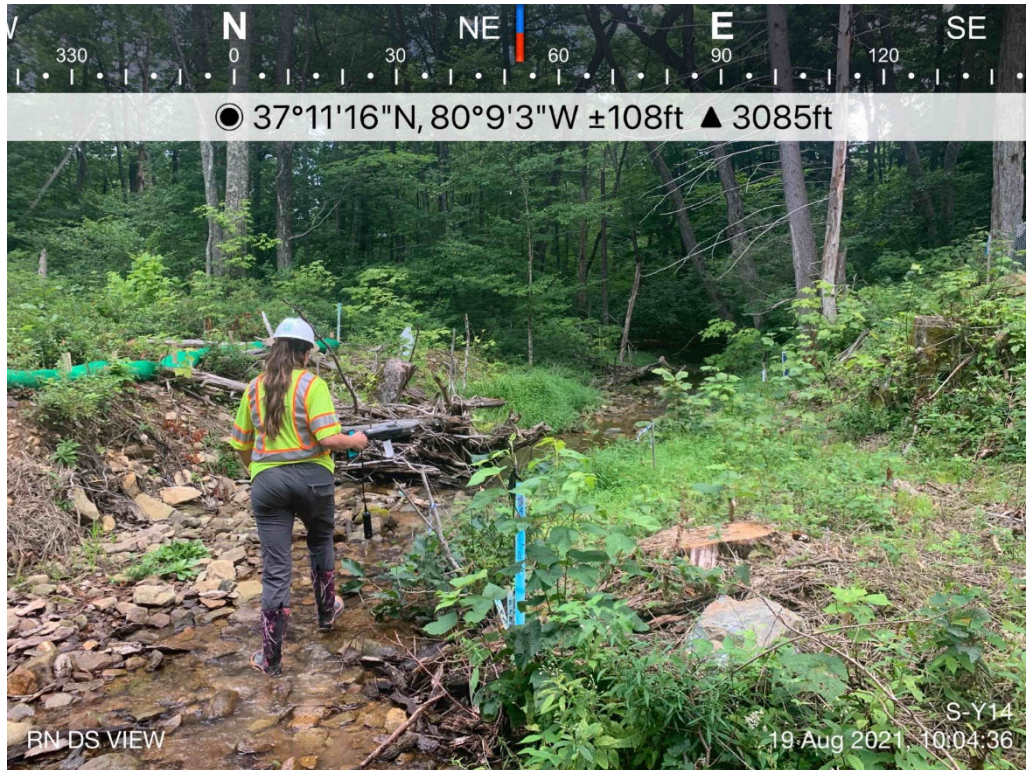
Photo Type: RB DS VIEW

Location, Orientation, Photographer Initials: Standing on RB looking downstream along the ROW looking NE, SB

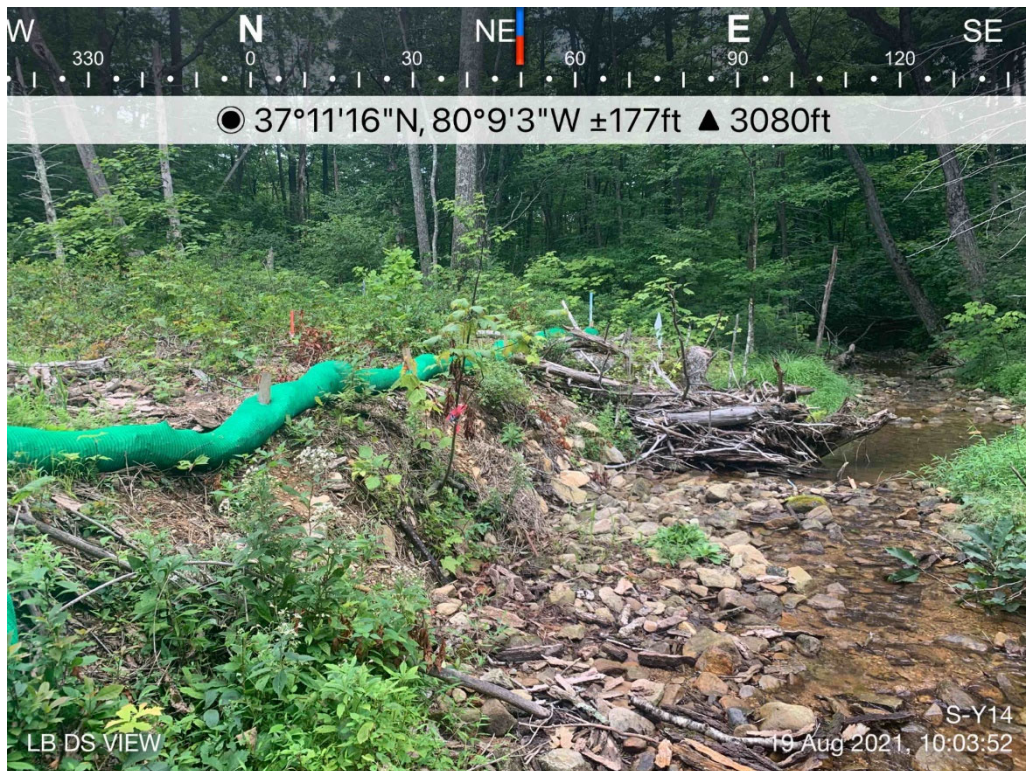
Photo Type: LB DS VIEW

Location, Orientation, Photographer Initials: Standing on LB looking downstream along the ROW looking NE, SB

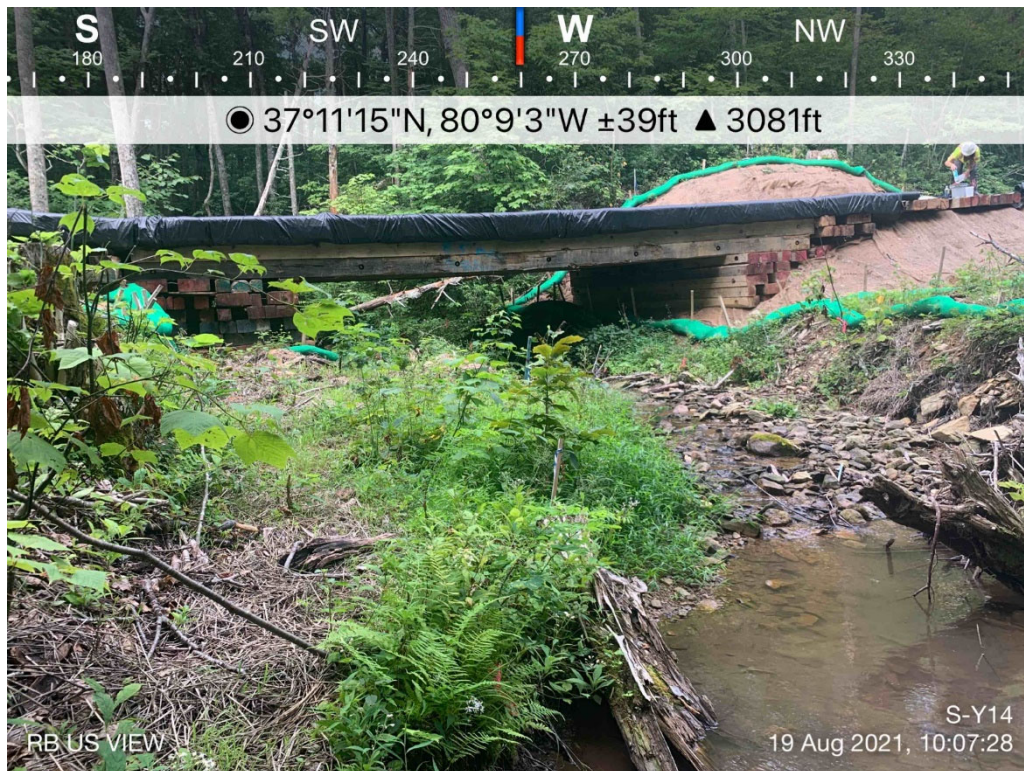
Photo Type: RB US VIEW

Location, Orientation, Photographer Initials: Standing on RB looking upstream along the ROW looking SW, SB

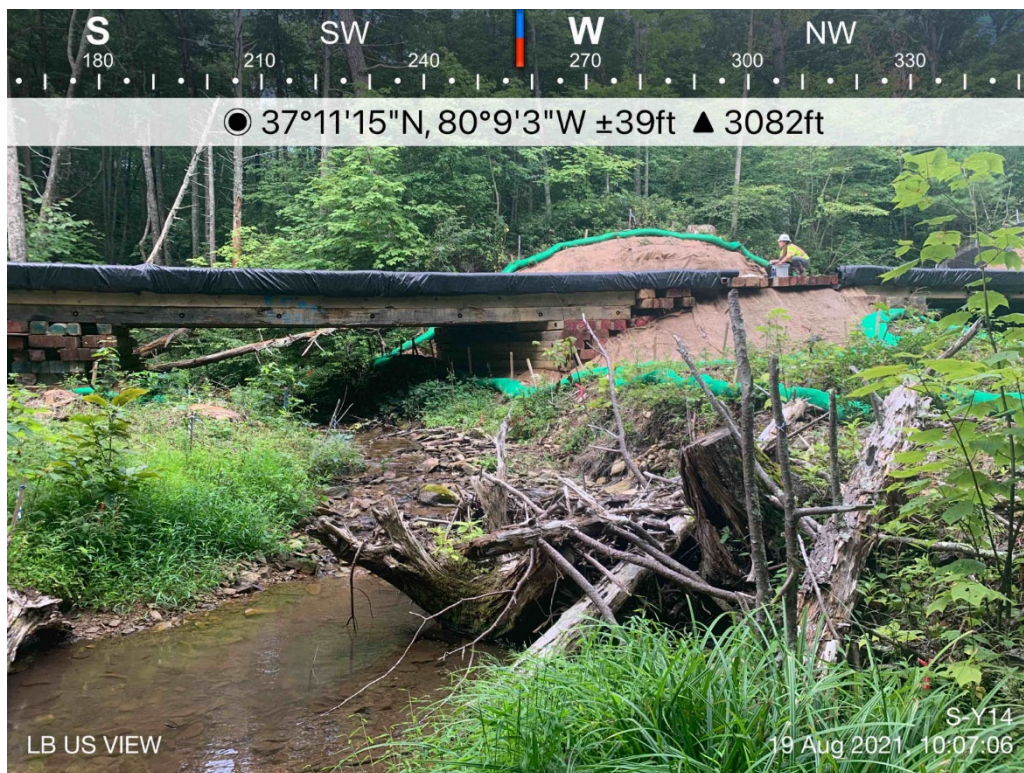
Photo Type: LB US VIEW

Location, Orientation, Photographer Initials: Standing on LB looking upstream along the ROW looking SW, SB

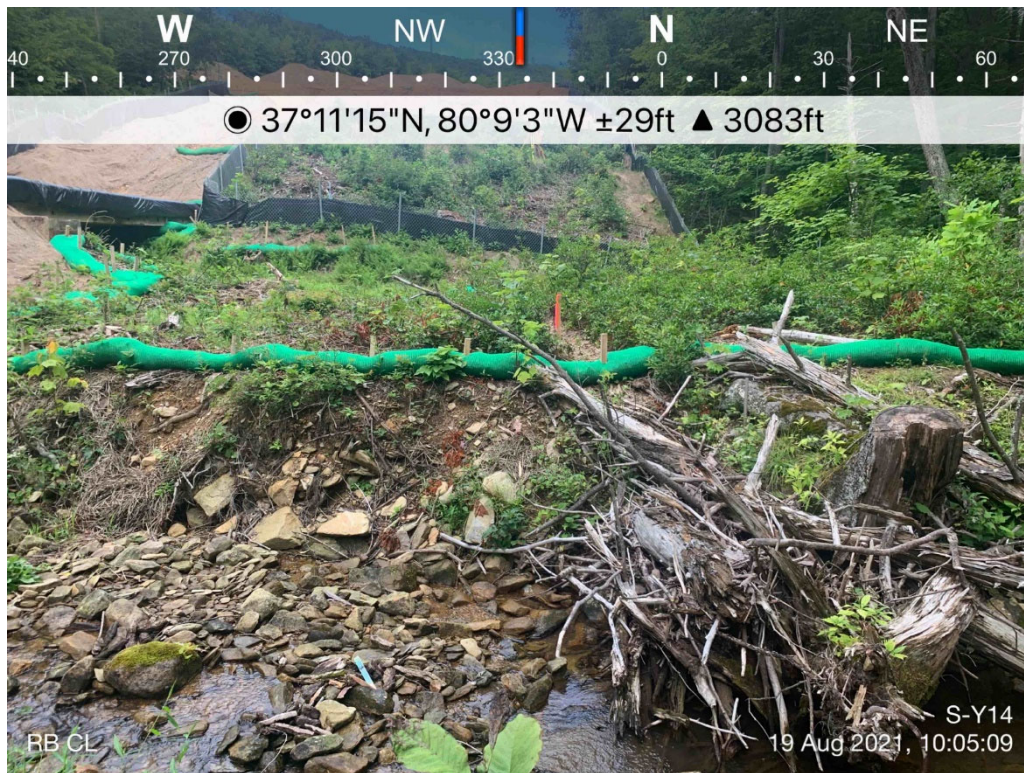
Photo Type: RB CL

Location, Orientation, Photographer Initials: Standing on RB looking at LB along pipe centerline looking NW, SB

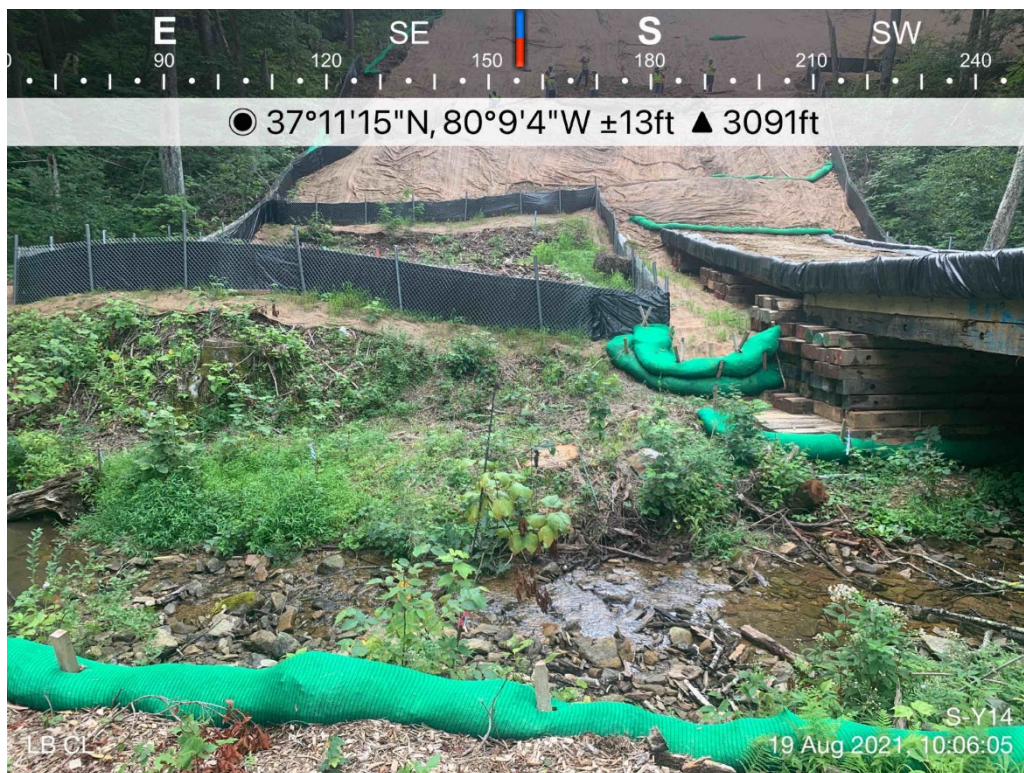
Photo Type: LB CL

Location, Orientation, Photographer Initials: Standing on LB looking at RB along pipe centerline looking SE, SB

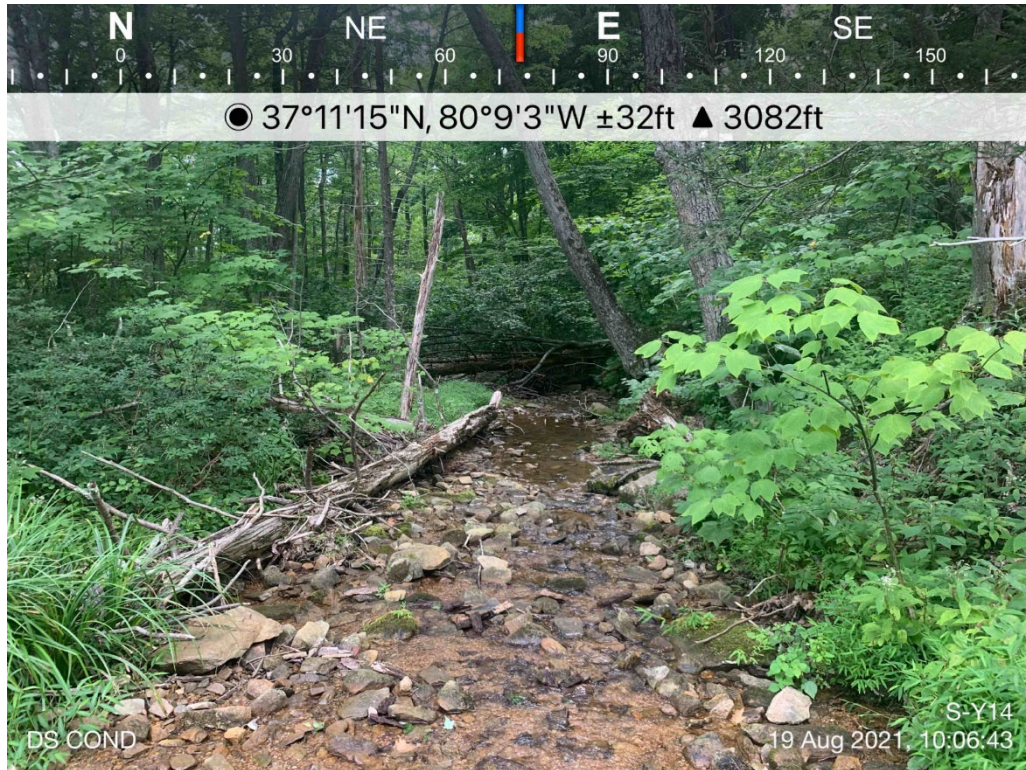
Photo Type: DS COND

Location, Orientation, Photographer Initials: Downstream conditions outside of ROW looking NE, SB

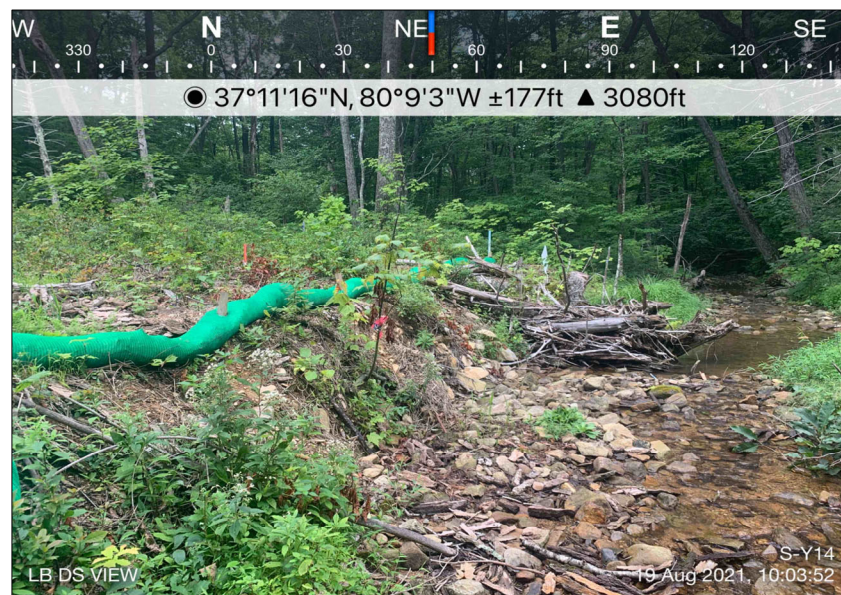
Downstream view within the ROW on the left bank. Assessment limited to areas within the temporary ROW
