Baseline Assessment – Stream Attributes

Reach S-C20 (Timber Mat Crossing) Ephemeral Spread I Franklin County, Virginia

Profile and Cross-Sections Baseline Survey

Crossing S-C20 - UNT to Maggodee Creek (MP 268.9)

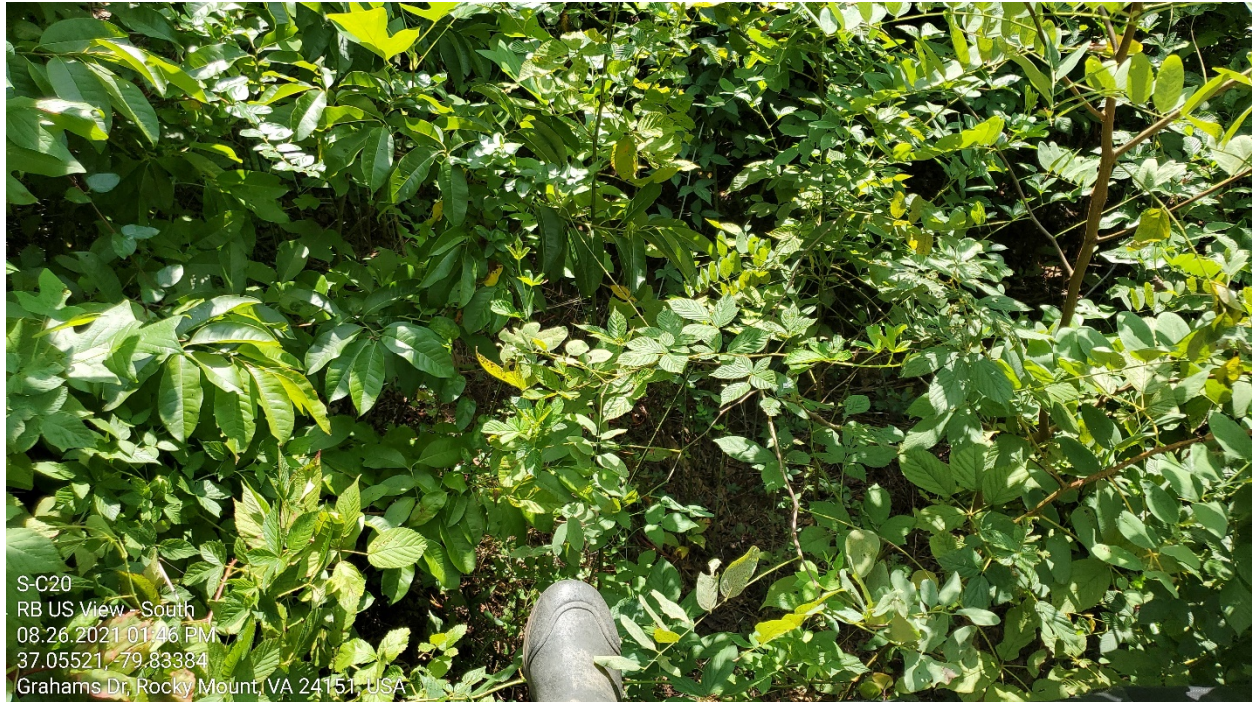
Photo Type: RB US VIEW

Location, Orientation, Photographer Initials: Downstream at ROW/LOD on right bank looking S upstream, DW

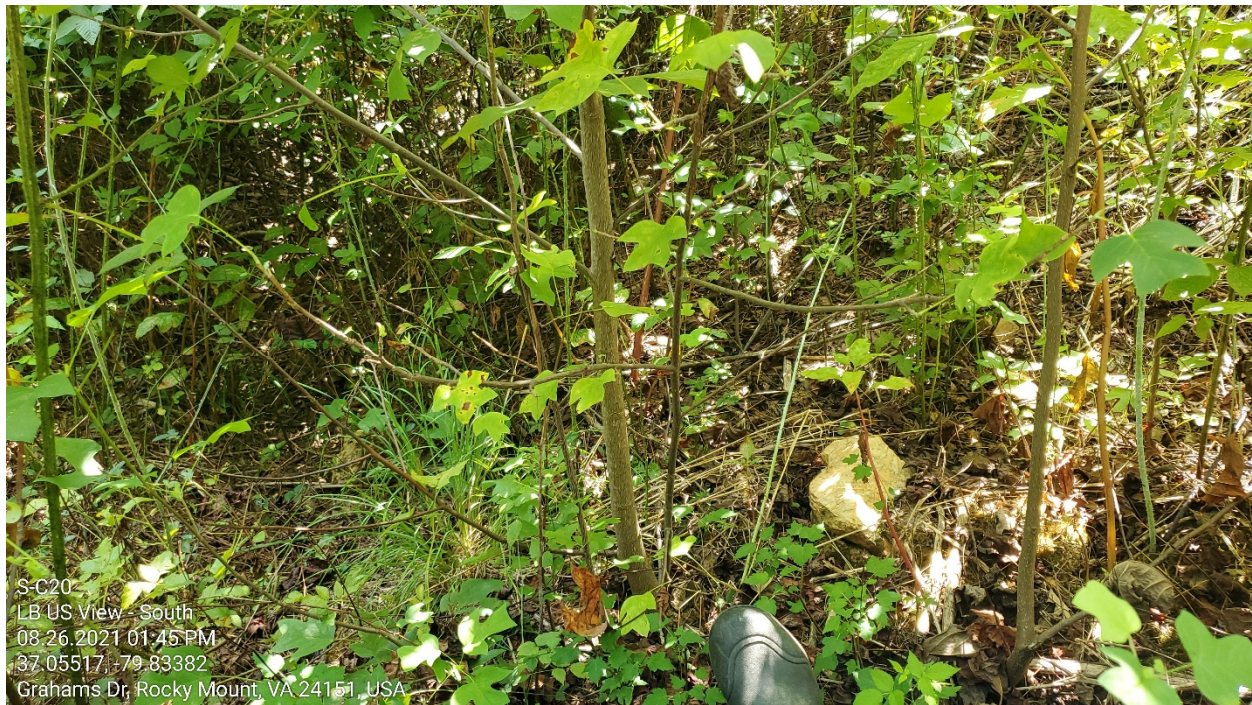
Photo Type: LB US VIEW

Location, Orientation, Photographer Initials: Downstream at ROW/LOD on left bank looking S upstream, DW

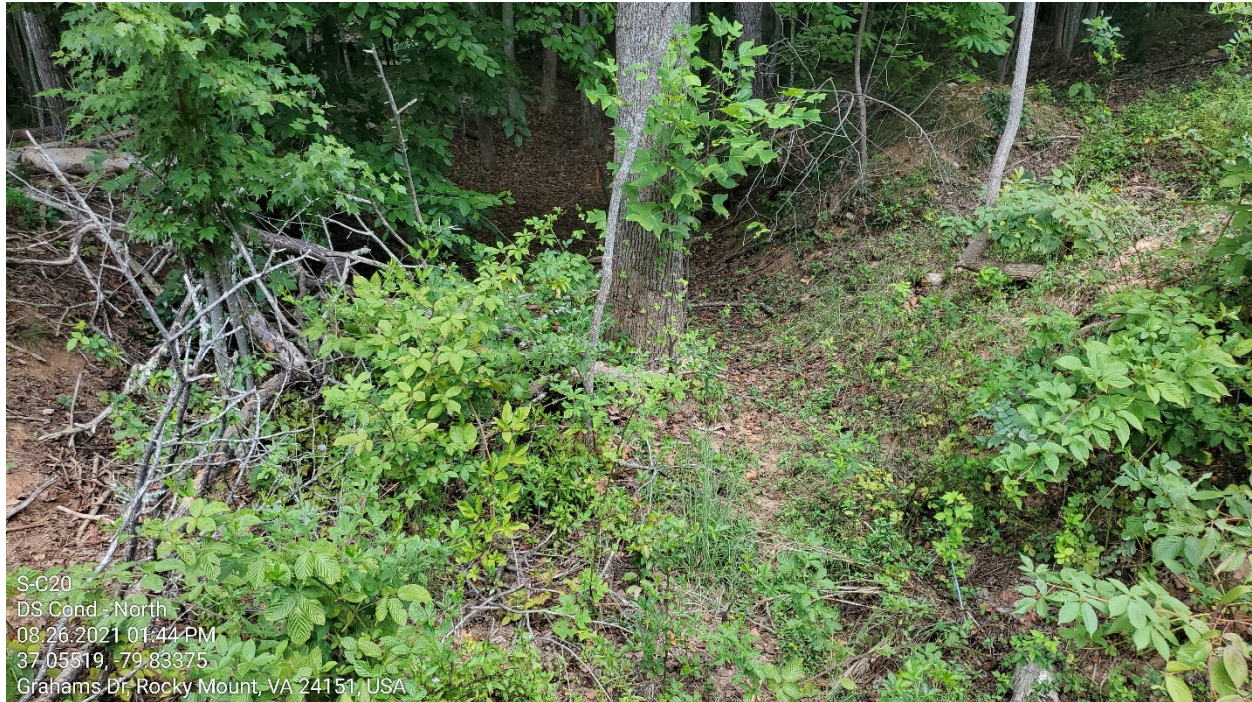
Photo Type: DS COND

Location, Orientation, Photographer Initials: Downstream at ROW/LOD looking N downstream, DW

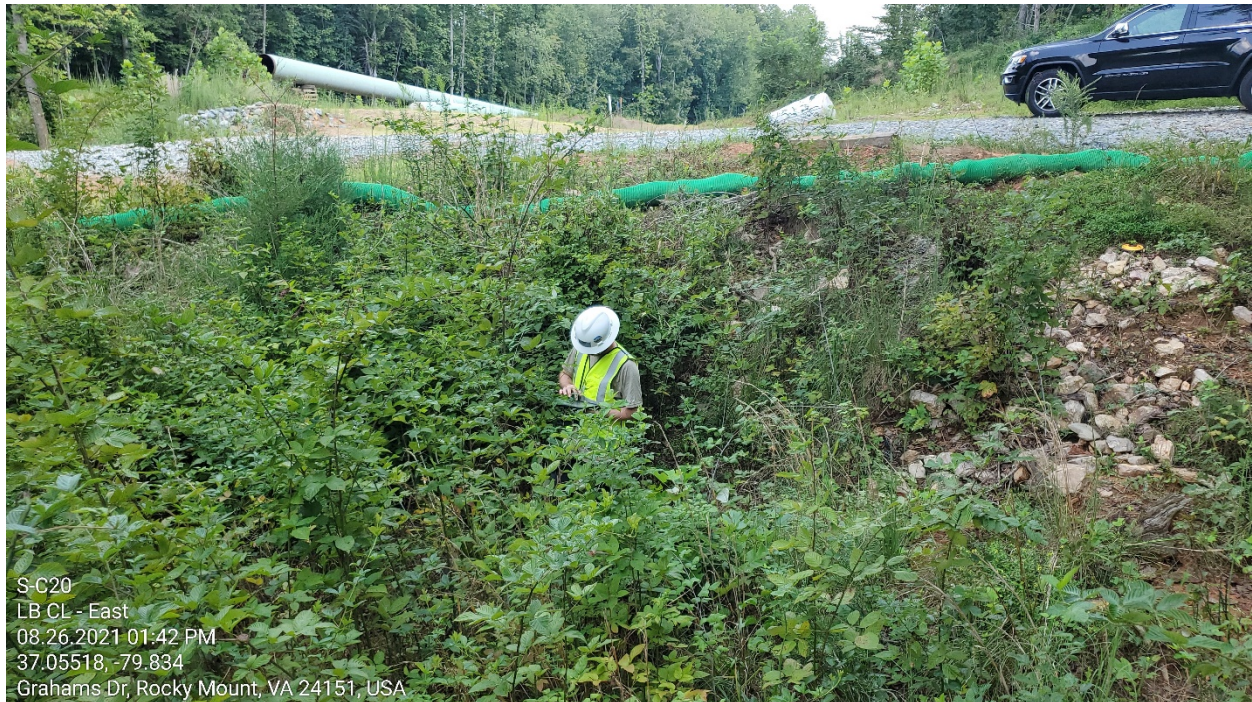
Photo Type: LB CL

Location, Orientation, Photographer Initials: On thalweg at pipe centerline looking E at right streambank, DW

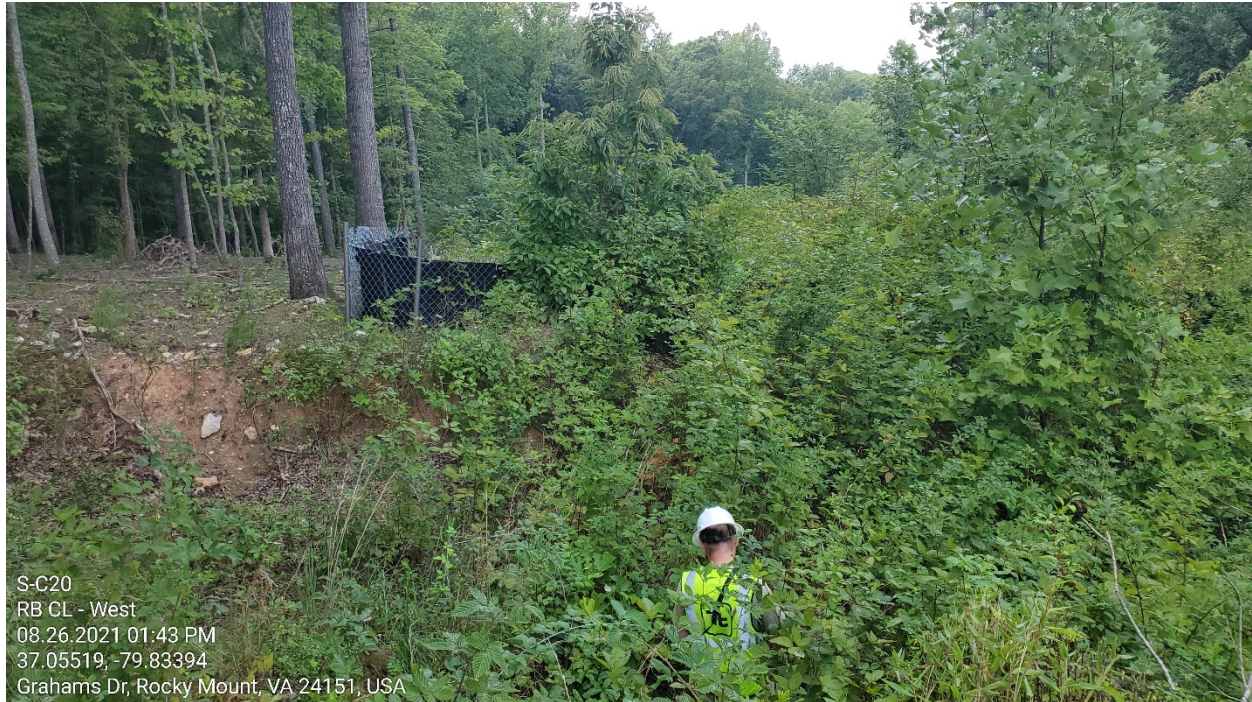
Photo Type: RB CL

Location, Orientation, Photographer Initials: On thalweg at pipe centerline looking W at left streambank, DW

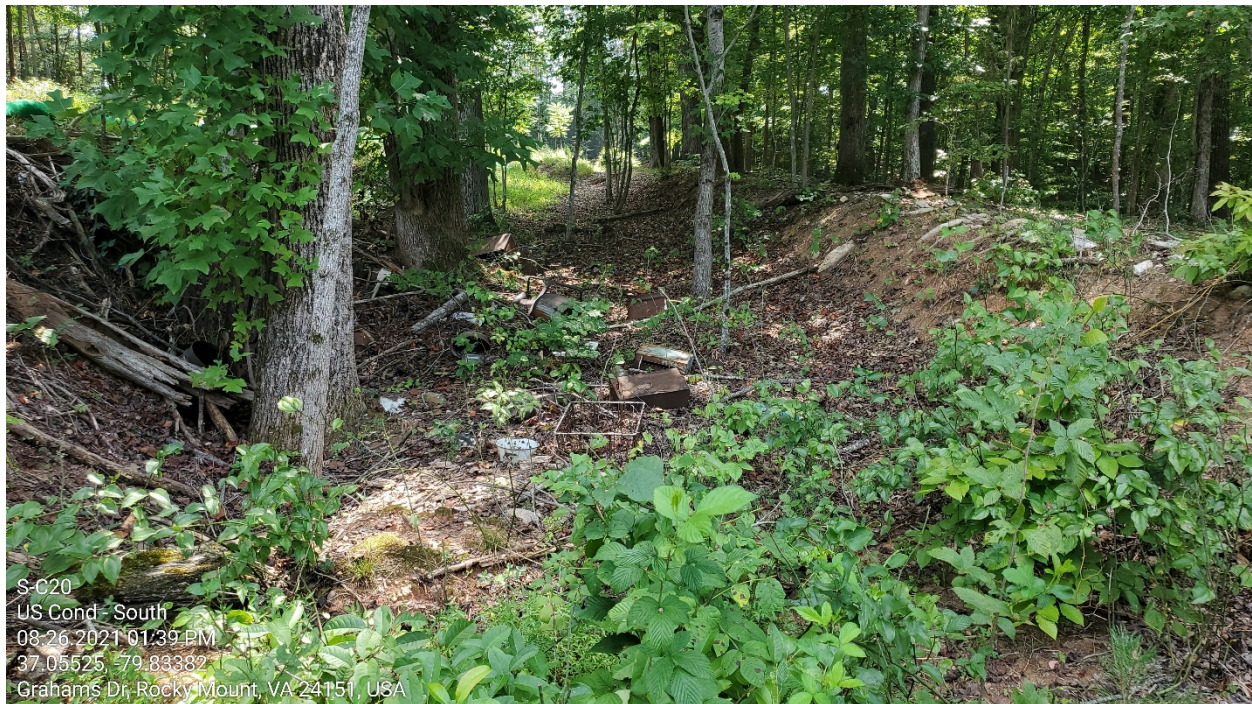
Photo Type: US COND

Location, Orientation, Photographer Initials: Upstream at ROW/LOD looking S upstream, DW

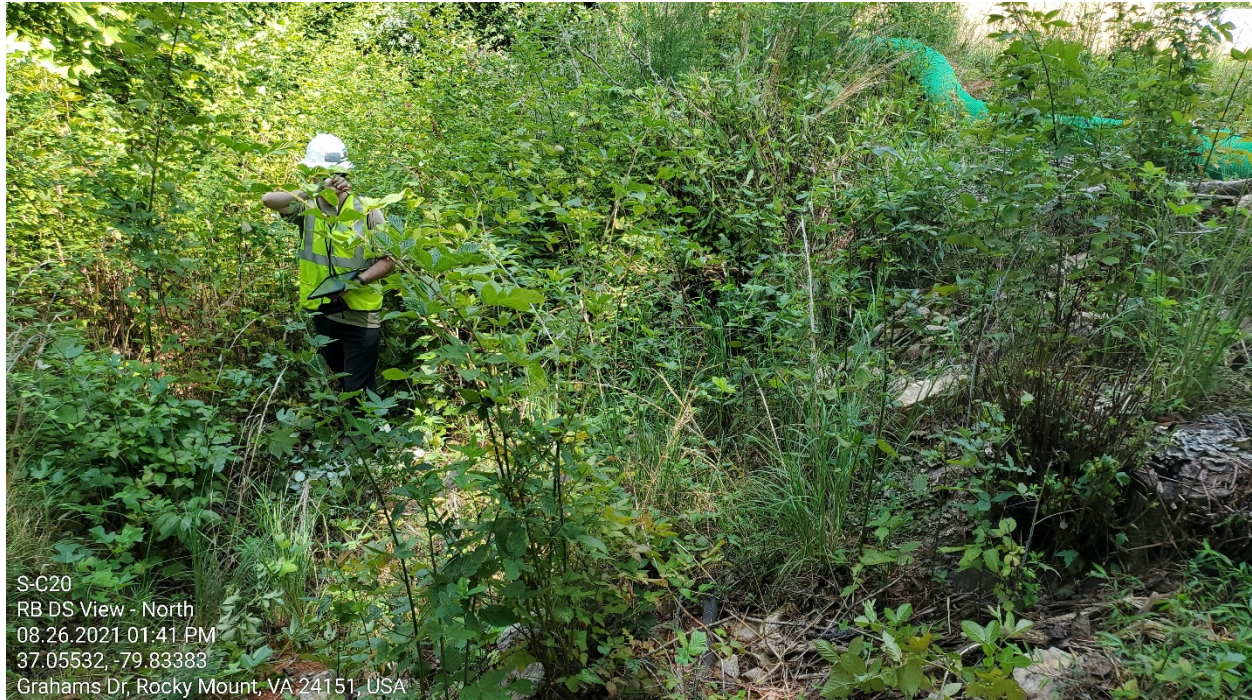
Photo Type: RB DS VIEW

Location, Orientation, Photographer Initials: Upstream at ROW/LOD on right bank looking N downstream, DW

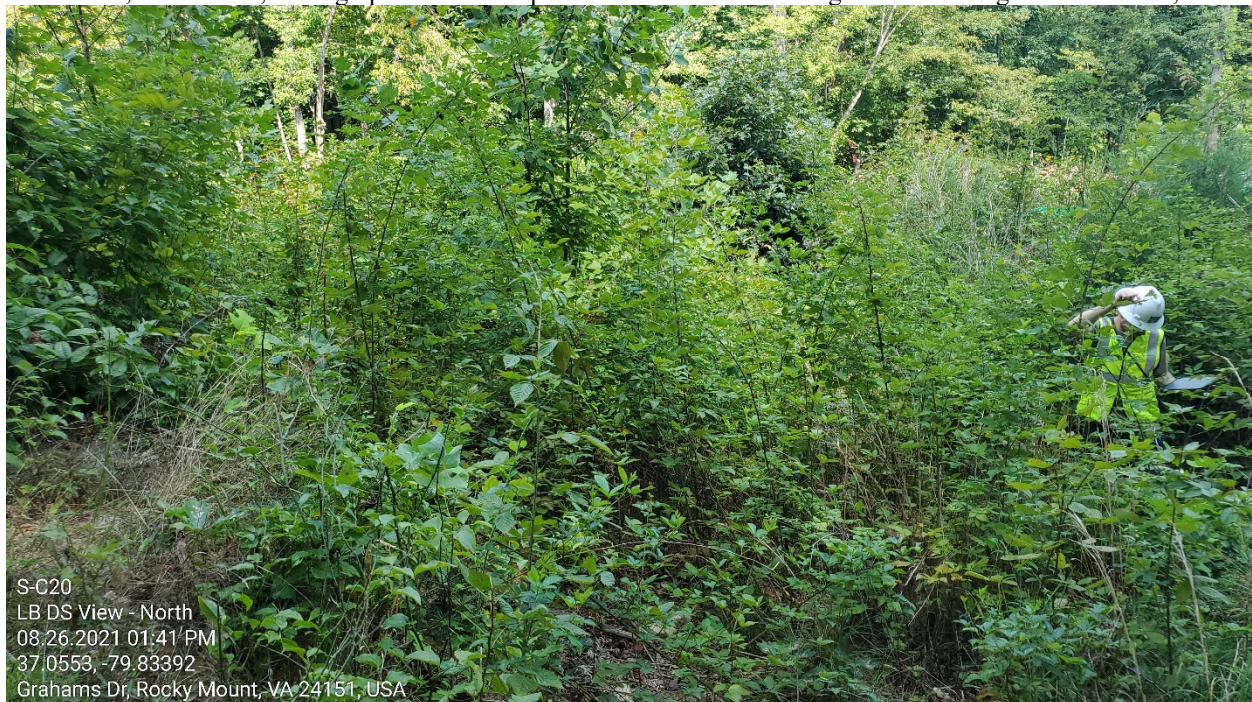
Photo Type: LB DS VIEW

Location, Orientation, Photographer Initials: Upstream at ROW/LOD on left bank looking N downstream, DW

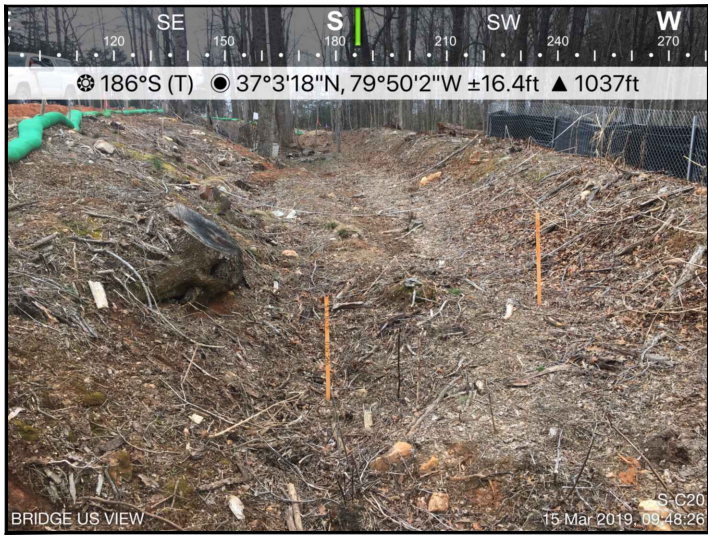
PHOTO TAKEN FROM BRIDGE LOOKING
UPSTREAM TO THE SOUTH ON 03/15/2019

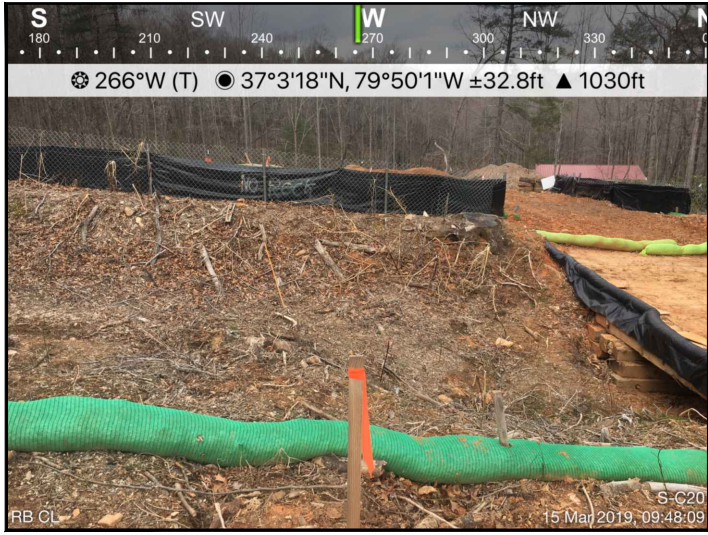
PHOTO TAKEN FROM RIGHT BANK OF CENTERLINE
LOOKING TO THE WEST ON 03/15/2019
