Baseline Assessment – Stream Attributes

Reach S-CC15 (Timber Mat Crossing/) Perennial Spread I Pittsylvania County, Virginia

Profile and Cross-Sections Baseline Survey

Crossing S-CC15- UNT to Cherrystone Creek (MP 293.6)

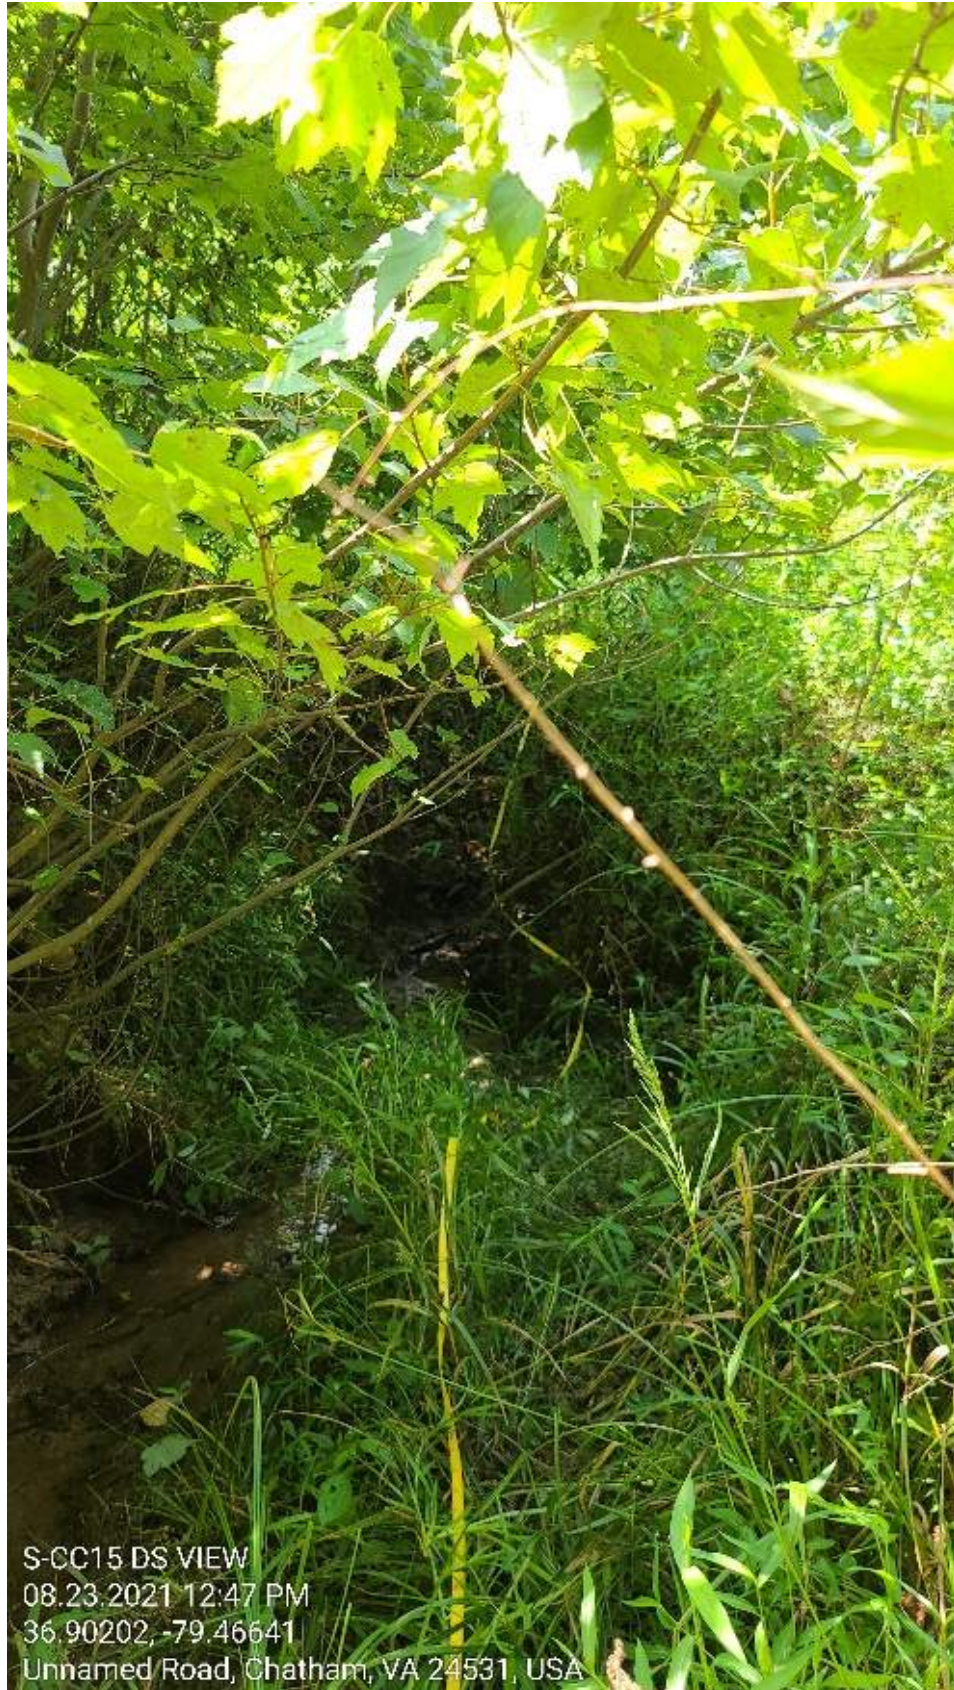
Photo Type: DS VIEW

S-CC15 DS VIEW
08.23.2021 12:47 PM
36.90202, -79.46641
Unnamed Road, Chatham, VA 24531, USA

Location, Orientation, Photographer Initials: Downstream view of ROW/LOC looking SE, AJ, VM

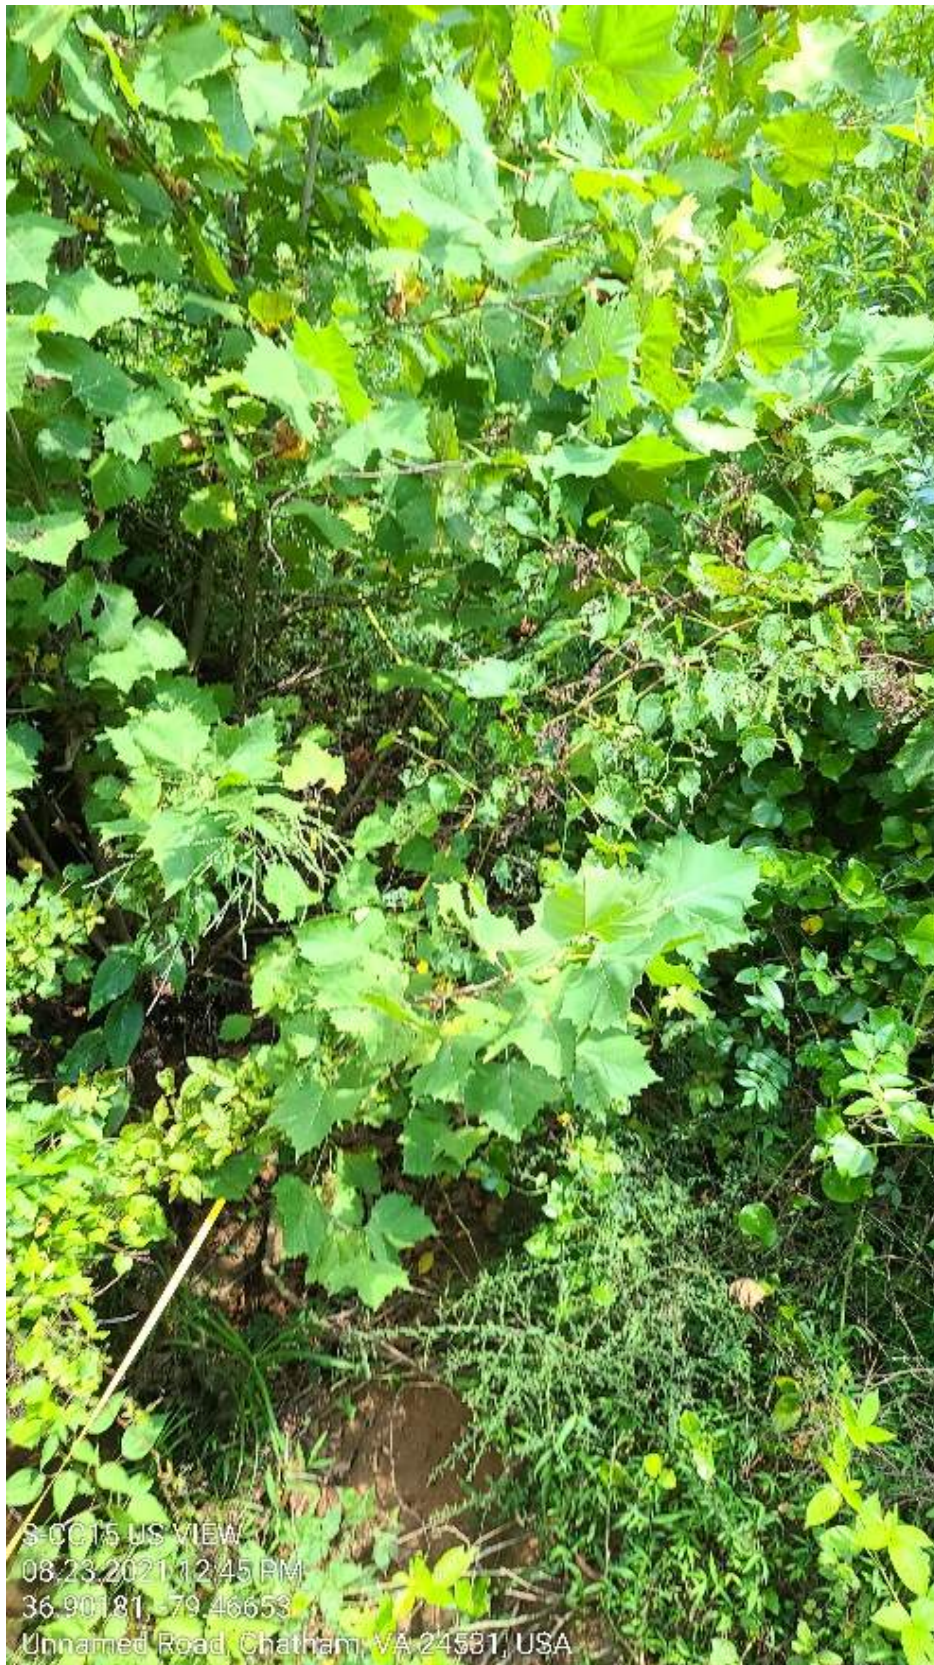
Photo Type: US VIEW

S-CC15 US VIEW
08.23.2021 12:45 PM
36.90181, -79.46653
Unnamed Road, Chatham, VA 24581, USA

Location, Orientation, Photographer Initials: Upstream view of ROW/LOC looking W, AJ, VM

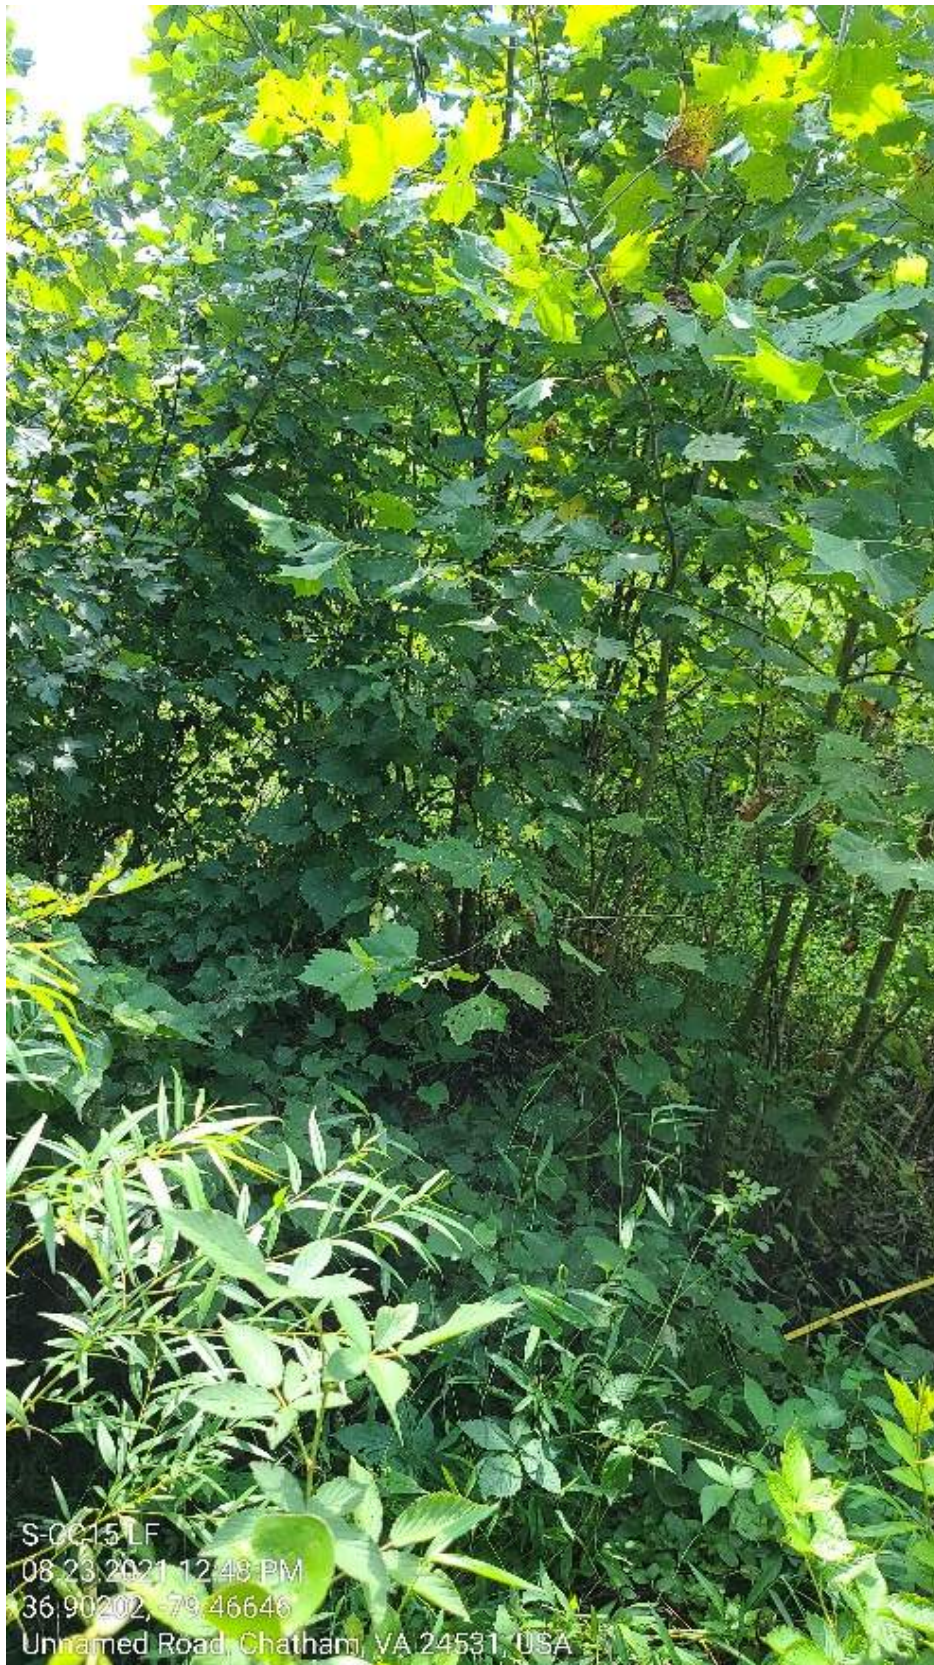
Photo Type: LB CL

Location, Orientation, Photographer Initials: Standing on LB looking at RB along pipe centerline looking S, AJ, VM

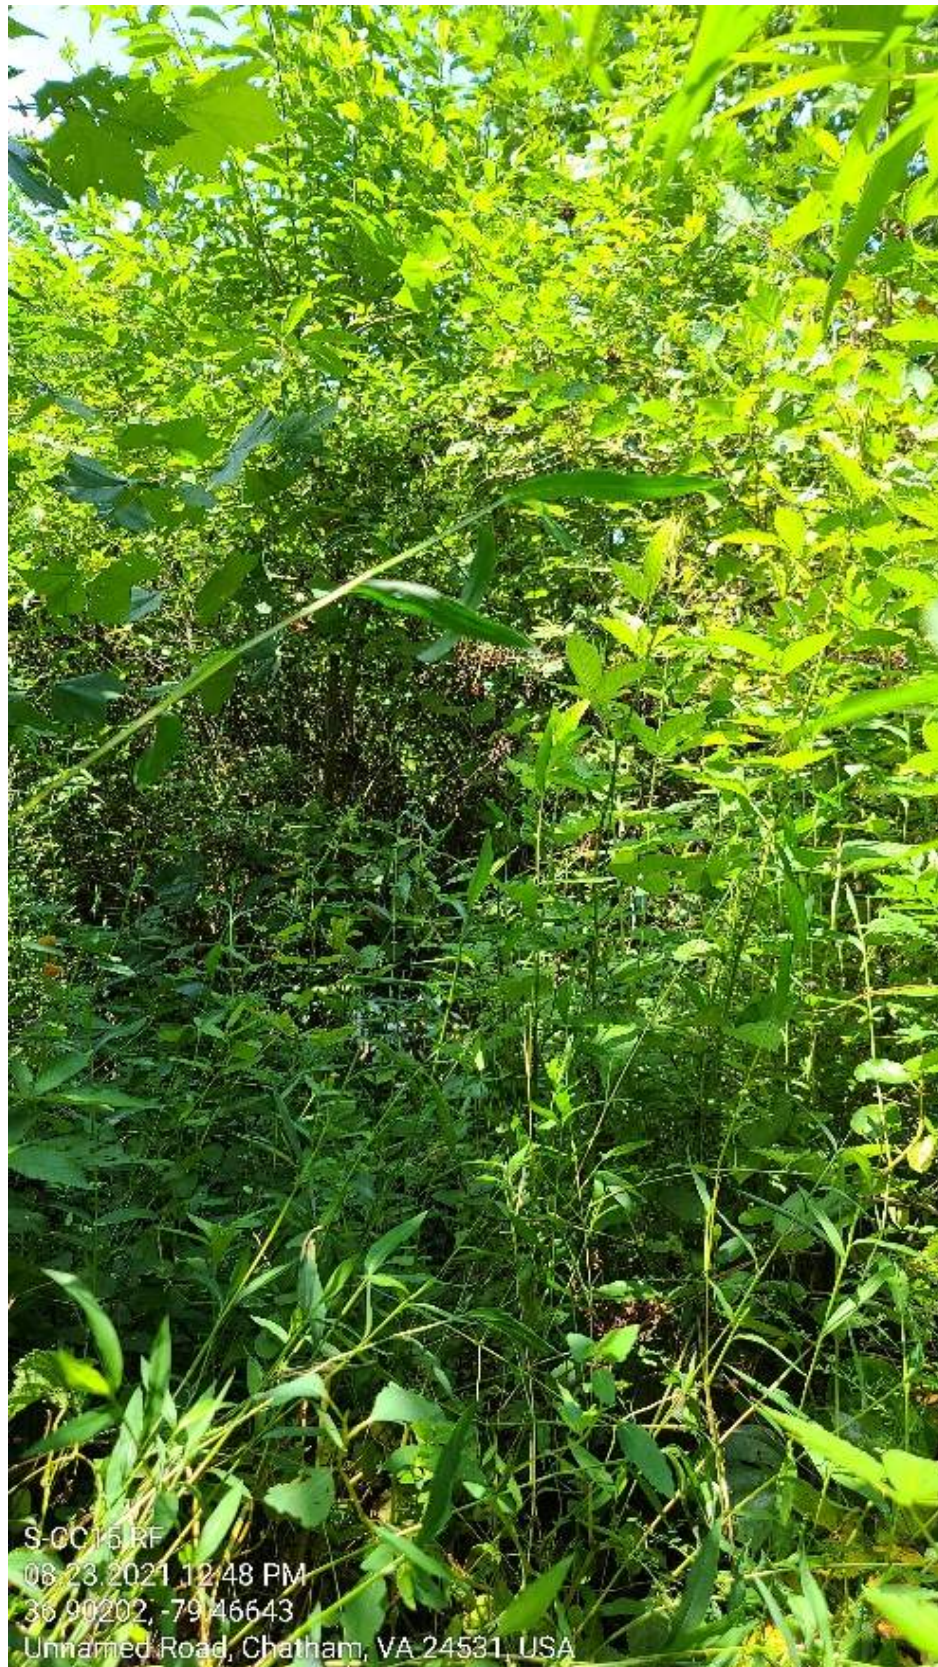
Photo Type: RB CL

Location, Orientation, Photographer Initials: Standing on RB looking at LB along pipe centerline looking S, AJ, VM

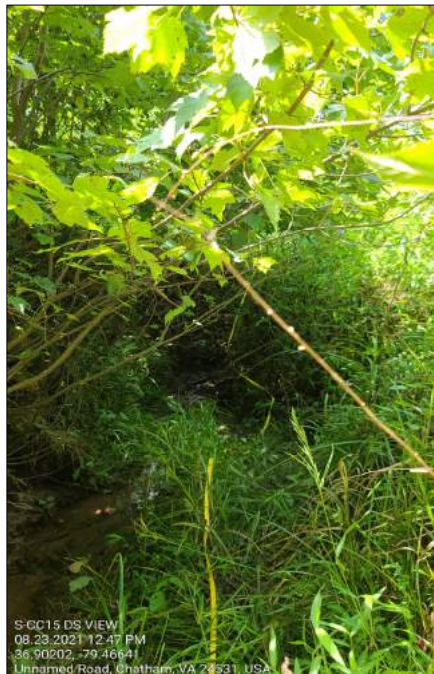
CAPTION: Assessment is limited to areas within the temporary ROW.
