## Baseline Assessment – Stream Attributes

**Reach S-CC5  
(Timber Mat Crossing)  
Perennial  
Spread I  
Pittsylvania County, Virginia**

USACE FILE NO./ Project Name: (v2.1, Sept 2015)				Mountain Valley Pipeline				IMPACT COORDINATES: (in Decimal Degrees)				Lat.	36.899248				Lon.	-79.462396				WEATHER:				Sunny				DATE:				8/23/2021																									
IMPACT STREAM/SITE ID AND SITE DESCRIPTION: (watershed size {acreage}, unaltered or impairments)												S-CC5; 975.29 Acres												MITIGATION STREAM CLASS./SITE ID AND SITE DESCRIPTION: (watershed size {acreage}, unaltered or impairments)												Comments:																							
STREAM IMPACT LENGTH:				20				FORM OF MITIGATION:				RESTORATION (Levels I-III)				MIT COORDINATES: (in Decimal Degrees)				Lat.					Lon.					PRECIPITATION PAST 48 HRS:				No				Mitigation Length:																					
Column No. 1- Impact Existing Condition (Debit)												Column No. 2- Mitigation Existing Condition - Baseline (Credit)												Column No. 3- Mitigation Projected at Five Years Post Completion (Credit)												Column No. 4- Mitigation Projected at Ten Years Post Completion (Credit)												Column No. 5- Mitigati

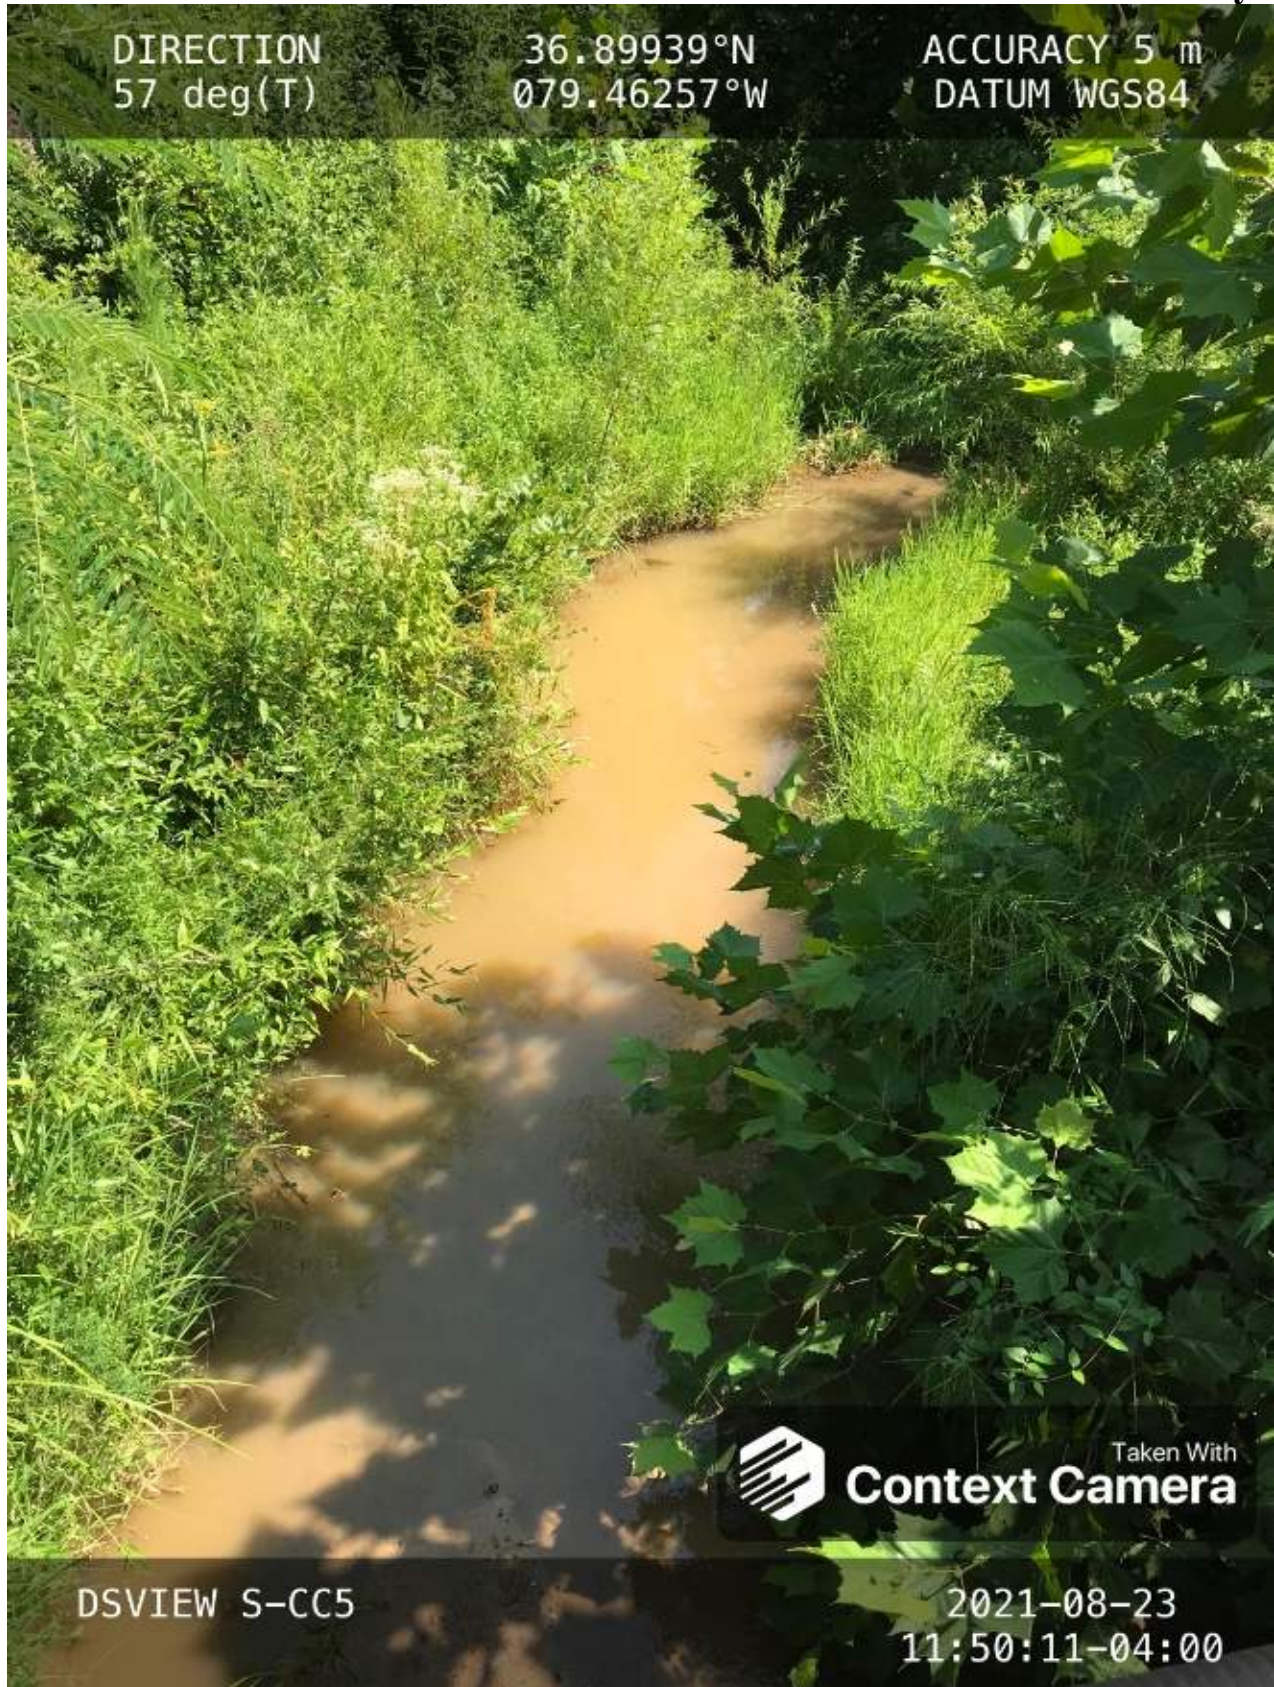
Photo Type: DS VIEW

Location, Orientation, Photographer Initials: Downstream view of ROW/LOC looking SE, RH, CL

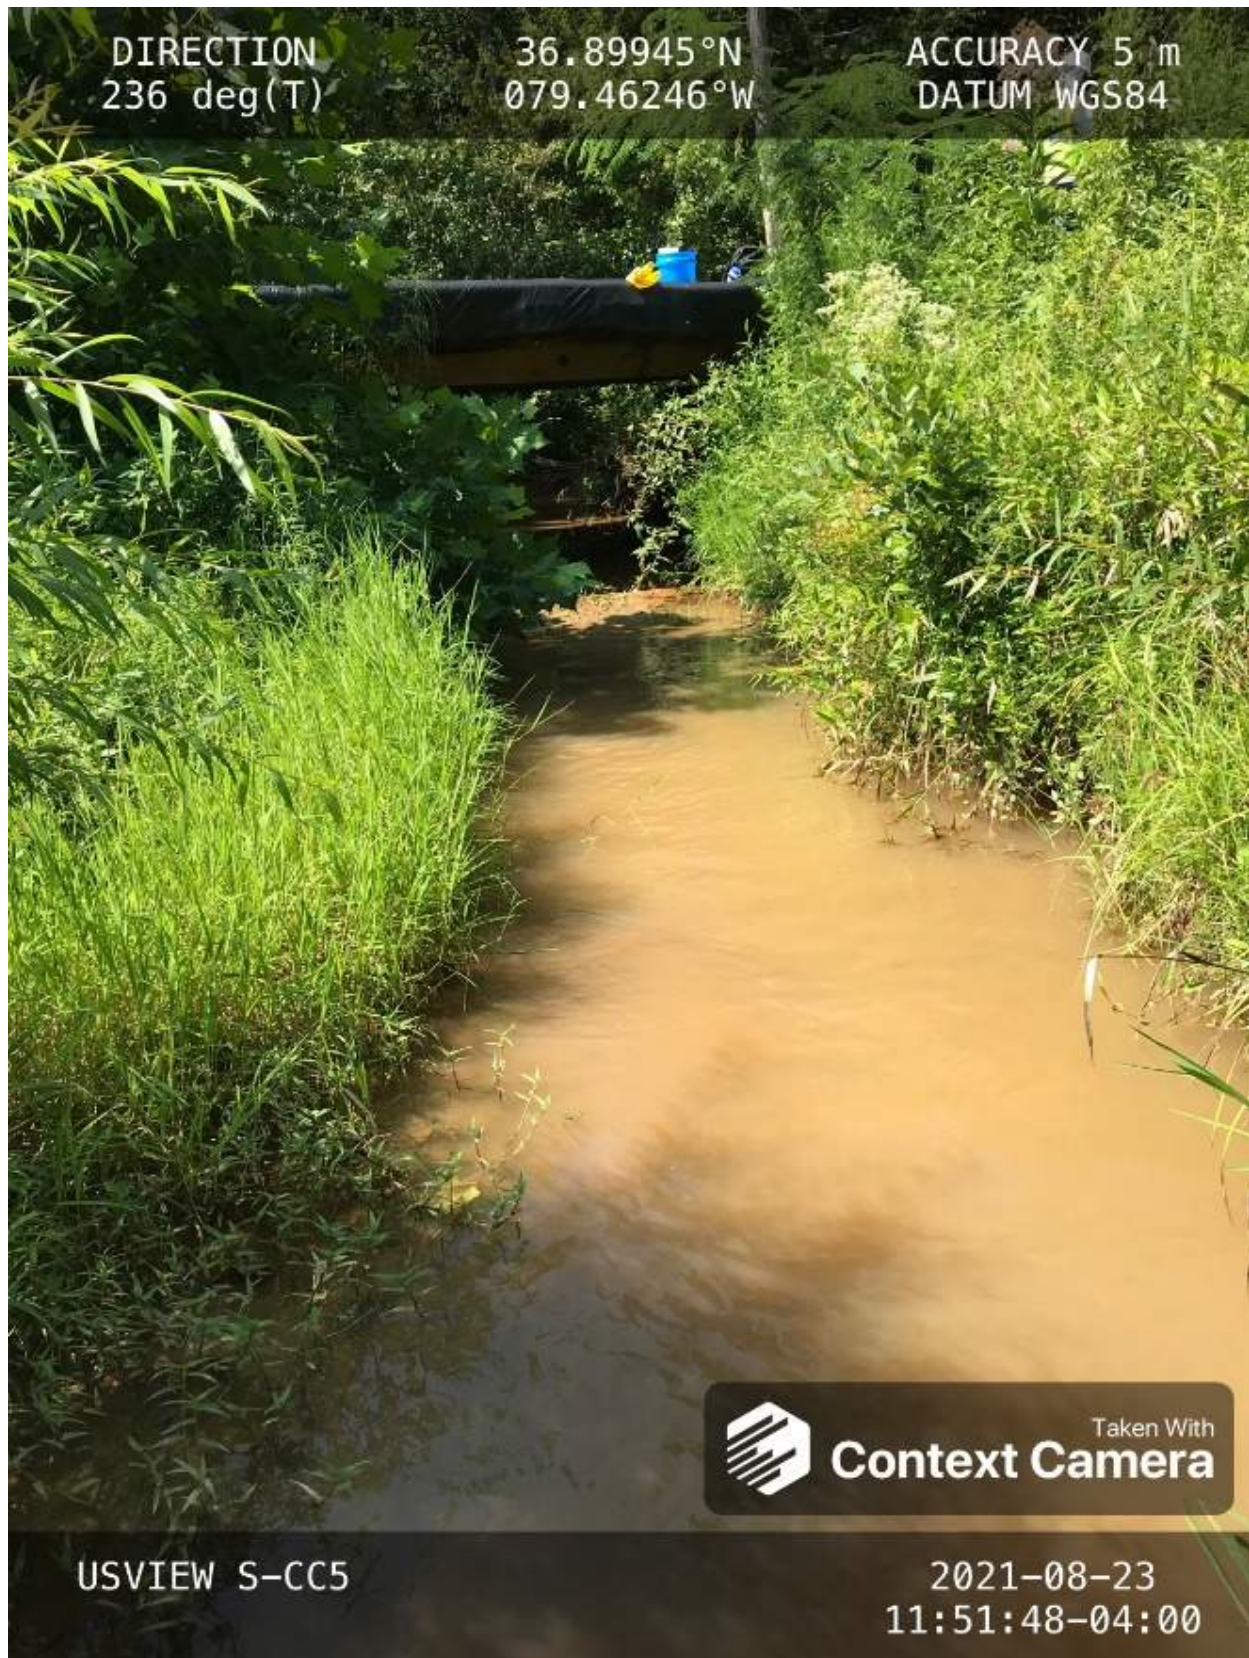
Photo Type: US VIEW

Location, Orientation, Photographer Initials: Upstream view of ROW/LOC looking W, RH, CL

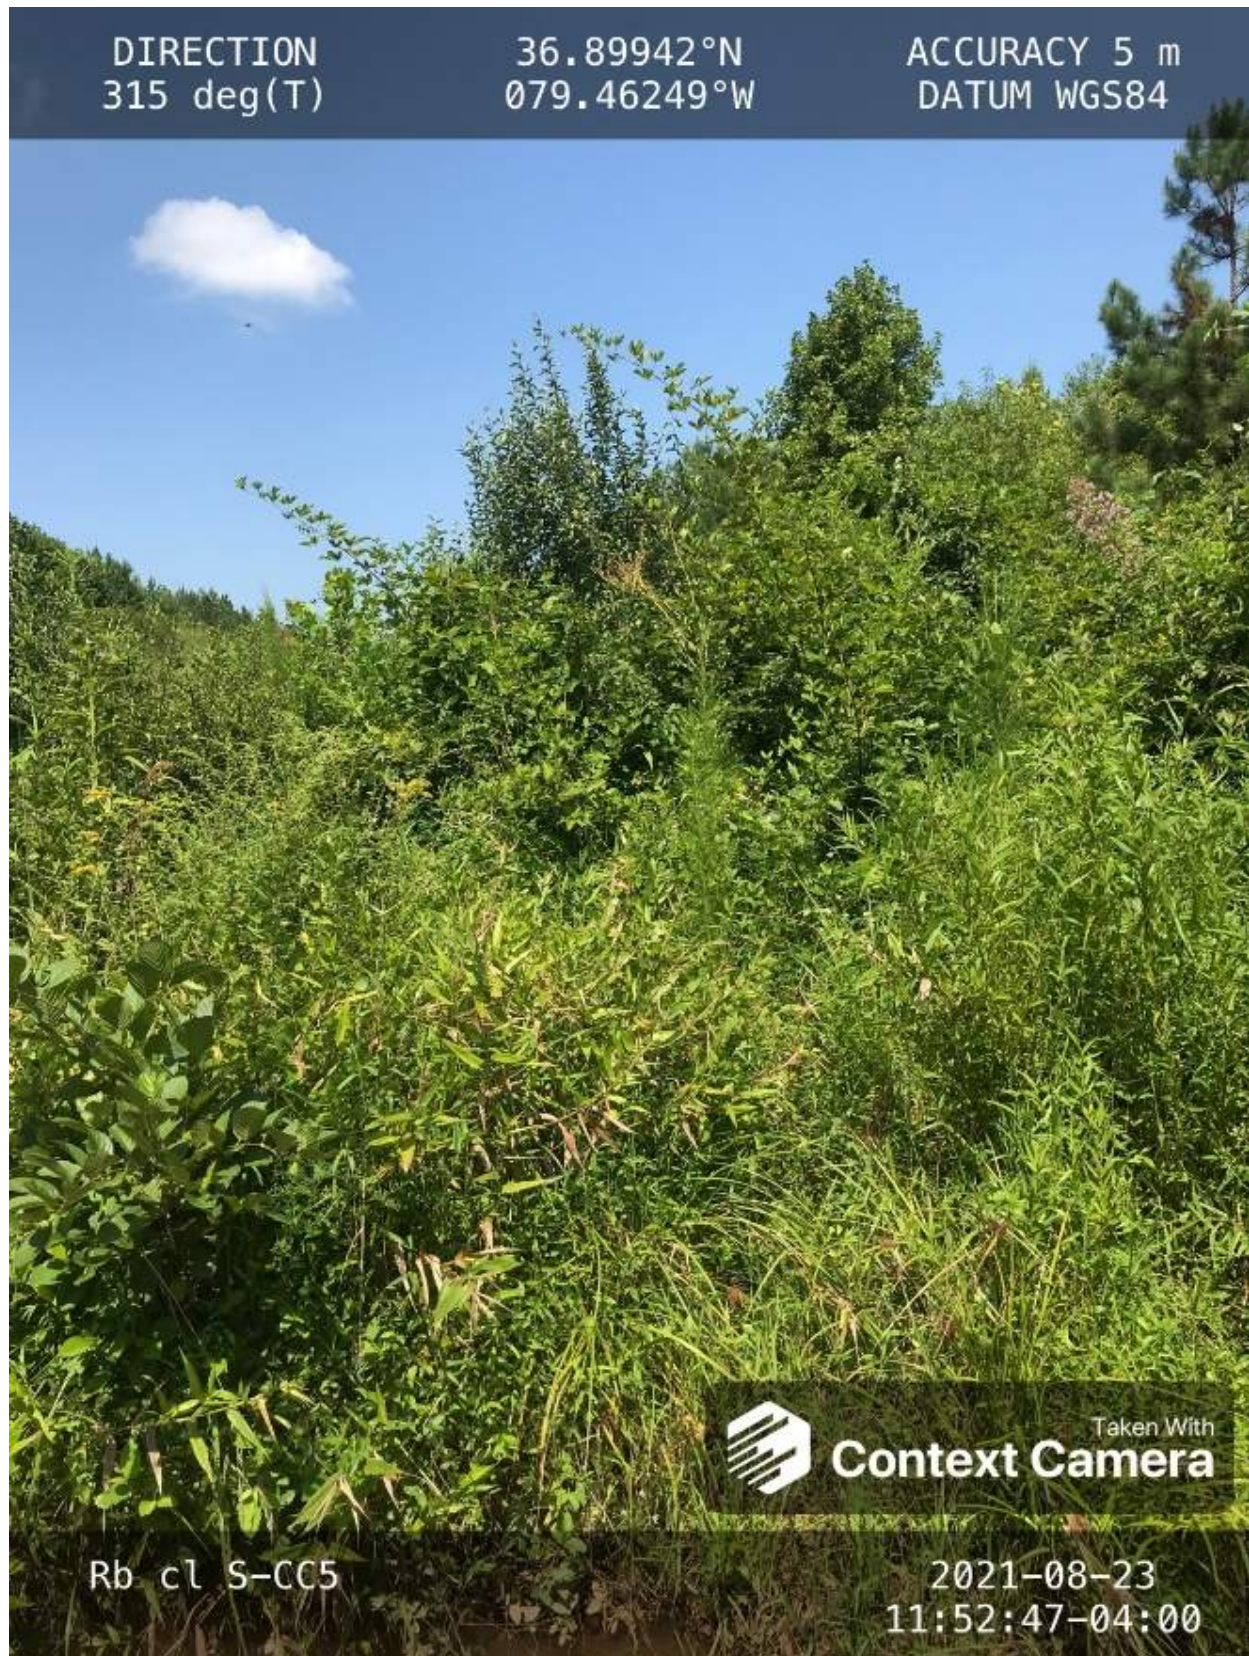
Photo Type: RB CL

Location, Orientation, Photographer Initials: Standing on RB looking at LB along pipe centerline looking S, RH, CL

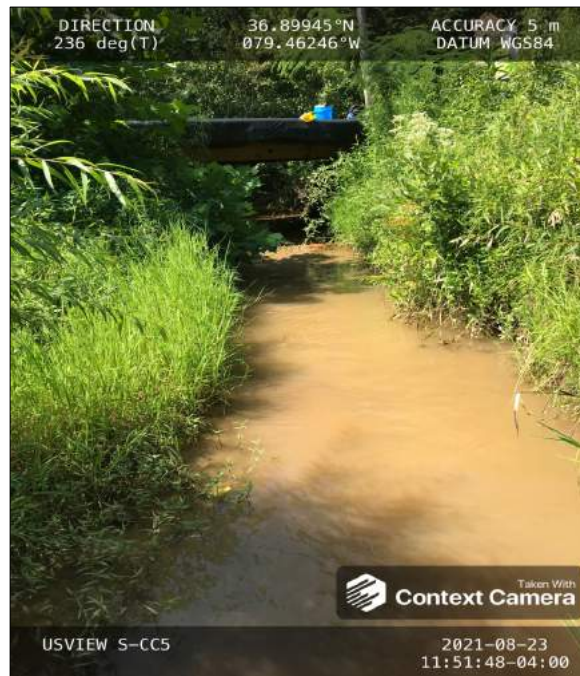
**CAPTION.** Assessment is limited to areas within the temporary ROW.
