Baseline Assessment – Stream Attributes

Reach S-D22 (Pipeline ROW)

Franklin County, Virginia

USACE FILE NO./ Project Name: <small>(V2.1, Sept 2015)</small>		Mountain Valley Pipeline		IMPACT COORDINATES: (in Decimal Degrees)		Lat.	37.070101	Lon.	-79.929732	WEATHER:		Sunny		DATE:		August 27, 2021			
IMPACT STREAM/SITE ID AND SITE DESCRIPTION: <small>(watershed size (acres), unaltered or impairments)</small>				S-D22				MITIGATION STREAM CLASS/SITE ID AND SITE DESCRIPTION: <small>(watershed size (acres), unaltered or impairments)</small>				Comments:							
STREAM IMPACT LENGTH:		83		FORM OF MITIGATION:		RESTORATION (Levels I-III)		MIT COORDINATES: (in Decimal Degrees)		Lat.		Lon.		PRECIPITATION PAST 48 HRS:		No		Mitigation Length:	
Column No. 1- Impact Existing Condition (Debit)				Column No. 2- Mitigation Existing Condition - Baseline (Credit)				Column No. 3- Mitigation Projected at Five Years Post Completion (Credit)				Column No. 4- Mitigation Projected at Ten Years Post Completion (Credit)				Column No. 5- Mitigation Projected at Maturity (Credit)

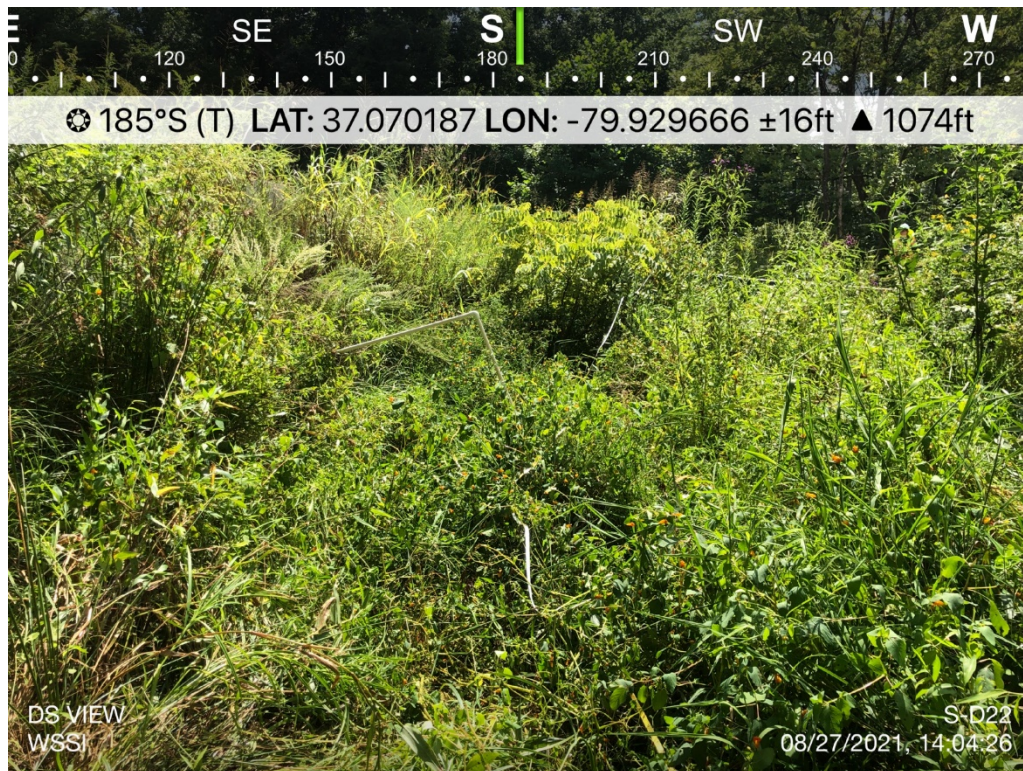
Photo Type: DS VIEW

Location, Orientation, Photographer Initials: Downstream view of ROW looking S, AO

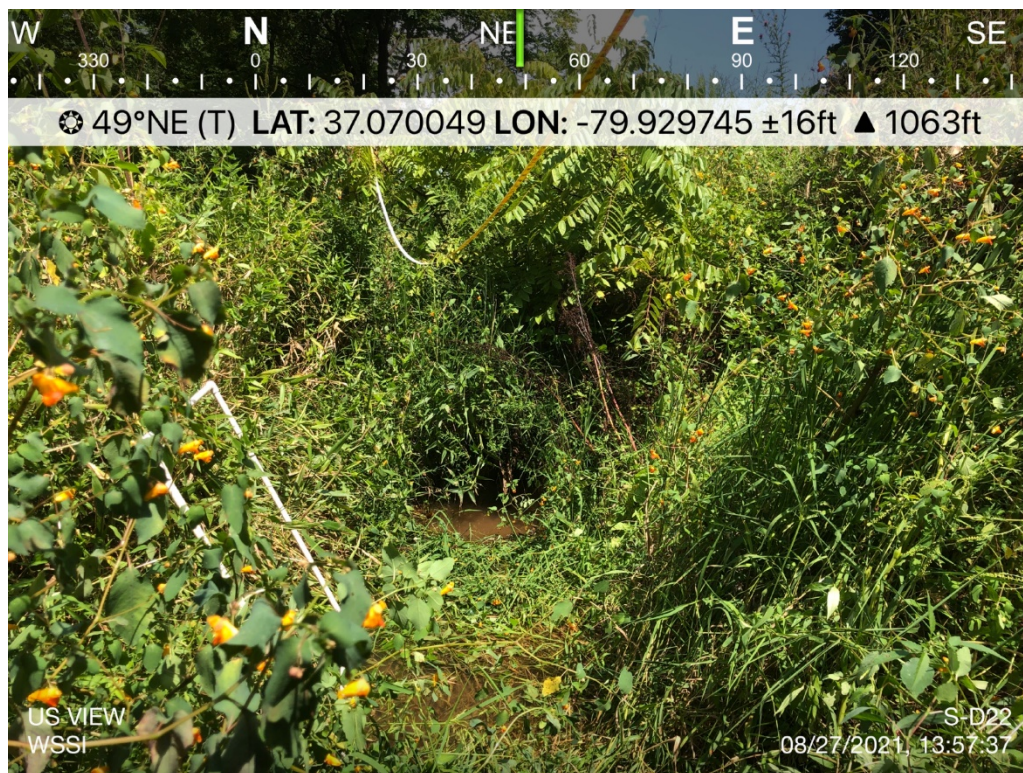
Photo Type: US VIEW

Location, Orientation, Photographer Initials: Upstream view of ROW looking NE, AO

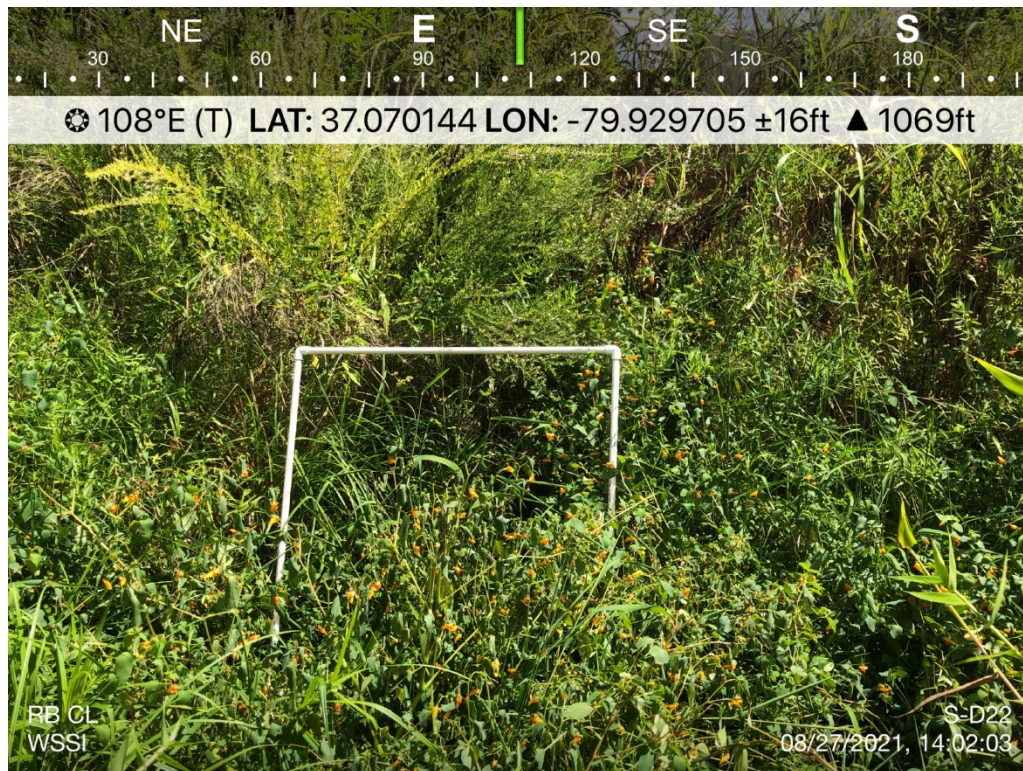
Photo Type: RB CL

Location, Orientation, Photographer Initials: Standing on RB looking at LB along pipe centerline looking E, AO

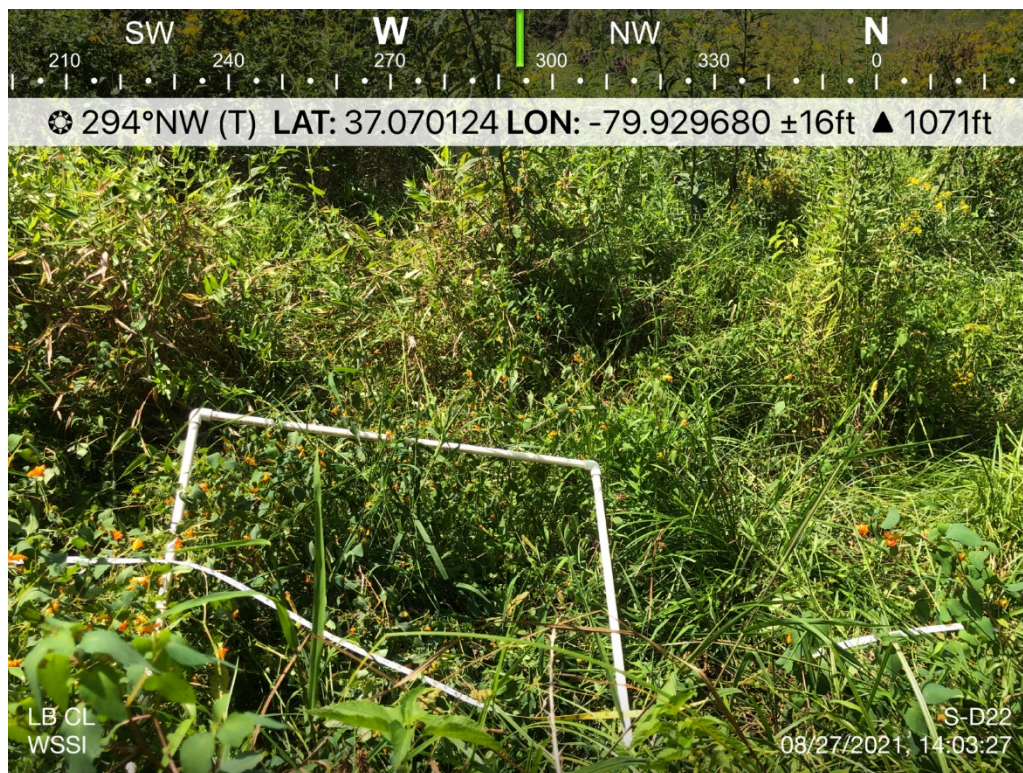
Photo Type: LB CL

Location, Orientation, Photographer Initials: Standing on LB looking at RB along pipe centerline looking NW, AO

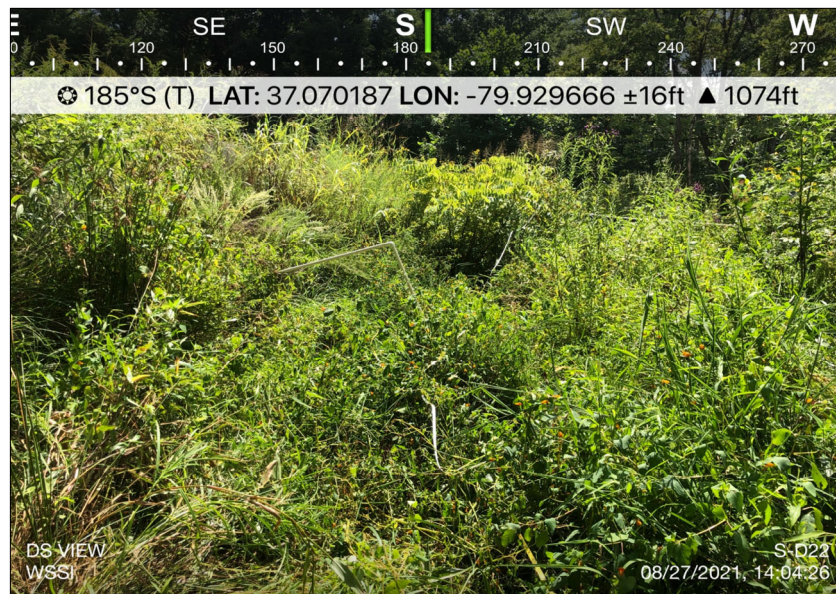
(WSSI Photo Location "L:\22000s\22800\22865.06\Admin\05-ENVR\Field Data\Spread I\Field Forms\S-D22\Photos\S-D22_DS VIEW_2021-08-27.jpg")

Looking downstream within the ROW. Assessment is limited to areas within the temporary ROW.
