Baseline Assessment – Stream Attributes

Reach S-D7 (Pipeline ROW) Intermittent Spread I Franklin County, Virginia

Spread I Stream S-D7 (Pipeline ROW) Franklin County

Profile and Cross-Sections Baseline Survey
Prepared For: MVP
Crossing S-D7 & W-MM17 - UNT to Jonnikin Creek (MP 283.4)
Franklin County, Virginia
Copyright © 2021 Wetland Studies and Solutions, Inc.

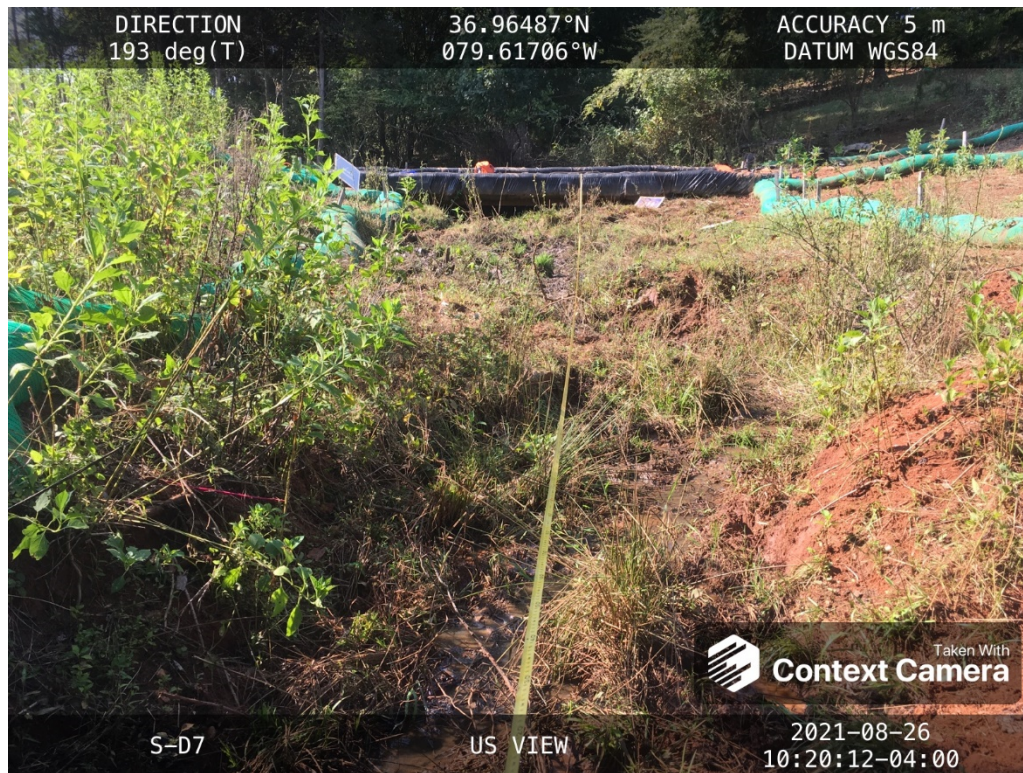
Photo Type: US VIEW

Location, Orientation, Photographer Initials: Downstream at ROW/LOD looking SW upstream, CB

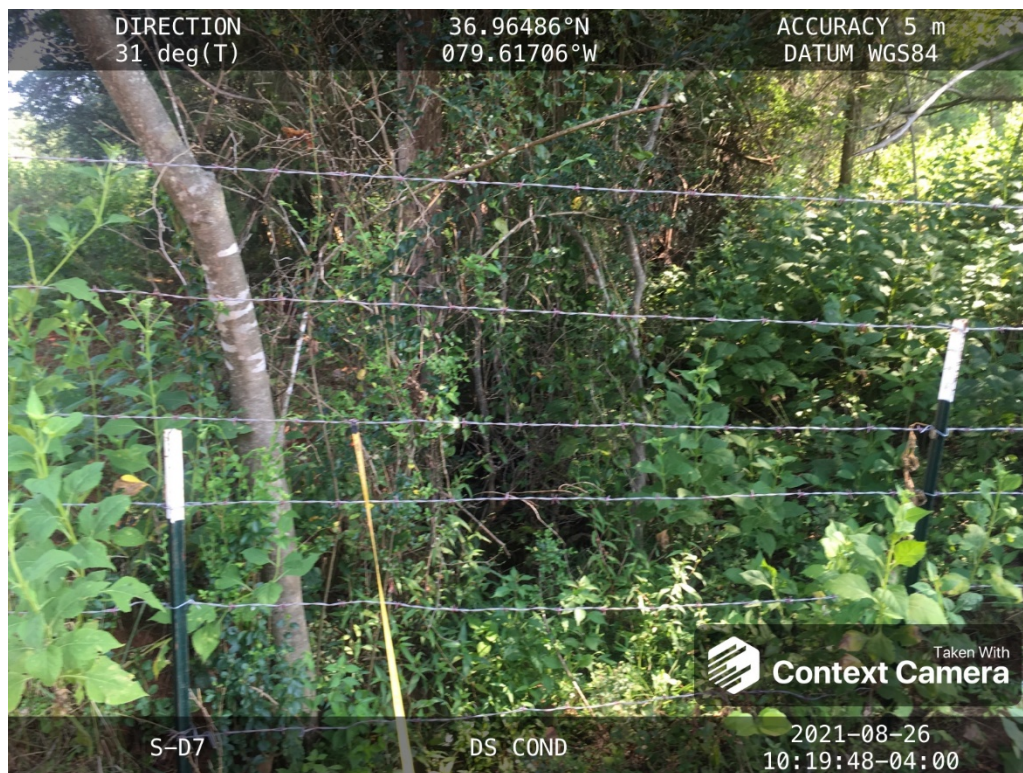
Photo Type: DS COND

Location, Orientation, Photographer Initials: Downstream at ROW/LOD looking NE downstream, CB

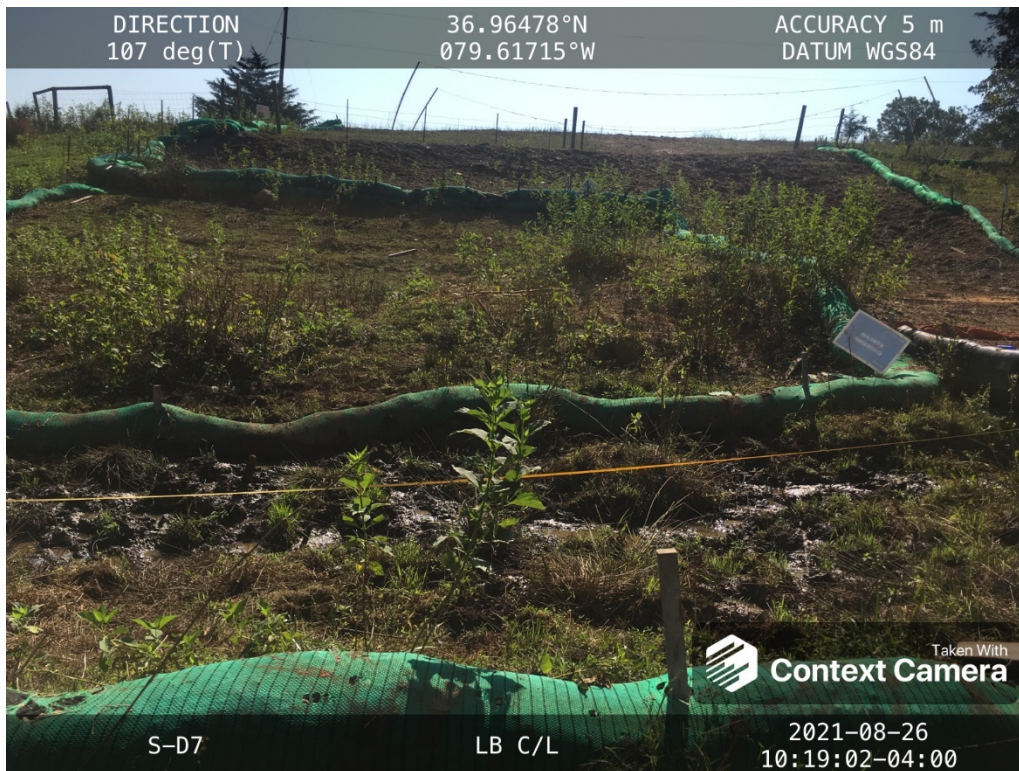
Photo Type: LB CL

Location, Orientation, Photographer Initials: On left bank at pipe centerline looking SE at right streambank, CB

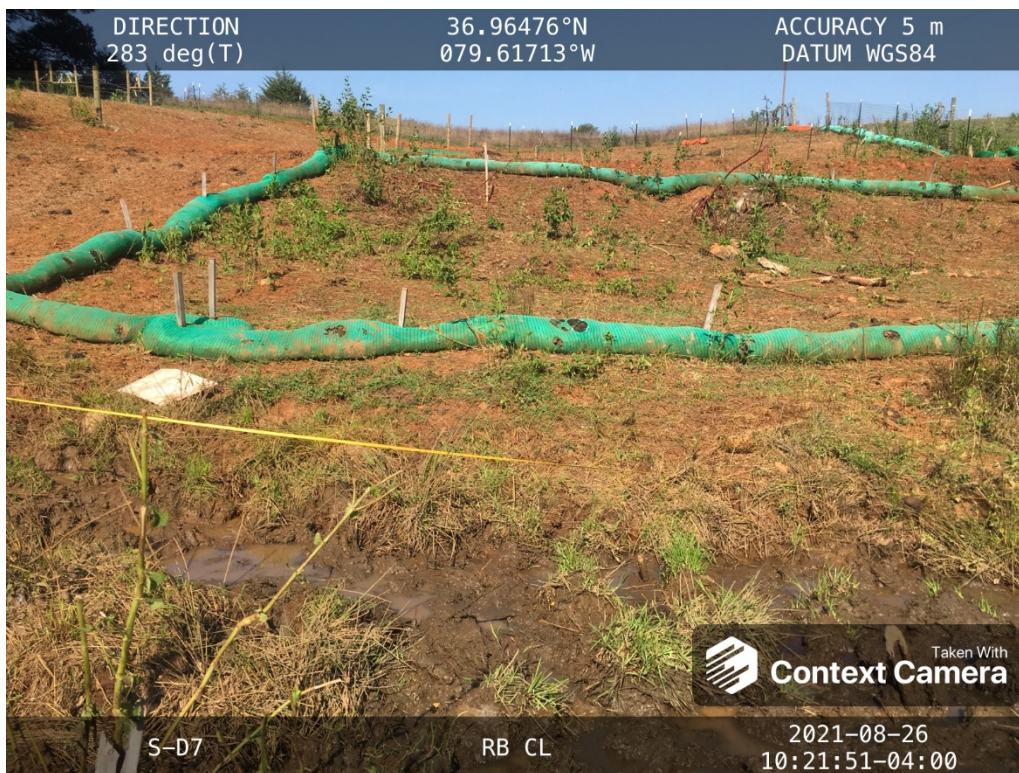
Photo Type: RB CL

Location, Orientation, Photographer Initials: On right bank at pipe centerline looking NW at left streambank, CB

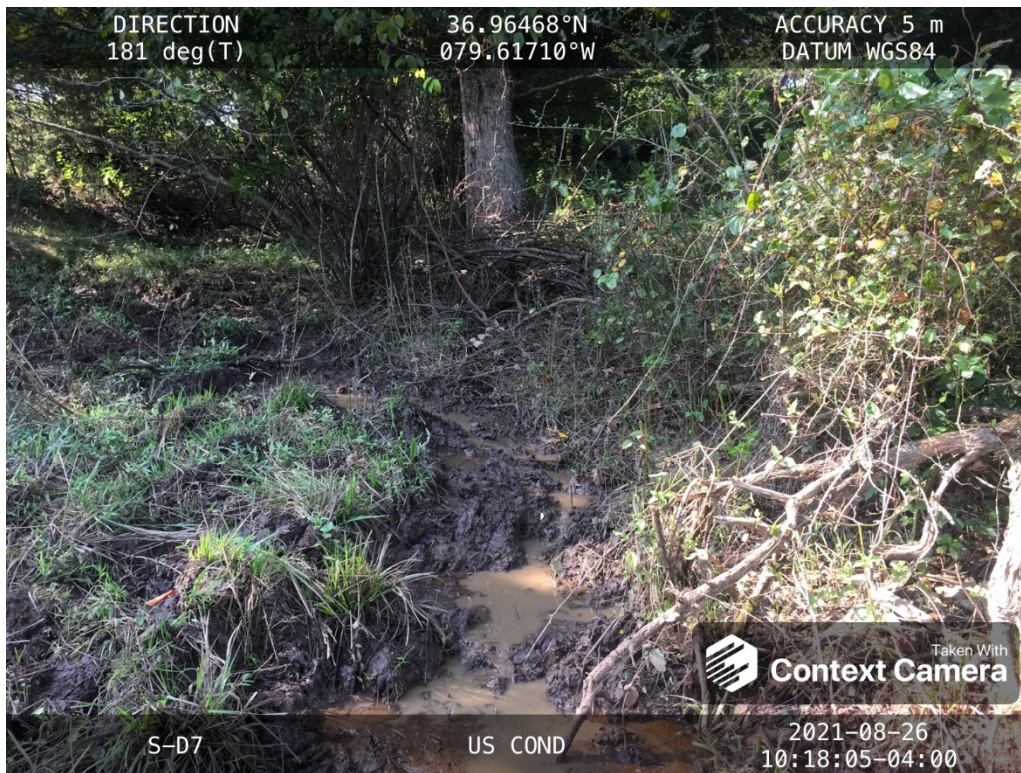
Photo Type: US COND

Location, Orientation, Photographer Initials: Upstream at ROW/LOD looking S upstream, CB

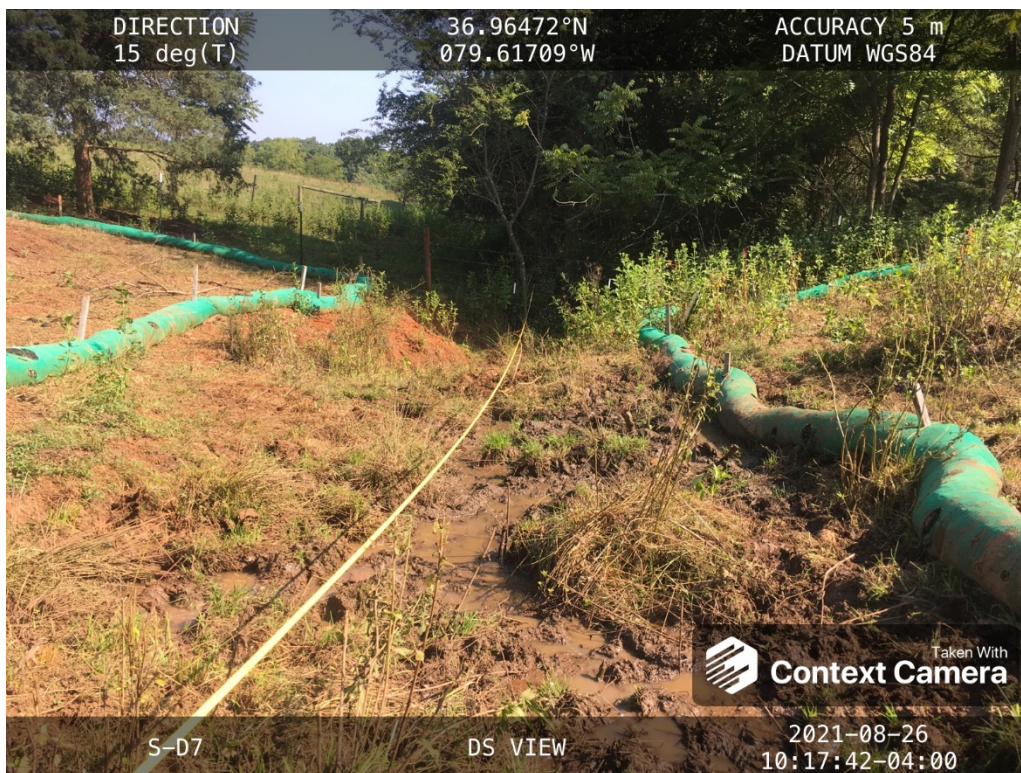
Photo Type: DS VIEW

Location, Orientation, Photographer Initials: Upstream at ROW/LOD looking NE downstream, CB

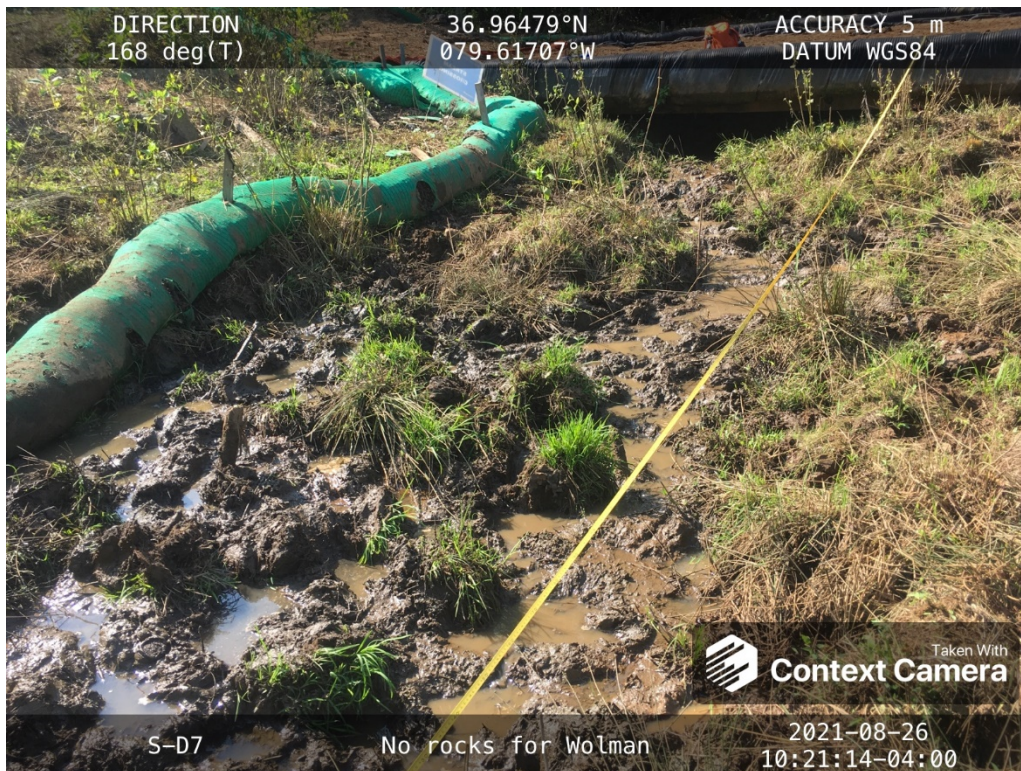
Photo Type: No Wolman pebble count due to no rocks in channel
Location, Orientation, Photographer Initials: Mid-channel looking SE upstream, CB

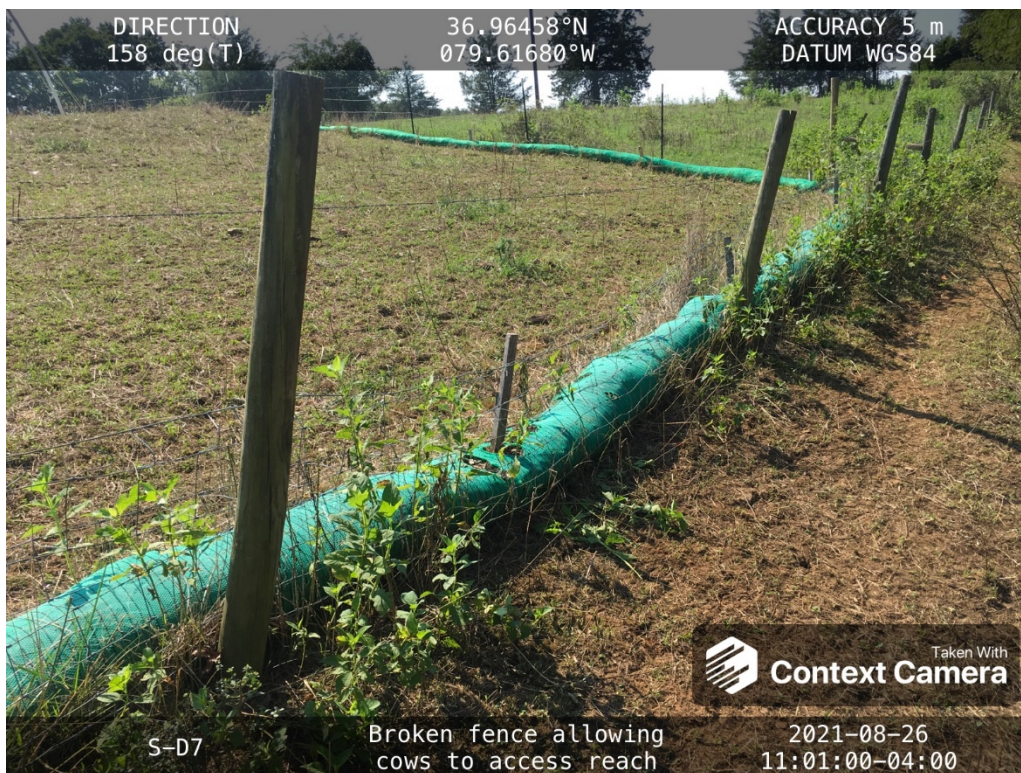
Photo Type: Fence section allowing cows access
Location, Orientation, Photographer Initials: SE of reach looking SE, CB

Livestock have impacted channel.
