Baseline Assessment – Stream Attributes

Reach S-F11 (Pipeline ROW/) Perennial Spread I Franklin County, Virginia

Stream S-F11 (Pipeline ROW) Franklin County

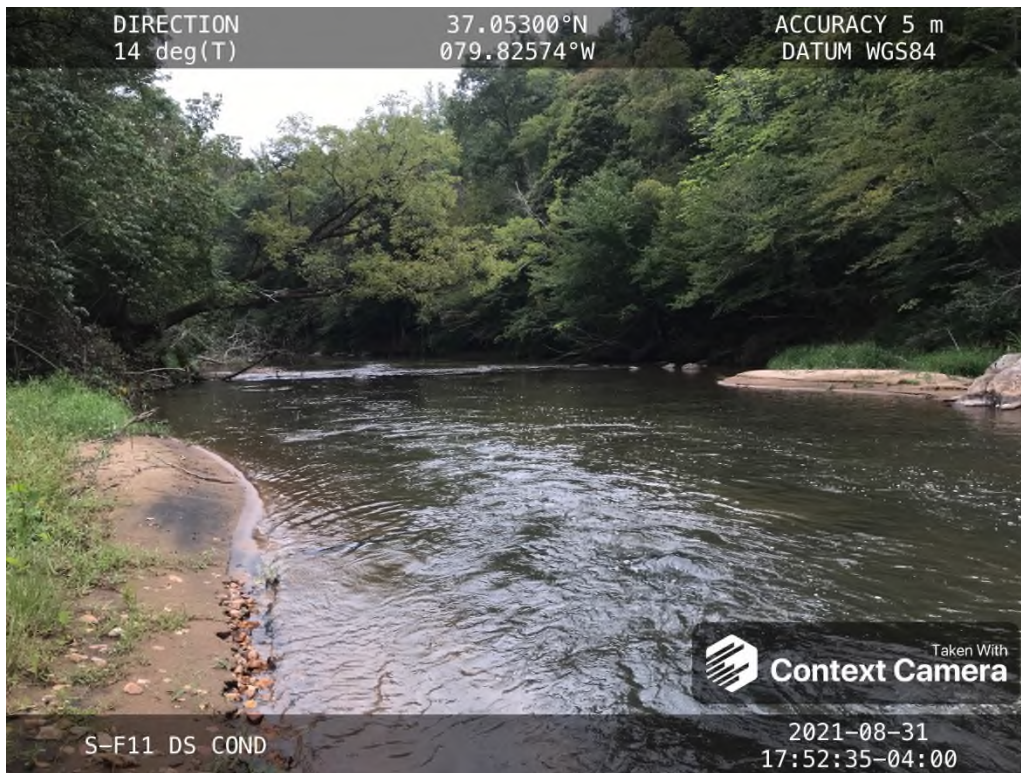
Photo Type: DS COND

Location, Orientation, Photographer Initials: Downstream at ROW/LOD looking NE downstream, RAH

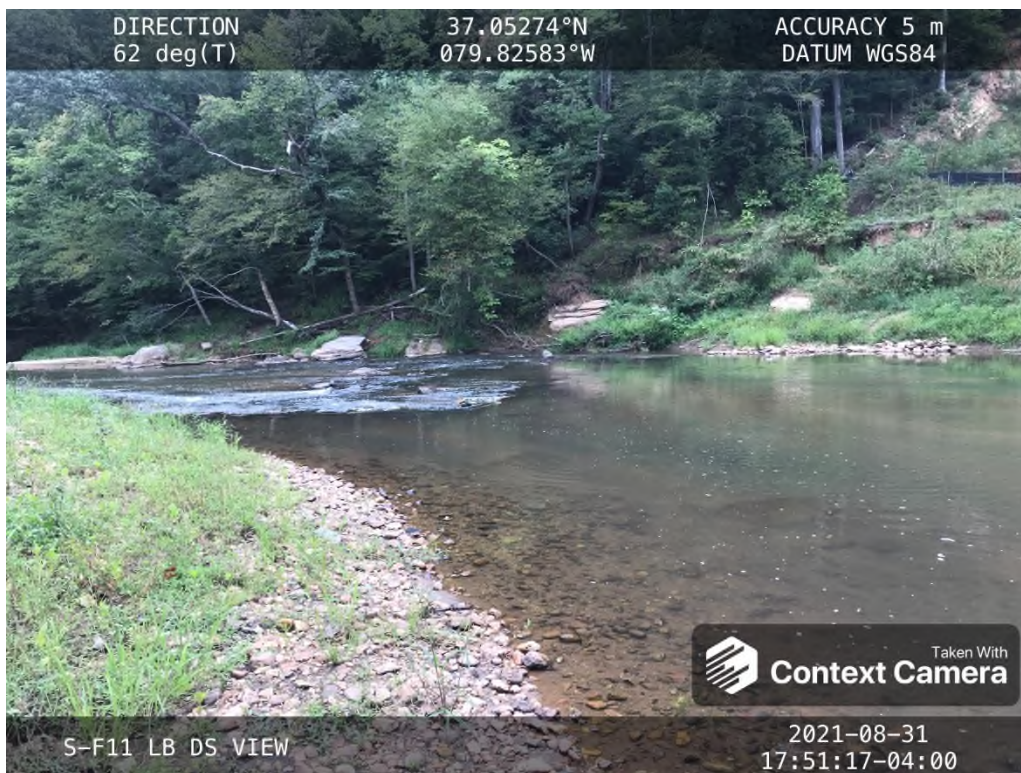
Photo Type: LB DS VIEW

Location, Orientation, Photographer Initials: Upstream at ROW/LOD on left bank looking NE downstream, RAH

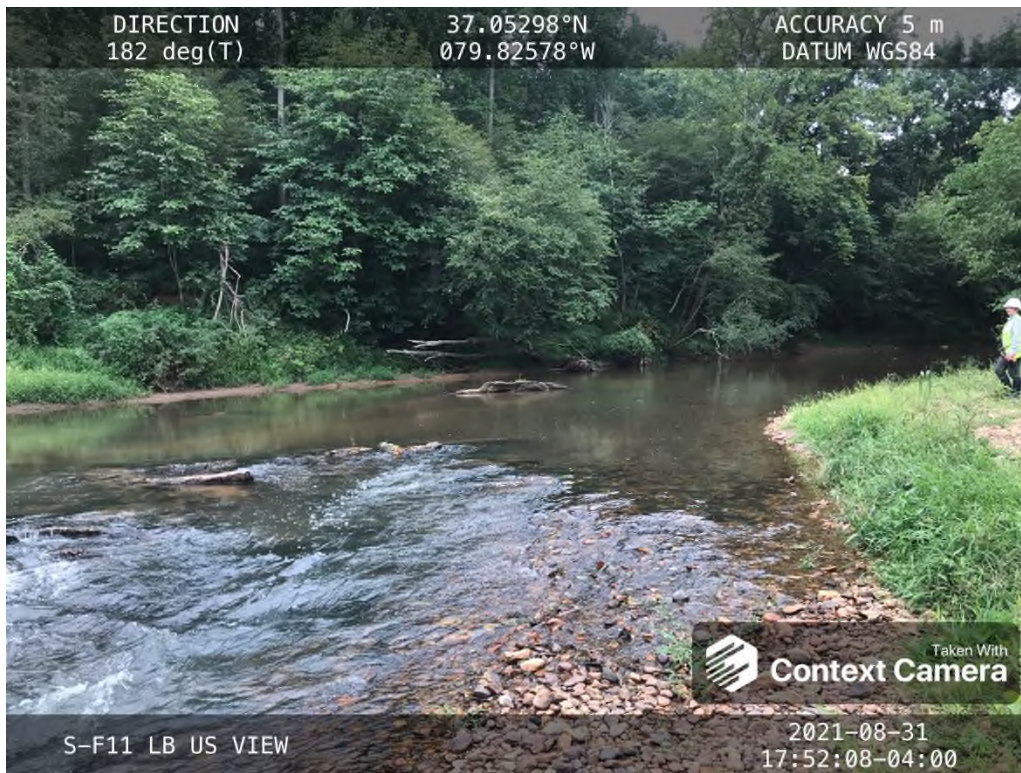
Photo Type: LB US VIEW

Location, Orientation, Photographer Initials: On ROW/LOD on left bank looking S upstream, RAH

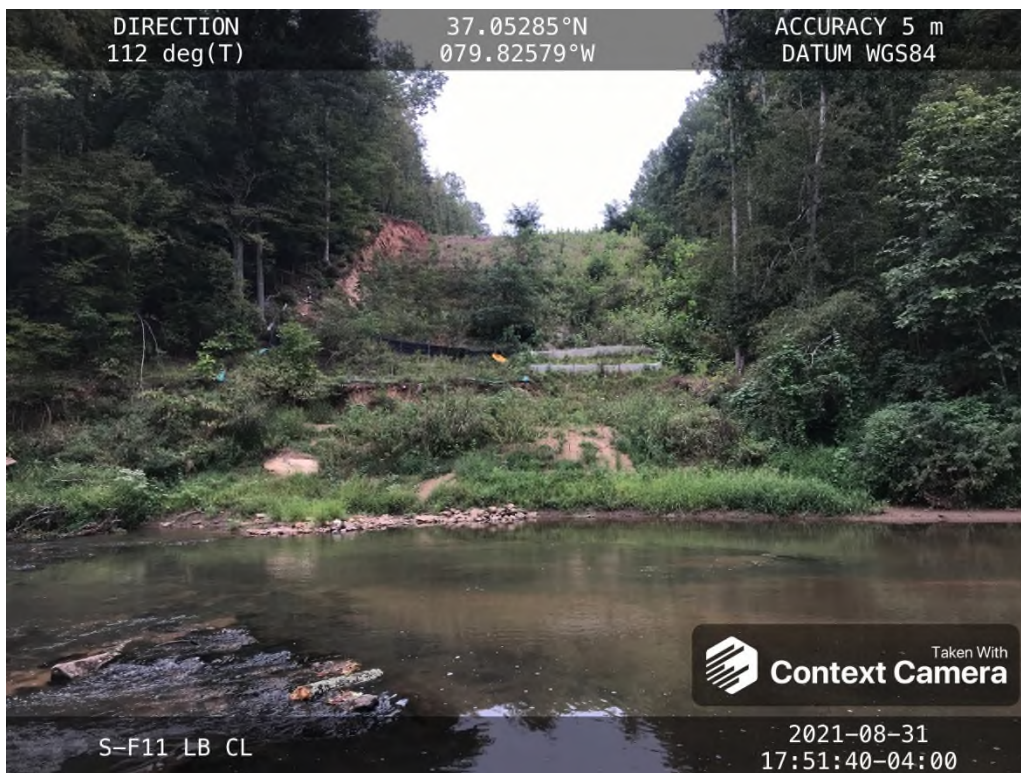
Photo Type: LB CL

Location, Orientation, Photographer Initials: On thalweg at pipe centerline looking SE at right streambank, RAH

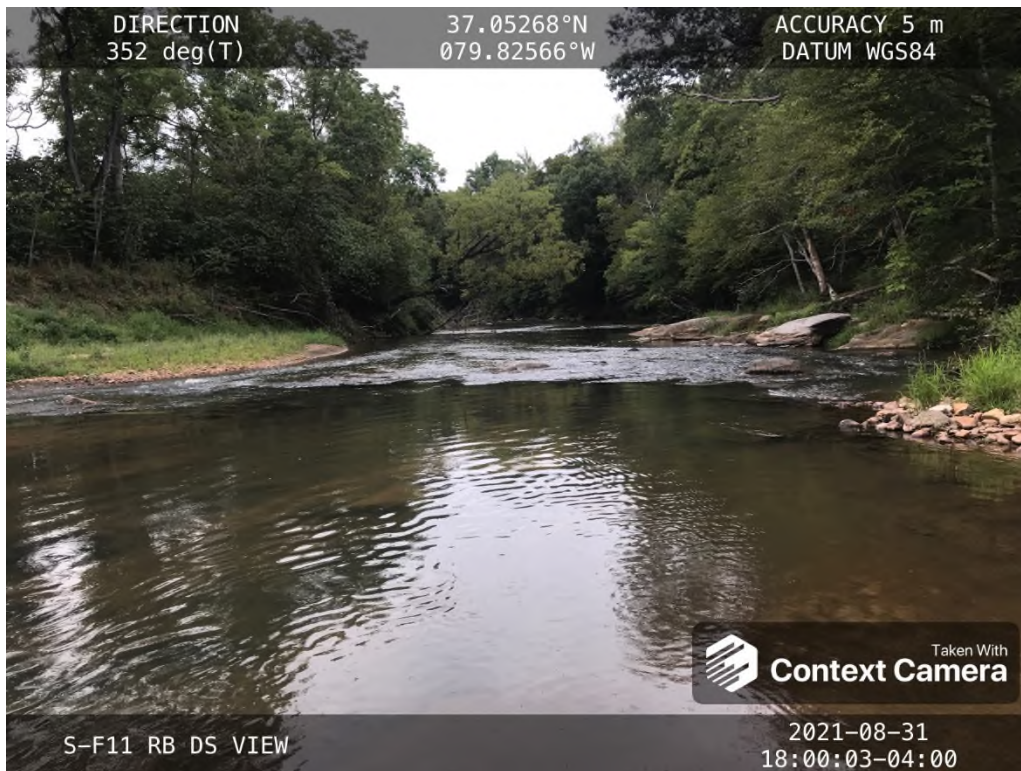
Photo Type: RB DS VIEW

Location, Orientation, Photographer Initials: Upstream at ROW/LOD on right bank looking NW downstream, RAH

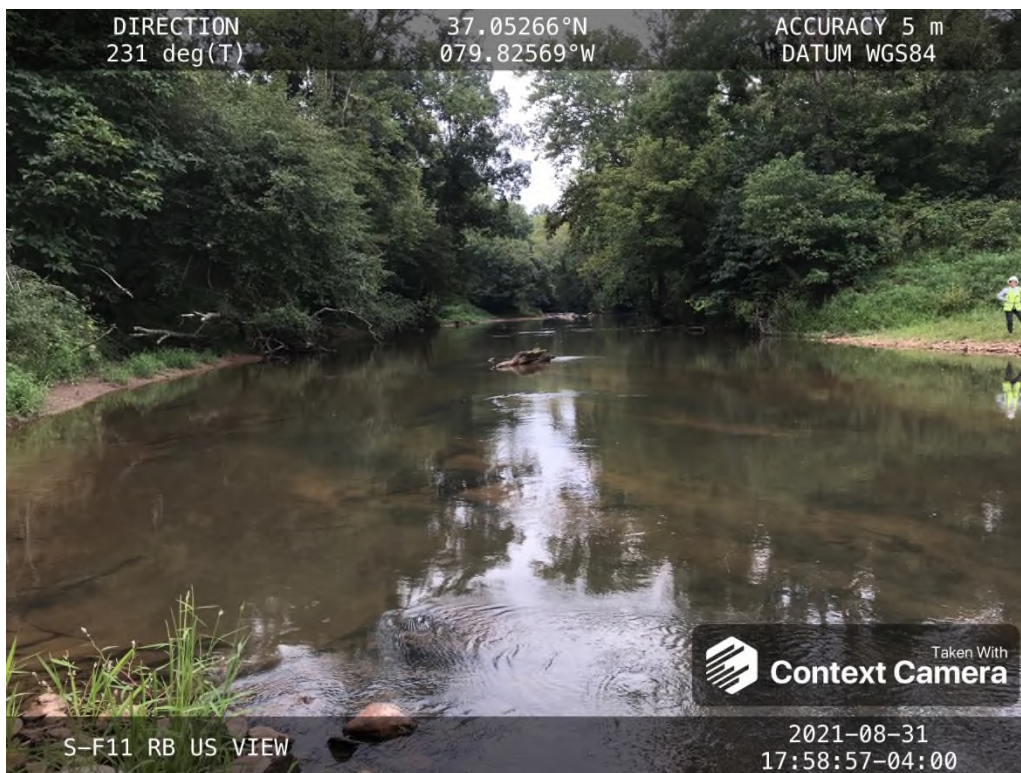
Photo Type: RB US VIEW

Location, Orientation, Photographer Initials: Downstream at ROW/LOD on right bank looking SW upstream, RAH

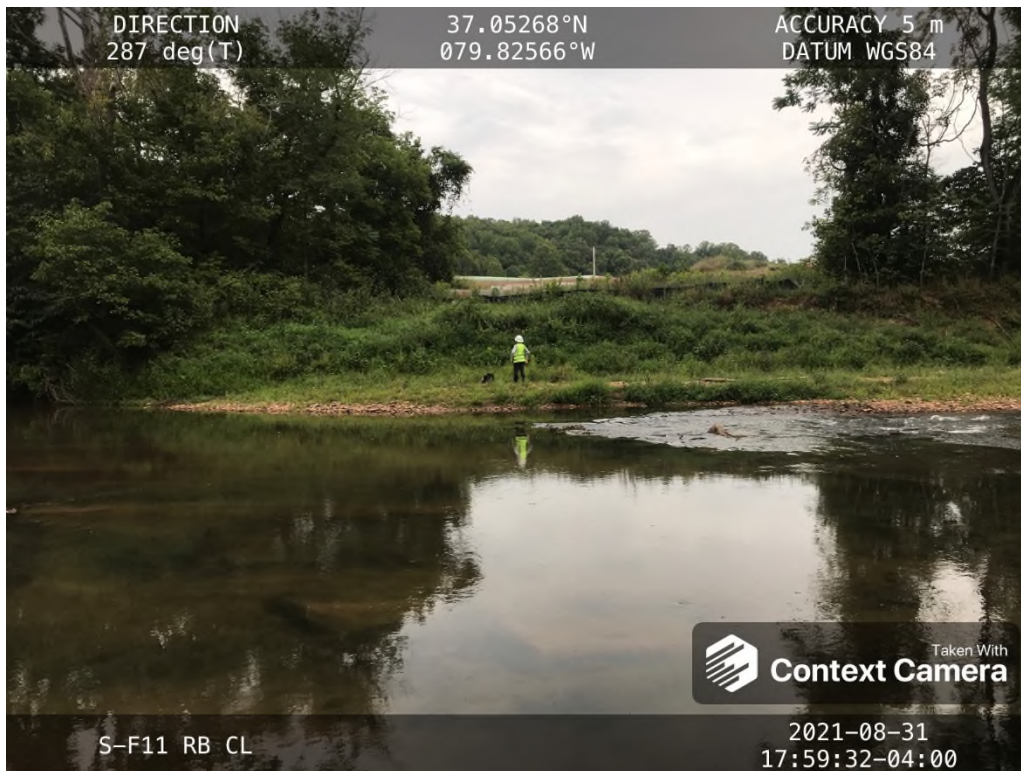
Photo Type: RB CL

Location, Orientation, Photographer Initials: On thalweg at pipe centerline looking NW at left streambank, RAH

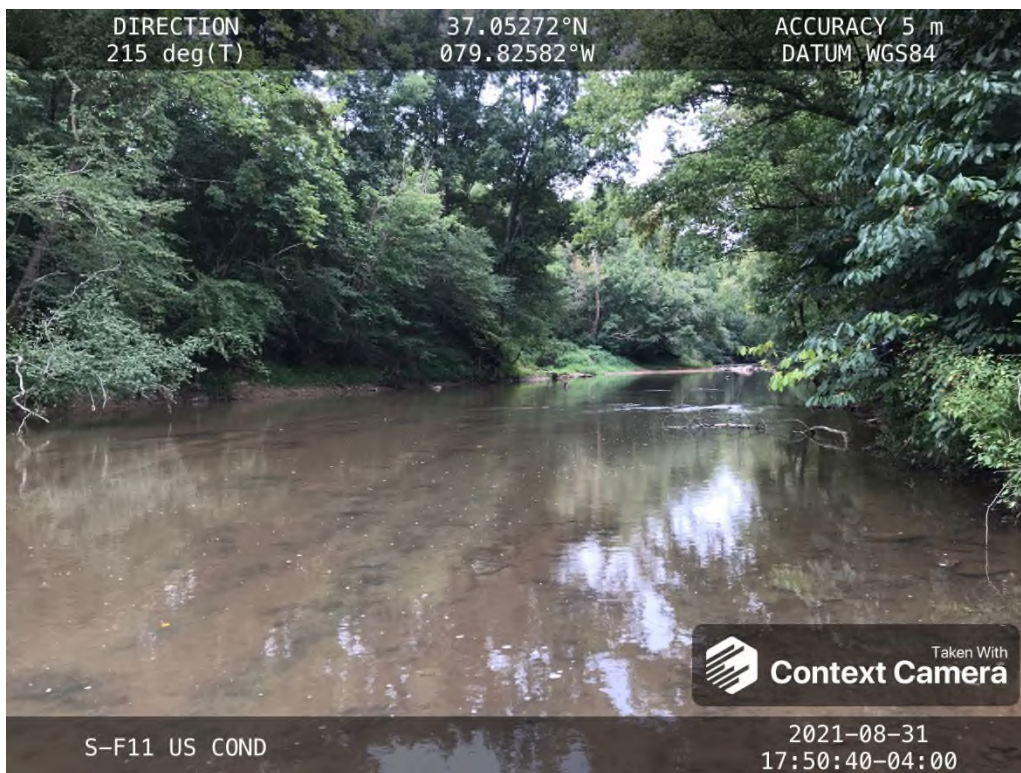
Photo Type: US COND

Location, Orientation, Photographer Initials: Upstream at ROW/LOD looking SW upstream, RAH

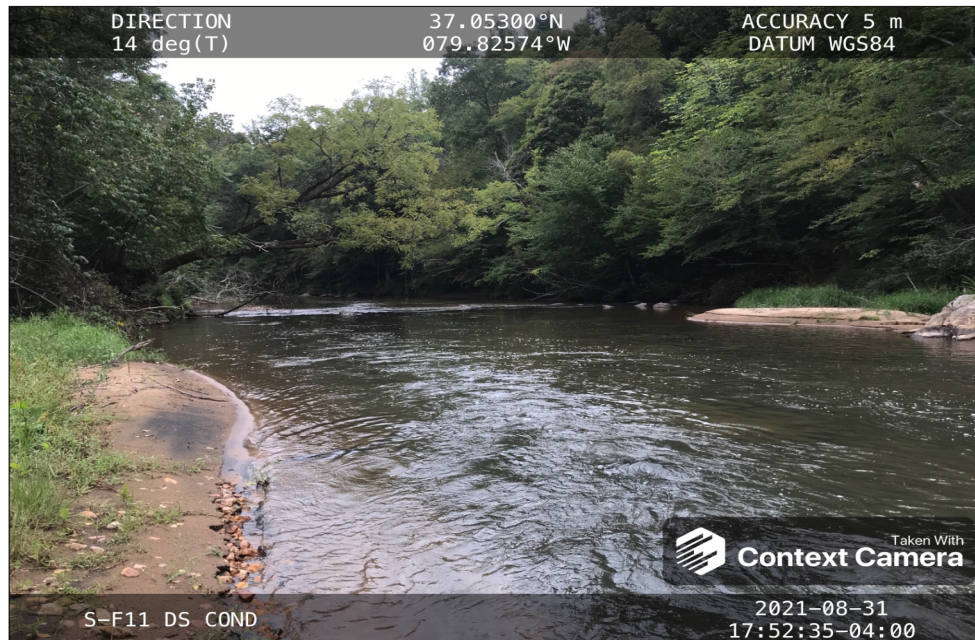
CAPTION. Assessment is limited to areas within the temporary ROW.

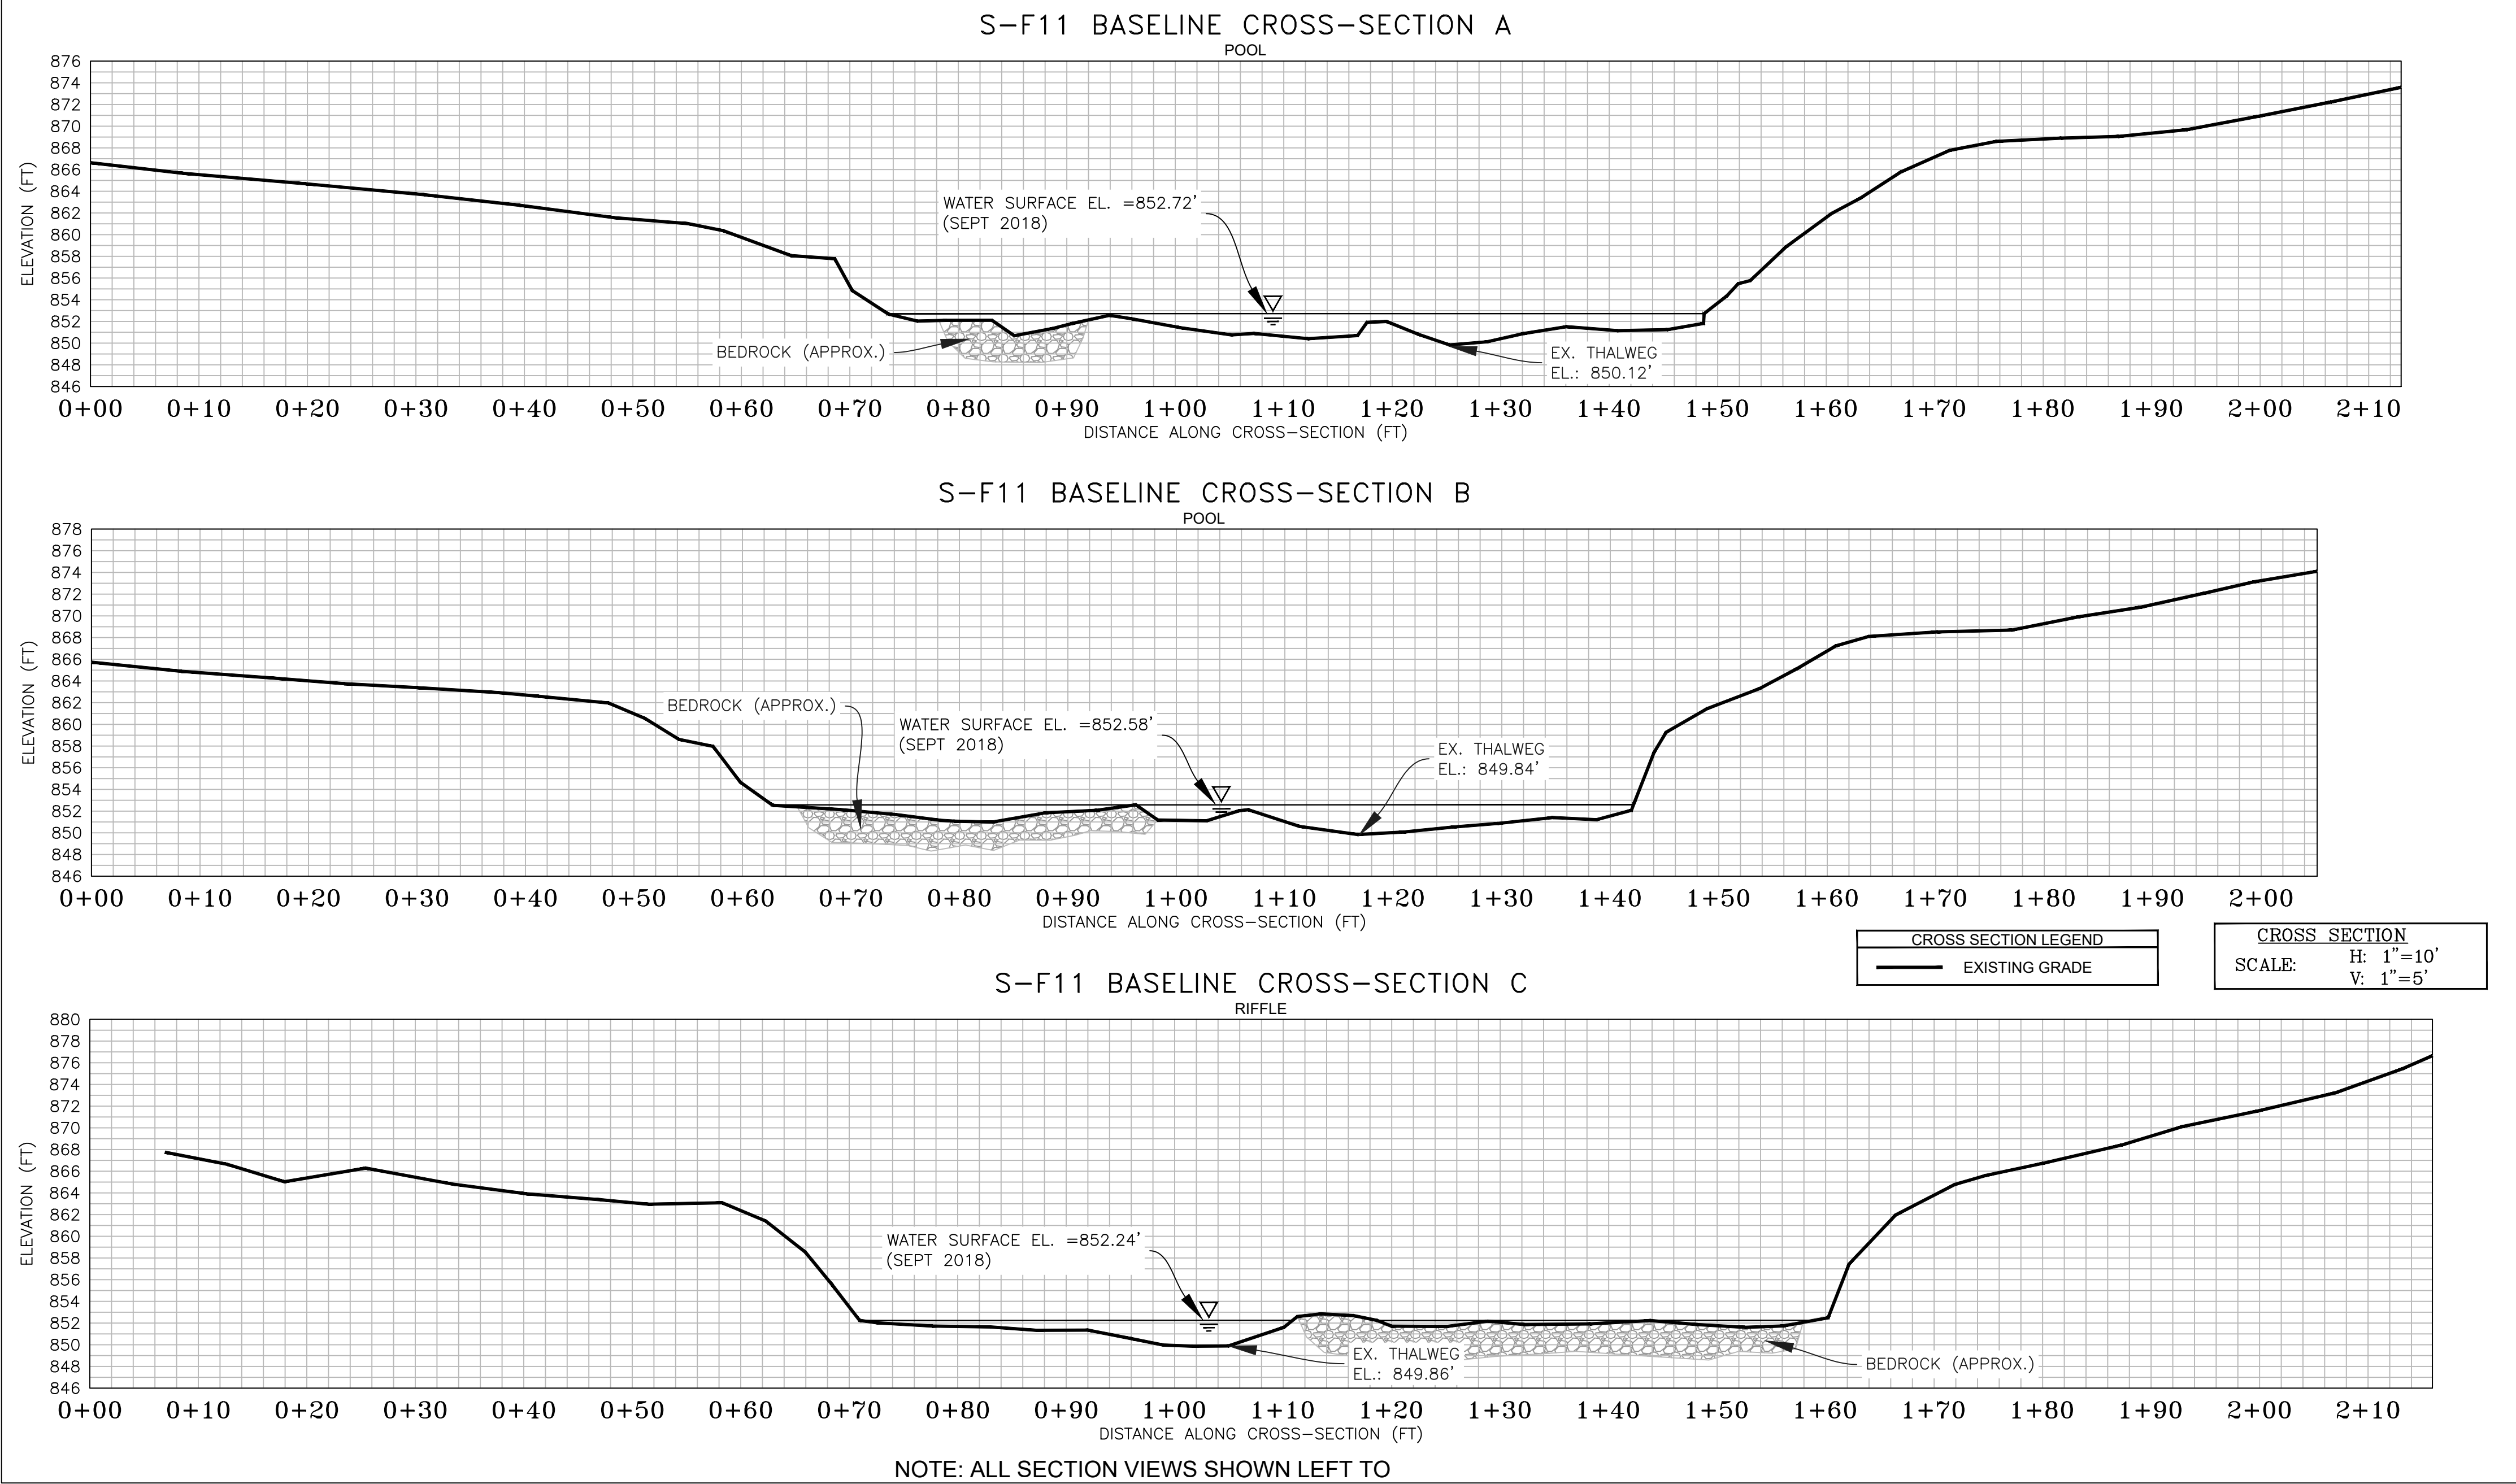
1. This map has been oriented to NAD 1983 UTM ZONE 17N, and vertically to The North American Vertical Datum of 1988 (NAVD 88), using a Real Time Network (RTN) GPS. Field locations were completed on September 5th, 2018.
2. Monumentation, including traverse stations and fly points, shown on this drawing should be used to orient any future boundary, topographic, or location survey.
3. Easement lines shown on plan view were provided by Mountain Valley Pipeline (MVP).
4. WSSI Contour Interval = 2.0'. Contours within the channel were interpolated using stream channel breaklines (i.e. top of slopes, toe of slopes, thalweg) and cross-sectional points. Contours outside the channel were interpolated using cross-sectional spot shots.
5. All section views shown are left to right facing downstream.
6. Cross-section B shot at location of pipe centerline (based on best professional judgement).

NOTE: ALL SECTION VIEWS SHOWN LEFT TO
RIGHT FACING DOWNSTREAM.
