Baseline Assessment – Stream Attributes

Reach S-GH38 (Pipeline ROW) Intermittent Spread I Franklin County, Virginia

Project Name: Mountain Valley Pipeline

Profile and Cross-Sections Baseline Survey

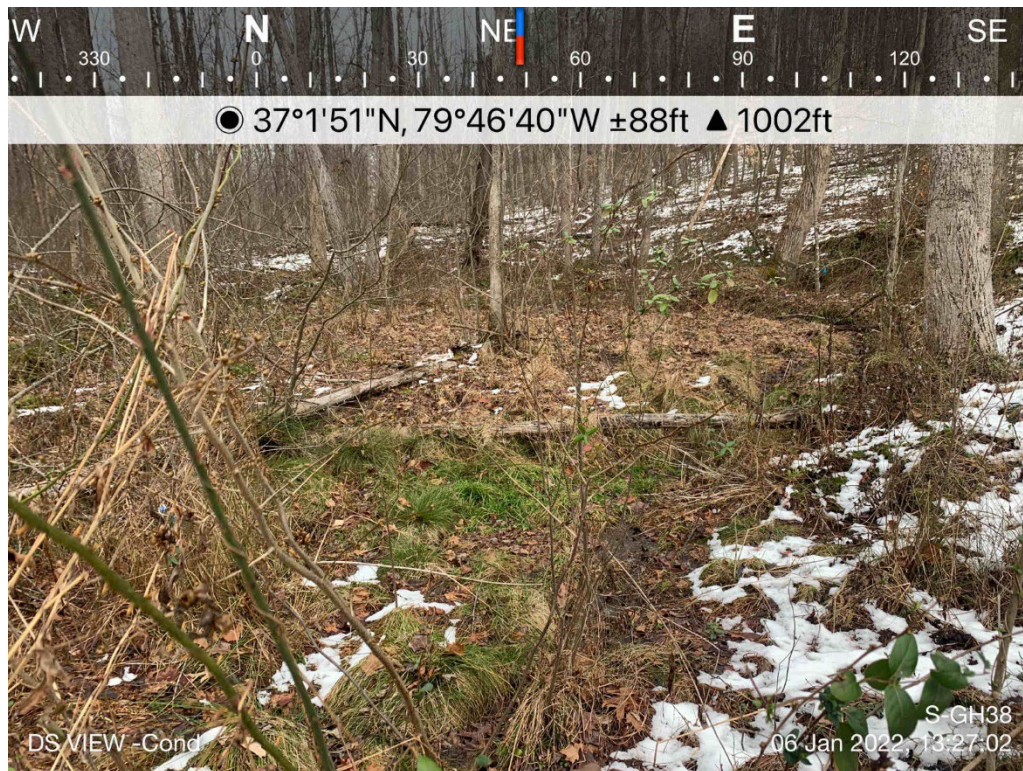
Photo Type: DS VIEW/COND

Location, Orientation, Photographer Initials: Downstream view of LOC looking NE, KB
01/06/2022, 1:27PM

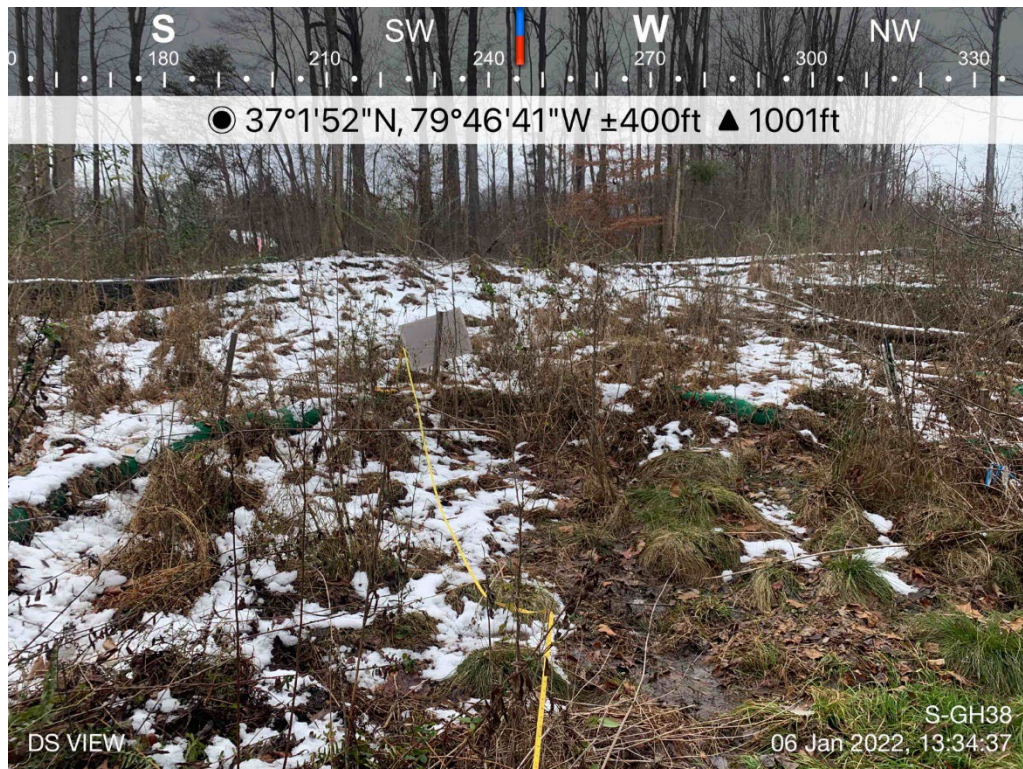
Photo Type: DS VIEW

Location, Orientation, Photographer Initials: Downstream view of LOC looking W/SW, KB
01/06/2022, 1:34 PM

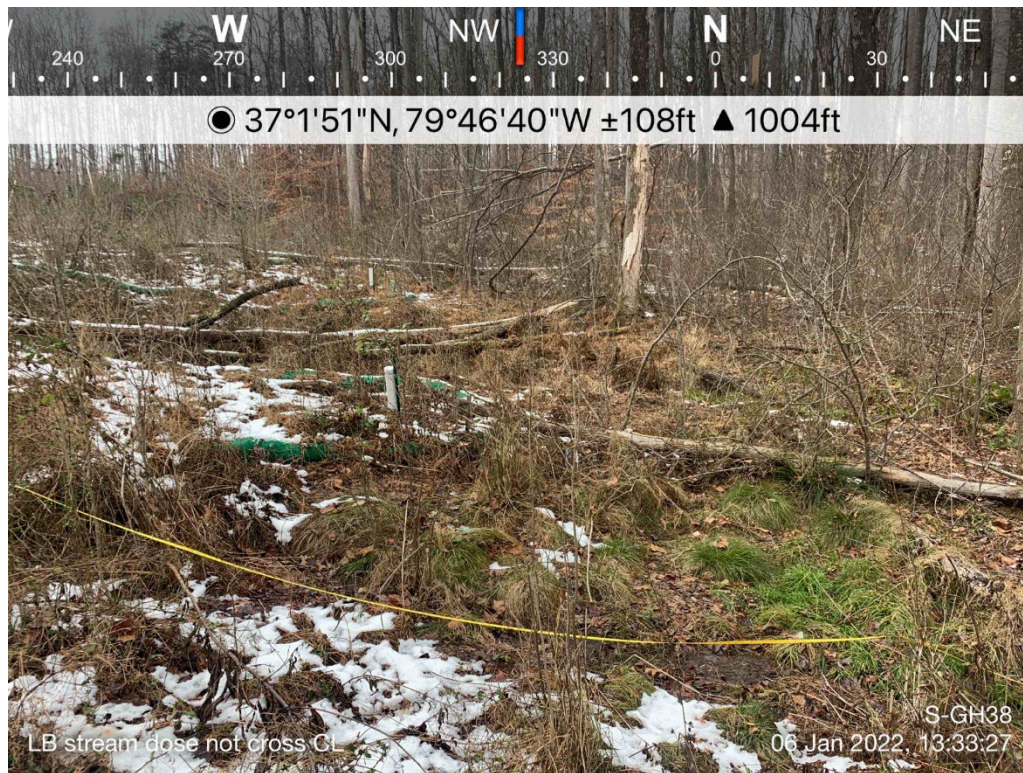
Photo Type: LB CL

Location, Orientation, Photographer Initials: Standing on LB looking at RB along pipe centerline looking NW, KB
01/06/2022, 1:33PM

(LB stream does not cross CL)

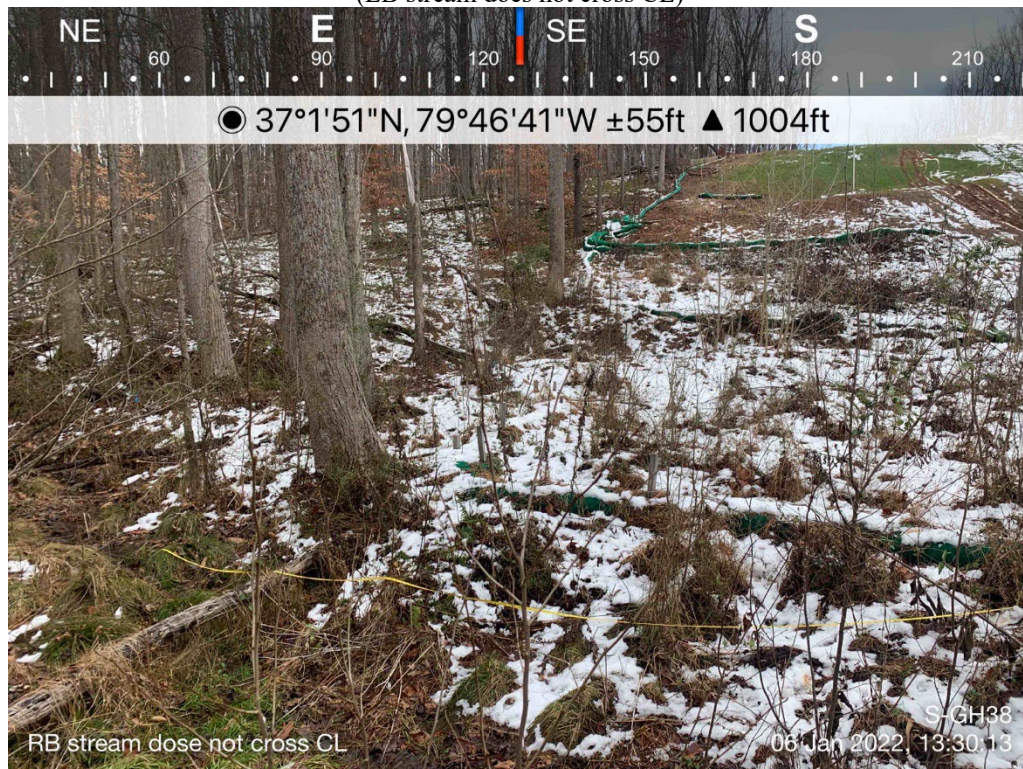
Photo Type: RB CL

Location, Orientation, Photographer Initials: Standing on RB looking at LB along pipe centerline looking SE, KB
01/06/2022, 1:30 PM

(RB stream does not cross CL)

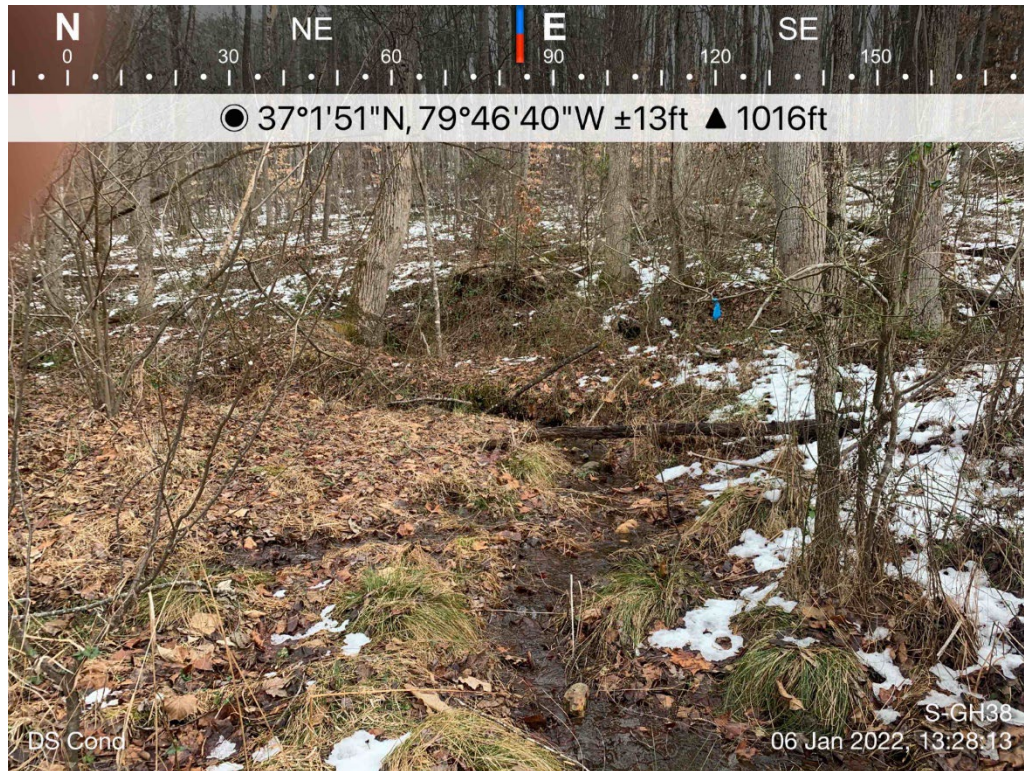
Photo Type: DS COND

Location, Orientation, Photographer Initials: Downstream conditions outside of LOC looking E, KB
01/06/2022, 1:28 PM
