Baseline Assessment – Stream Attributes

Reach S-H17 (Pipeline ROW) Intermittent Spread I Franklin County, Virginia

Profile and Cross-Sections Baseline Survey

Crossing S-H17 - Dinner Creek (MP 280.8)

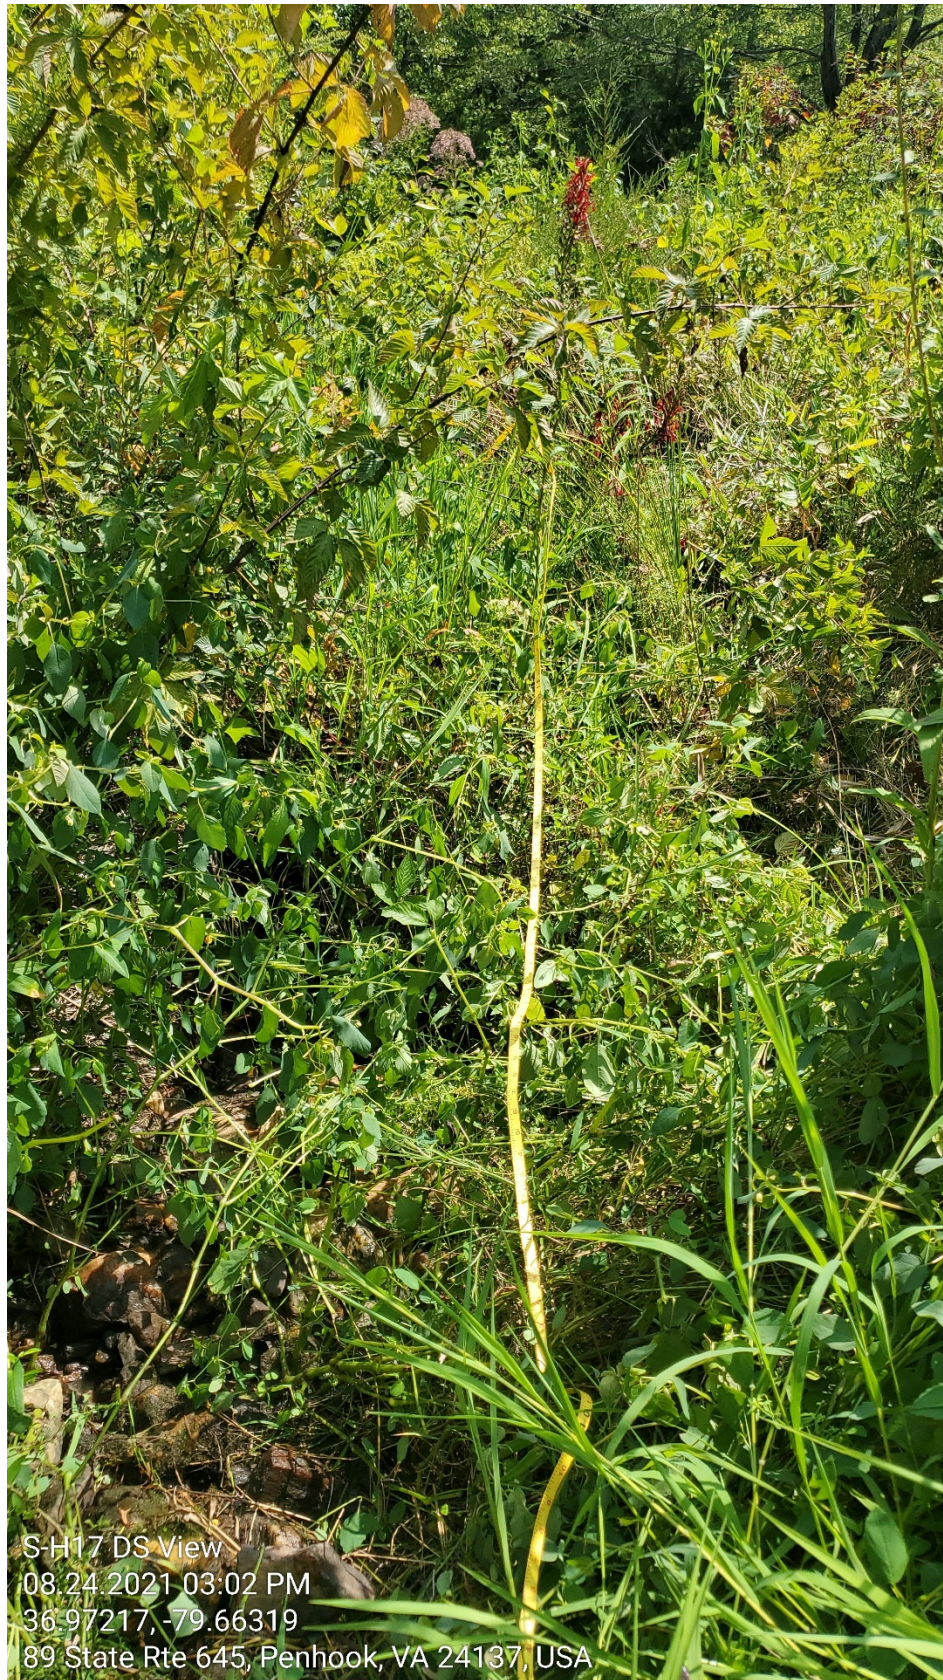
Photo Type: DS VIEW

S-H17 DS View
08/24/2021 03:02 PM
36.97217, -79.66319
89 State Rte 645, Penhook, VA 24137, USA

Location, Orientation, Photographer Initials: Downstream view of ROW/LOD looking S, DW

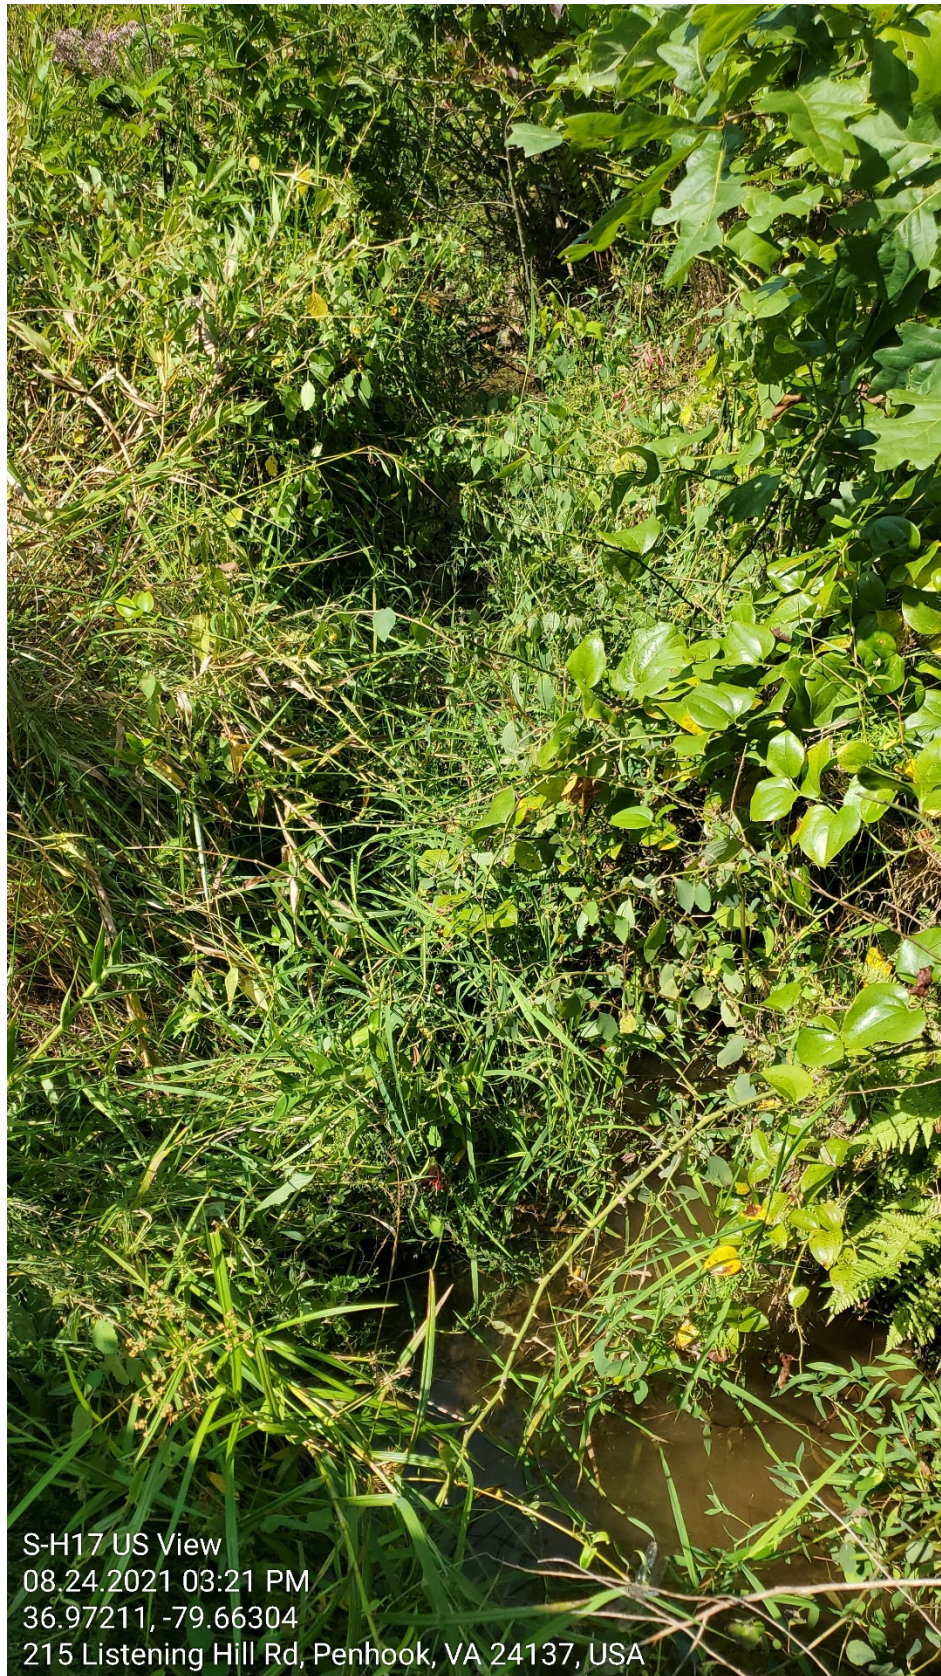
Photo Type: US VIEW

S-H17 US View
08.24.2021 03:21 PM
36.97211, -79.66304
215 Listening Hill Rd, Penhook, VA 24137, USA

Location, Orientation, Photographer Initials: Upstream view of ROW/LOD looking N, DW

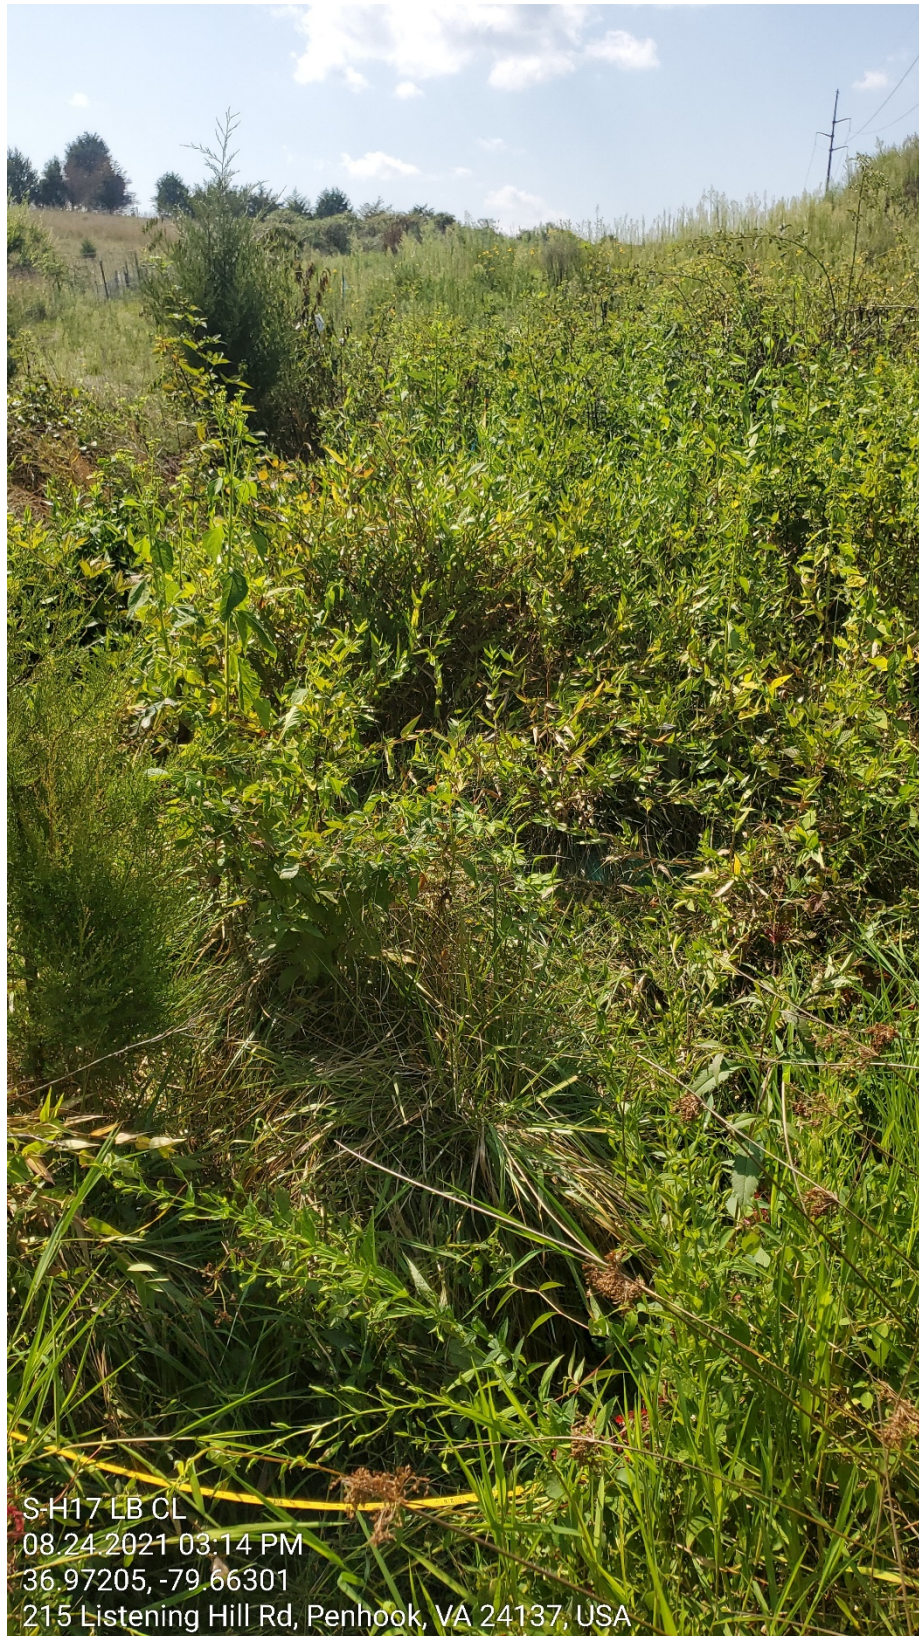
Photo Type: LB CL

S-H17 LB CL
08/24/2021 03:14 PM
36.97205, -79.66301
215 Listening Hill Rd, Penhook, VA 24137, USA

Location, Orientation, Photographer Initials: Standing on LB looking at RB along pipe centerline looking W, DW

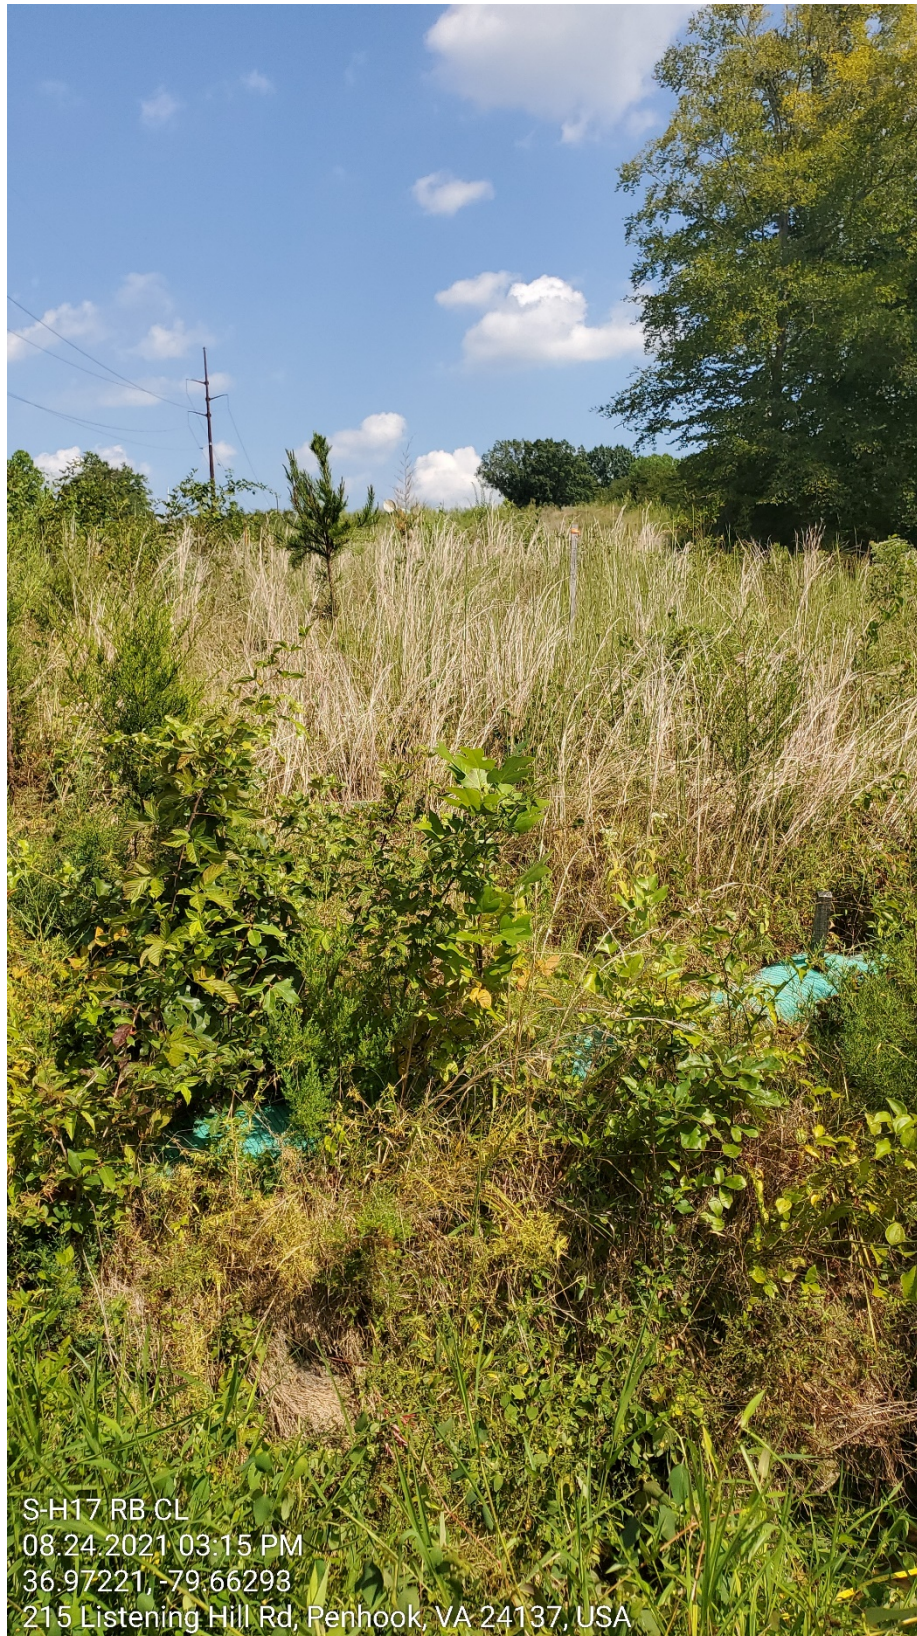
Photo Type: RB CL

S-H17 RB CL
08.24.2021 03:15 PM
36.97221, -79.66293
215 Listening Hill Rd, Penhook, VA 24137, USA

Location, Orientation, Photographer Initials: Standing on RB looking at LB along pipe centerline looking E, DW

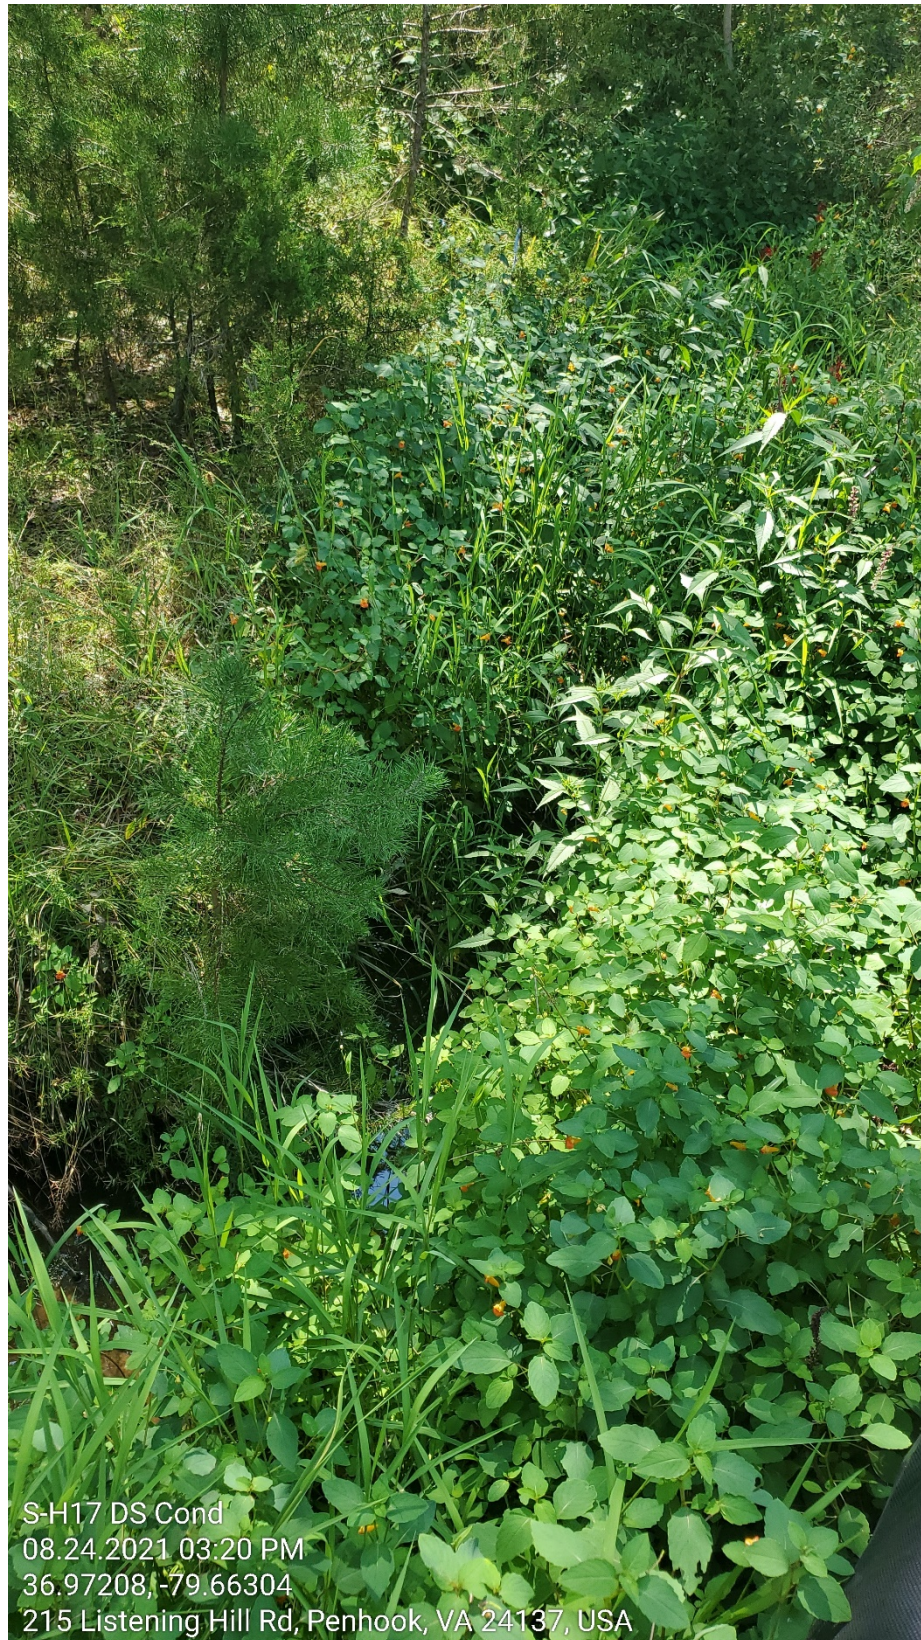
Photo Type: DS COND

Location, Orientation, Photographer Initials: Downstream conditions outside of ROW/LOD looking S, DW

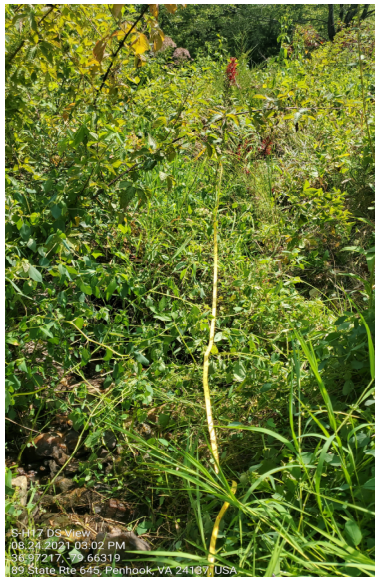
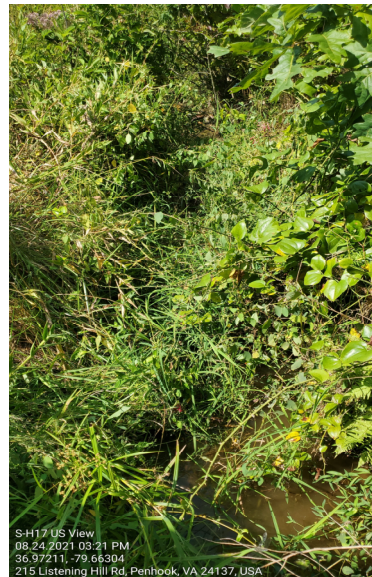
CAPTION. Assessment is limited to areas within the temporary ROW.

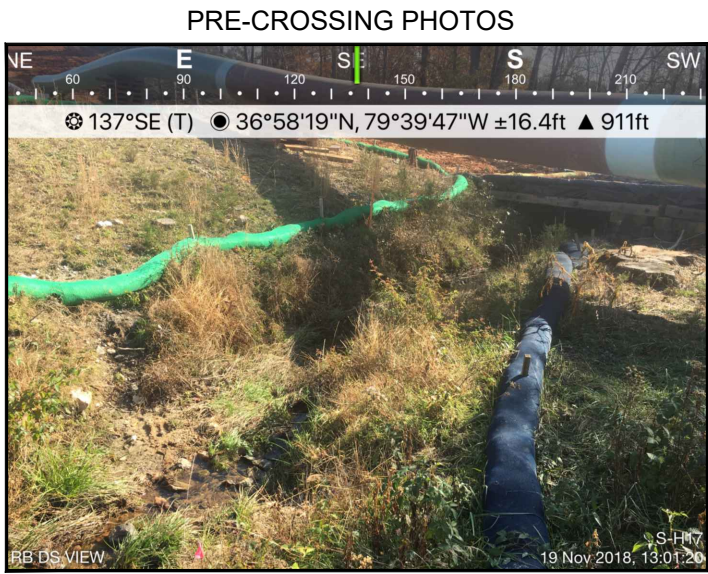
PHOTO TAKEN FROM RIGHT BANK LOOKING DOWNSTREAM TO THE SOUTHEAST ON 11/19/2018

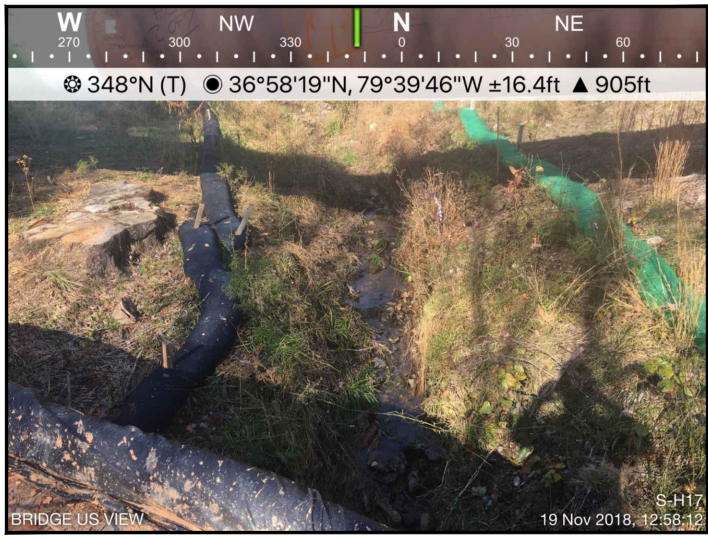
PHOTO TAKEN FROM BRIDGE LOOKING UPSTREAM TO THE NORTH ON 11/19/2018

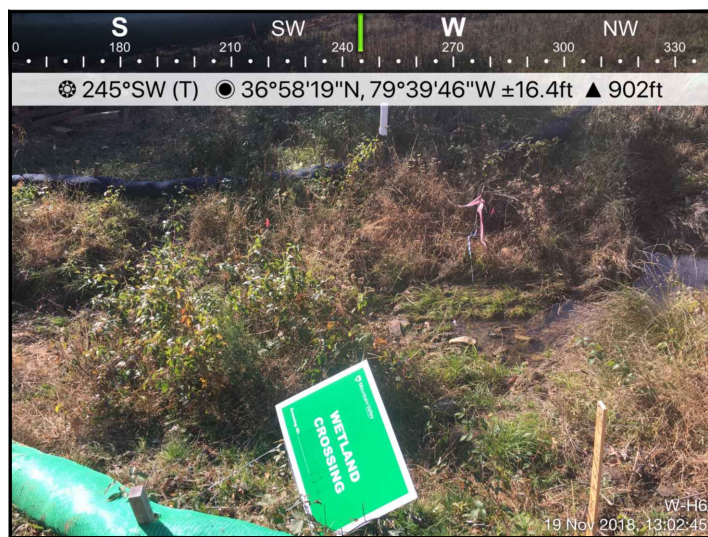
PHOTO TAKEN LOOKING AT W-H6 FROM LEFT BANK OF S-H17 ON 11/19/2018
