Baseline Assessment – Stream Attributes

Reach S-H5 (Pipeline ROW) Perennial Spread I Pittsylvania County, Virginia

Spread I Stream S-H5 (Pipeline ROW) Pittsylvania County

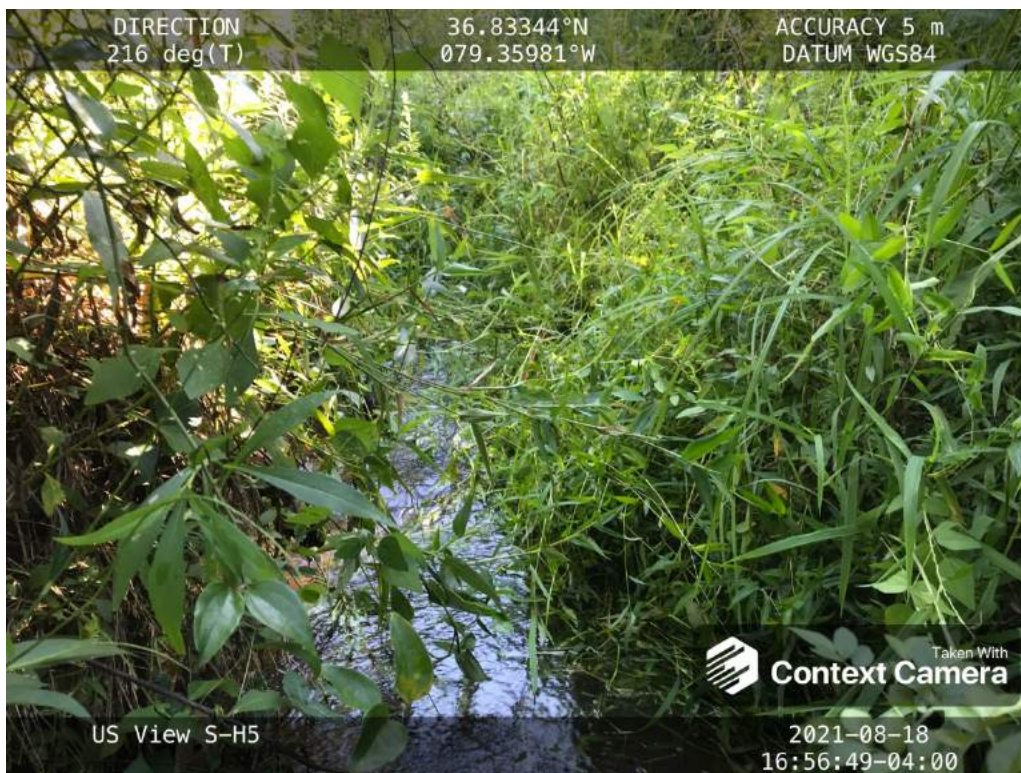
Location, Orientation, Photographer Initials: Upstream view of ROW/LOD looking SW, MB

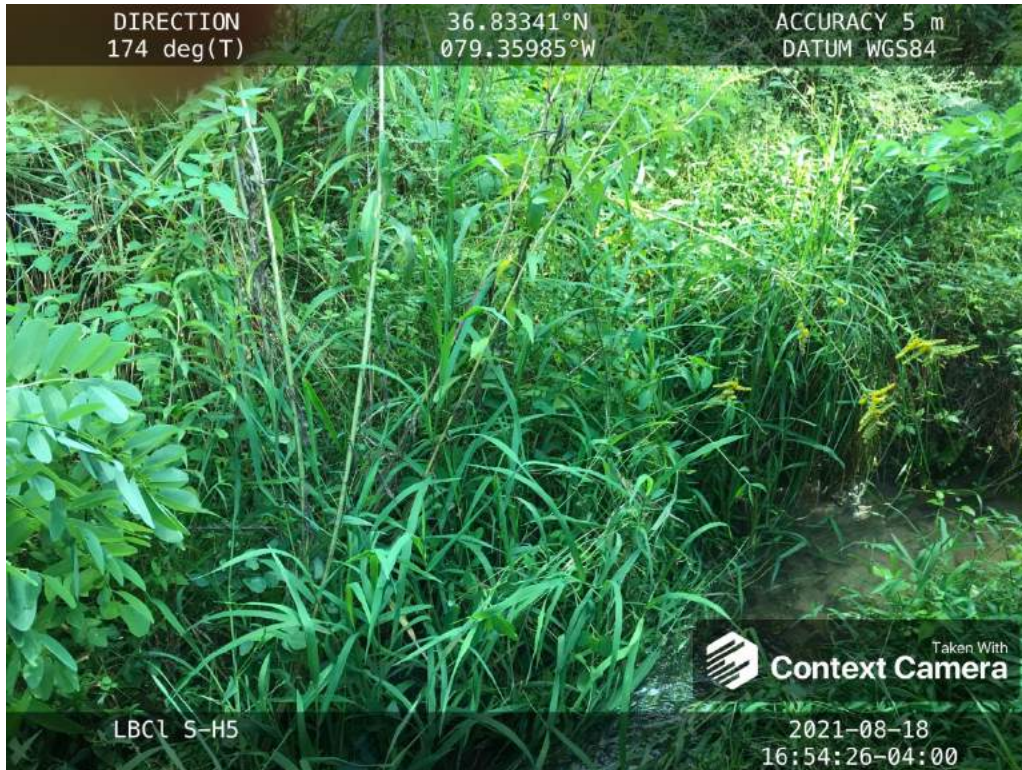
Photo Type: LB CL

Location, Orientation, Photographer Initials: Standing on LB looking at RB along pipe centerline looking S, MB

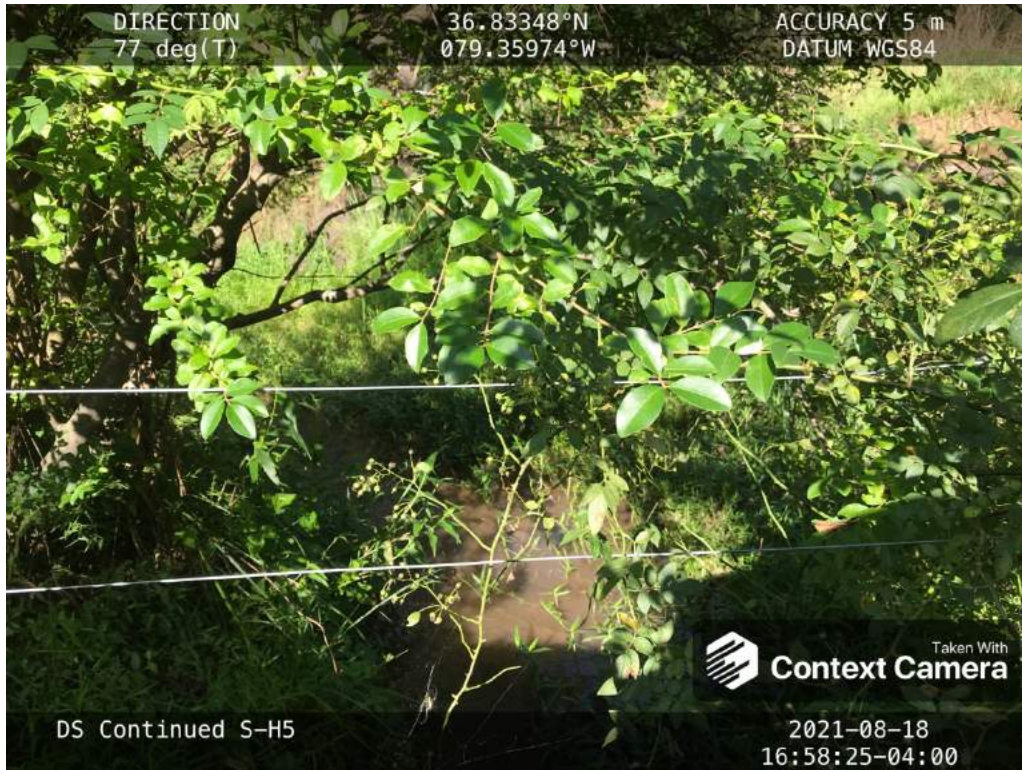
Photo Type: DS COND

Location, Orientation, Photographer Initials: Downstream conditions outside of ROW/LOD looking E, MB
