Baseline Assessment – Stream Attributes

Reach S-HH4 (Pipeline ROW) Intermittent Spread I Franklin County, Virginia

USACE FILE NO./ Project Name: (v2.1, Sept 2015)			Mountain Valley Pipeline			IMPACT COORDINATES: (in Decimal Degrees)			Lat.	37.056594	Lon.	-79.835785	WEATHER:		Sunny		DATE:		8/26/2021		
IMPACT STREAM/SITE ID AND SITE DESCRIPTION: (watershed size (acreage), unaltered or impairments)					S-HH4;11.87 ac					MITIGATION STREAM CLASS./SITE ID AND SITE DESCRIPTION: (watershed size (acreage), unaltered or impairments)					Comments:						
STREAM IMPACT LENGTH:			97		FORM OF MITIGATION:		RESTORATION (Levels I-III)		MIT COORDINATES: (in Decimal Degrees)		Lat.		Lon.		PRECIPITATION PAST 48 HRS:		No		Mitigation Length:		
Column No. 1- Impact Existing Condition (Debit)				Column No. 2- Mitigation Existing Condition - Baseline (Credit)				Column No. 3- Mitigation Projected at Five Years Post Completion (Credit)				Column No. 4- Mitigation Projected at Ten Years Post Completion (Credit)				Column No. 5- Mitigation Projected at Maturity (Credit)

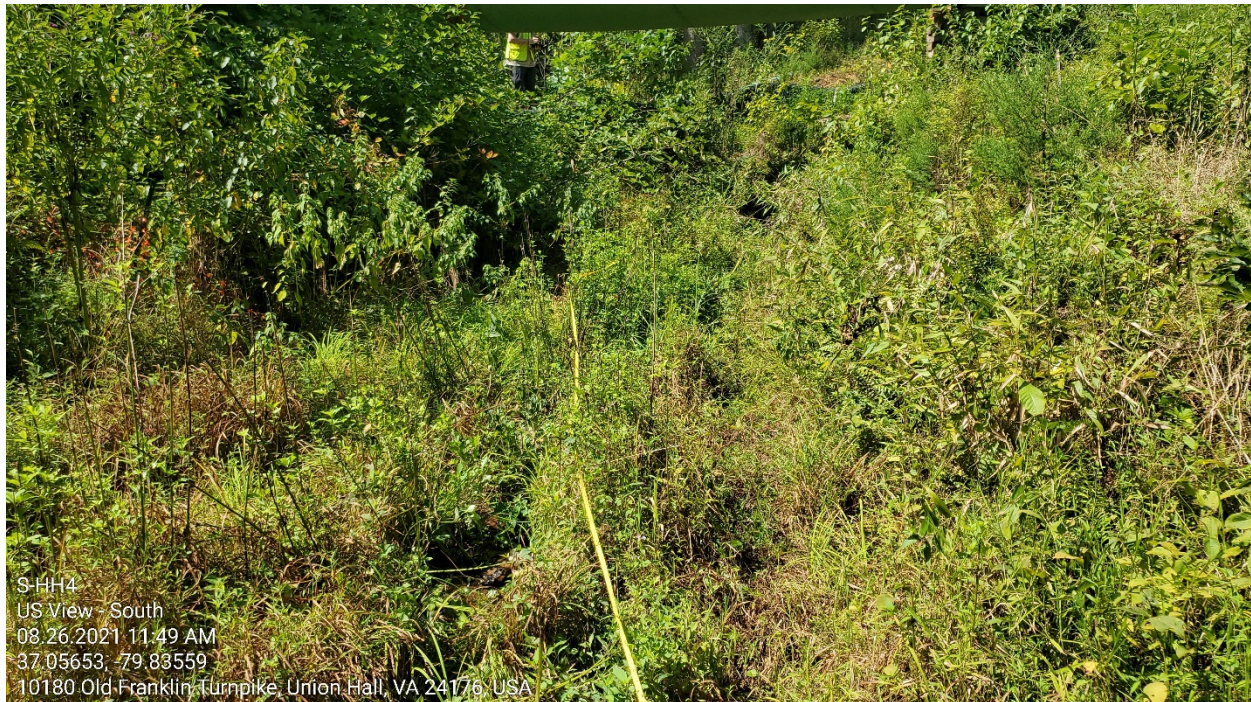
Photo Type: US VIEW

Location, Orientation, Photographer Initials: Downstream at ROW/LOD looking S upstream, DW

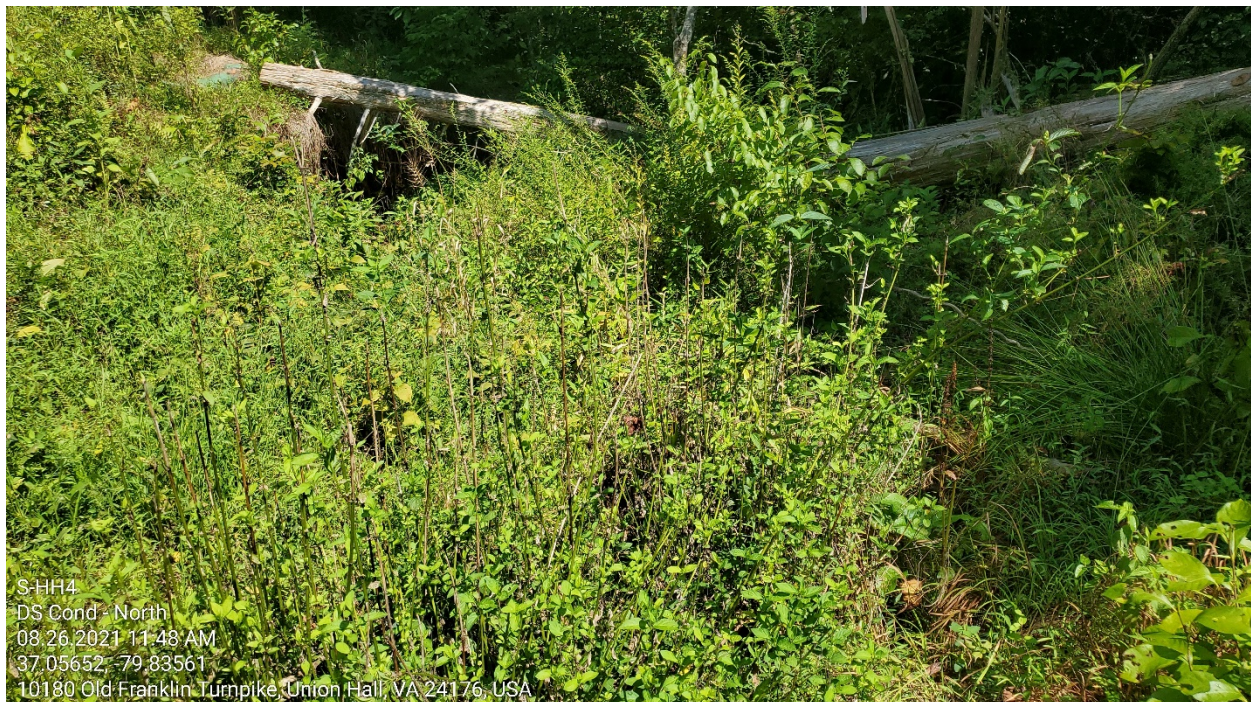
Photo Type: DS COND

Location, Orientation, Photographer Initials: Downstream at ROW/LOD looking N downstream, DW

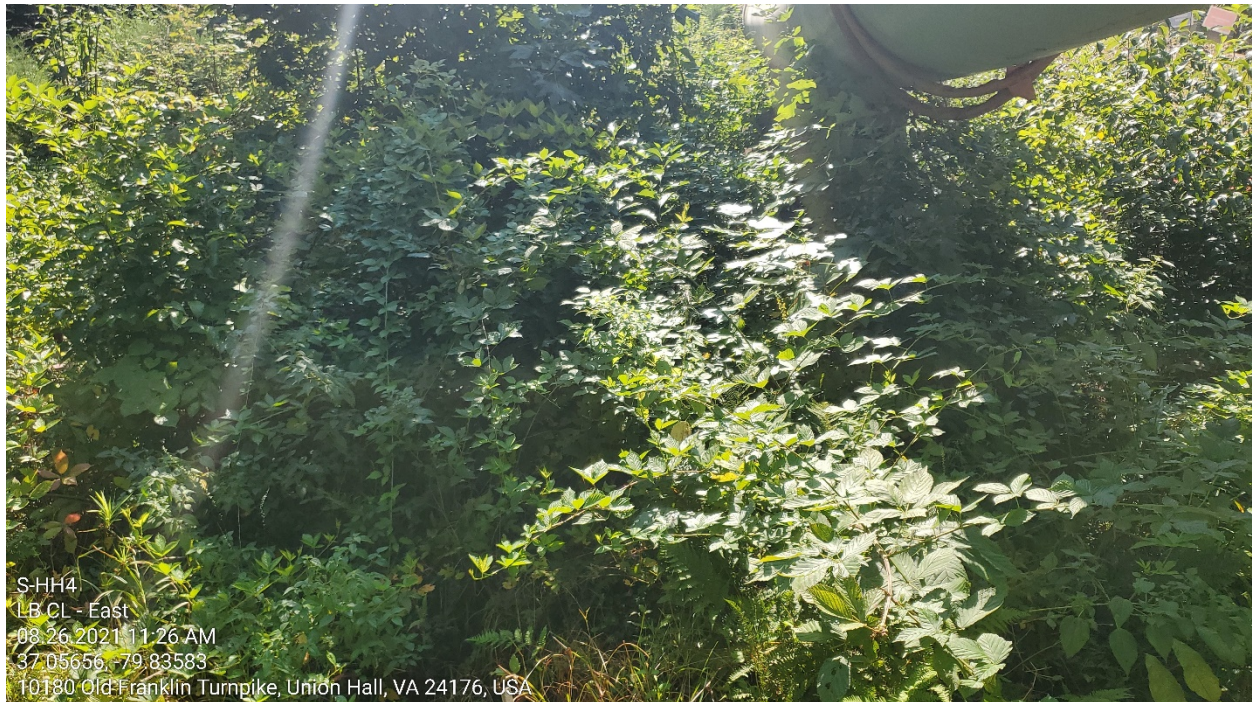
Photo Type: LB CL

Location, Orientation, Photographer Initials: On thalweg at pipe centerline looking E at right streambank, DW

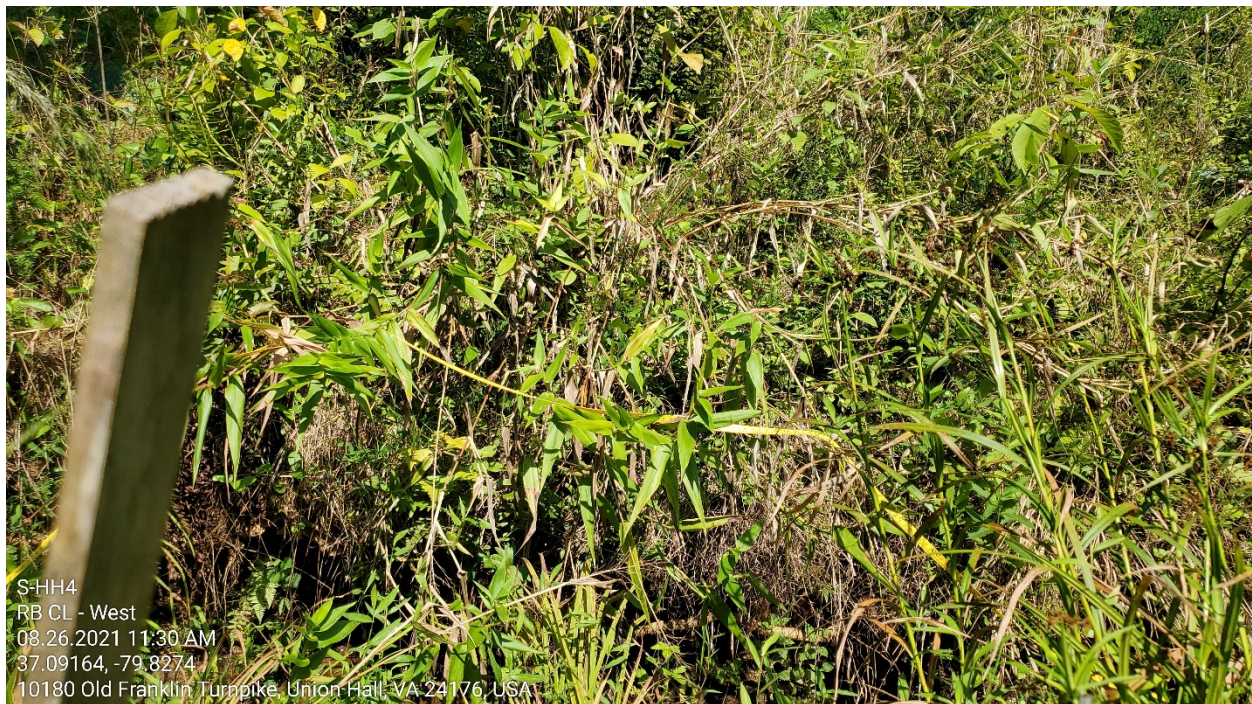
Photo Type: RB CL

Location, Orientation, Photographer Initials: On thalweg at pipe centerline looking W at left streambank, DW
