Baseline Assessment – Stream Attributes

Reach S-IJ10 (Timber Mat Crossing)

Franklin County, Virginia

Project #	Project Name (Applicant)	Locality	Cowardin Class.	HUC	Date	SAR #	Impact Length	Impact Factor	
22865.06	Mountain Valley Pipeline (Mountain Valley Pipeline, LLC)	Franklin County	R3	03010101	8/27/21	S-IJ10	20	1	
Name(s) of Evaluator(s)		Stream Name and Information					SAR Length		
TC, KD		Little Creek					83

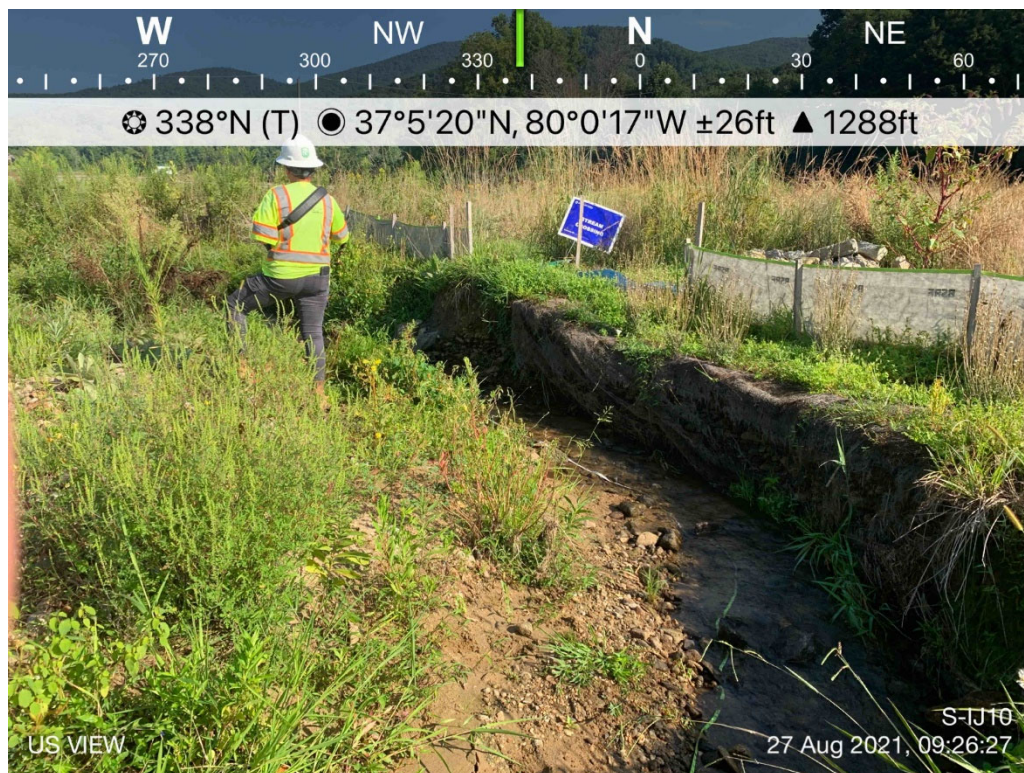
Photo Type: US VIEW

Location, Orientation, Photographer Initials: Upstream view of ROW looking NW, TC

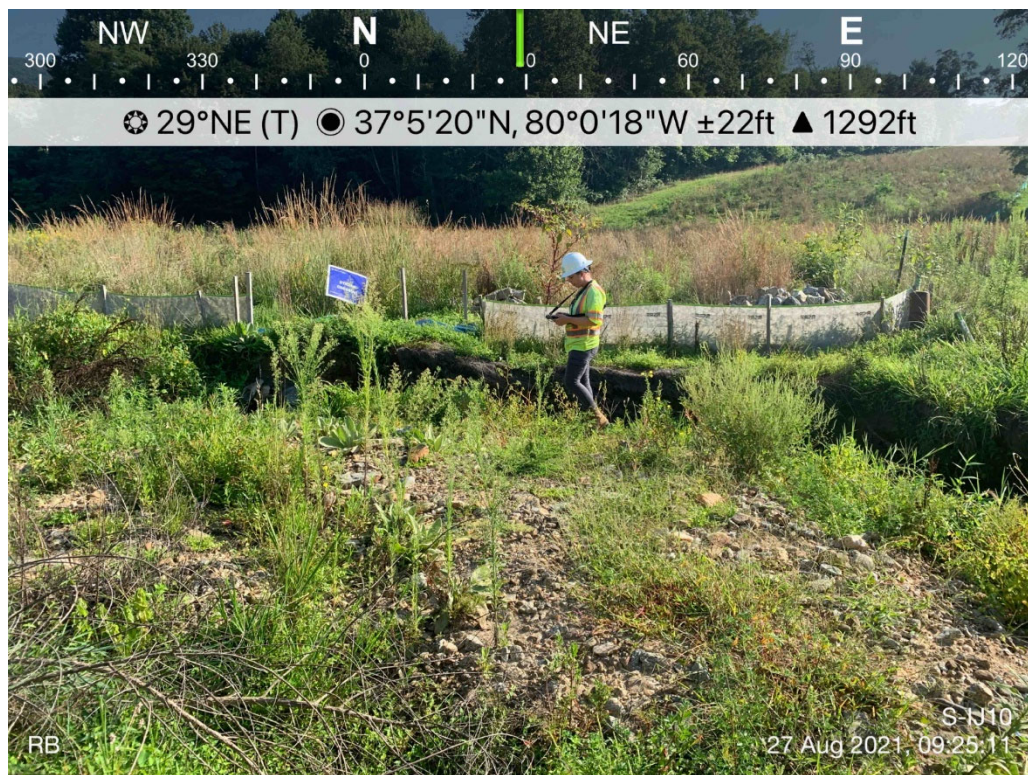
Photo Type: RB CL

Location, Orientation, Photographer Initials: Standing on RB looking at LB along pipe centerline looking NE, TC

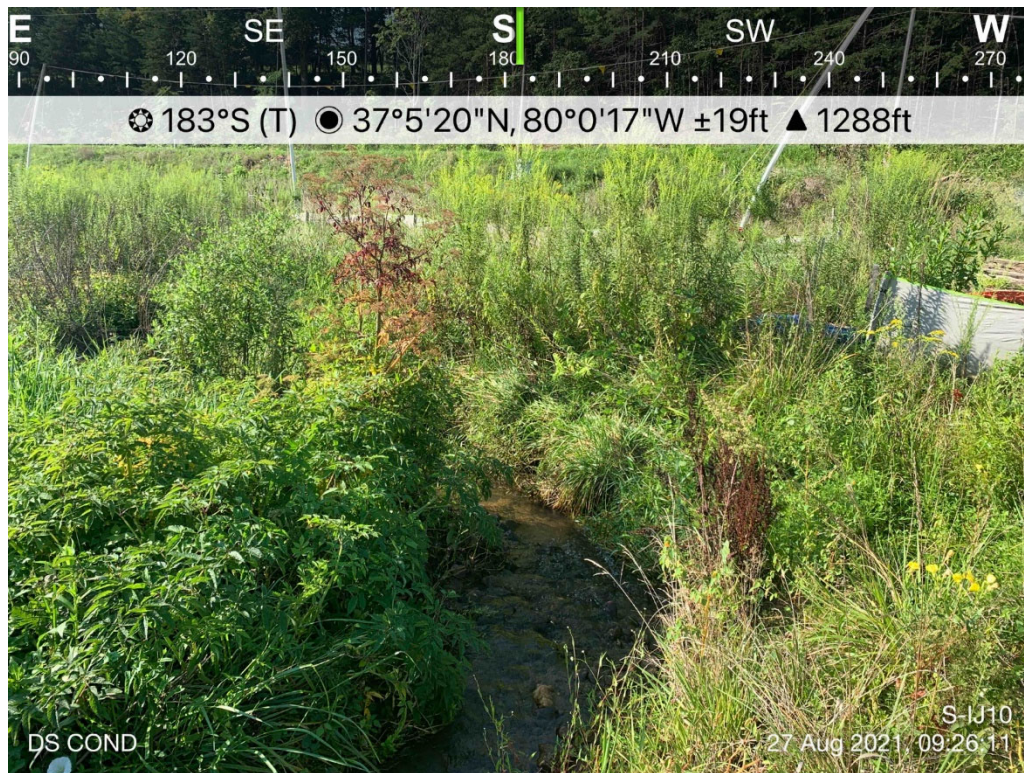
Photo Type: DS COND

Location, Orientation, Photographer Initials: Downstream conditions outside of ROW looking S, TC

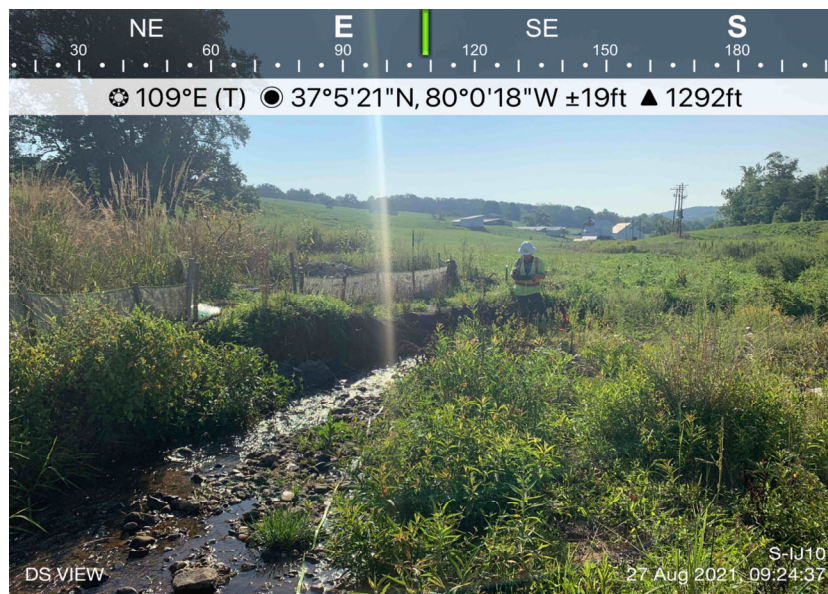
(WSSI Photo Location L:\22000s\22800\22865.06\Admin\05-ENVR\Field Data\Spread I\Field Forms\S-IJ10\Photos\DS VIEW.JPG)

Downstream view facing E within the ROW. Assessment is limited to areas within the temporary ROW.
