Baseline Assessment – Stream Attributes

Reach S-001 (Pipeline ROW) Intermittent Spread I Pittsylvania County, Virginia

Crossing S-001/W-MM3- UNT to Little Cherrystone Creek (MP 302.1)

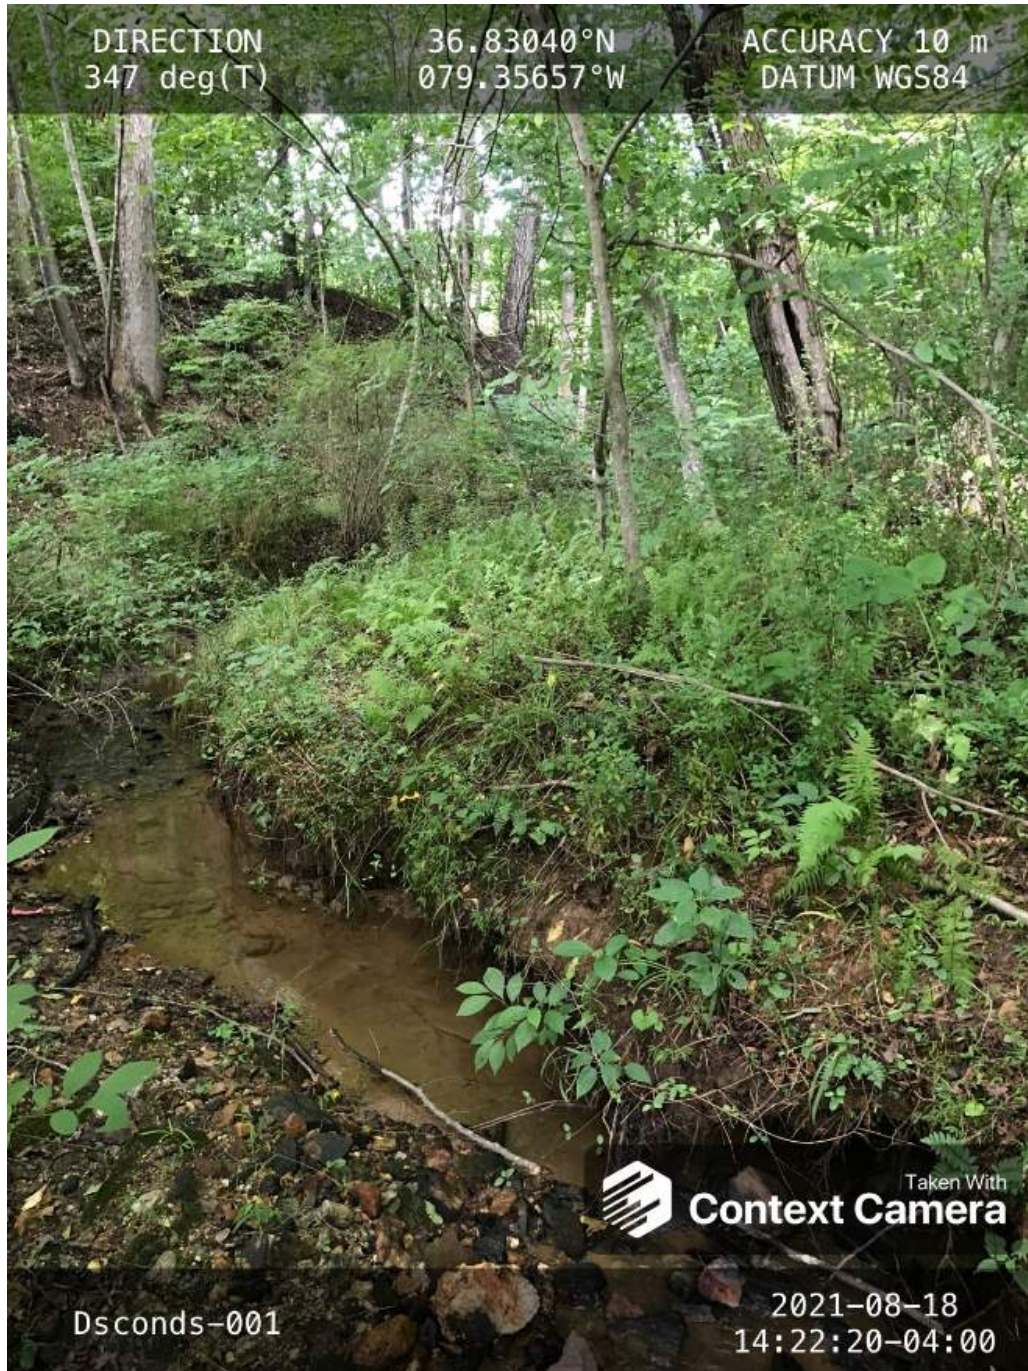
Photo Type: DS COND

Location, Orientation, Photographer Initials: Downstream conditions outside LOD looking NE, RH

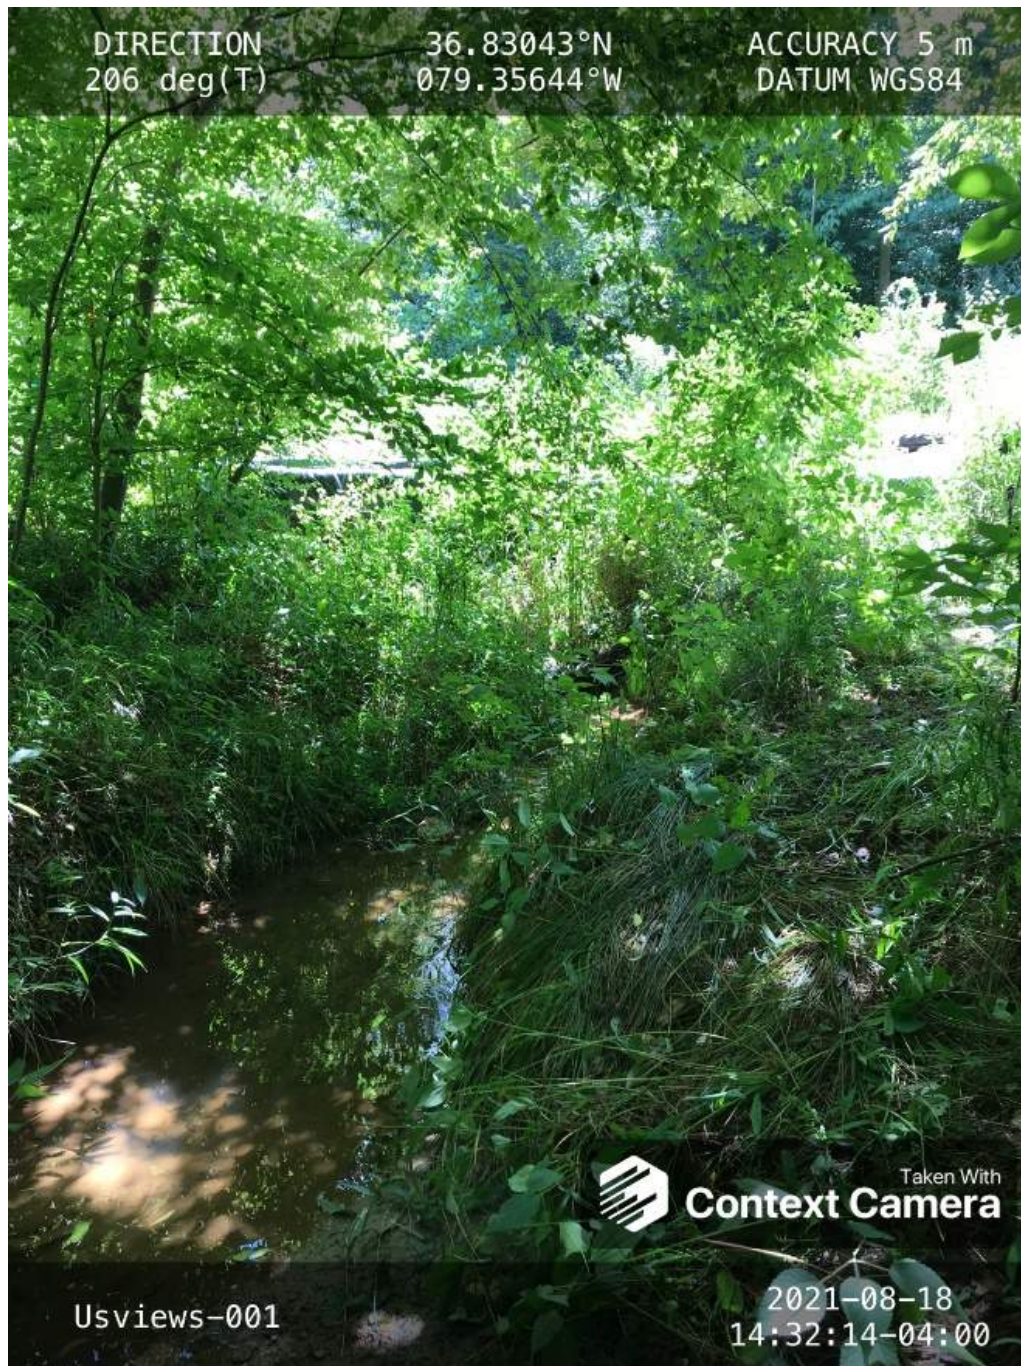
Photo Type: US VIEW

Location, Orientation, Photographer Initials: Upstream View of impact area inside LOD looking SW, RW

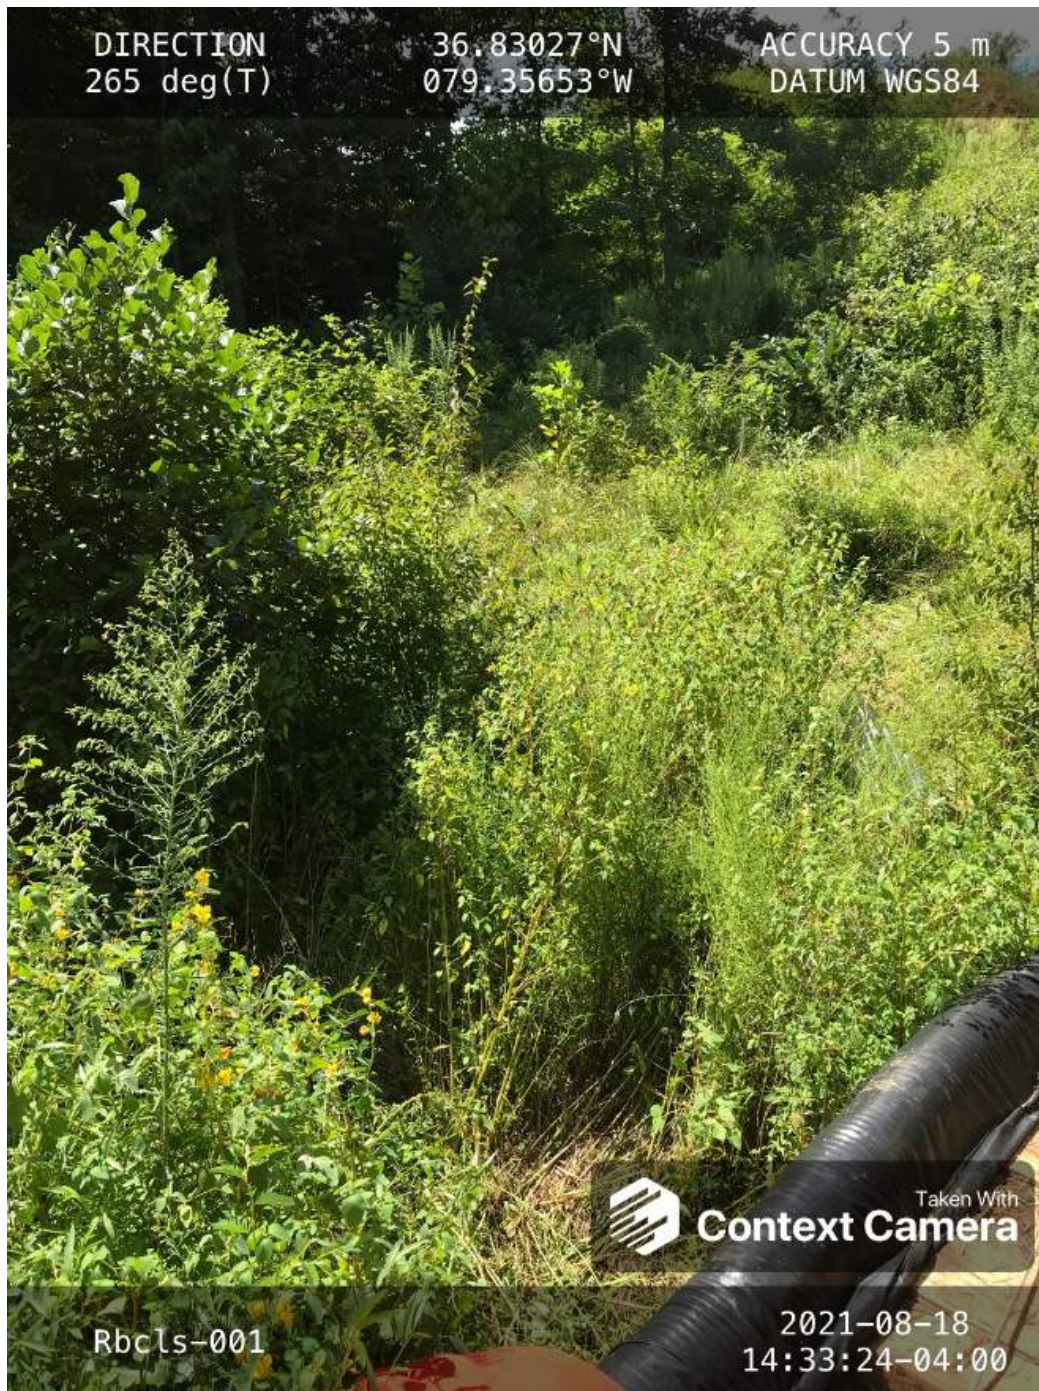
Photo Type: RB CL

Location, Orientation, Photographer Initials: Standing on Right Bank looking down pipe C/L to the NE, RH

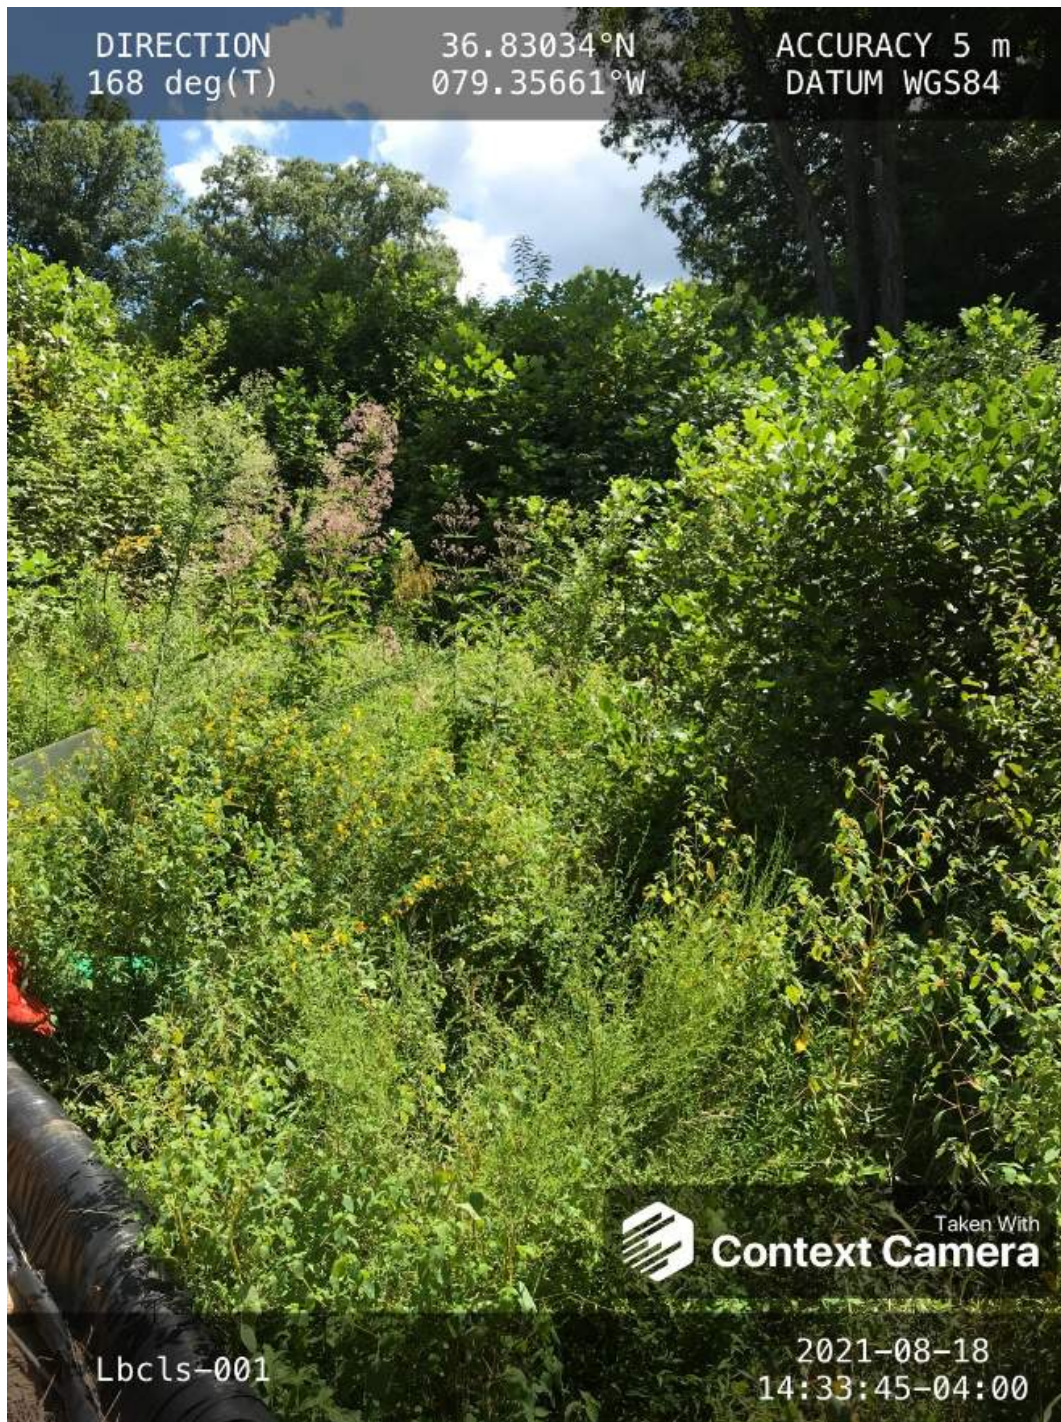
Photo Type: LB CL

Location, Orientation, Photographer Initials: Standing on Left Bank looking down pipe C/L looking NE, RH

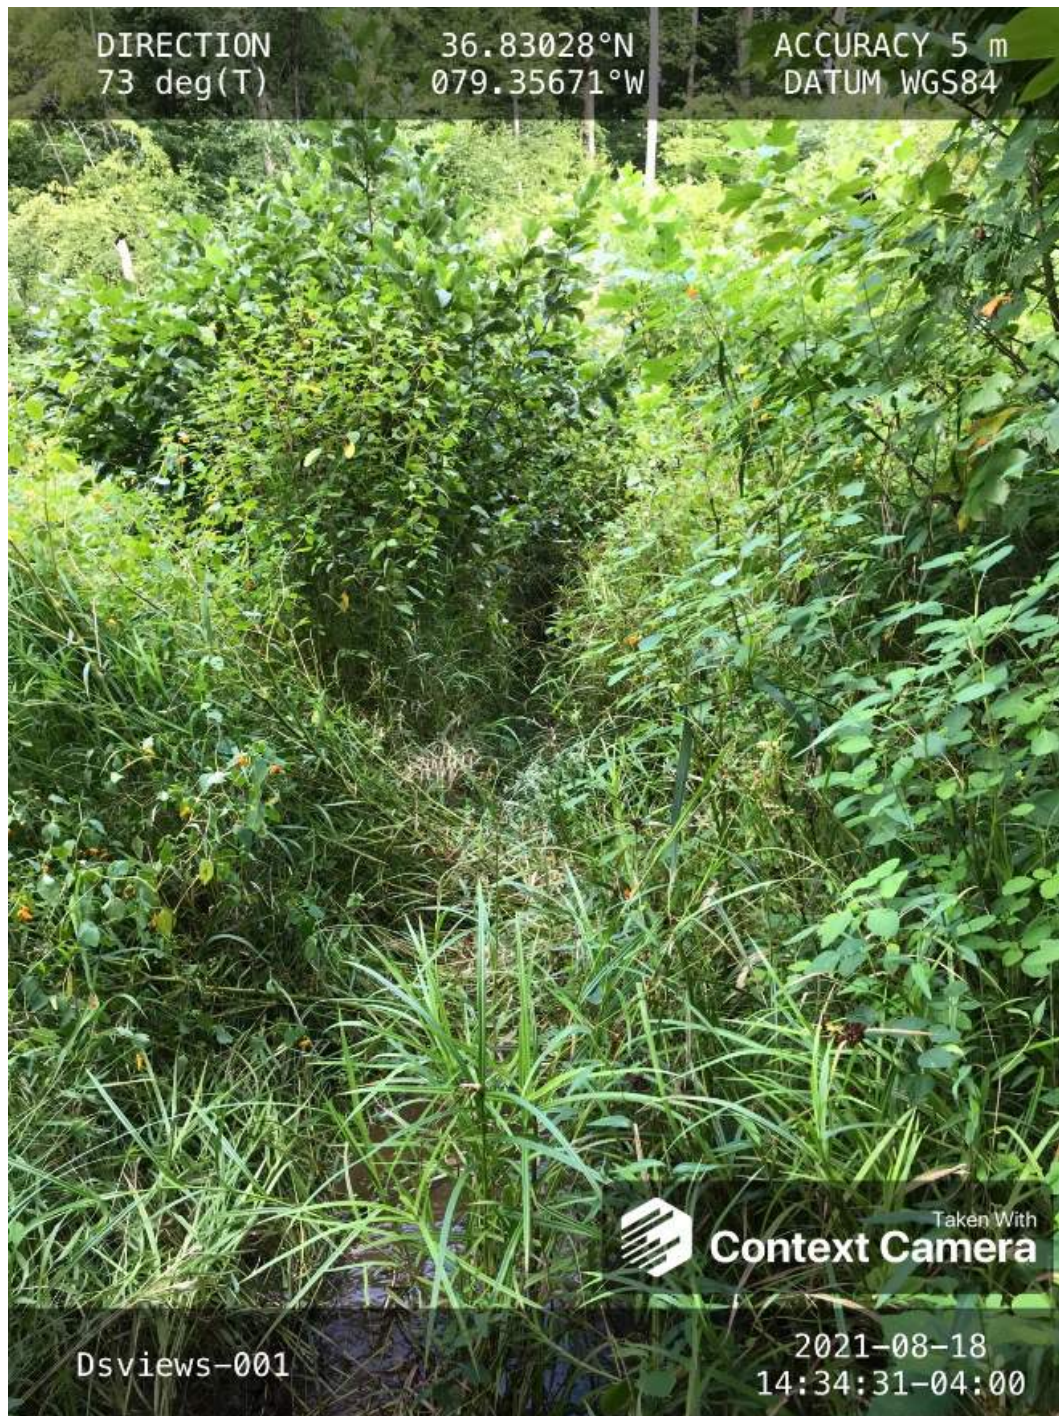
Photo Type: DS VIEW

Location, Orientation, Photographer Initials: Downstream View of impact area inside LOD looking NE, RH
